POST-FIRE DAMAGE ASSESSMENT OF A COMPOSITE WINGBOX

May 2004

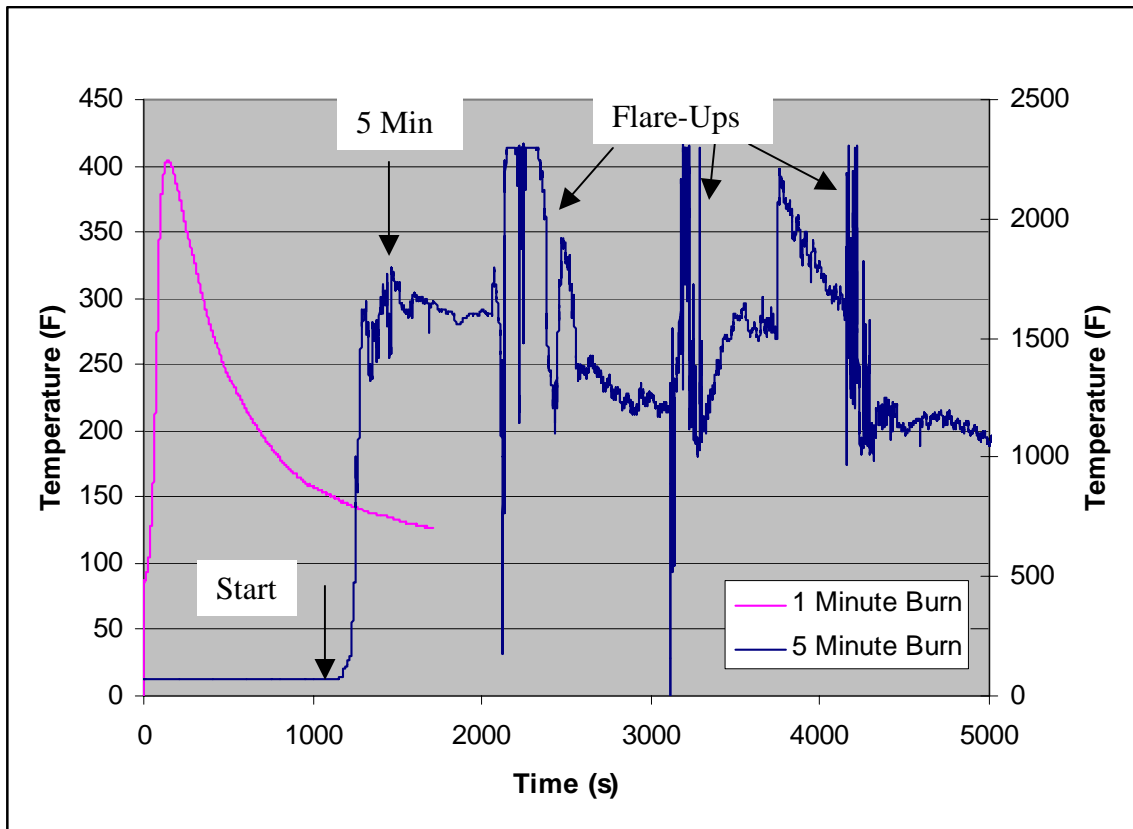
Figure 5 Typical Thermal History of Samples from both Wing Boxes

Typical thermal profiles are shown in Figure 5 for both burn tests, as measured on the exposed side (bottom) of the wing boxes. As expected, the 5 minute burn results in composite ignition and continued heat release and burn despite extinguishing the flame, indicating deep-seated fires within the structure. Optical micrograph and SEM analyses are ongoing.

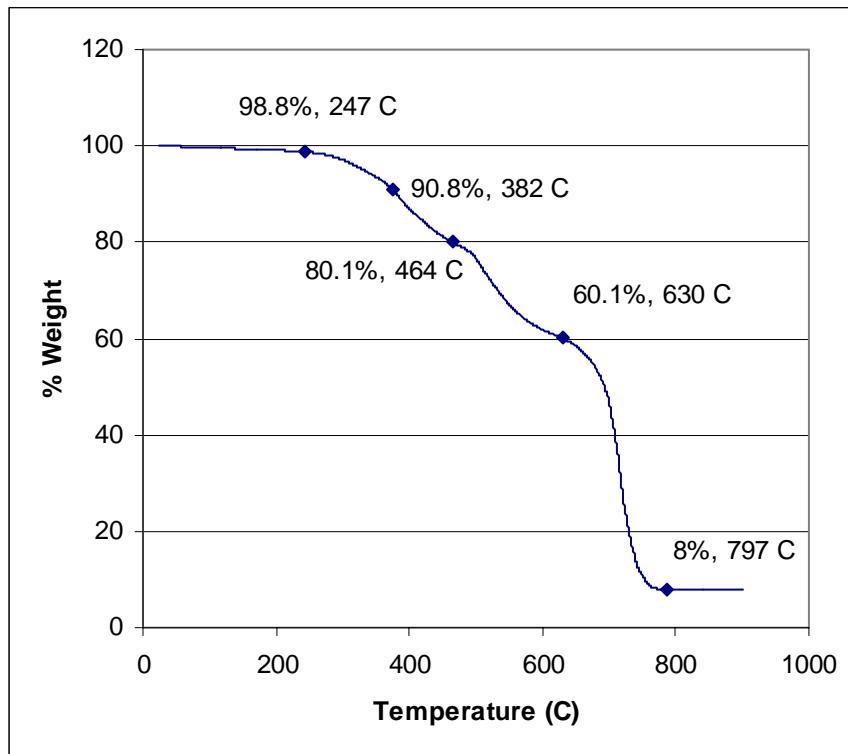
Figure 6 Degradation Behavior of AS4/3501-6. Sample from 1 minute Wing Box (1W-T-4)

Thermogravimetric analysis of wing box samples was done using a TA Instruments Q500 TGA. Air was used as the purge gas with a flow rate of 5C/min. Figure 6 shows the averaged weight loss of the sample as a function of temperature. Initially 0.5% weight loss up to 140C was observed, indicating the moisture lost which agrees well with our drying experiment measurement (~0.4%). The next significant step occurred at 1.2% up to 248C, which maybe due to decomposition of the surface coating (paint etc) of the wing box. However, this needs to be verified with additional experiments. The third weight loss (10%) step occurs up to 382C followed by 40% weight loss up to 630C, which correlates well with the expected resin content (~ 40%). The final weight loss of approximately 92% is due to carbon fiber decomposition. However, depending on the heat flux (much higher in a fire compared to the TGA) and thermal properties of the fiber and resin decomposition may have occurred at lower temperatures in the wing box samples. The TGA results indicate an “idealized” decomposition pattern of the composite material used in the wing box. Further investigation is ongoing.

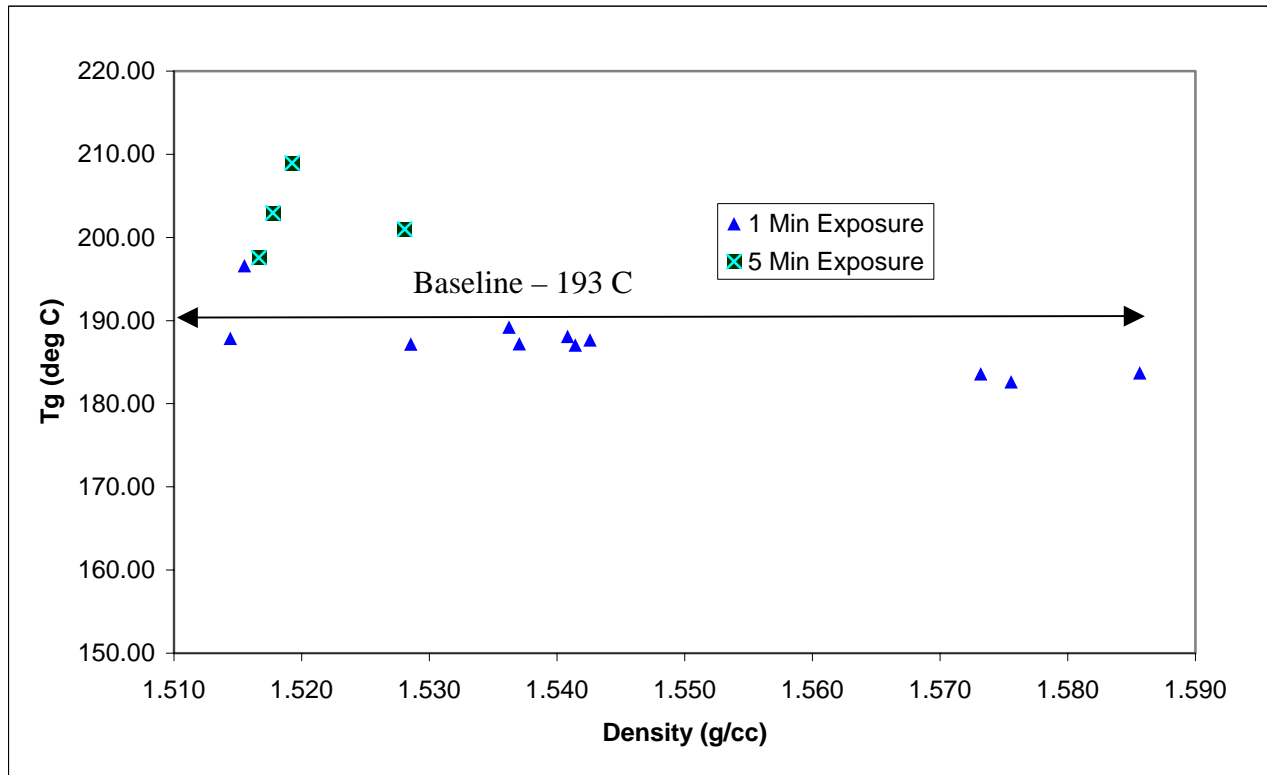
Figure 7 Density and Tg variations in the Wing Box Samples

A comparison of Tg vs measured density is shown in Figure 7 for the 1 minute and 5 minute samples. The higher exposure samples (that were measurable) show a consistently high Tg compared to the lower exposure samples. While Tg values are reasonably consistent for the 1W samples, the wide variations in density may be due to the following reasons: coating loss on samples showing some surface damage will reduce density (reductions average ~4%), while samples that show scorching and pitting may have localized resin loss, thus artificially increasing

density. All the 2W samples will show lower density due to fiber oxidation and resin decomposition. This hypothesis is being further investigated and validated.

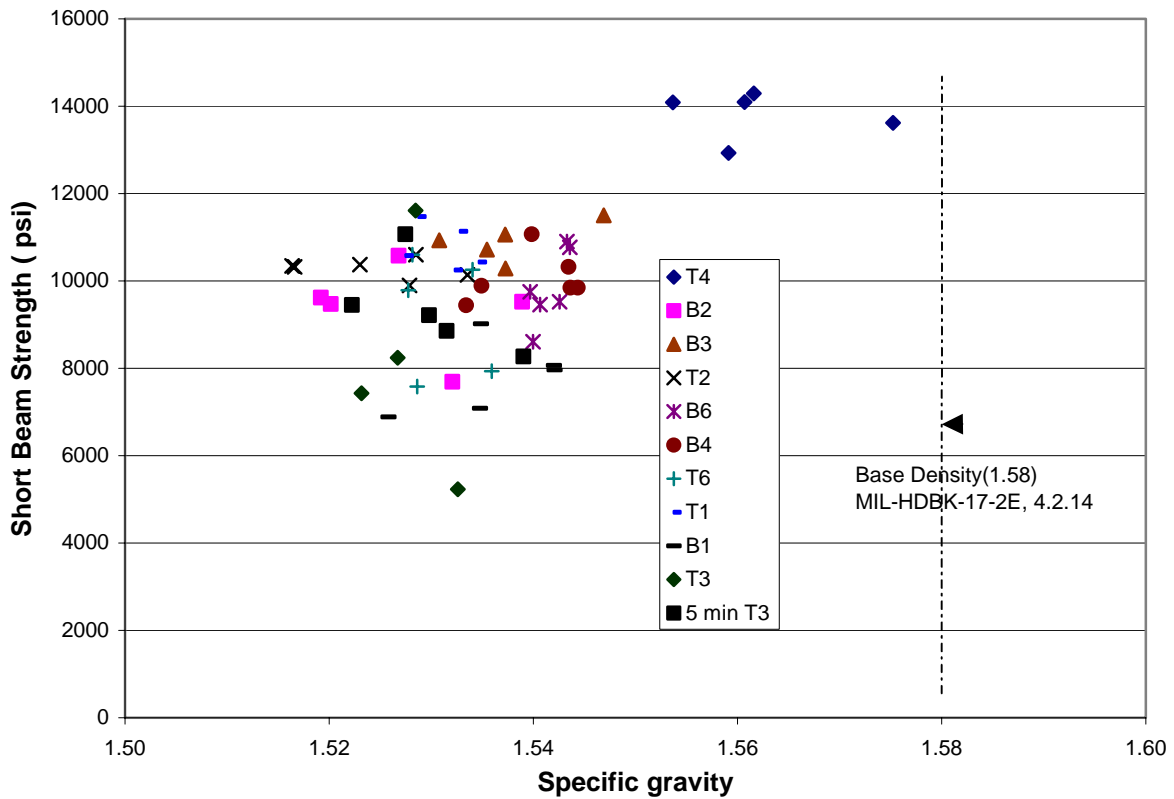
Figure 8 Short Beam Shear Strengths as a function of Wing Box Sample Density

Short beam shear strengths were measured for specimens from both wing box samples. Average values are listed in Table 3, with the actual values plotted as a function of density in Figure 8. The trend of decreasing shear strength with decreasing density is clear and an examination of the failure modes shows a mix interlaminar shear and tension/compression failure. This is expected due to the surface damage on the 1W samples and ongoing flexure tests are expected to better quantify the effect surface damage.

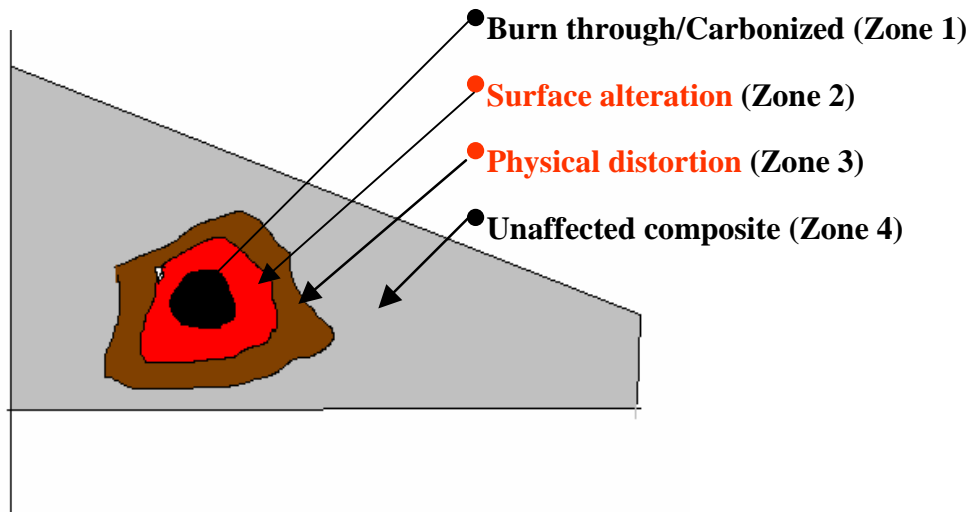
Figure 9: Schematic of typical burn zones due to fire damage

Based on the property assessments in the wing box samples, fire damage can generally be classified into four zones as shown schematically in Figure 9, irrespective of thermal history.

- Zone 1-Complete carbonization/burn through
