## **Assessment of Paint Layers by FE-SEM and EDS Examination**

**ARL-TR-3232**

**June 2004**

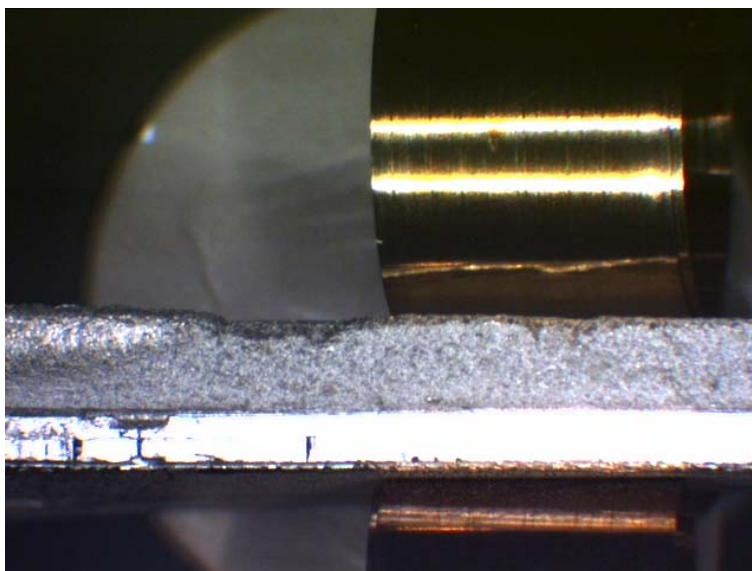
Figure 1. Panel 7 fracture face. Coating film is the thin light line across the upper quarter of the field. The thick bright bar running across the lower portion is the back-scored area.

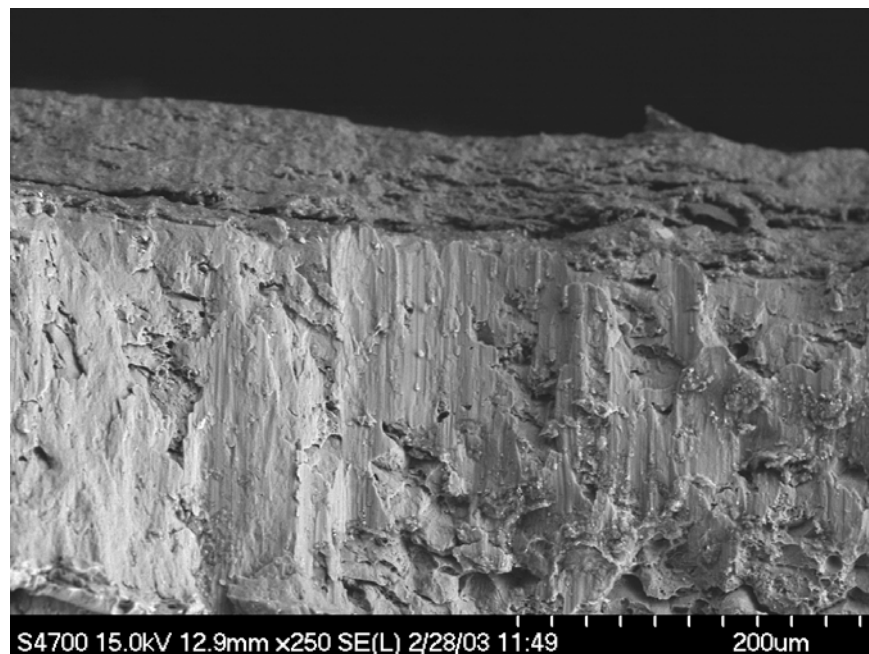
Figures 6 and 7 complete the available morphology documentation from panel 7. Note in figure 7 that only a portion of the surface is in clear focus. The film edge being imaged is below the panel fracture edge, and the size of both the vise mount and the panel strip limited stage tilt, so it was not possible to clearly focus the entire depth or width of the film thickness.

Figure 6. Lower SE detector image of panel 7 strip, light gray area, and coating, thin dark gray area.

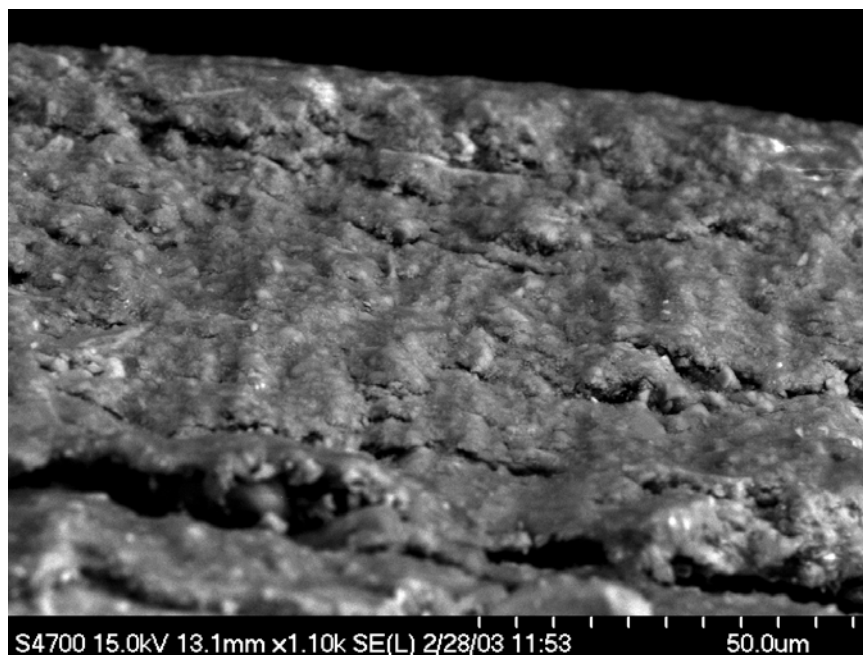
Figure 7. Lower SE detector image of panel 7 coating with aluminum panel (foreground).

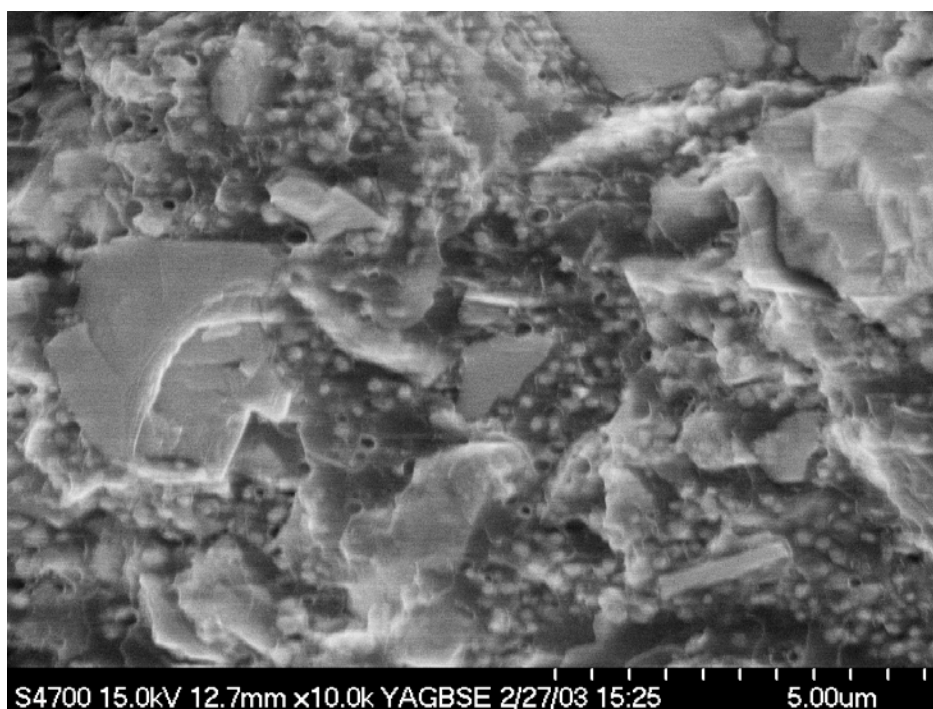
That clarity is reduced by charging at 10 KX (figure 12). Above 10 KX, charging became a problem. The 10-KX image was focused and stigmated at 18 KX, and a series of overlapping micrographs was taken to fully document the cross-section morphology of the film.

Figure 12. Panel 2 film YAGBSE image at 5 KeV.

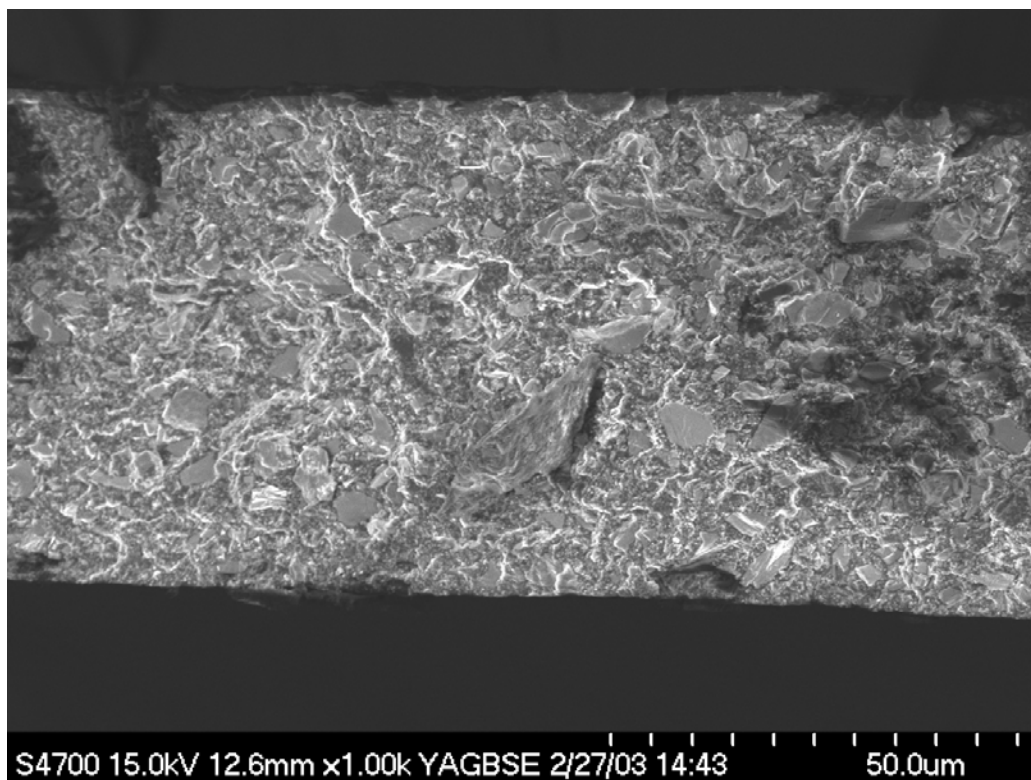
Figure 14. YAGBSE image at 15 KeV. Note charging.

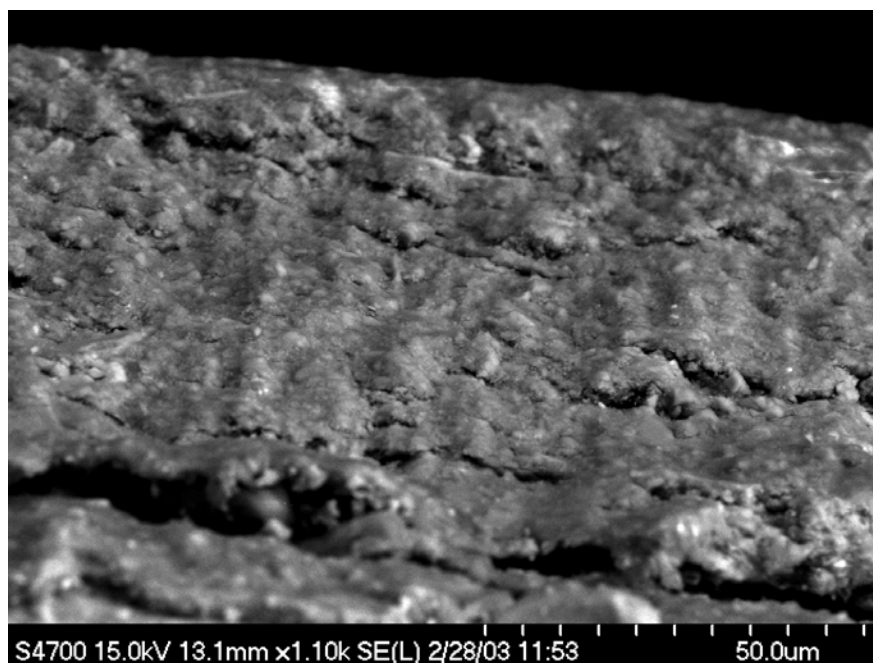
Figure 18. 1-KX image. Note lack of focus due to tilt.

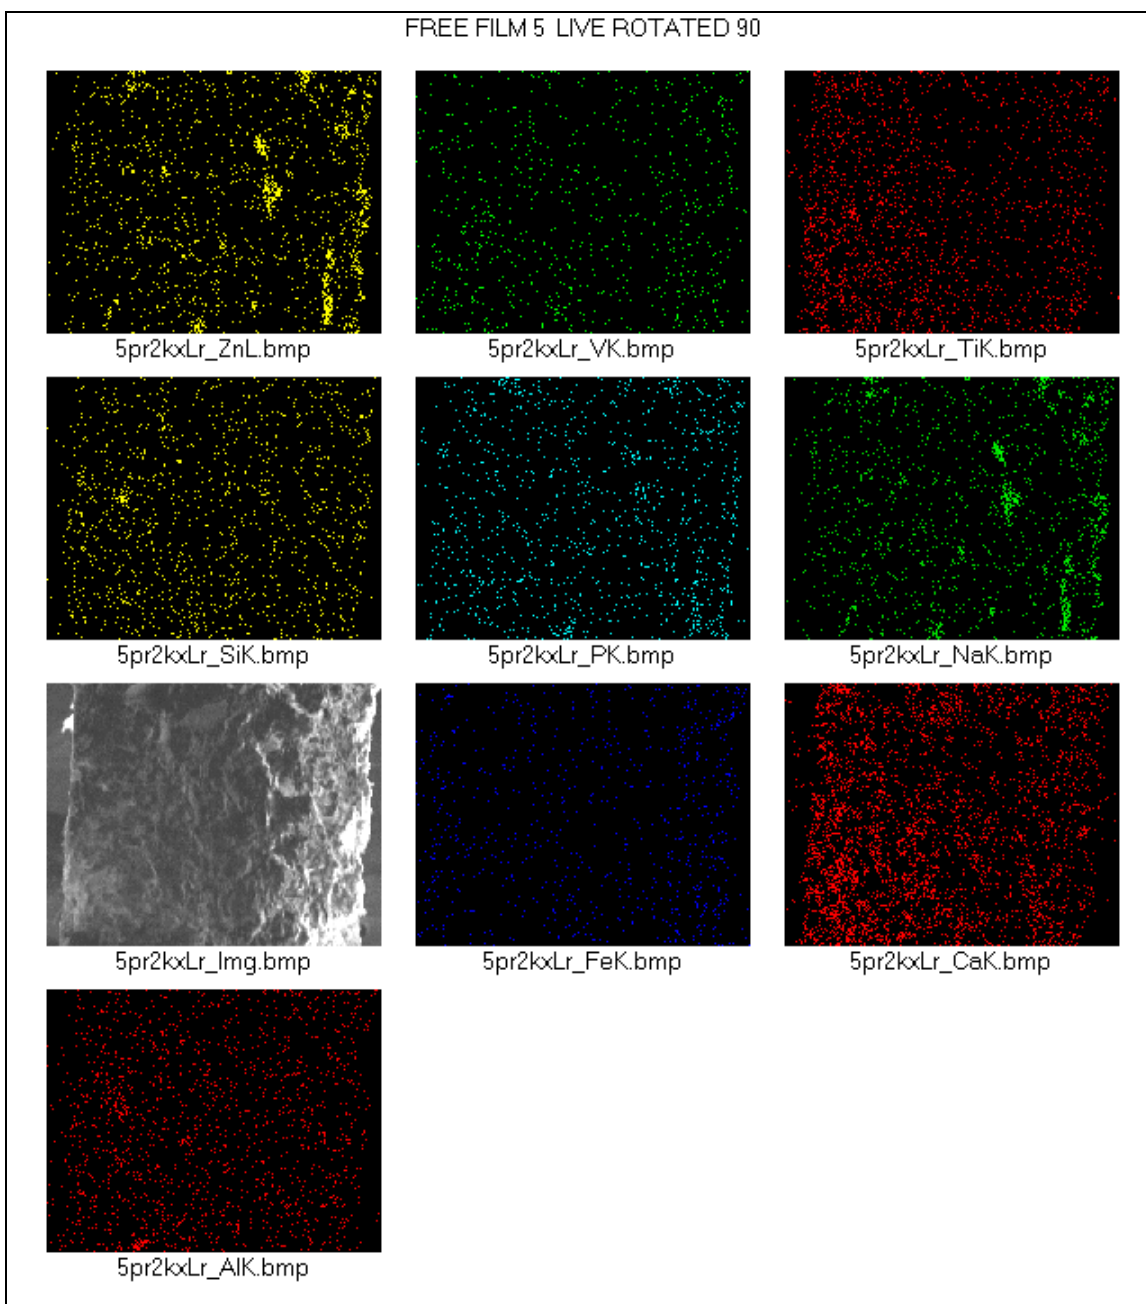
A Live mapping of this same region is shown in figure 25. For the Live mapping the dwell time was 100 ms/256 × 200 pixels frame, and 32 frames were captured. Note the loss of response for the P K peak.

Figure 25. Live mapping of figure 24 region post Quant mapping.

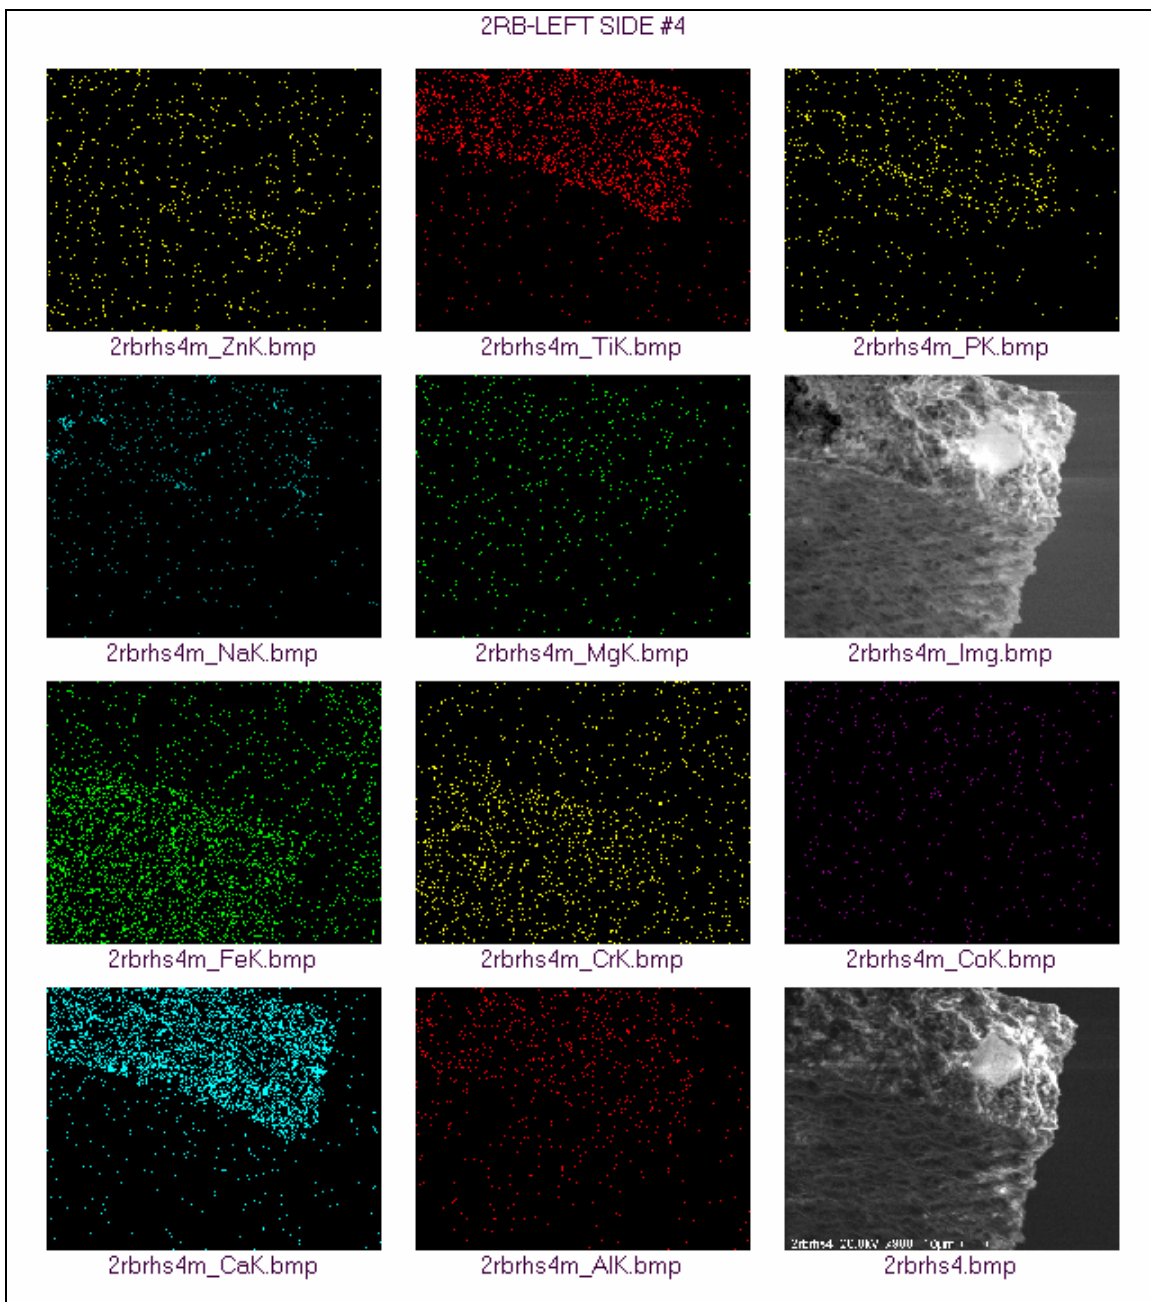
The Cr K maps in figures 29 and 30 appear to be similar for each edge. This may be a result of stacking the panels coated face to chromated face. These Live maps don't have sufficient information to identify a panel interface surface (figure 31).

Figure 31. Repeat of Live elemental map from figure 29.

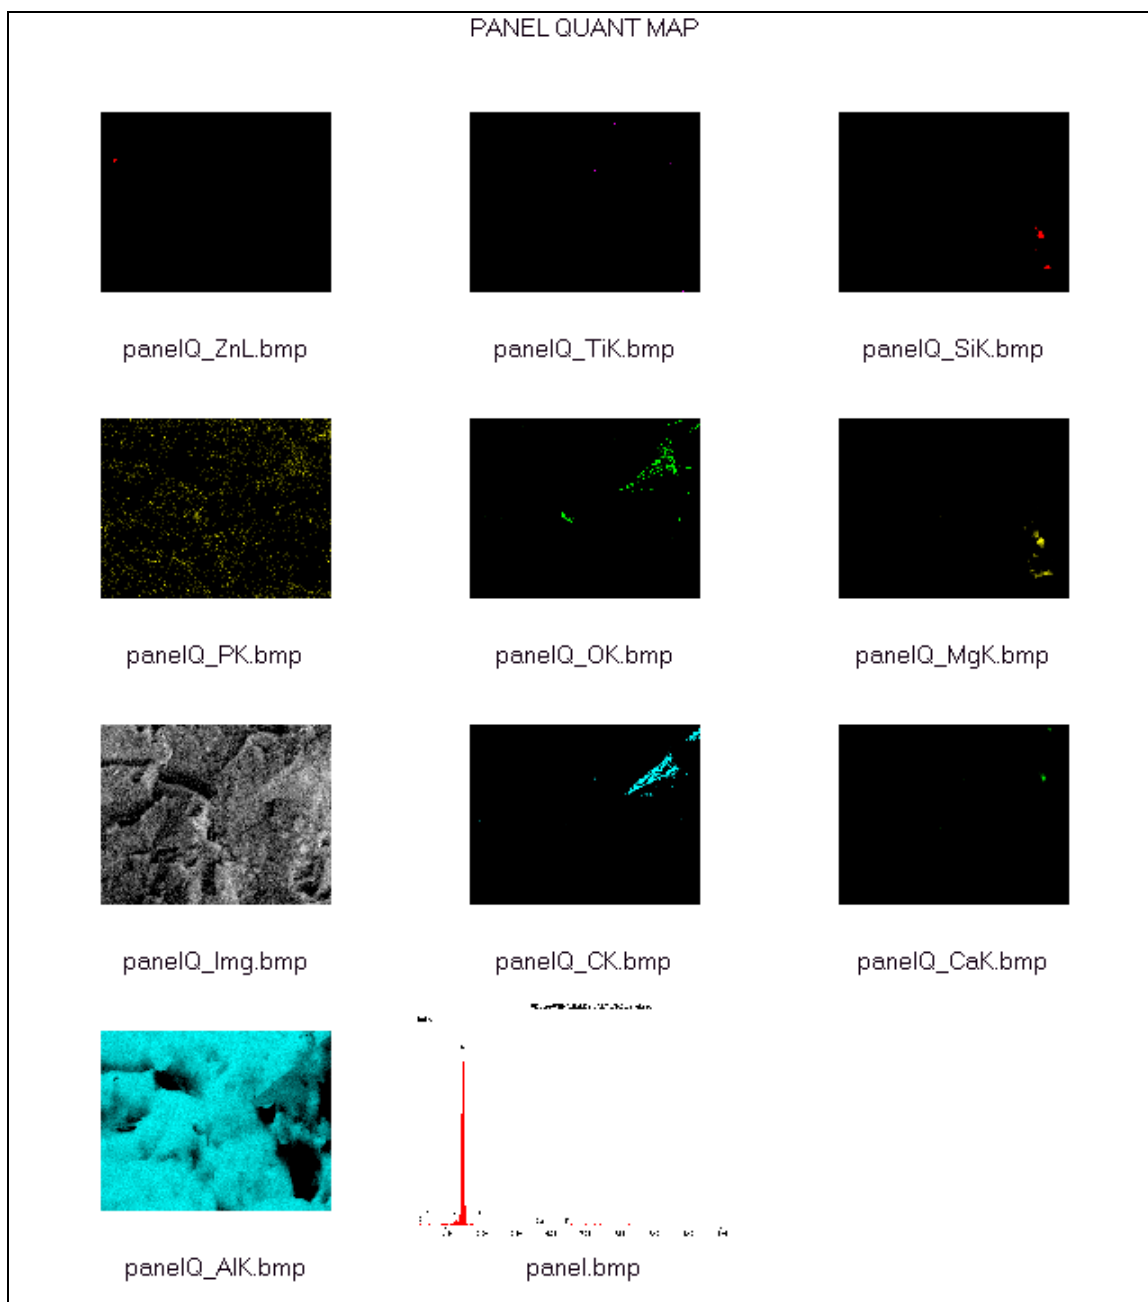
Finally, a spectrum and a Quant map were taken of the aluminum fracture face of panel 7 (figure 34). The panel with coating spectrum and the panel spectrum are presented in figure 35 for comparison.

Figure 34. Elemental mapping of the fracture face from panel 7.

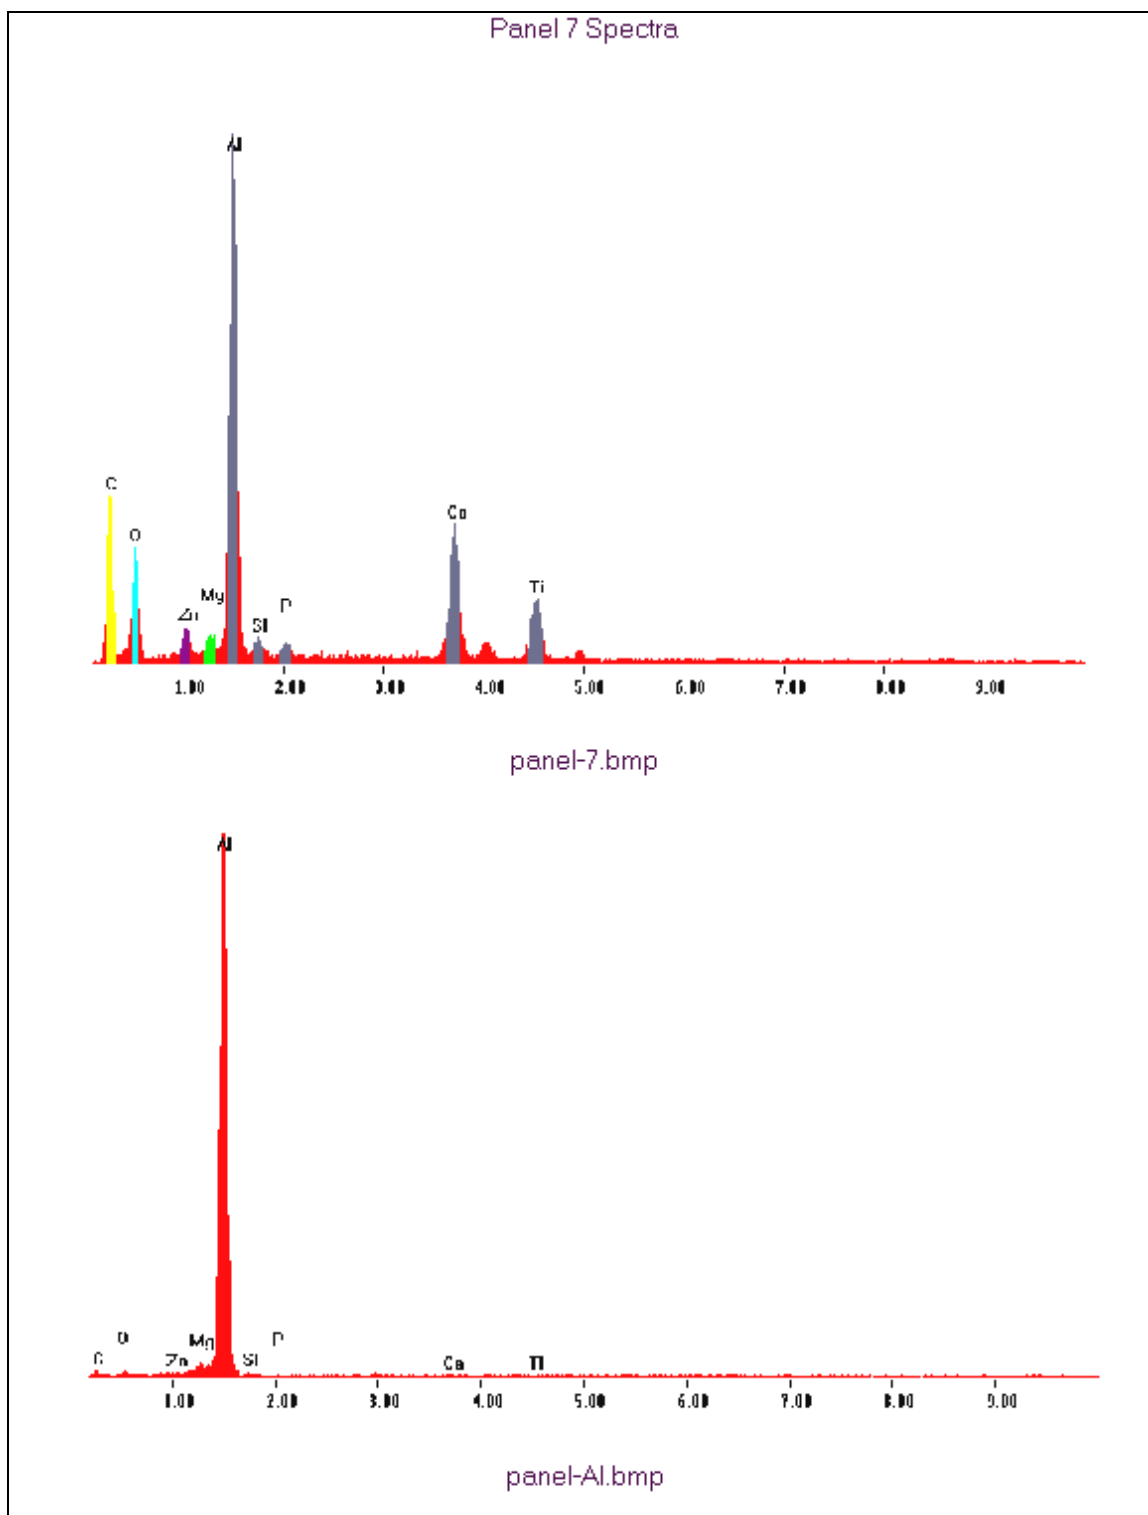
Figure 35. Panel 7 reference spectra.
