# FAILURE OF TUNGSTEN HEAVY ALLOYS SUBJECTED TO DYNAMIC TRANSVERSE LOADING

## ABSTRACT

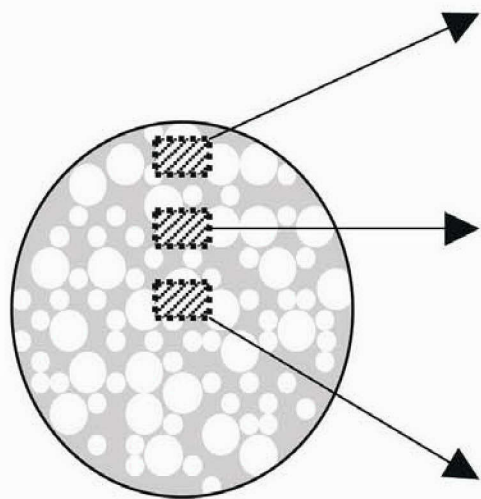
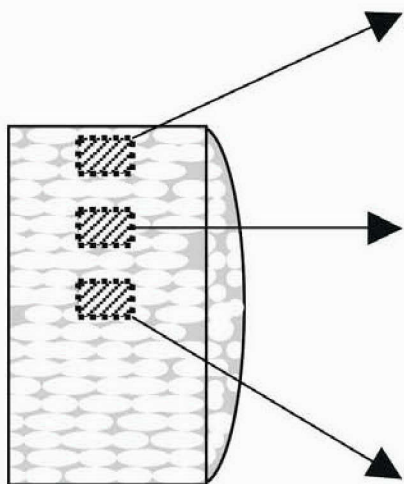
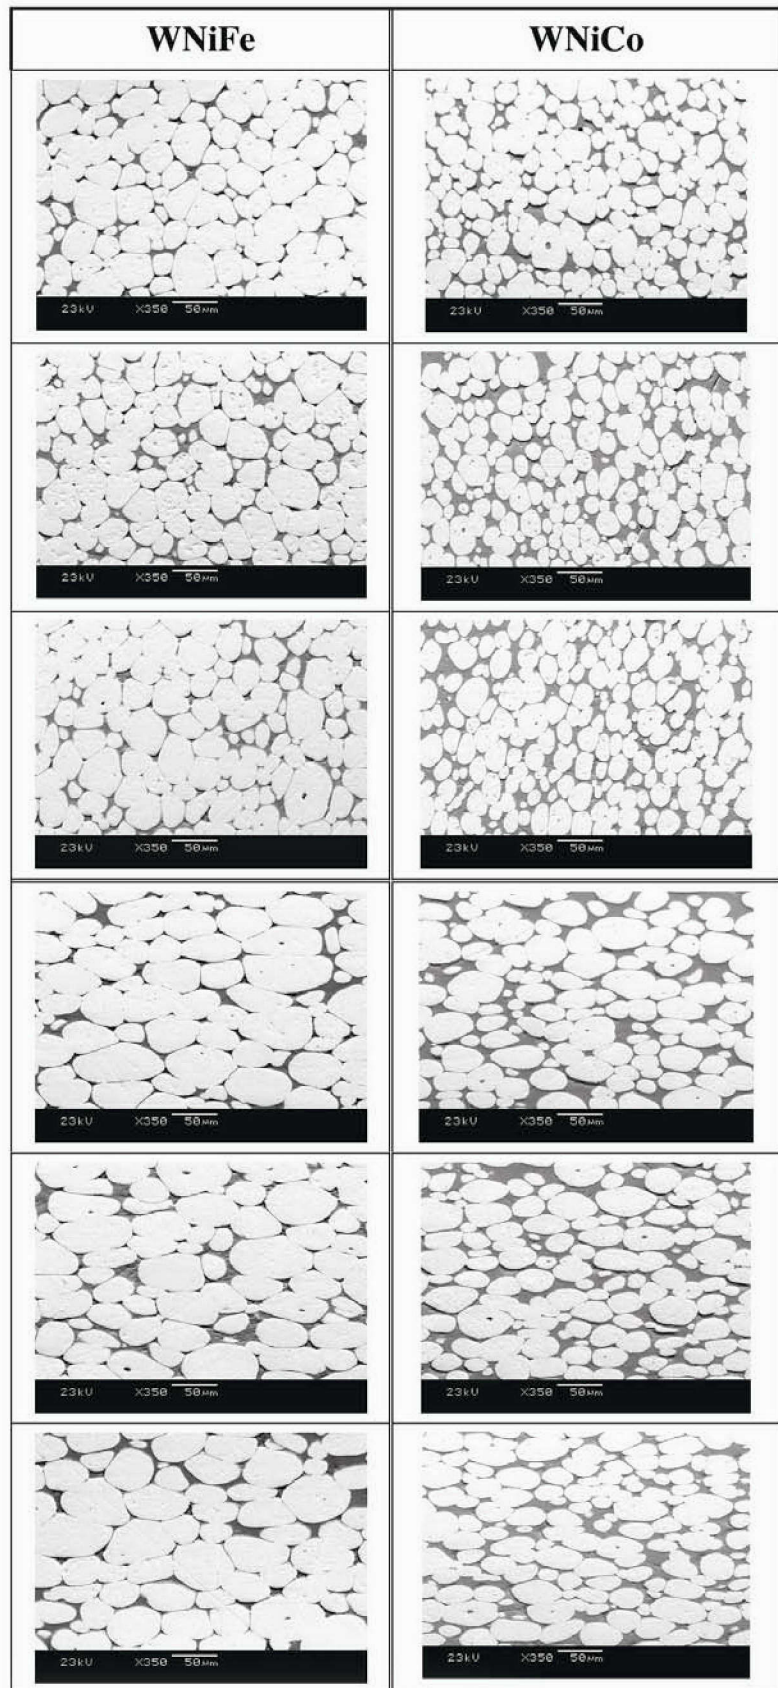
Figure 2. Microstructure of the as-received tungsten stock

Results are shown in Fig. 2. Each material is remarkably homogenous. The WNiCo alloy has a notably finer W grain size than the WNiFe alloy.

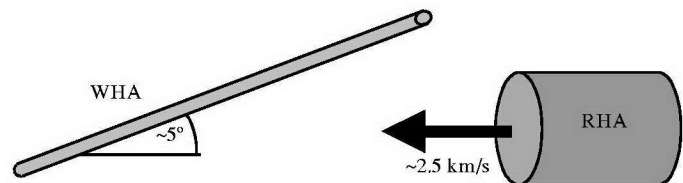
Figure 4. Reverse impact setup.

rod and the sleeve was avoided. Slightly increasing the sleeve thickness and reducing the core diameter as a result dropped the mass to 360 g while maintaining the exterior dimensions. The impact simulates a yawed rod impact onto a thick RHA target. The first part of the impact, which produces a crater, is avoided. However, the side of the rod comes in contact with the steel cylinder and cuts a slot in the cylinder. This is identical to what happens in a forward-ballistics yawed rod impact when the rod comes in contact with the sidewall of the crater. As the rod cuts a channel into the steel, the reaction forces from the steel deflect the rod. The mechanical response of the rod is the same as if it had hit a stationary target while flying with an angle of attack. It is also identical to the response of a rod struck by a transversely-moving flyer plate. Both scenarios are of great practical interest to the Army.
