# **NAVAL POSTGRADUATE SCHOOL**

**ANALYSIS OF THE FAILURE OF A VACUUM SPIN-PIT  
DRIVE TURBINE SPINDLE SHAFT**

Jason M. Pettitt

September 2005

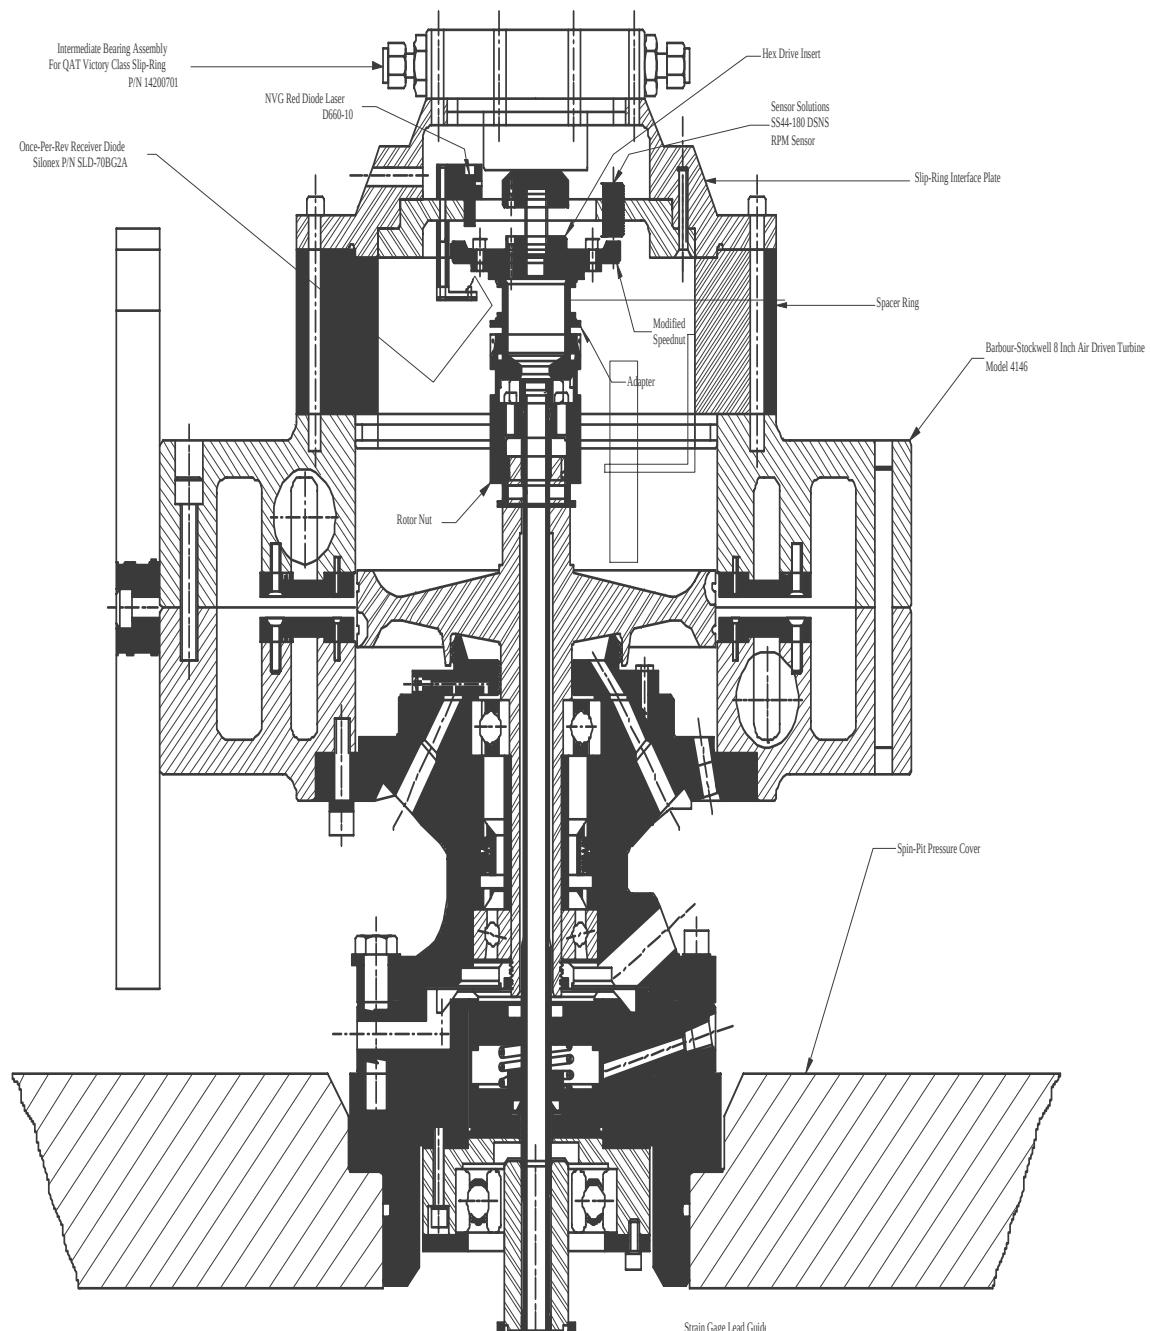
Figure 2. Turbine and Shaft Assembly

Figure 2 shows the turbine assembly and its complexity. At the time of the failure, the turbine was connected to the rotor test article by a hollow spindle shaft. The shaft was 14.775" in length, and had an outer diameter of 0.625" and an inner diameter of 0.400". The shaft was suspended on a button resting on a horizontal surface in the air turbine and was secured by a threaded nut.

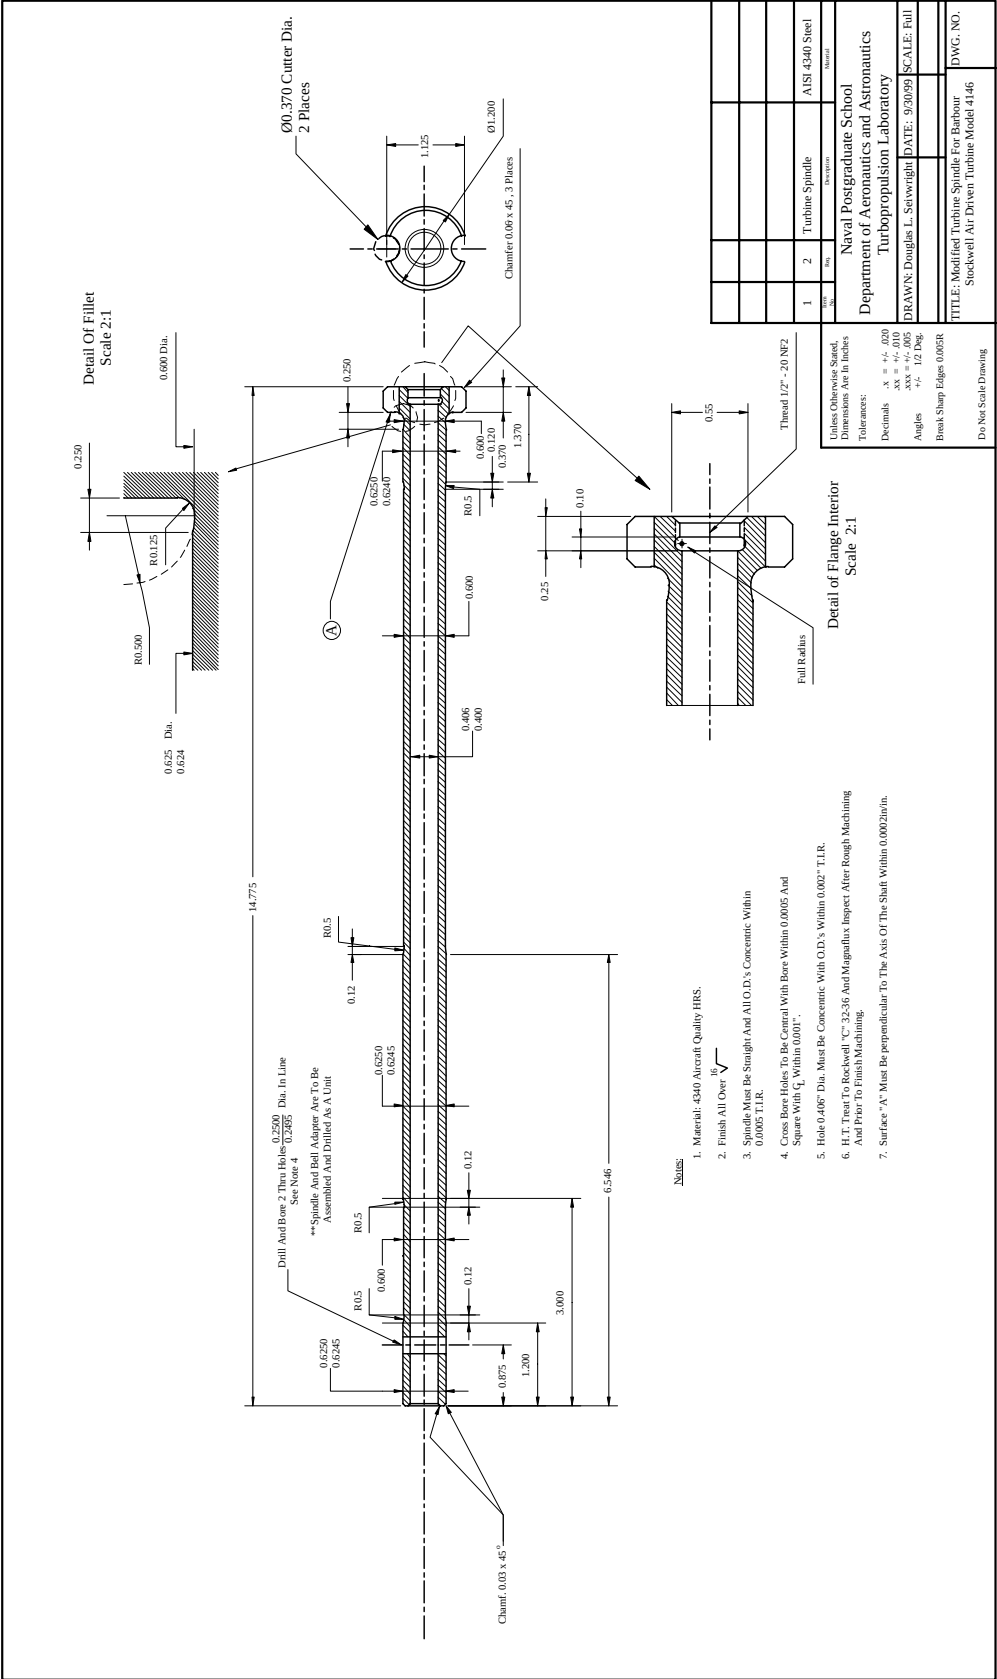
Figure 3. Design Drawing of the Spindle Drive Shaft

Figure 3 shows the design drawing for the spindle drive shaft, and Figure 4 shows how the shaft was connected to the adapter, collar and arbor. The test rotor was attached to the flange at the bottom of the arbor. The

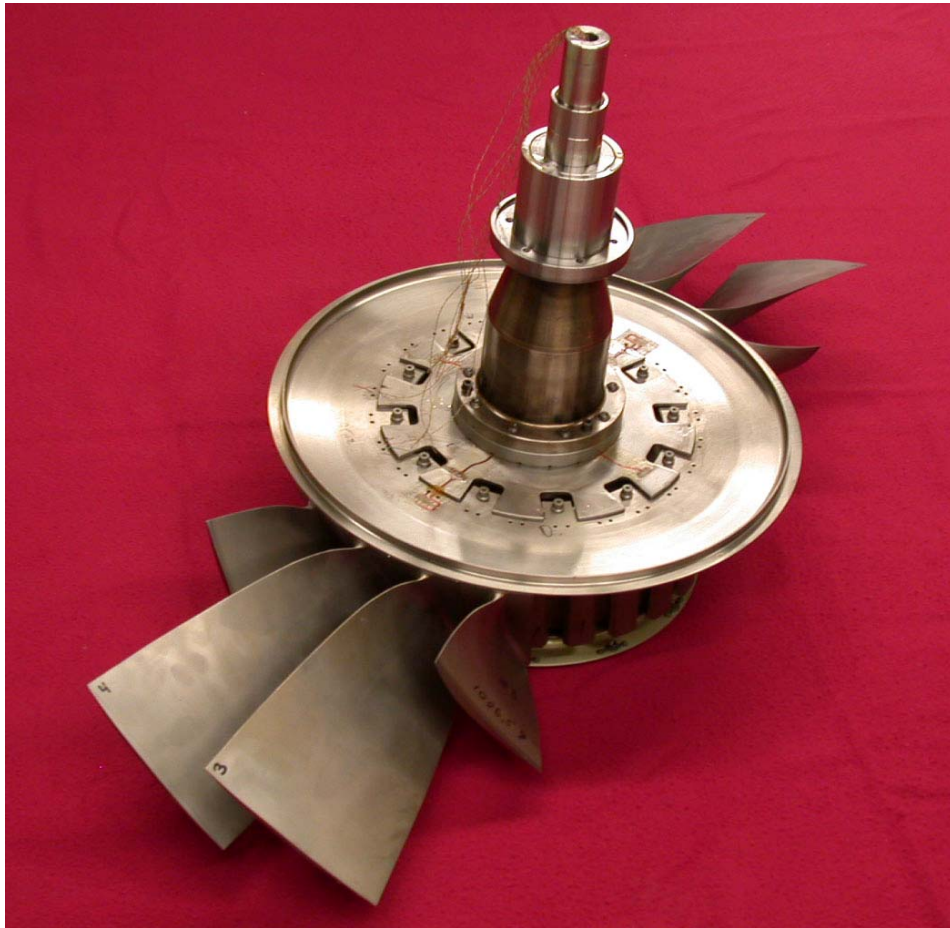
Figure 5. AE3007 (Configuration 2) Fan Rotor

On 14 March 2005, the Rotor Spin Research Facility began testing a revised oil nozzle configuration for blade excitation. The AE3007 (Configuration 2), shown in Figure 5, was the rotor that was installed.

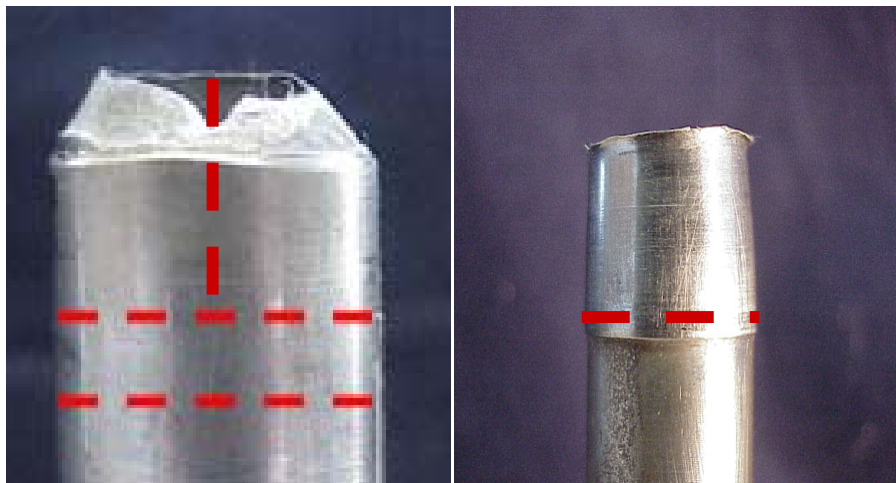
Figure 14. Sectioning of Spindle Shaft

complete lower spindle fracture surface was set aside for Scanning Electron Microscopy (SEM) Analysis. The upper spindle fracture surface was cut into two pieces in the axial direction, mounted, polished and etched with a Nital solution, for examination under the optical microscope. A “donut” cross-section was also taken from the shaft in order to conduct hardness testing of the material. This is shown in Figure 14.

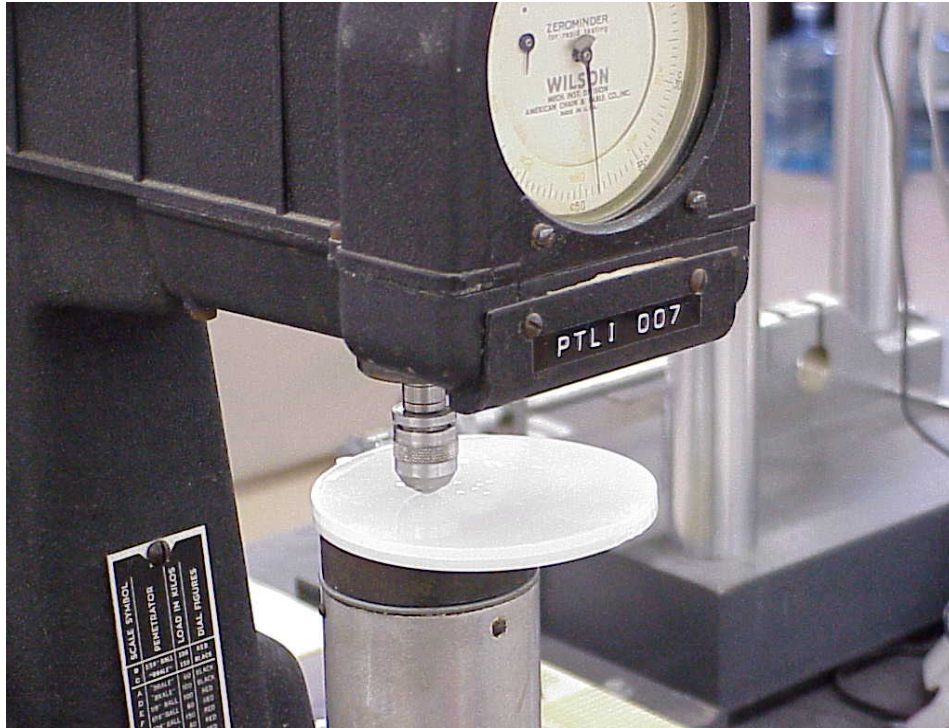
Figure 15. Wilson MIG1 Hardness Tester

Hardness testing was performed along the exposed sleeve of the sample using a Wilson MIG1 hardness tester (shown in Figure 15) calibrated for use on the Rockwell C scale. These measurements indicated a material hardness that was consistent with the 32-36 HRC range that was originally specified for the shaft. Six hardness measurements were taken at various places on the “donut” sleeve and a value of  $33.5 \pm 0.5$  HRC was established for the material. As this hardness reading was consistent with the specifications, it helped rule out improper treatment of the material as a possible contribution to the failure of the shaft.

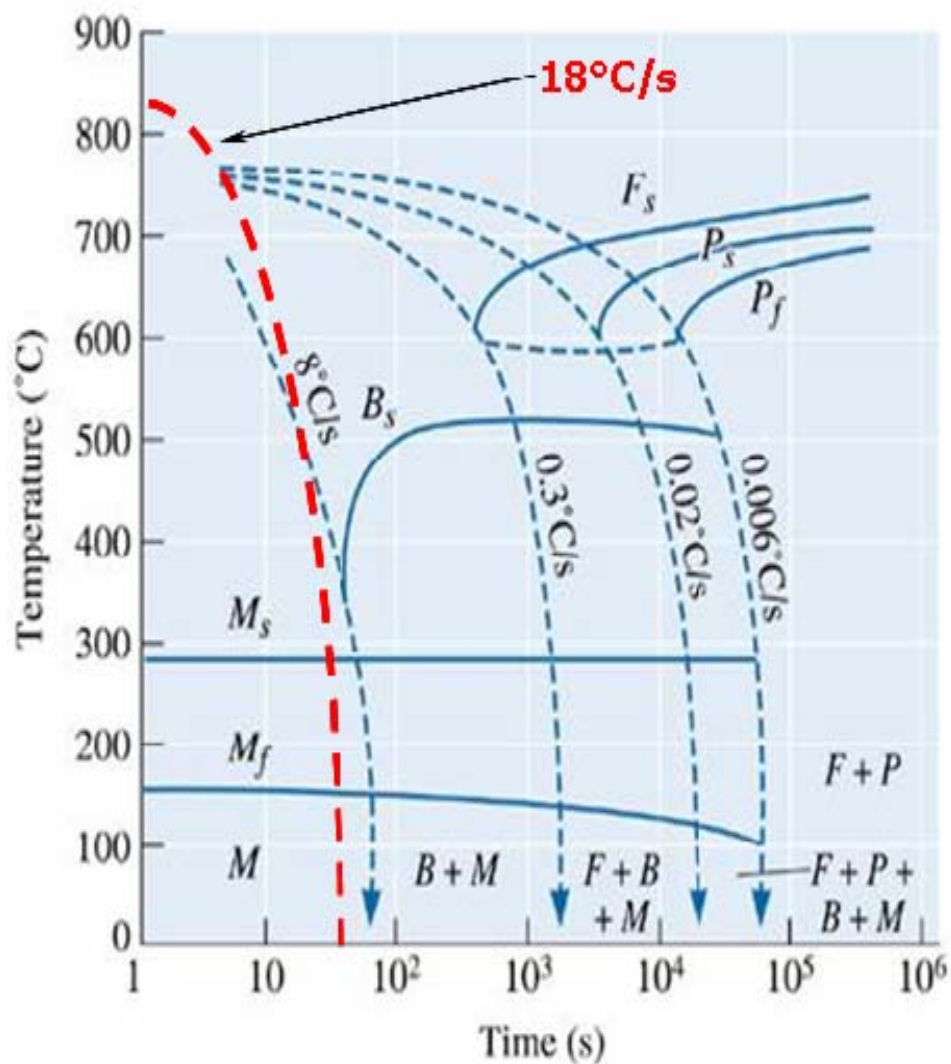
Figure 20. Continuous Cooling Transformation Curve for 4340 Steel (After Ref. 2)

From the continuous cooling transformation curve, shown in Figure 20, and using a conservative cooling rate of  $18^{\circ}\text{C/s}$  for an oil quench hollow shaft, it could be concluded that the spindle microstructure was 100% tempered martensite.

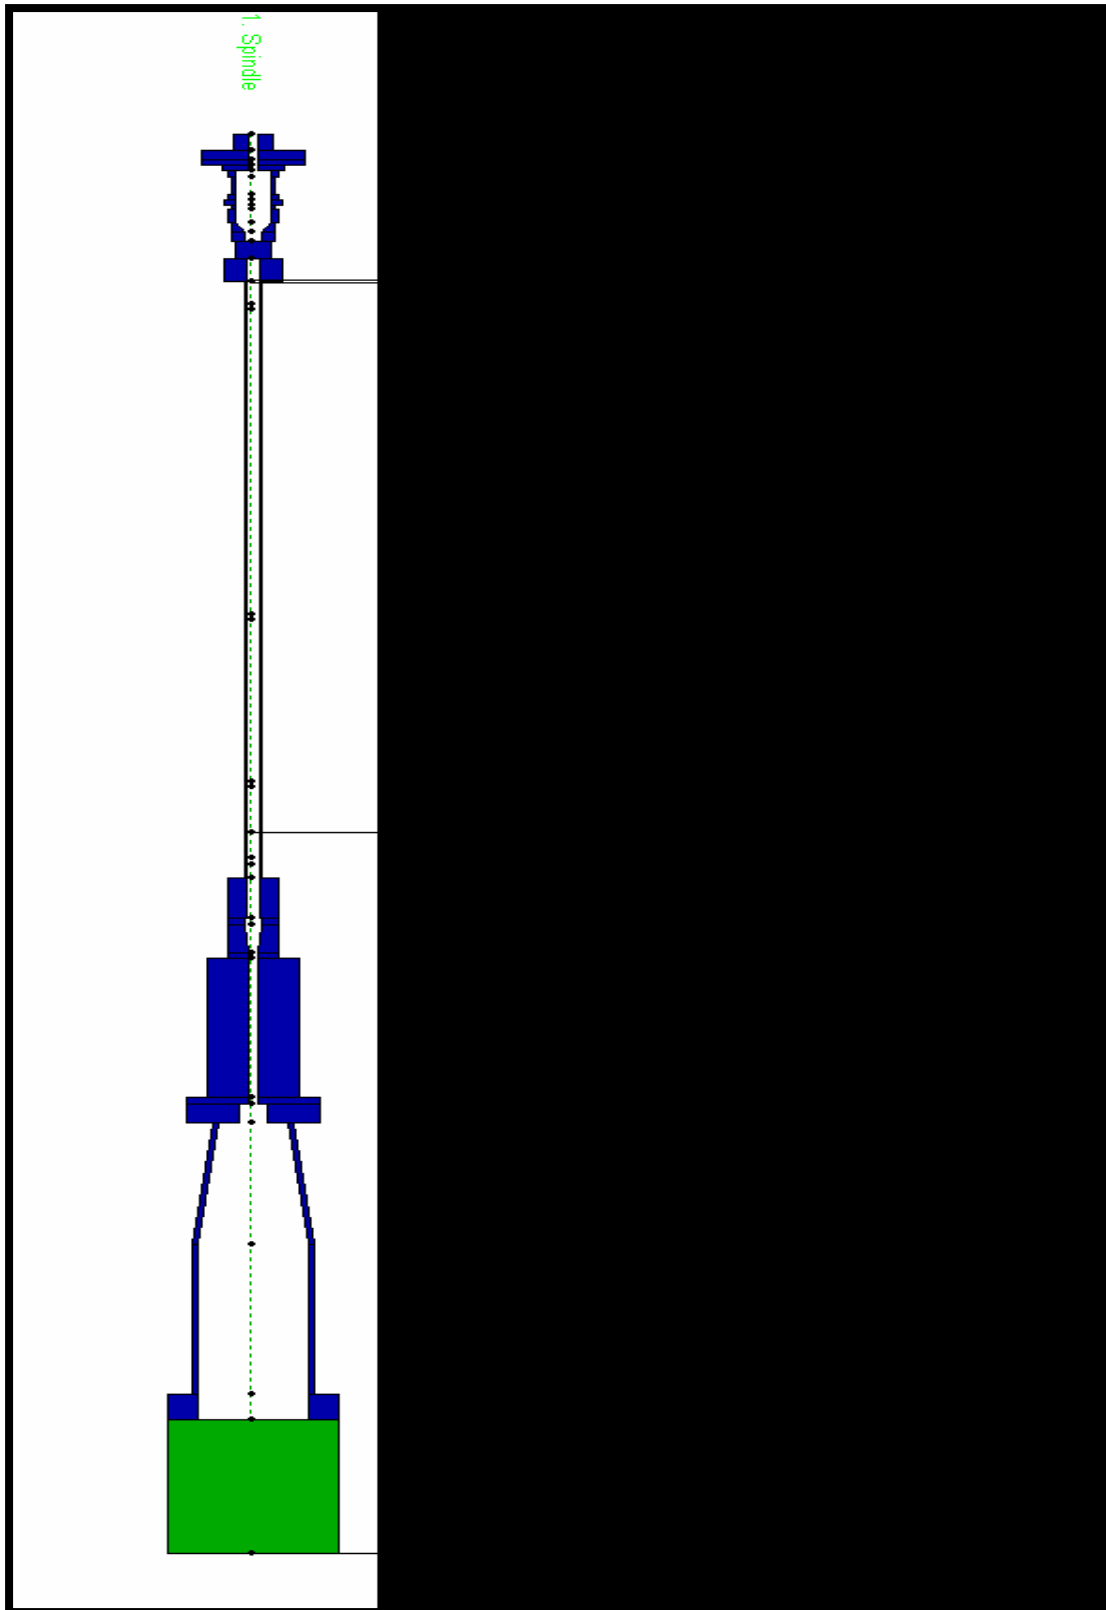
Figure 27. Torsional Vibration Model

Figure 27 shows the torsional model that was used in order to determine the natural torsional modes that were present. The torsional program in the ARMD software package allowed for the connection of the two branches from the rotor dynamics analysis. The models that were
