**NSWCCD-65-TR-2005/24** October 2005

### **Structural Irregularity and Damage Evaluation Routine (SIDER) for Testing of the 1/2-Scale Corvette Hull Section Subjected to UNDEX Testing**

From: Commander, Naval Surface Warfare Center, Carderock Division  
To: Chief of Naval Research (ONR 332)  
Subj: SIDER NDE INSPECTION OF A 1/2-SCALE CORVETTE HULL SECTION  
Ref: (a) Project Agreement RTP-US-GE-N-95-002  
Encl: (1) NSWCCD-65-TR-2005/24, *Structural Irregularity and Damage Evaluation Routine (SIDER) for Testing of the 1/2-Scale Corvette Hull Section Subjected to UNDEX Testing*

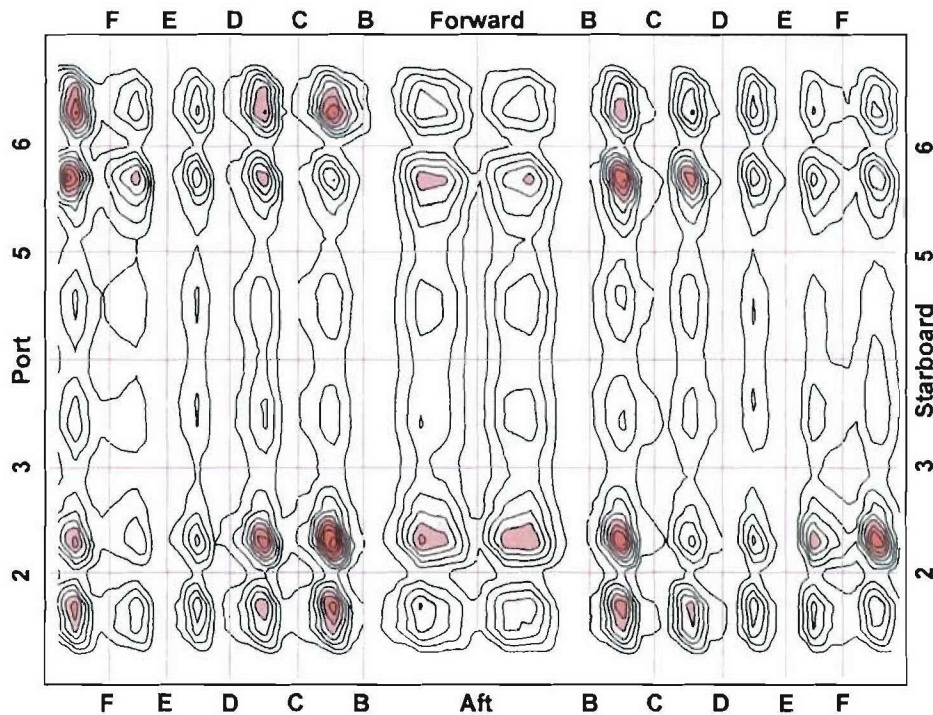
**Figure 7. Baseline SIDER ID#0a – Fore/Aft Analysis**

This test provided the baseline used for all the later difference results. The data were acquired over two days, as shown in Table 1. The structure was quiet during testing, and there is high confidence in the quality of the data. The single SIDER results are shown in Figure 7 and Figure 8.

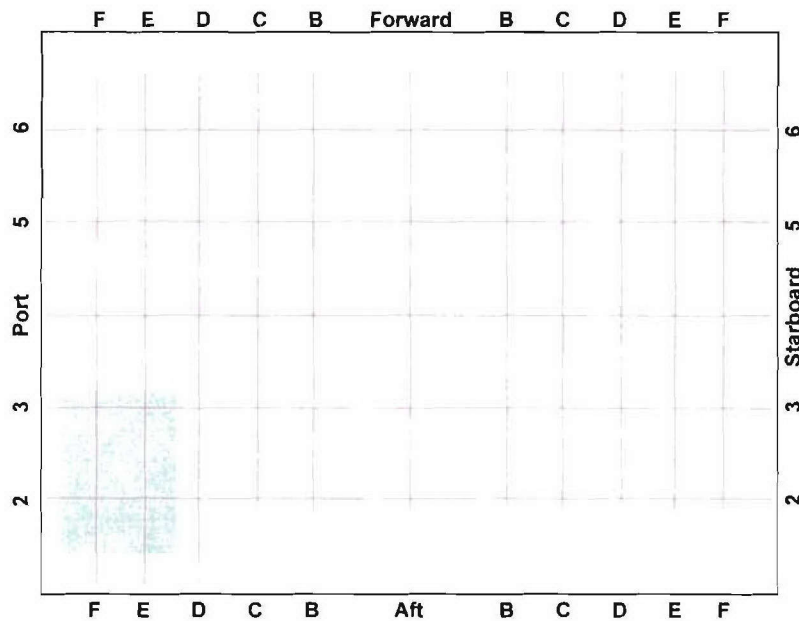
**Figure 11. SIDER ID#0c – Green Showing the Data Patch Area**

It was decided to retest the area coincident where there was a significant change in the SIDER difference analysis. Because of the concerns with the instrumentation on the first day of data acquisition as described earlier in this report, it was decided to slightly extend the patch to

the area shown as the green region in Figure 11. This subset of data replaced matching data in ID#0b, and was cumulatively called ID#0c.

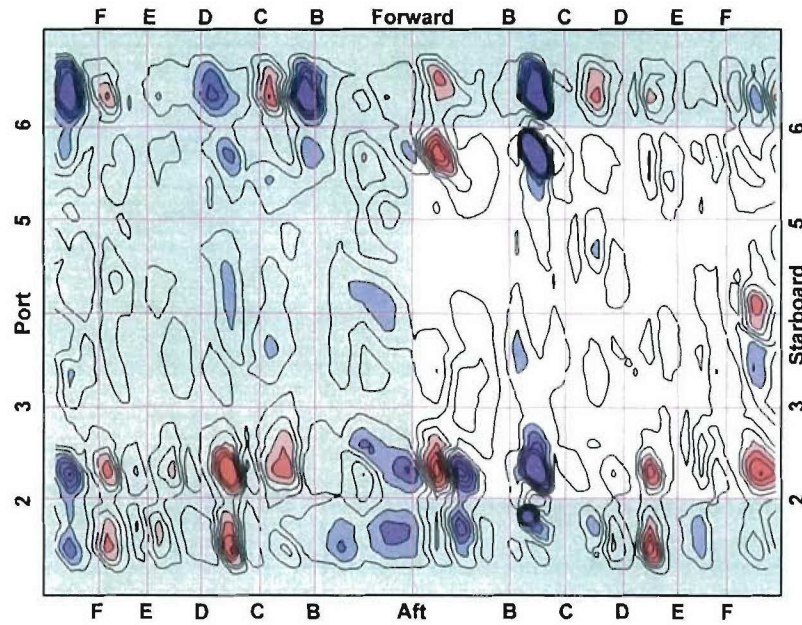
**Figure 14. SIDER Difference (ID#2-ID#0a) Fore/Aft**

UNDEX 1 or 2 caused some structural change, probably a relaxation of tabbing. There was no further development with later UNDEX.

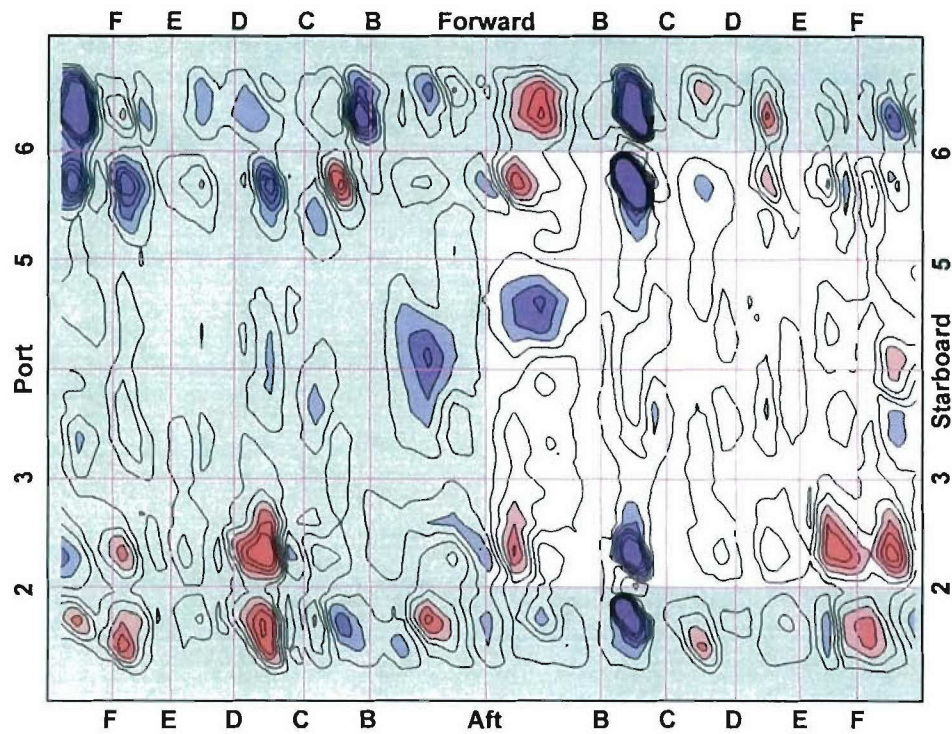
Figure 16. SIDER Difference (ID#3-ID#0a) Fore/Aft

Steady progress of localized structural change with increasing UNDEX. This is the location where the external ply buildup failed after UNDEX 3; see Figure 23.
