# **Commercialization of Technologies to Lower Defense Costs**

## **Final Demonstration/Validation Report For STAPP Bullet Catcher Evaluation at Fort A.P. Hill March 2, 2006**

Contract No. W74V8H-04-D-0005  
Task No. 0403  
CDRL A012  
Report Number: NDCEE-CR-2006-001

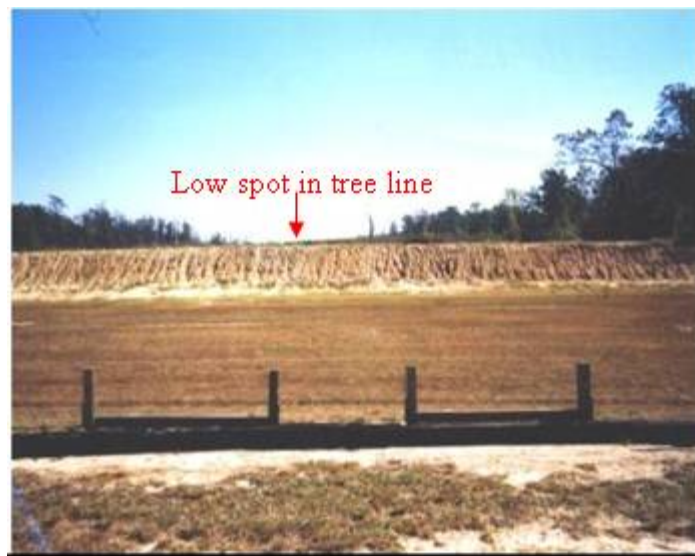
**Figure 3. Original Condition of Range 5.**

The physical condition of the Range 5 berm is best depicted in the Figure 3. Range 5 does not have any craters similar to the ones seen on Range 4 and has little, if any, woody vegetation or plant life. Erosion of the soil has created deep ruts on the face of the berm. There is also a large distance (271 feet, 6 inches) between the firing point and the berm, which allows bullets to “travel” upwards and beyond the height of the berm. By the observing the surrounding tree line and plant growth, it is obvious that bullets pass over the berm, cutting down trees and plant-life. This is shown clearly in Figure 3.

Although there were 16,177 rounds fired upon the Range 5 Bullet Catcher, it is believed that a high percentage of the rounds fired did not actually impact the Bullet Catcher. There is a large distance (271 feet, 6 inches) between the firing point and the berm, which allow bullets to “travel” upwards and beyond the height of the berm, as well as to the sides and below the Bullet Catcher. By observing the surrounding tree line and plant growth, it is probable that bullets pass over the berm, cutting down trees and plant-life. This is not an ideal distance with or without the addition of a Bullet Catcher and is clearly shown in Figure 3.

It is recommended that the design of the range be reconsidered. On Range 5 the distance from the firing sites to the target areas is 10 meters. That leaves approximately 241 feet of open space between the target and the berm. One option would be to move the firing sites and target areas closer to the berm, perhaps leaving an open space between the target and berm of 25 meters or so. This could eliminate the problem of bullets “traveling” beyond, below, and to the sides of the berm.

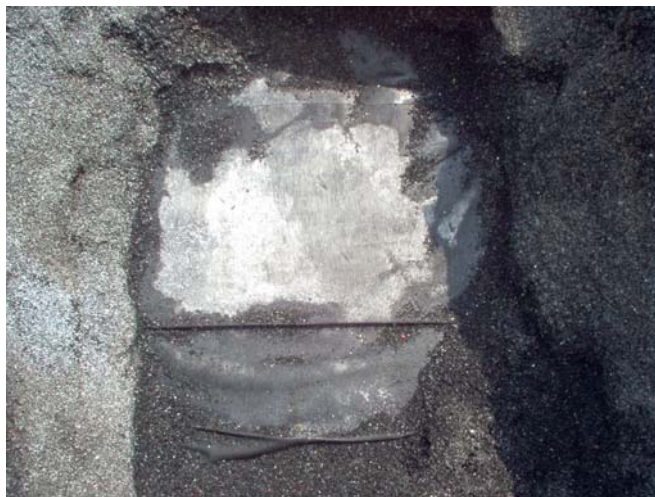
**Figure 48. Bottom Rubber Liner of Range 4, Lane 52.**

As sifting of the hot spot continued, it became obvious that the majority of the bullets were located in the top 6-8 inches of the granular rubber. Once the entire hot spot was sifted and the bottom rubber liner exposed, the liner was visually inspected for tears/holes. There were no visible tears/holes in the bottom rubber liner (please see Figure 48). Lane 52 hot spot sifting was complete at roughly 2:55pm.

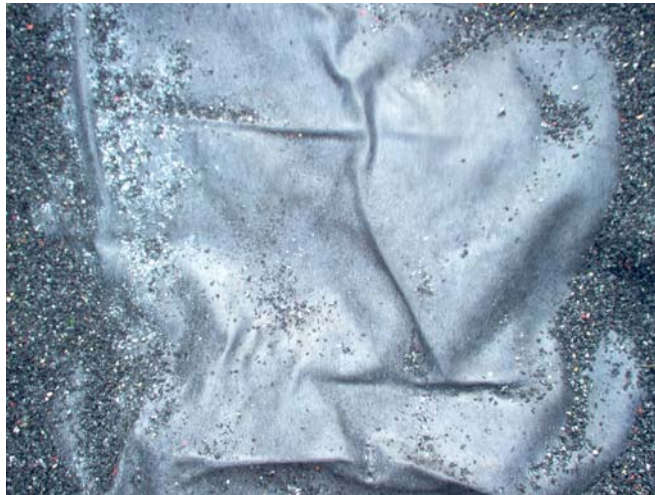
**Figure 49. Bottom Rubber Liner of Range 4, Lane 53.**

At 7:00am on 19 August 2004, Clean Harbors' 3-man crew was on-site and immediately began to continue sifting Lane 53. As with Lane 52, the majority of the bullets were concentrated in the top 6-8 inches of the granular rubber. Once the entire hot spot was sifted and the bottom rubber liner exposed, the liner was visually inspected for tears/holes. There were no visible tears/holes in the bottom rubber liner (please see Figure 49). Lane 53 hot spot sifting was complete at roughly 10:40am.

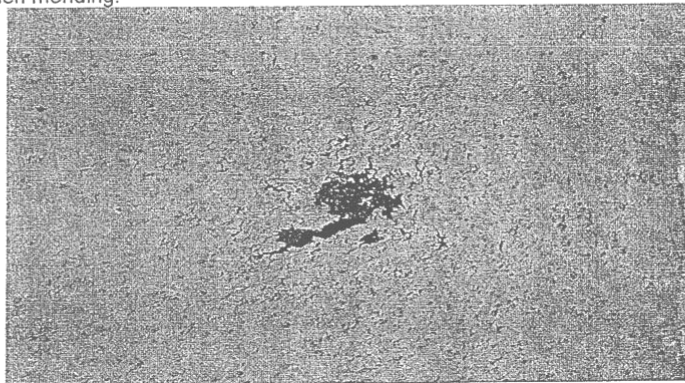
Bullet Catcher is saturated after intensive shooting with low-energy impact, large-bore rounds. Repair is imminent. It is recommended that upper rubber granules be replaced with new. Mend using CA-glue (alternative 1) or vulcanized-tape, (alternative 2).
