# **THE NATIONAL SHIPBUILDING RESEARCH PROGRAM**

## **Evaluation of New Surface Preparation and Coating Repair Techniques in Ballast Tanks - Phase IV**

**EVALUATION OF  
NEW SURFACE PREPARATION AND COATING REPAIR  
TECHNIQUES IN BALLAST TANKS-PHASE IV  
TWENTY YEARS OF BALLAST TANK COATING SYSTEM TESTING**

**NSRP 3-96-2**

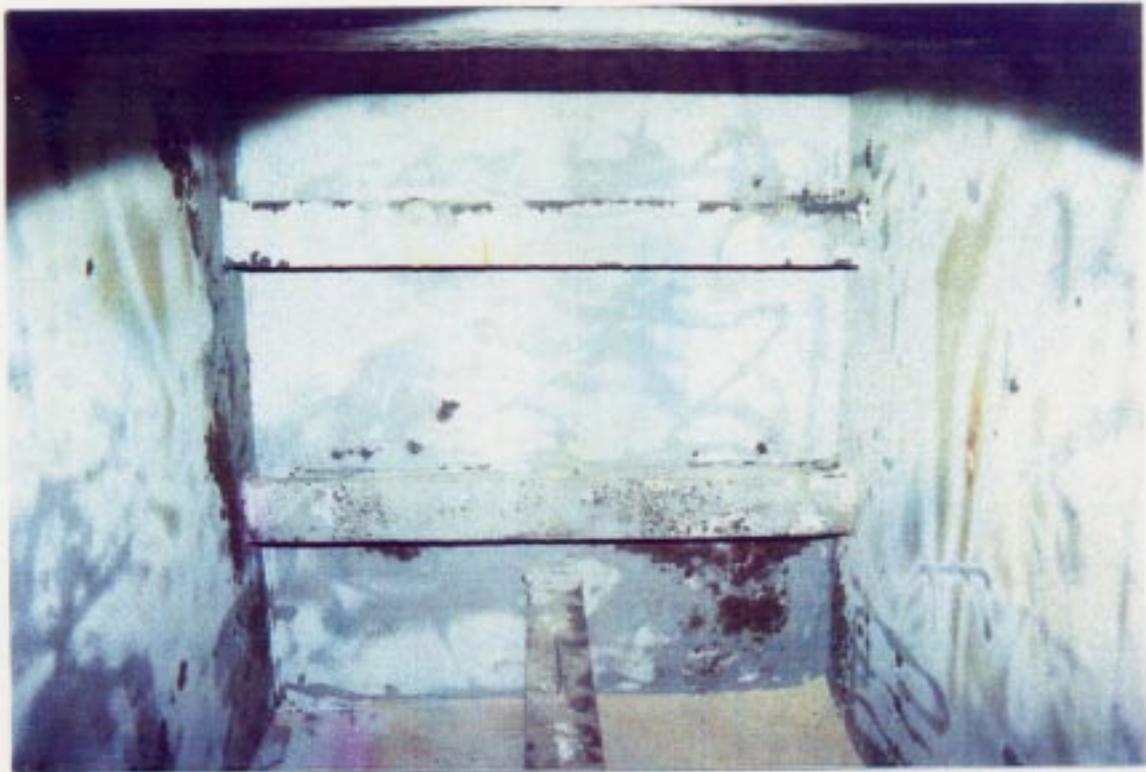
**PHOTOGRAPH 2A- SWEEP BLAST CLEANED SURFACE**

Hand (SSPC SP-2) and Power Tool Cleaning (SSPC SP-3) performed during the maintenance portion of the test program consisted of chipping hammers, hand and power wire brushes, and needle guns and power disc sanders. Hand sanding was used to feather the edge of intact remaining coatings. See photograph 2A (Sweep Blast Cleaned) and 2B (Hand & Power Tool Cleaned) for examples of the resultant surface preparation prior to the application Surface Tolerant Epoxy "A."

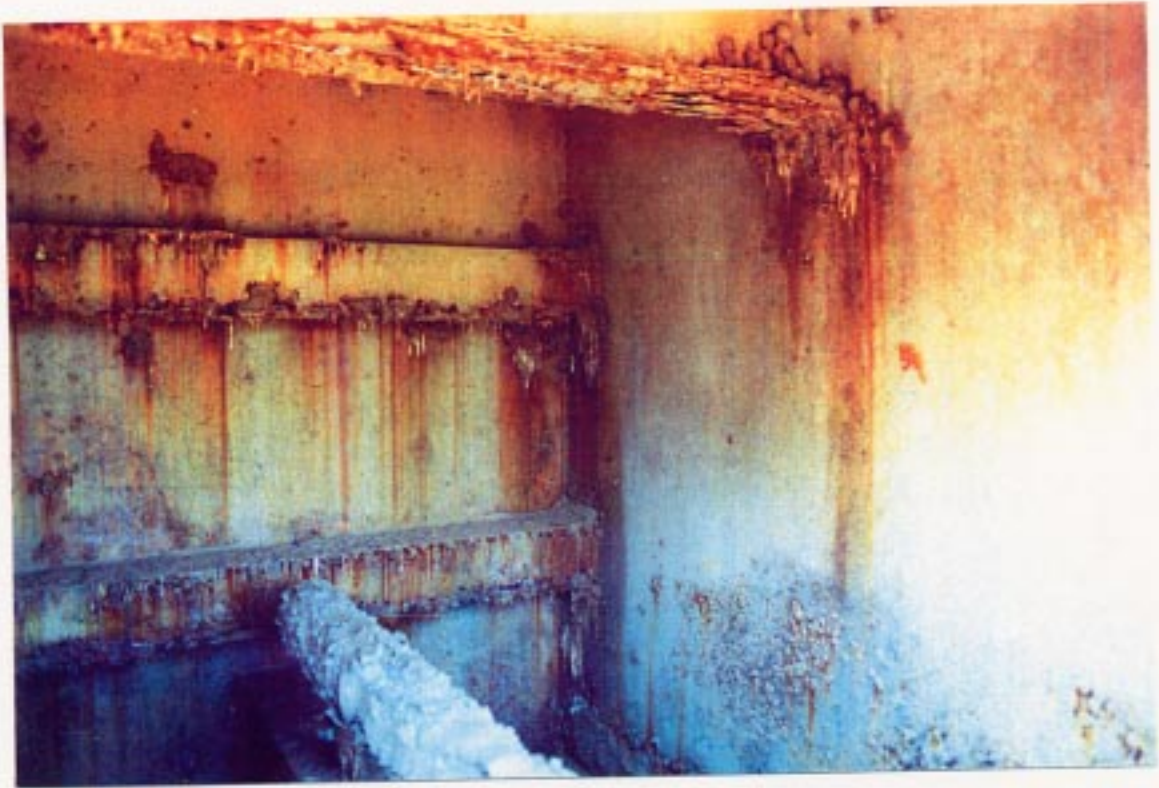
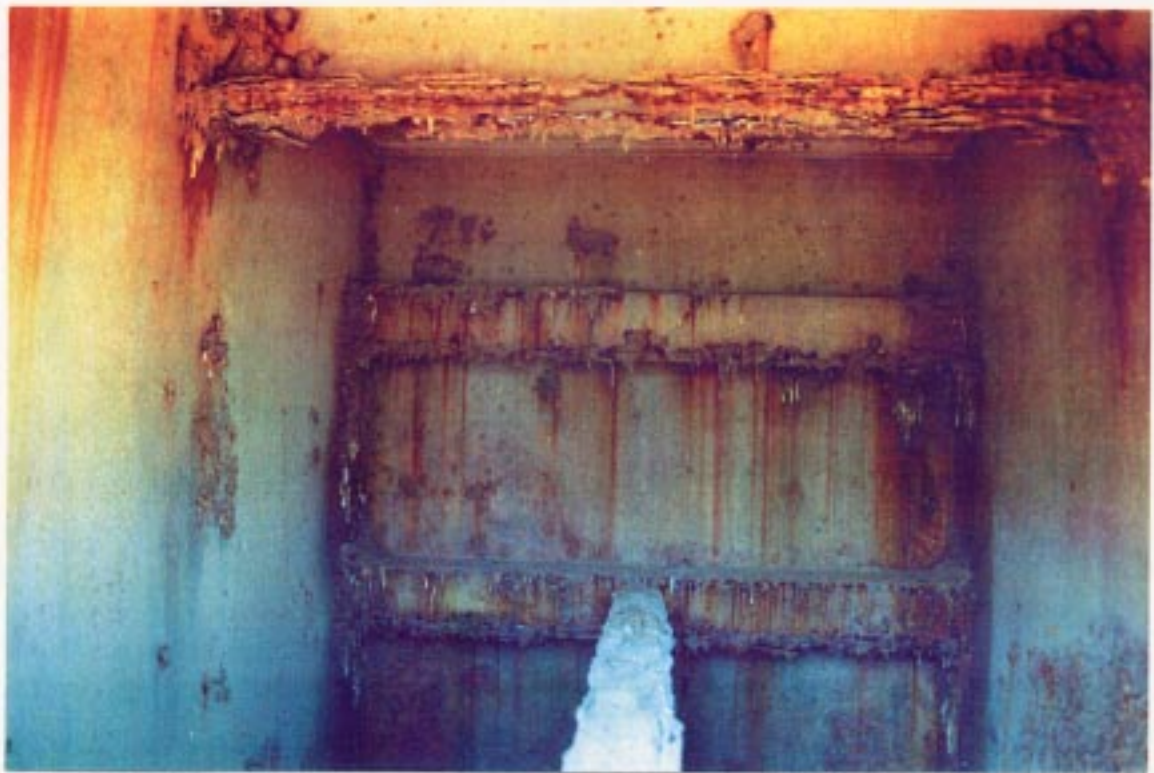
**PHOTOGRAPH 10-AGED EPOXY WITH ADDED ZINC ANODE**

Very little change was noted in the performance of the aged epoxy (Mil-P-23236) over the life of the system, once the zinc anode was added. This has proven to be a true twenty-year system. No new coating failure was detected in the fourteen years since the anode was added. Calcareous deposits continue to increase. Very little anode consumption was noted. See Photograph 10.

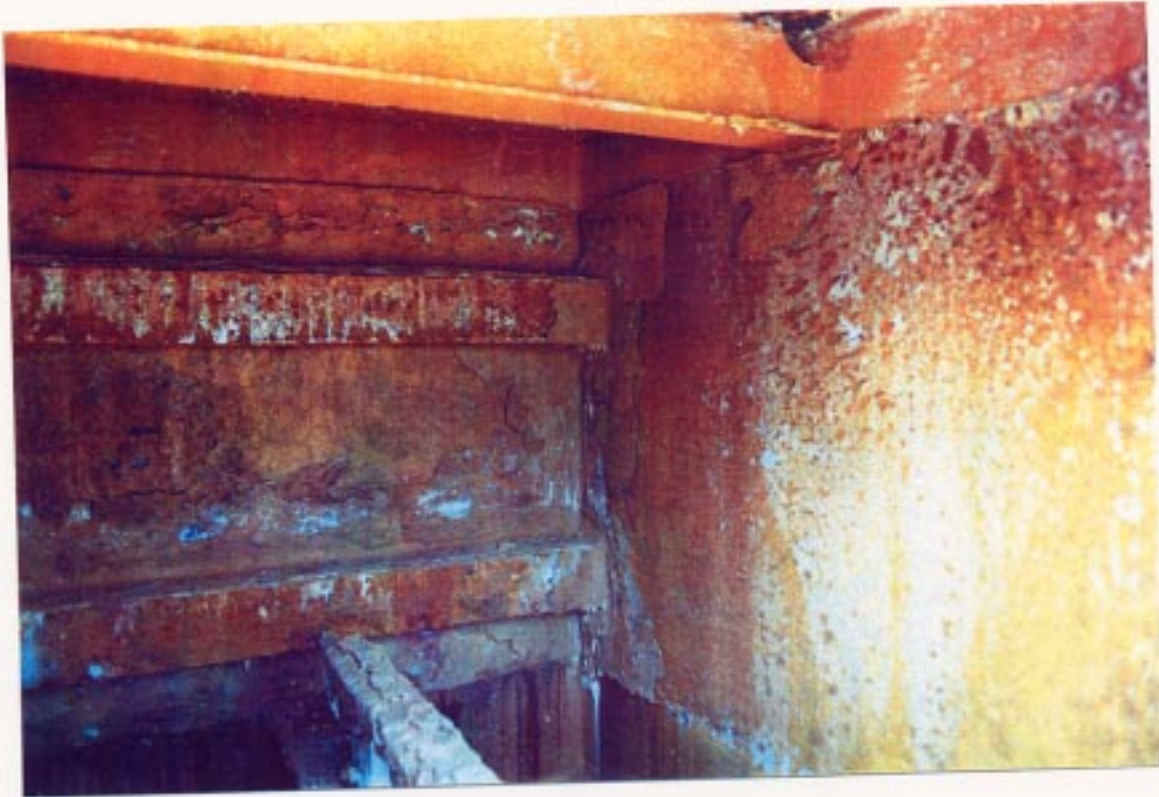
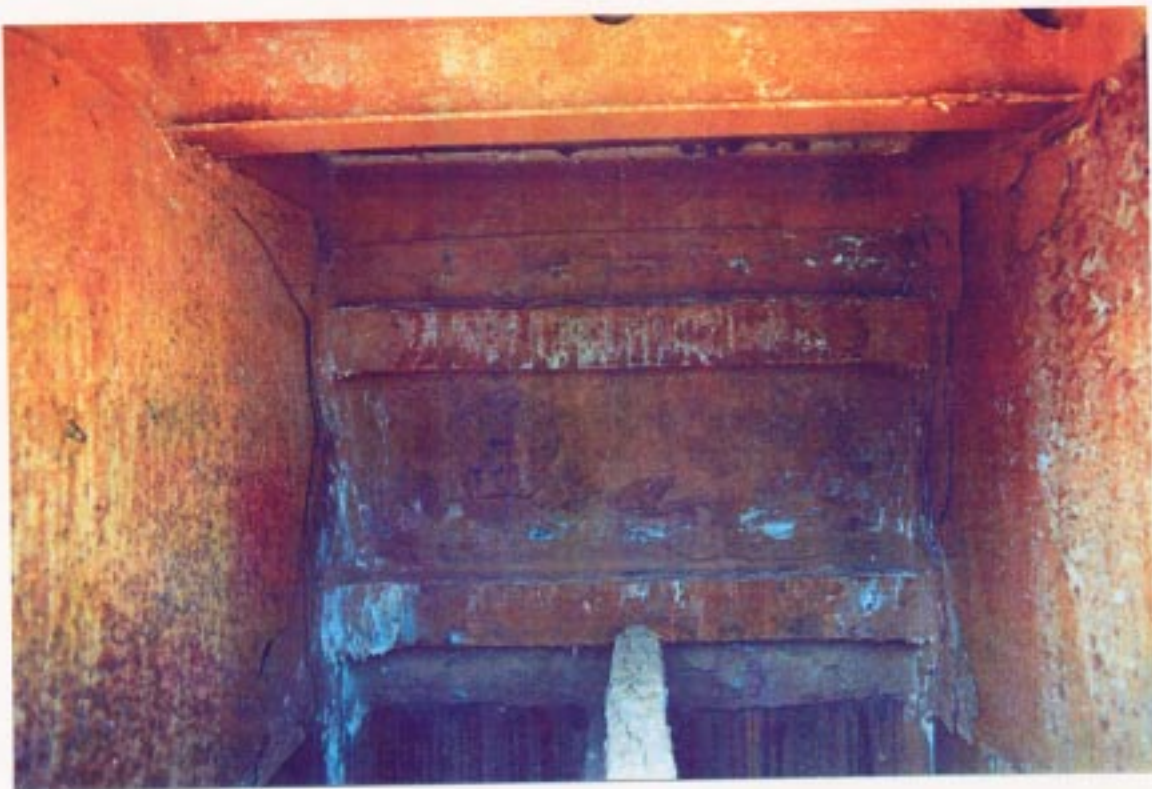
**PHOTOGRAPH 11- PARTIAL COATING WITH ZINC ANODE**

This system requires further evaluation prior to selection as a corrosion control alternative. It could be that the calcareous deposits initially form during the ballasted condition and provides adequate protection. As the deposit increases in thickness, there is a tendency for the deposit to dry out during the de-ballasted or dry portion of the cycle, partially detaching from the substrate, forming a void between the calcareous deposit and the steel substrate. The partially detached deposit can shield the cathodic protection from further protection of the underlying substrate. Once the deposit completely detaches and falls off the surface, new deposits form providing protection until the thickness increases. One solution may be periodic removal of all loose deposits during dry-docking and maintenance. This would be much less expensive than re-coating the tank. The loss of half the metal thickness appears severe until it is remembered that the system performed for twenty years with no maintenance except anode replacement. It should also be remembered that cathodic protection only provides protection during the wet portion of the cycle – twenty days of the thirty-day cycle. See Photograph 11.

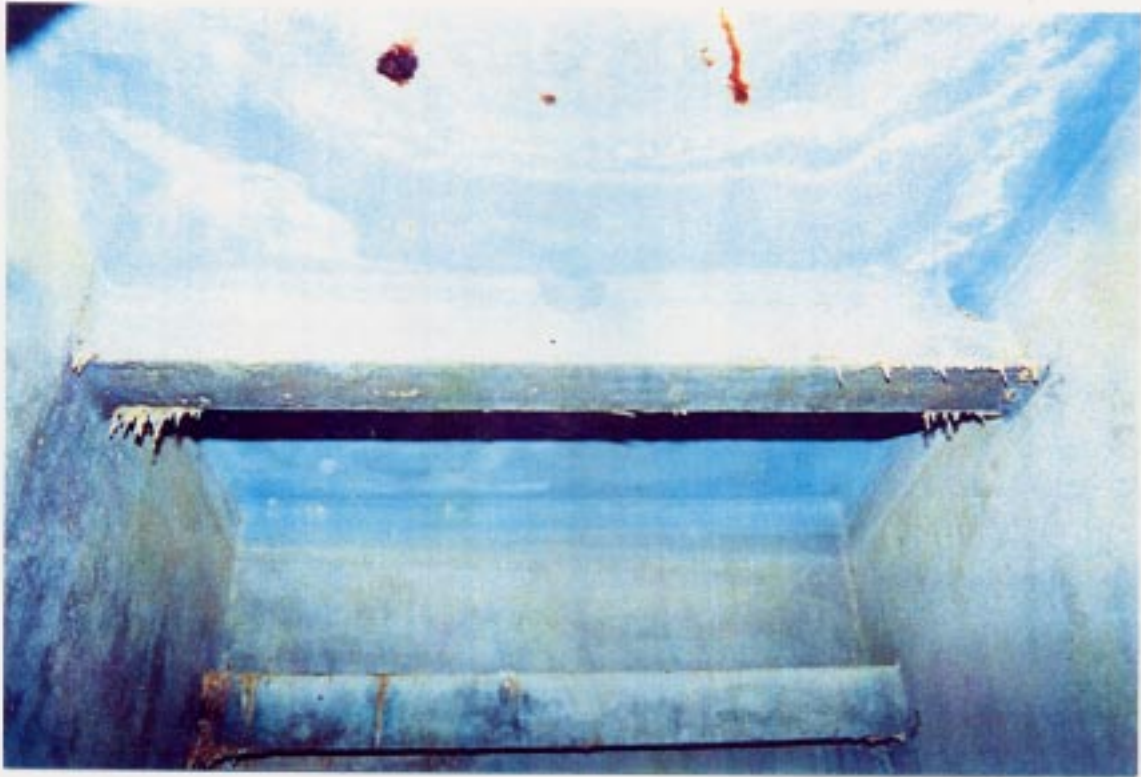
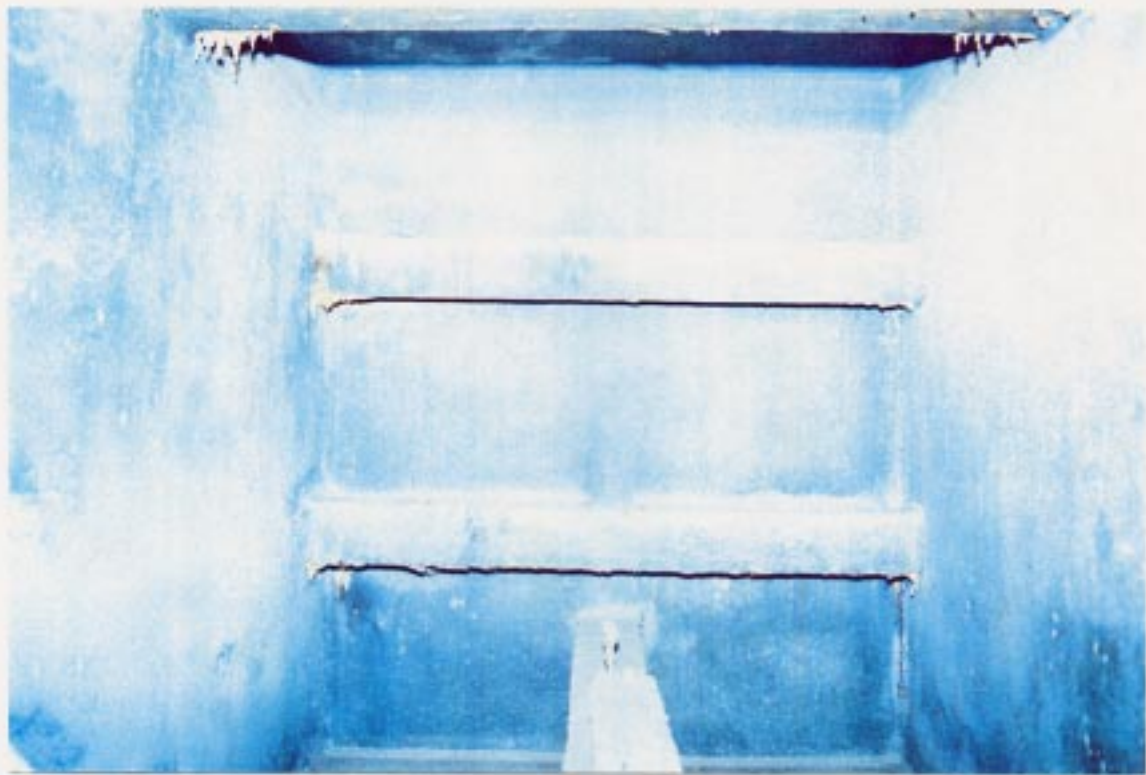
**PHOTOGRAPH 12- SOLVENT BASED INORGANIC ZINC WITH ZINC ANODE**

At the conclusion of seven years of testing, both the inorganic zinc with and without zinc anode are providing good protection, with the system with the zinc anode demonstrating superior performance with less than 0.03% failure. The system without the zinc anode is showing some edge failure at seven years; whereas, the system with the anode has no edge failure. Very little anode consumption was noted. Based on the earlier results, where the thin film pre-construction zinc primer went ten years prior to failure, the full thickness inorganic zinc coating with zinc anode should provide twenty years of protection, thus being a permanent system for the life of the ship. See Photographs 12, and 13.
