## **Chesapeake Bay Breakwater Database Project, Section 227 Demonstration Site: Hurricane Isabel Impacts to Four Breakwater Systems**

C. S. Hardaway, Jr., D. A. Milligan, C. A. Wilcox,  
L. M. Meneghini, G. R. Thomas, and T. R. Comer

July 2006

Final Report

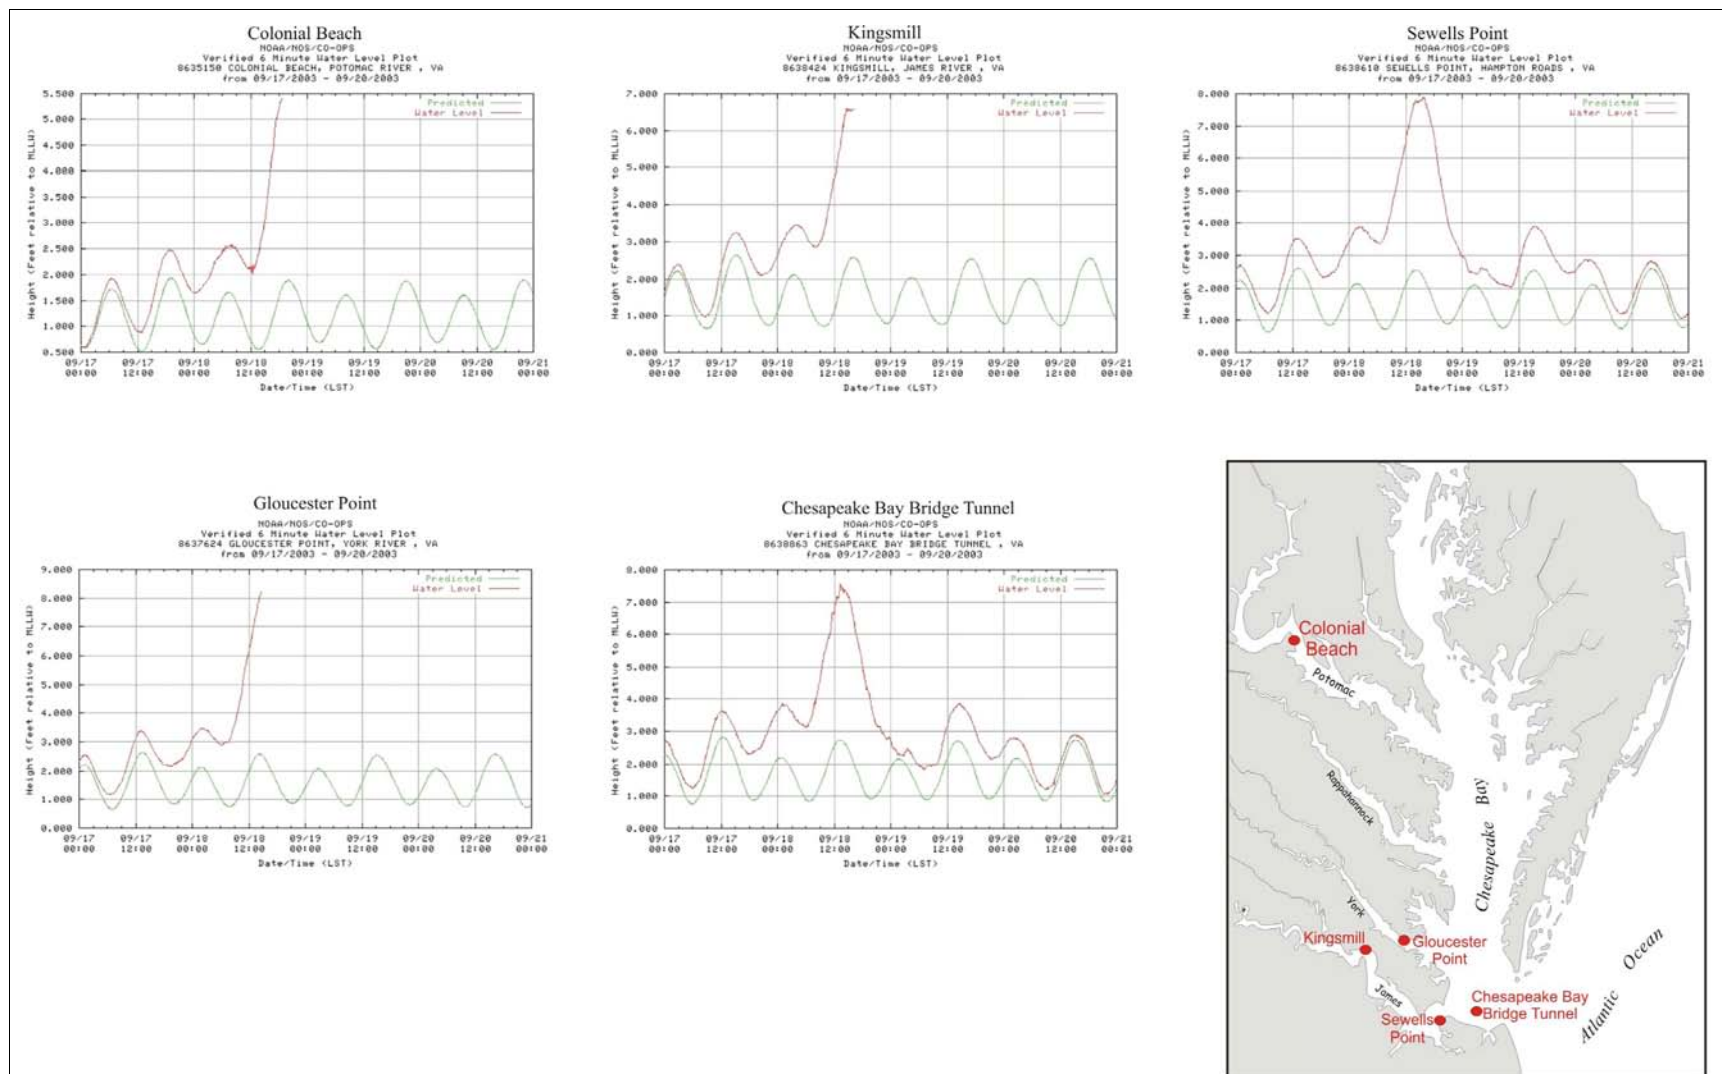
Yorktown is located across the York River from VIMS where NOAA maintains the Gloucester Point tide gauge (Figure 14). During Isabel the gauge stopped at about 2:30 p.m. with a reading of about el +8.3 as the tide was still rising. Wind speed measurements at VIMS provided by instruments atop VIMS' Byrd Hall showed that maximum sustained winds on the campus reached 65 mph, with 144.8-km/hr (90-mph) gusts. The barometer bottomed out at 74.1 cm (29.2 in.), with a rainfall accumulation of about 5.6 cm (2.2 in.). At the height of the storm, VIMS' ADCP measured what might be considered a deepwater wave of 1.8 m (6 ft) with a 5 sec period. Still-water level at Yorktown was measured at el 8.6 (mean tide range is 0.7 m (2.4 ft)), and the combination of maximum storm surge and wave runup was measured at about el 12.5. One could infer that there could have been a 1.2 m (4 ft) or greater wave breaking across the breakwater system and into the adjacent infrastructure.

Figure 14. Verified water levels at wave gauges around Chesapeake Bay during the storm and approximate gauge location. From the NOAA Web Site (<http://www.co-ops.nos.noaa.gov/>)

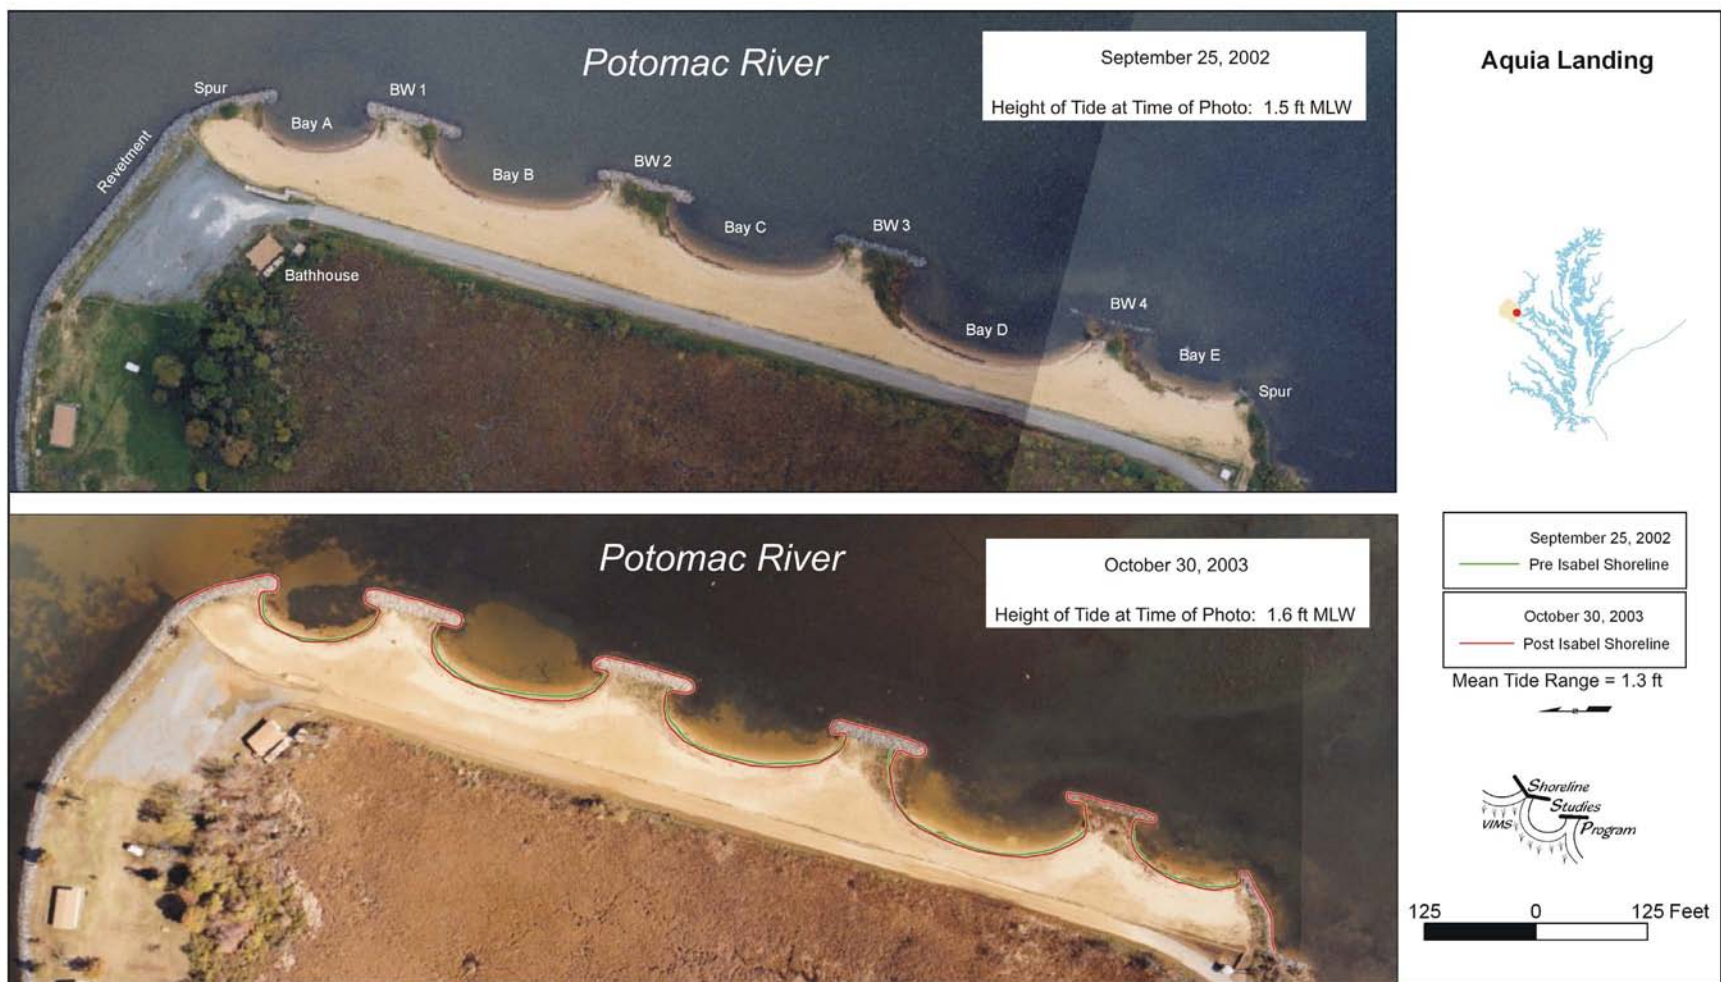
Figure 15. Aquia Landing low-level pre- and post-Hurricane Isabel ortho-rectified aerial photographs

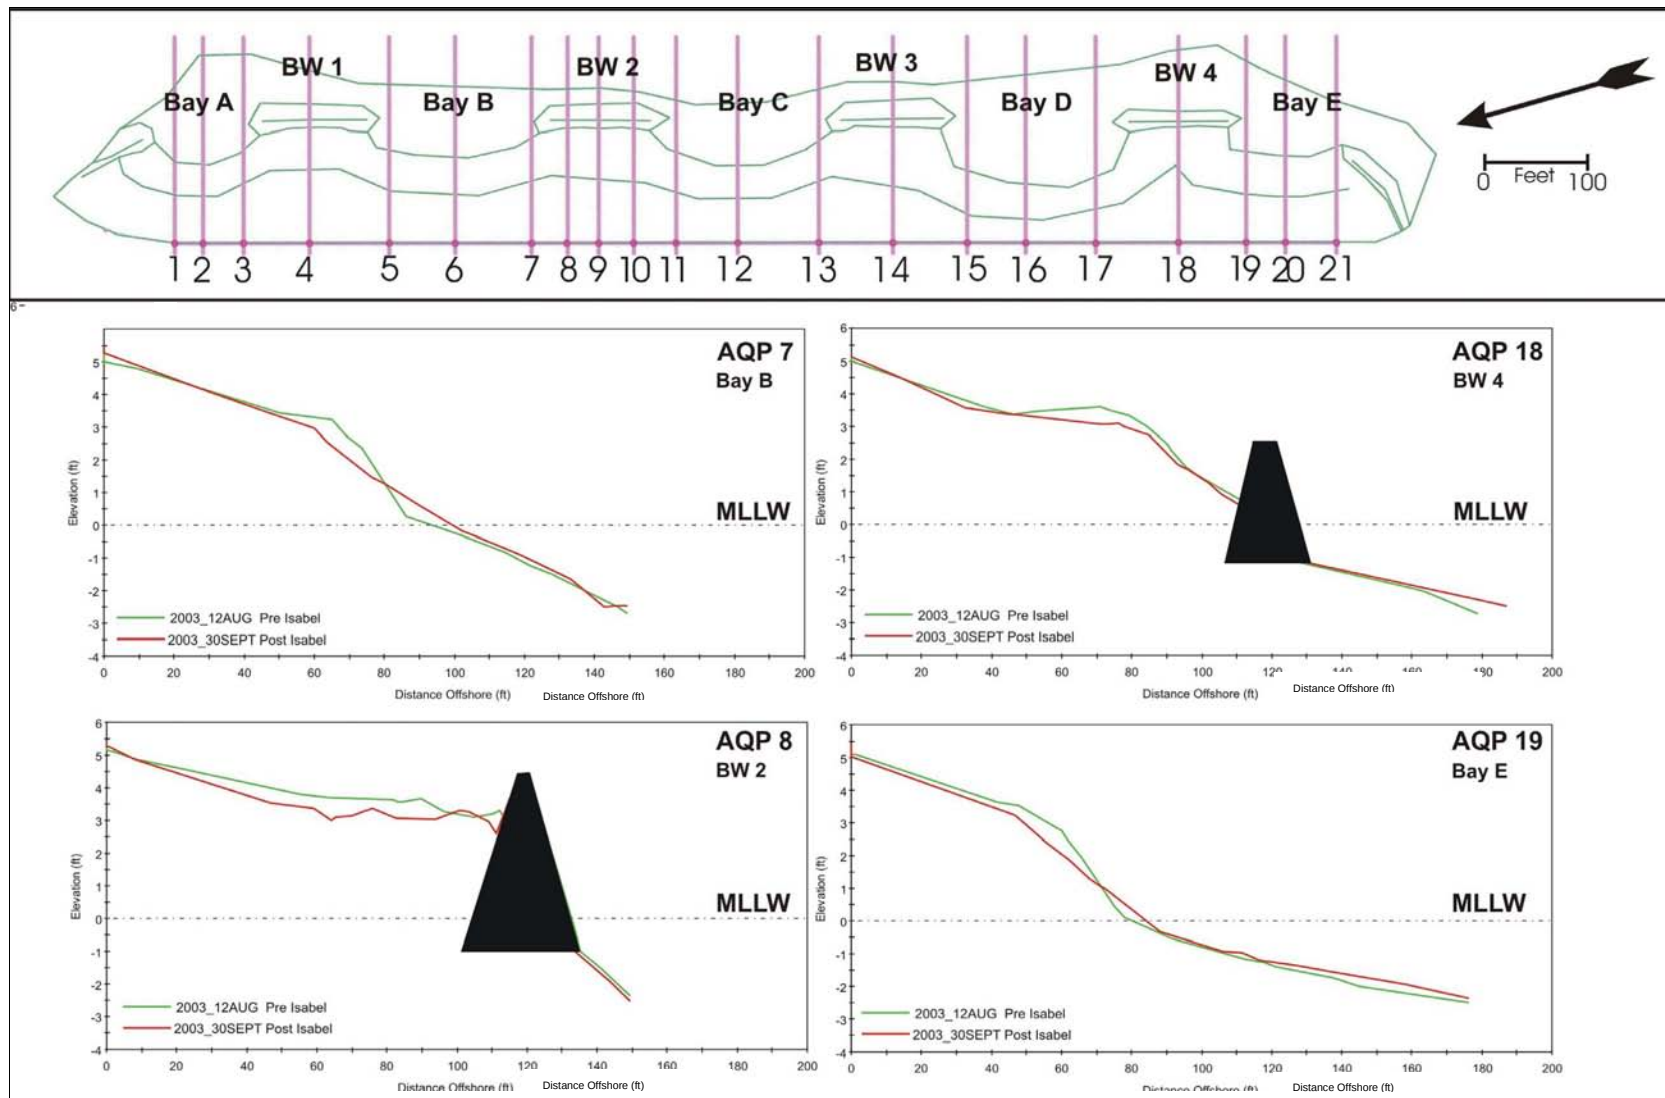
Figure 16. Aquia Landing (AQP) baseline and selected pre- and post-storm cross sections

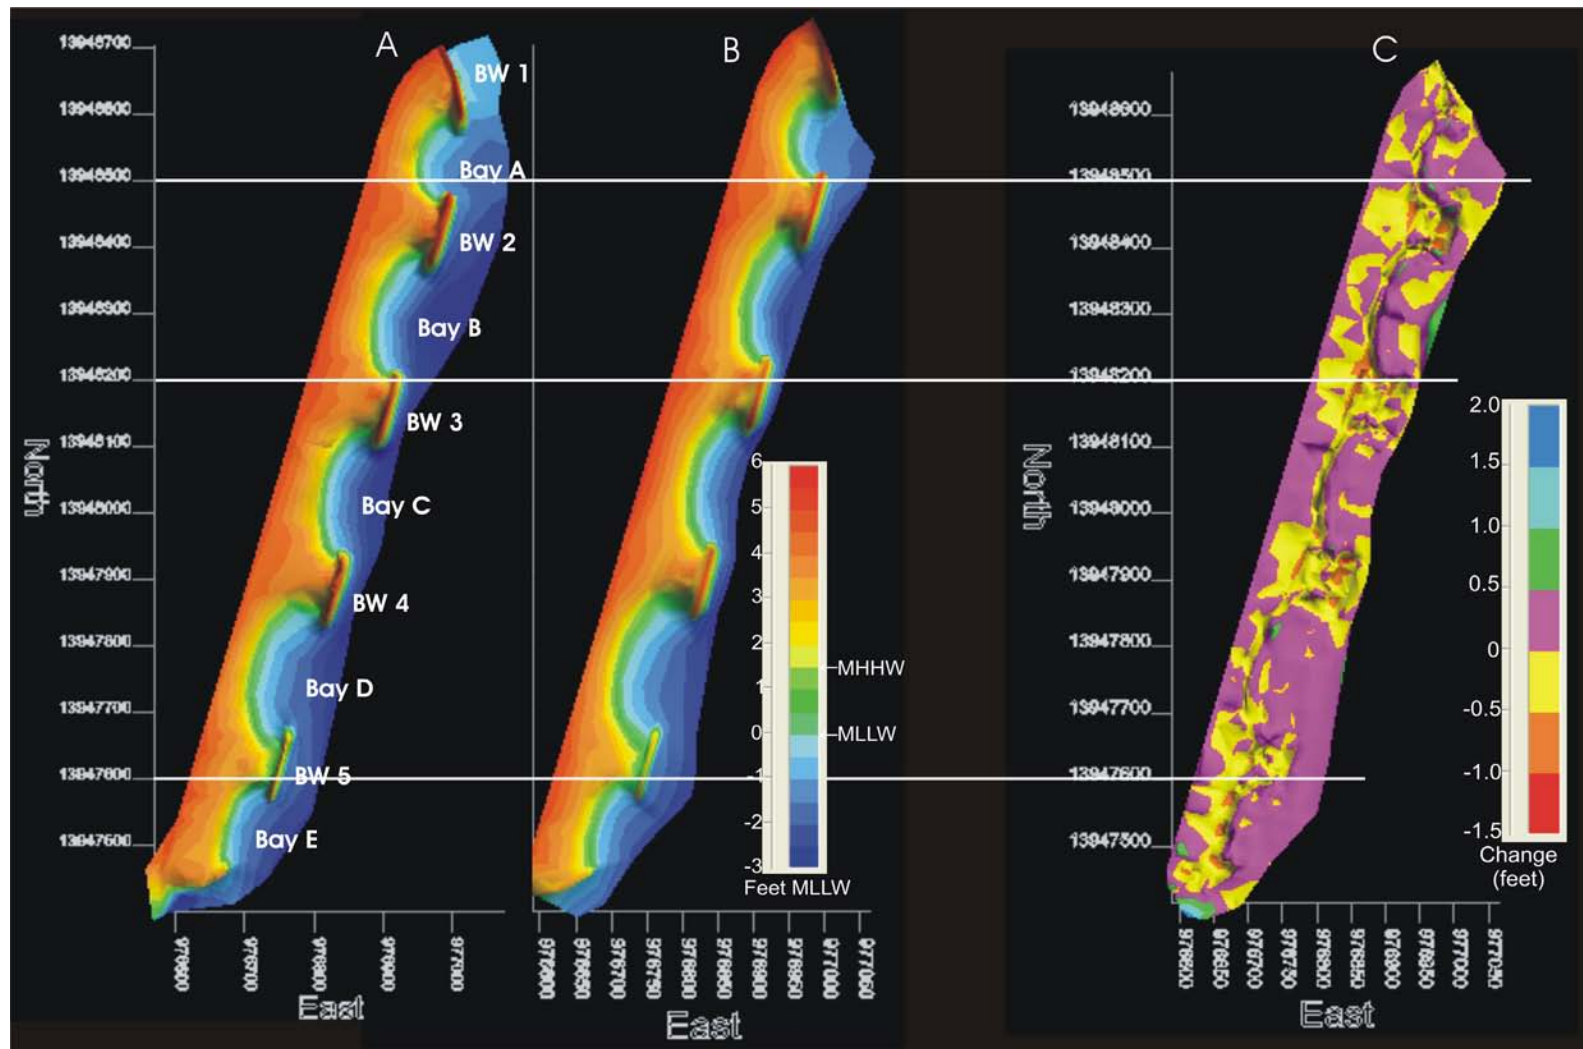
Figure 18. Aquia Landing color contour maps for: (a) pre- and (b) post-storm conditions, and (c) isopach map showing elevation changes between surveys

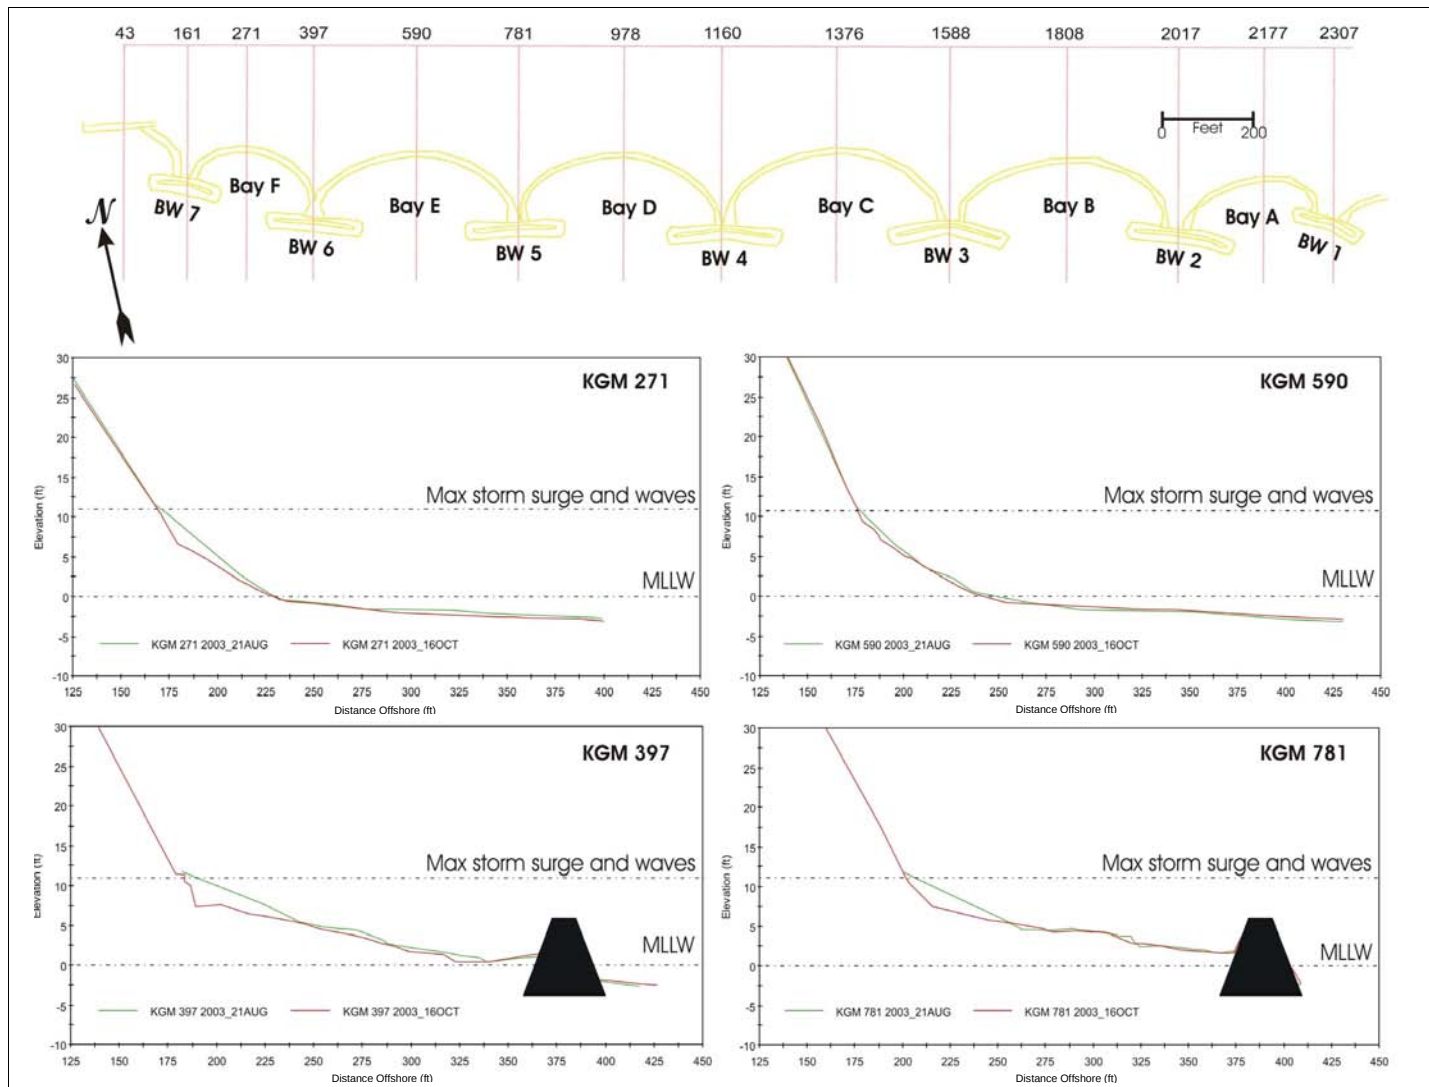
Figure 20. Kingsmill (KGM) baseline and selected pre- and post-storm cross sections

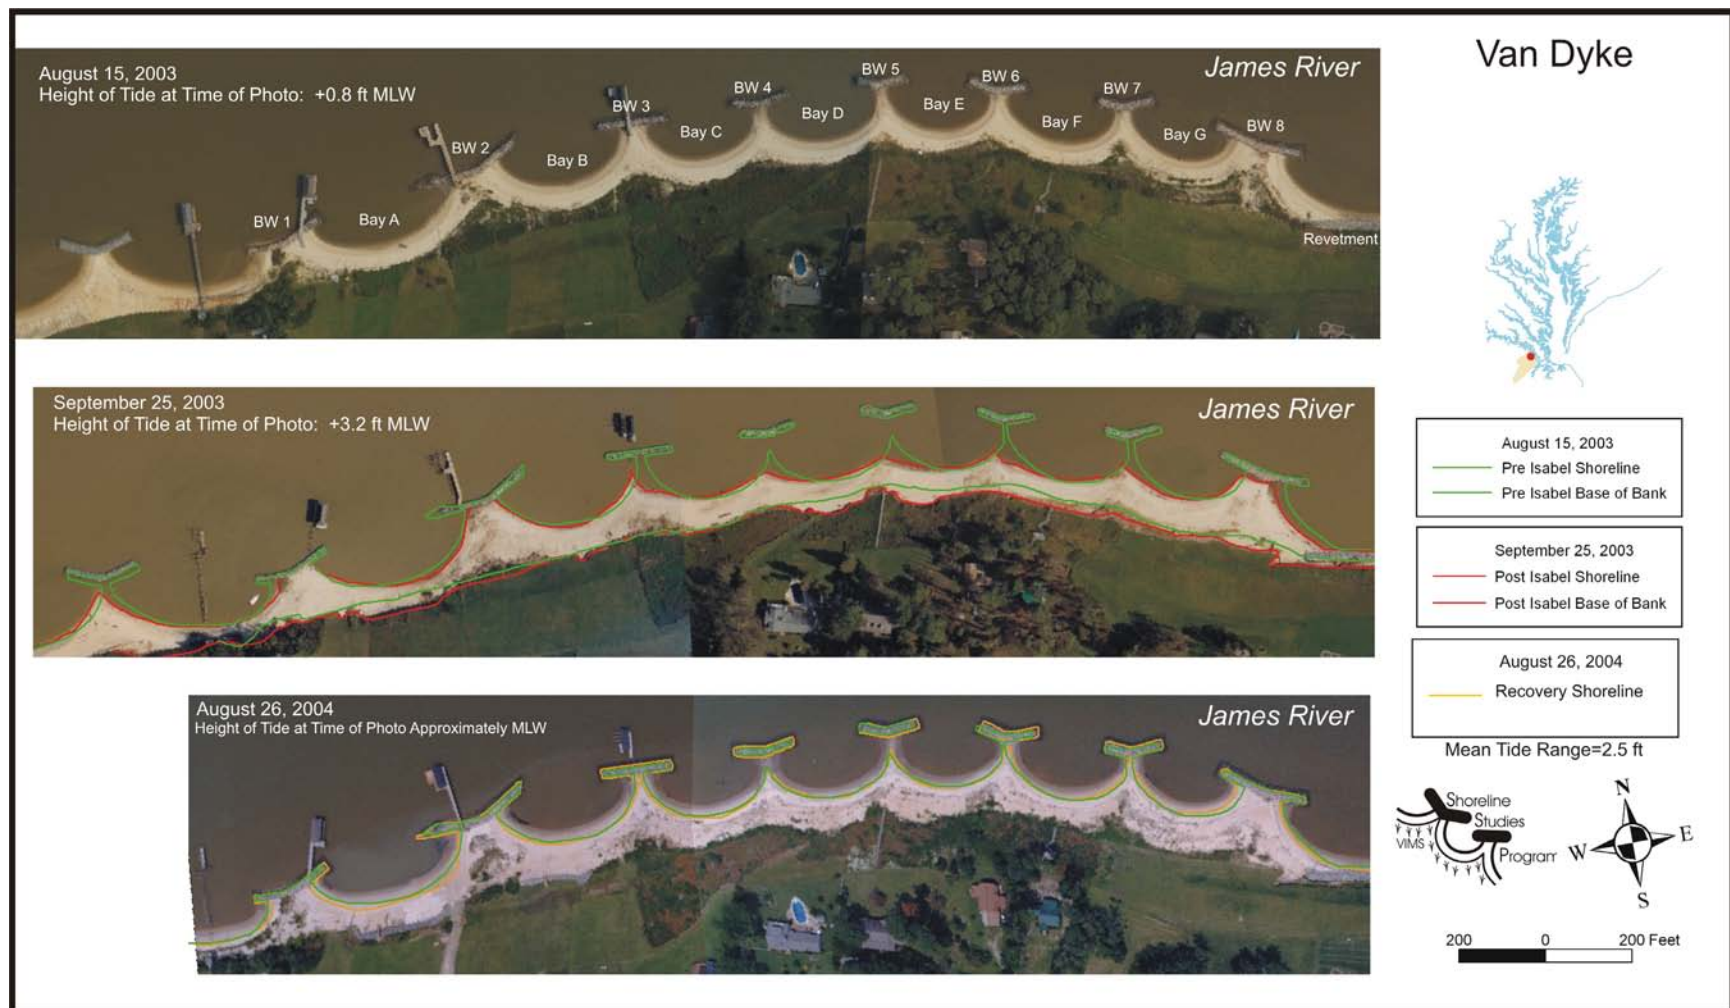
Aerial imagery pre- and post-Isabel shows mostly landward shifts in the positions of both the shoreline and base of bank (Figure 23). Reduction in tombolo size are seen behind BW3, BW4, BW5, BW6, and also BW7, which had the narrowest attachment before the storm. The adjacent BOB along these structures also receded. Significant BOB recession also occurred in Bay A. General BOB stability is seen between BW2 and BW4 as well as between BW7

and BW8. These trends are shown in typical profiles for select bays and breakwaters (Figure 24). The combination of storm surge and wave height exceeded el 11, about 0.9 m (3 ft) higher than project design. Post-storm recovery shows the shore planforms have returned to approximately their pre-storm configuration (Figure 23).

Figure 23. Van Dyke low-level pre- and post-Hurricane Isabel and recovery ortho-rectified aerial photographs

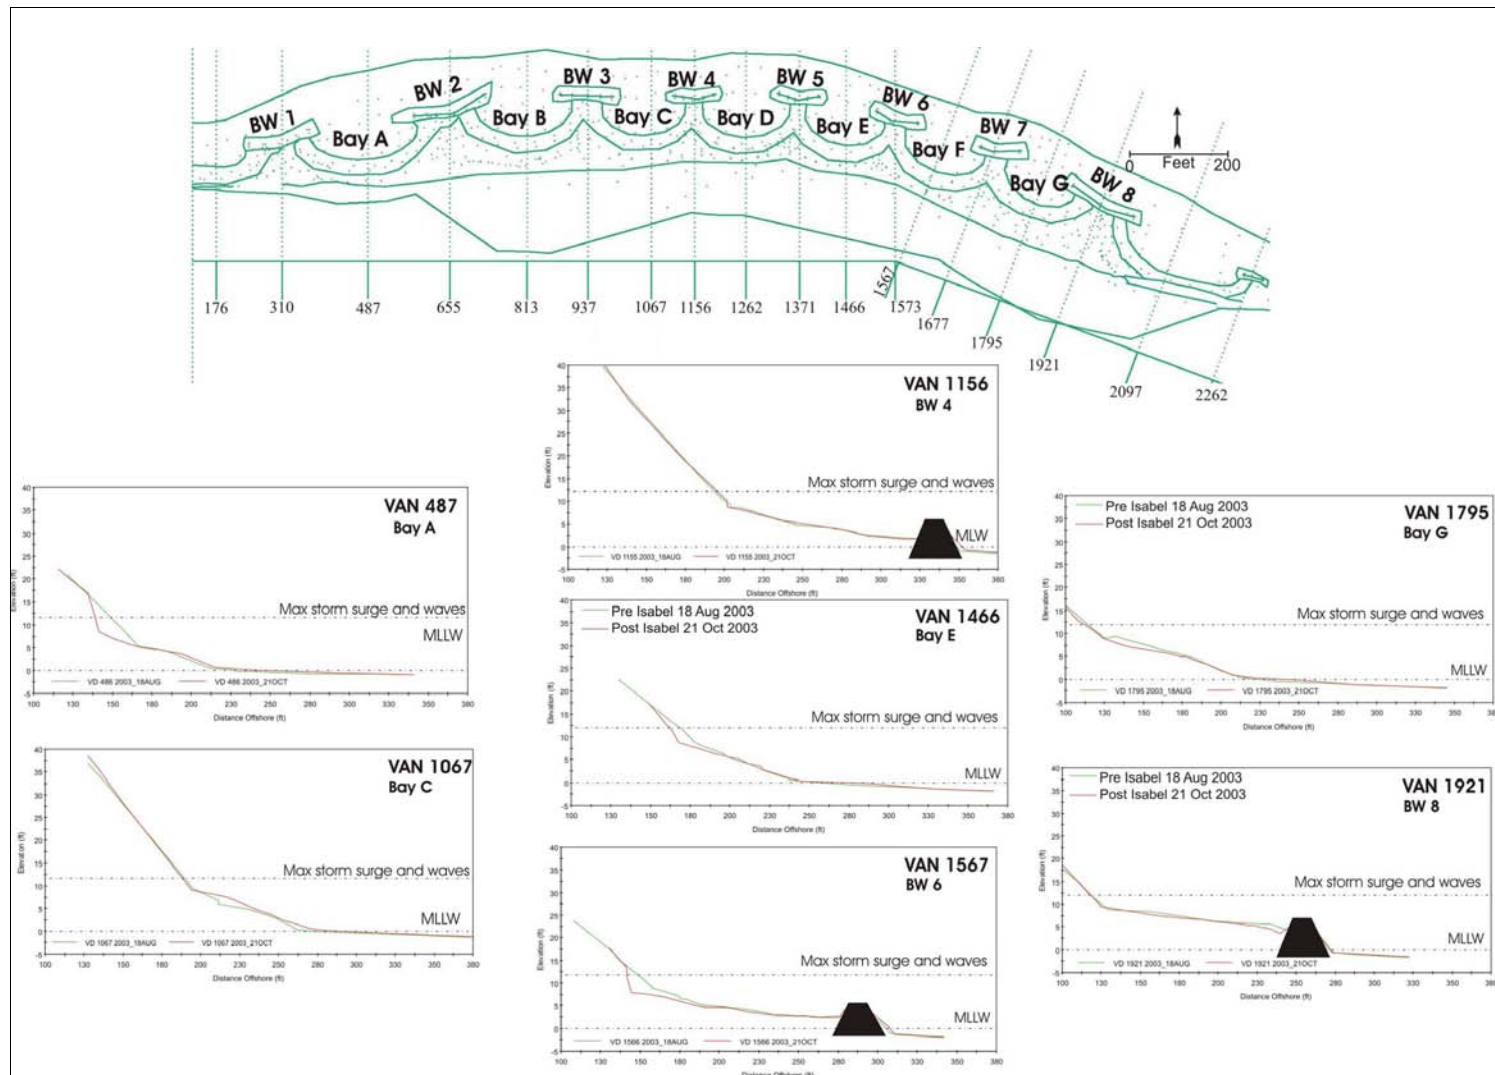
Figure 24. Van Dyke (VAN) baseline and selected pre- and post-storm cross sections

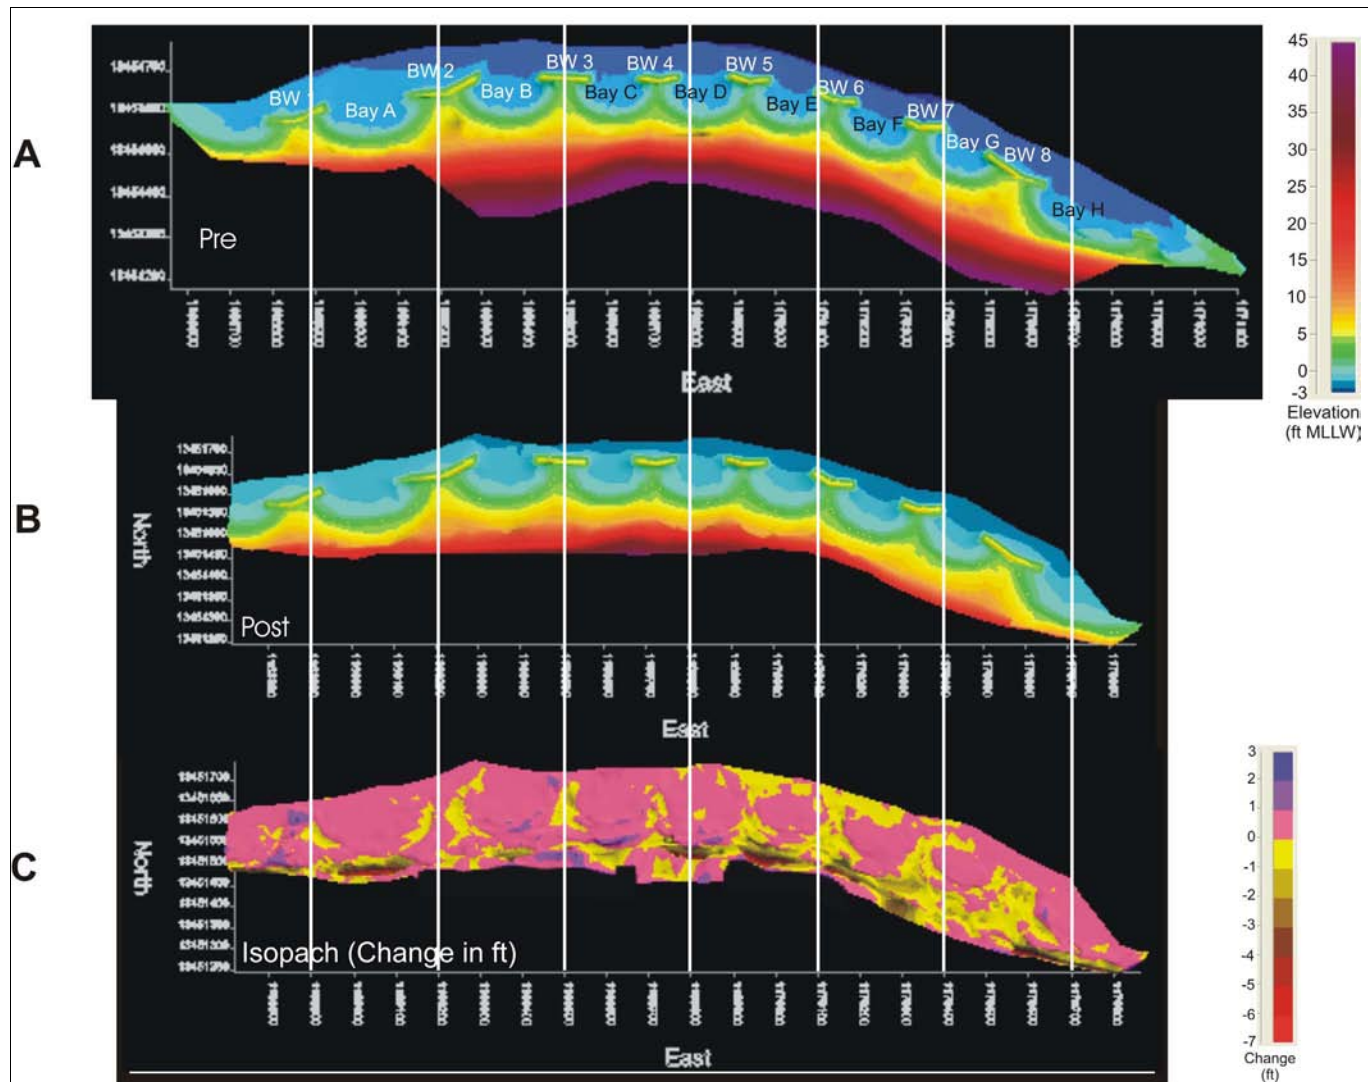
The overall change in topography at this site is seen in Figure 26. Negative topographic changes are evident at each tombolo and around and in front of BW5, BW6, and BW7. Severe land reduction occurs along the aforementioned BOB and along the top of the downriver revetment. Consequent increases or no change in topography are generally greater in the nearshore areas as indicated by the pink patterns ( $0\text{ m} < \text{change} < 0.3\text{ m}$ ) ( $0\text{ ft} < \text{change} < 1\text{ ft}$ ).

Figure 26. Van Dyke: (a) pre- and (b) post-storm color contour maps, and (c) isopach map showing elevation changes between surveys

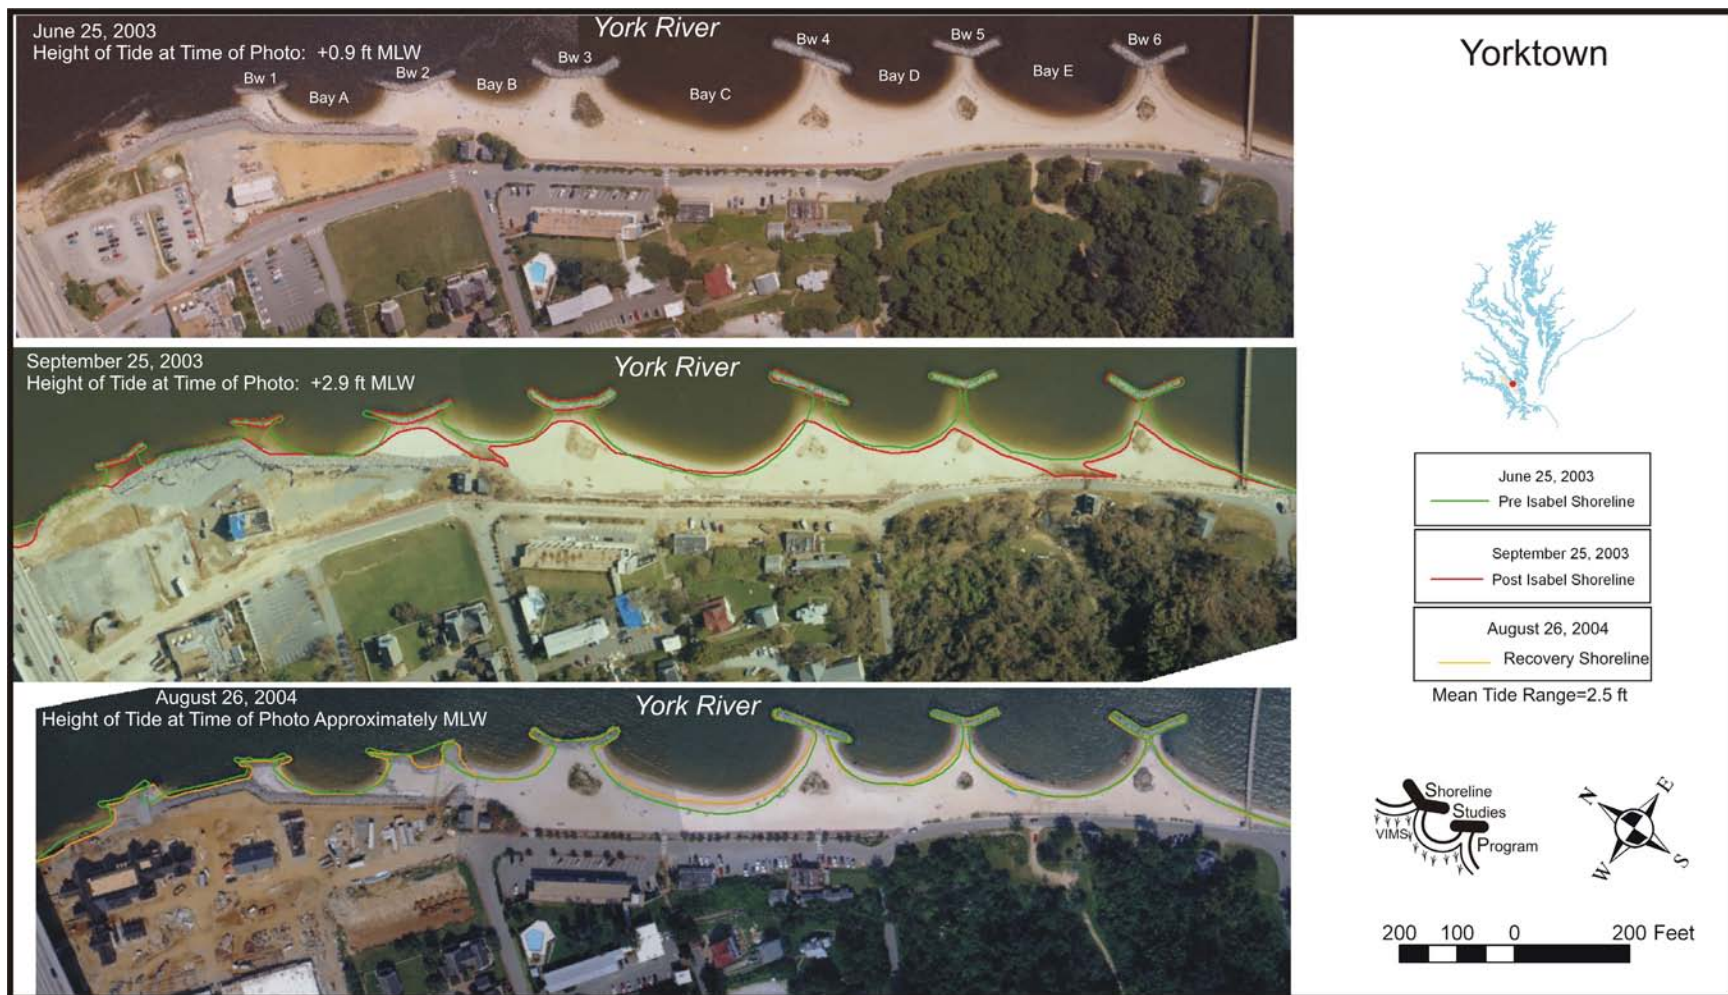
Pre- and post-Isabel low-level aerial imagery show a narrowing of each tombolo and a landward shift of sand behind each breakwater unit (Figure 27). The shoreline position in the two middle and largest embayments showed only slight changes after the storm. Typical profiles show cross-sectional changes as a basic cut and fill in the embayments (Figure 28). Shearing occurred across the top of the tombolos as well. Some sand was lost to the offshore after the storm, but the county filled the beach to its pre-storm profile shortly after the hurricane. Post-storm recovery about 1 year later shows shore planforms to have returned to their pre-storm position. A noticeable shore advance is seen in Bay B and D.

Figure 27. Yorktown low-level pre- and post-Hurricane Isabel and recovery ortho-rectified aerial photographs

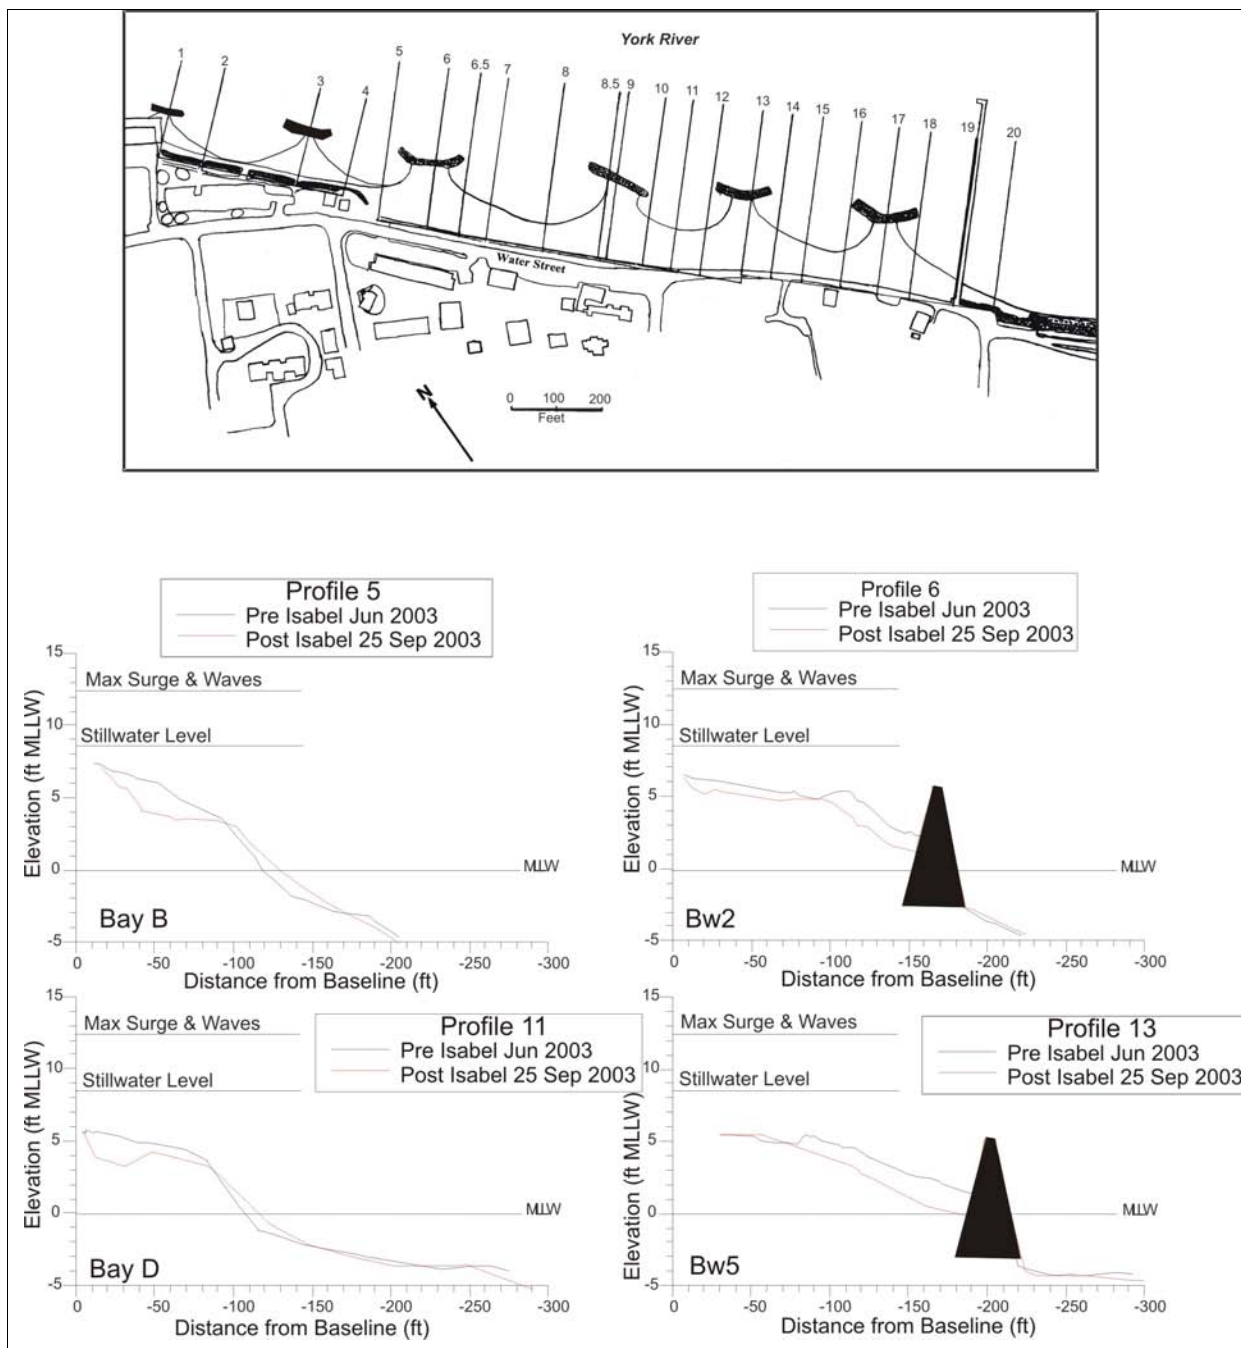
Figure 28. Yorktown baseline and selected pre- and post-storm cross sections

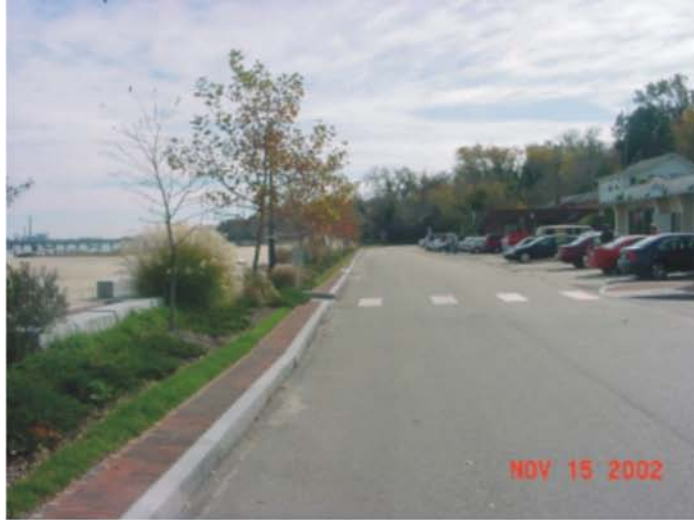
a. Pre-storm low backshore

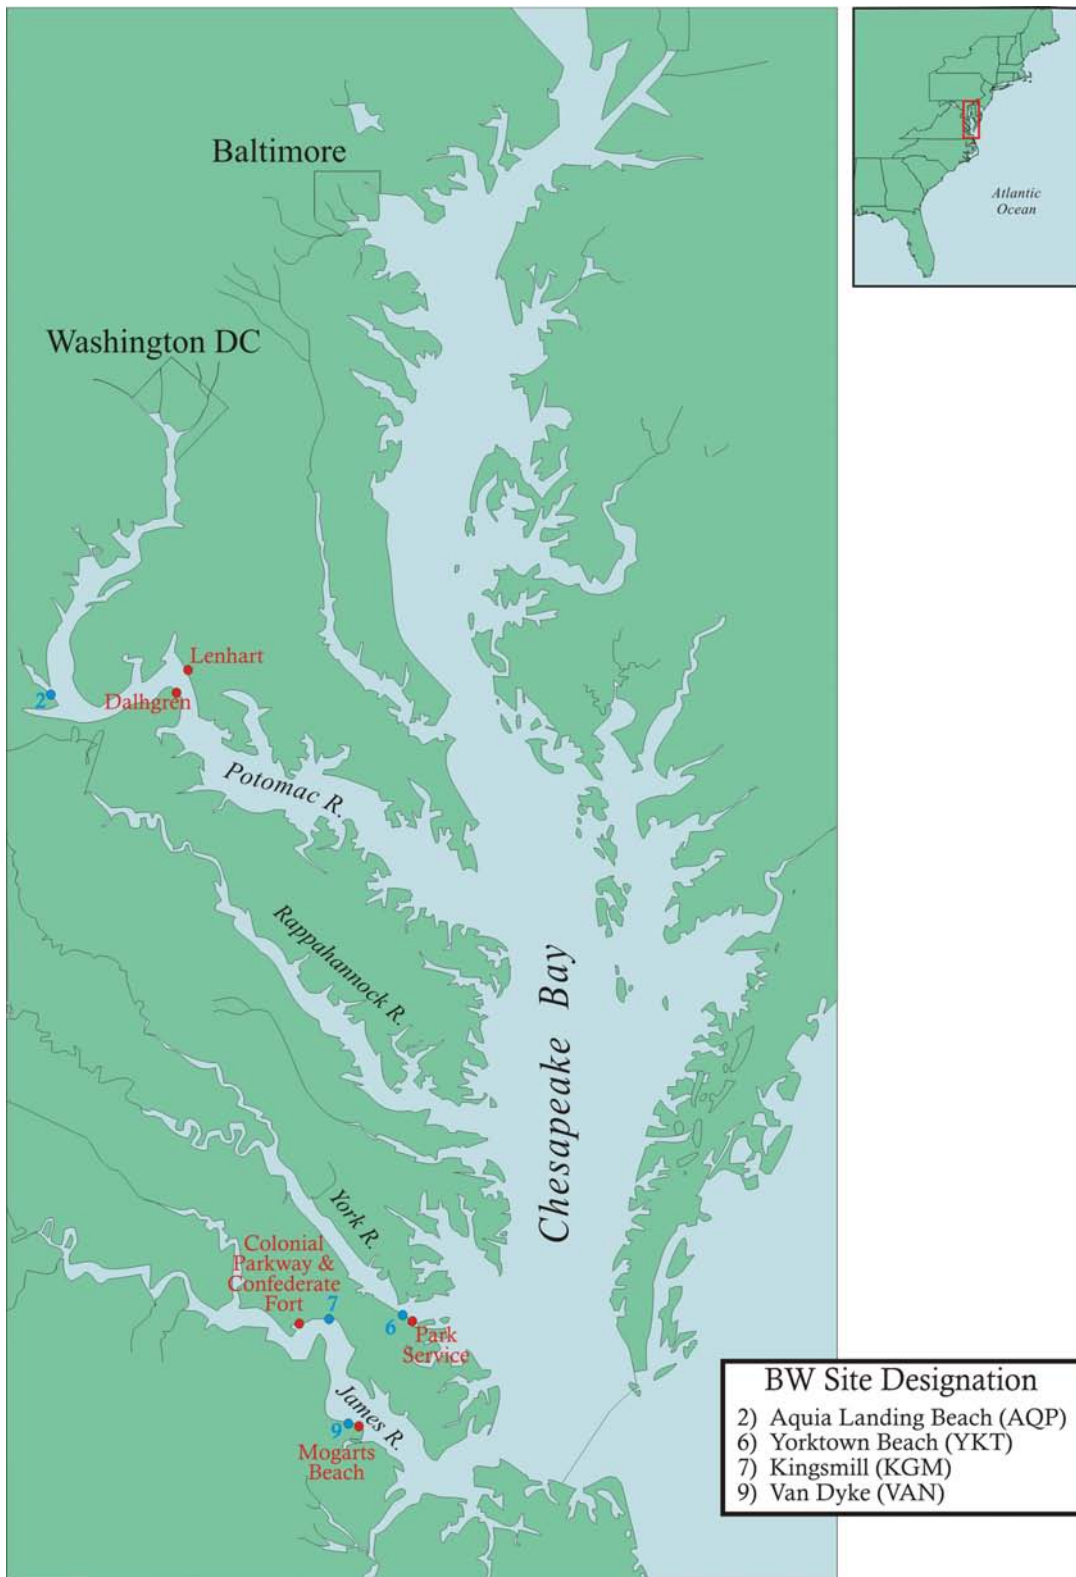
Just downriver at two other sites which had no shore protection system, significant change occurred (Figure 31). Dahlgren is on the south side of the Potomac River just downriver from the Route 301 Potomac River Bridge. Its bank was eroded 4.6 to 6.1 m (15 to 20 ft) threatening upland infrastructure (Figure 32). On the north side of the Potomac River, Lenhart is slated for development. During the storm, its bank retreated 3.0-4.6 m (10-15 ft) (Figure 33).

Figure 31. Location of breakwater sites used in this report (blue) and other affected sites (red)

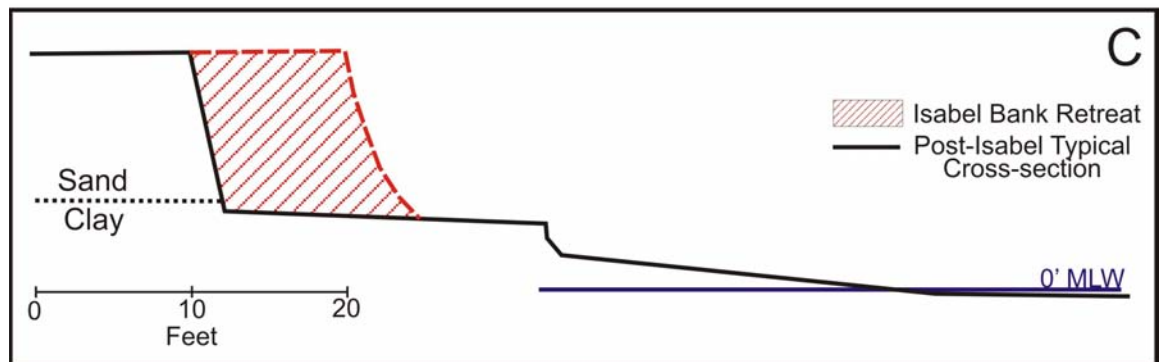
c. Typical post-storm cross section

Figure 33. Impacts to unprotected shore at Lenhart due to Hurricane Isabel
