## **In-Place Pipe Lining of Pre-action Fire Suppression System at Fort McPherson, GA**

Orange S. Marshall

March 2007

Final report

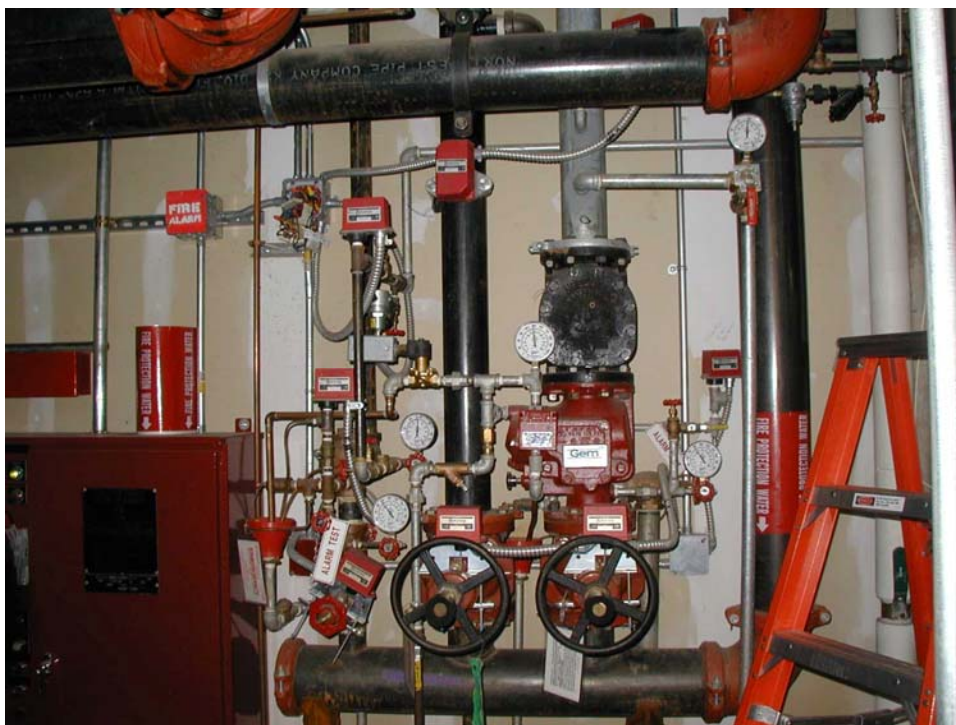
Figure 8. Valving in Building 315.

A pre-action fire suppression system is a modified dry-pipe fire suppression system. It is essentially the same as wet-pipe systems except that the pipes in the protected area contain pressurized air rather than water. The air holds a valve closed which prevents water from entering the sprinkler piping. If a heat or smoke detector indicates a fire, a valve automatically opens, discharging the air in the pipes and permitting water to flow into the piping. The water discharges from the sprinklers that have opened due to exposure to a heat source. Figure 7 is a drawing depicting a pre-action system, and Figure 8 shows the valving in Building 315.
