# **Commercialization of Technologies to Lower Defense Costs**

## **Final Demonstration/Validation Report For STAPP Bullet Catcher Evaluation at Fort A.P. Hill March 2, 2006**

Contract No. W74V8H-04-D-0005  
Task No. 0403  
CDRL A012  
Report Number: NDCEE-CR-2006-001

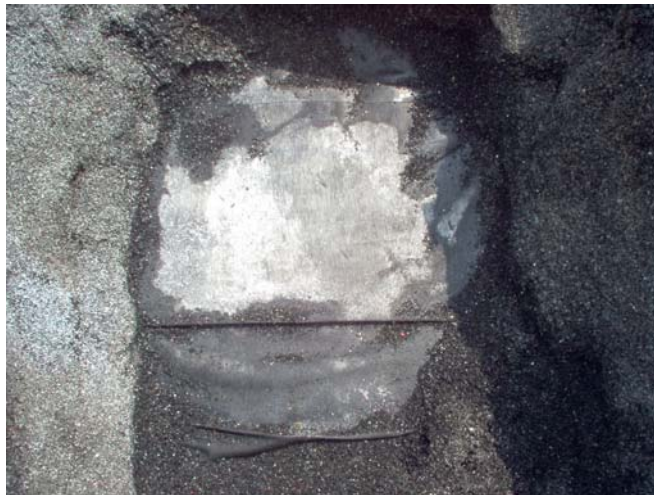
**Figure 48. Bottom Rubber Liner of Range 4, Lane 52.**

As sifting of the hot spot continued, it became obvious that the majority of the bullets were located in the top 6-8 inches of the granular rubber. Once the entire hot spot was sifted and the bottom rubber liner exposed, the liner was visually inspected for tears/holes. There were no visible tears/holes in the bottom rubber liner (please see Figure 48). Lane 52 hot spot sifting was complete at roughly 2:55pm.

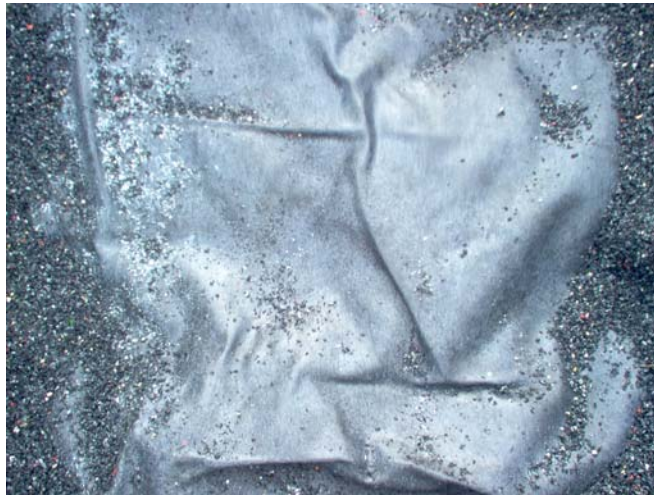
**Figure 49. Bottom Rubber Liner of Range 4, Lane 53.**

At 7:00am on 19 August 2004, Clean Harbors' 3-man crew was on-site and immediately began to continue sifting Lane 53. As with Lane 52, the majority of the bullets were concentrated in the top 6-8 inches of the granular rubber. Once the entire hot spot was sifted and the bottom rubber liner exposed, the liner was visually inspected for tears/holes. There were no visible tears/holes in the bottom rubber liner (please see Figure 49). Lane 53 hot spot sifting was complete at roughly 10:40am.

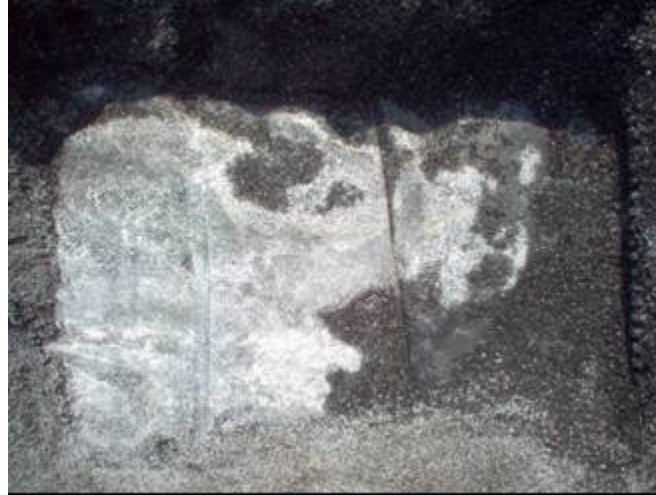
**Figure 51. Bottom Rubber Liner of Range 4, Lane 54.**

At approximately 11:00am Lane 54 sifting operations began. As with the other lanes the hot spot area was 70 inches x 50 inches and the bullets were also contained in the top 6-8 inches of granular rubber. The bottom rubber liner was visually inspected. No holes/tears were found (see Figure 51). Lane 54 sifting was complete at 4:15pm.

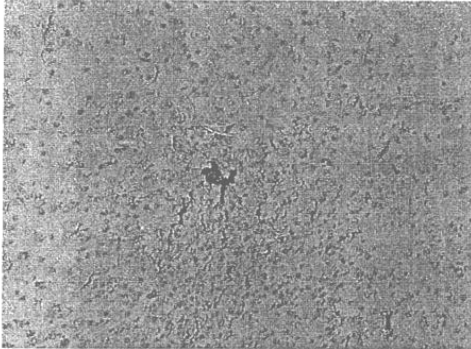
1. Example of wear damage which should be covered with a repair patch.
