## Task Order 2 Enhanced Preliminary Assessment

DEFENSE MAPPING AGENCY (DMA)  
HERNDON, VIRGINIA

December 1989

Roy F. Weston, Inc.  
West Chester,  
Pennsylvania 19380

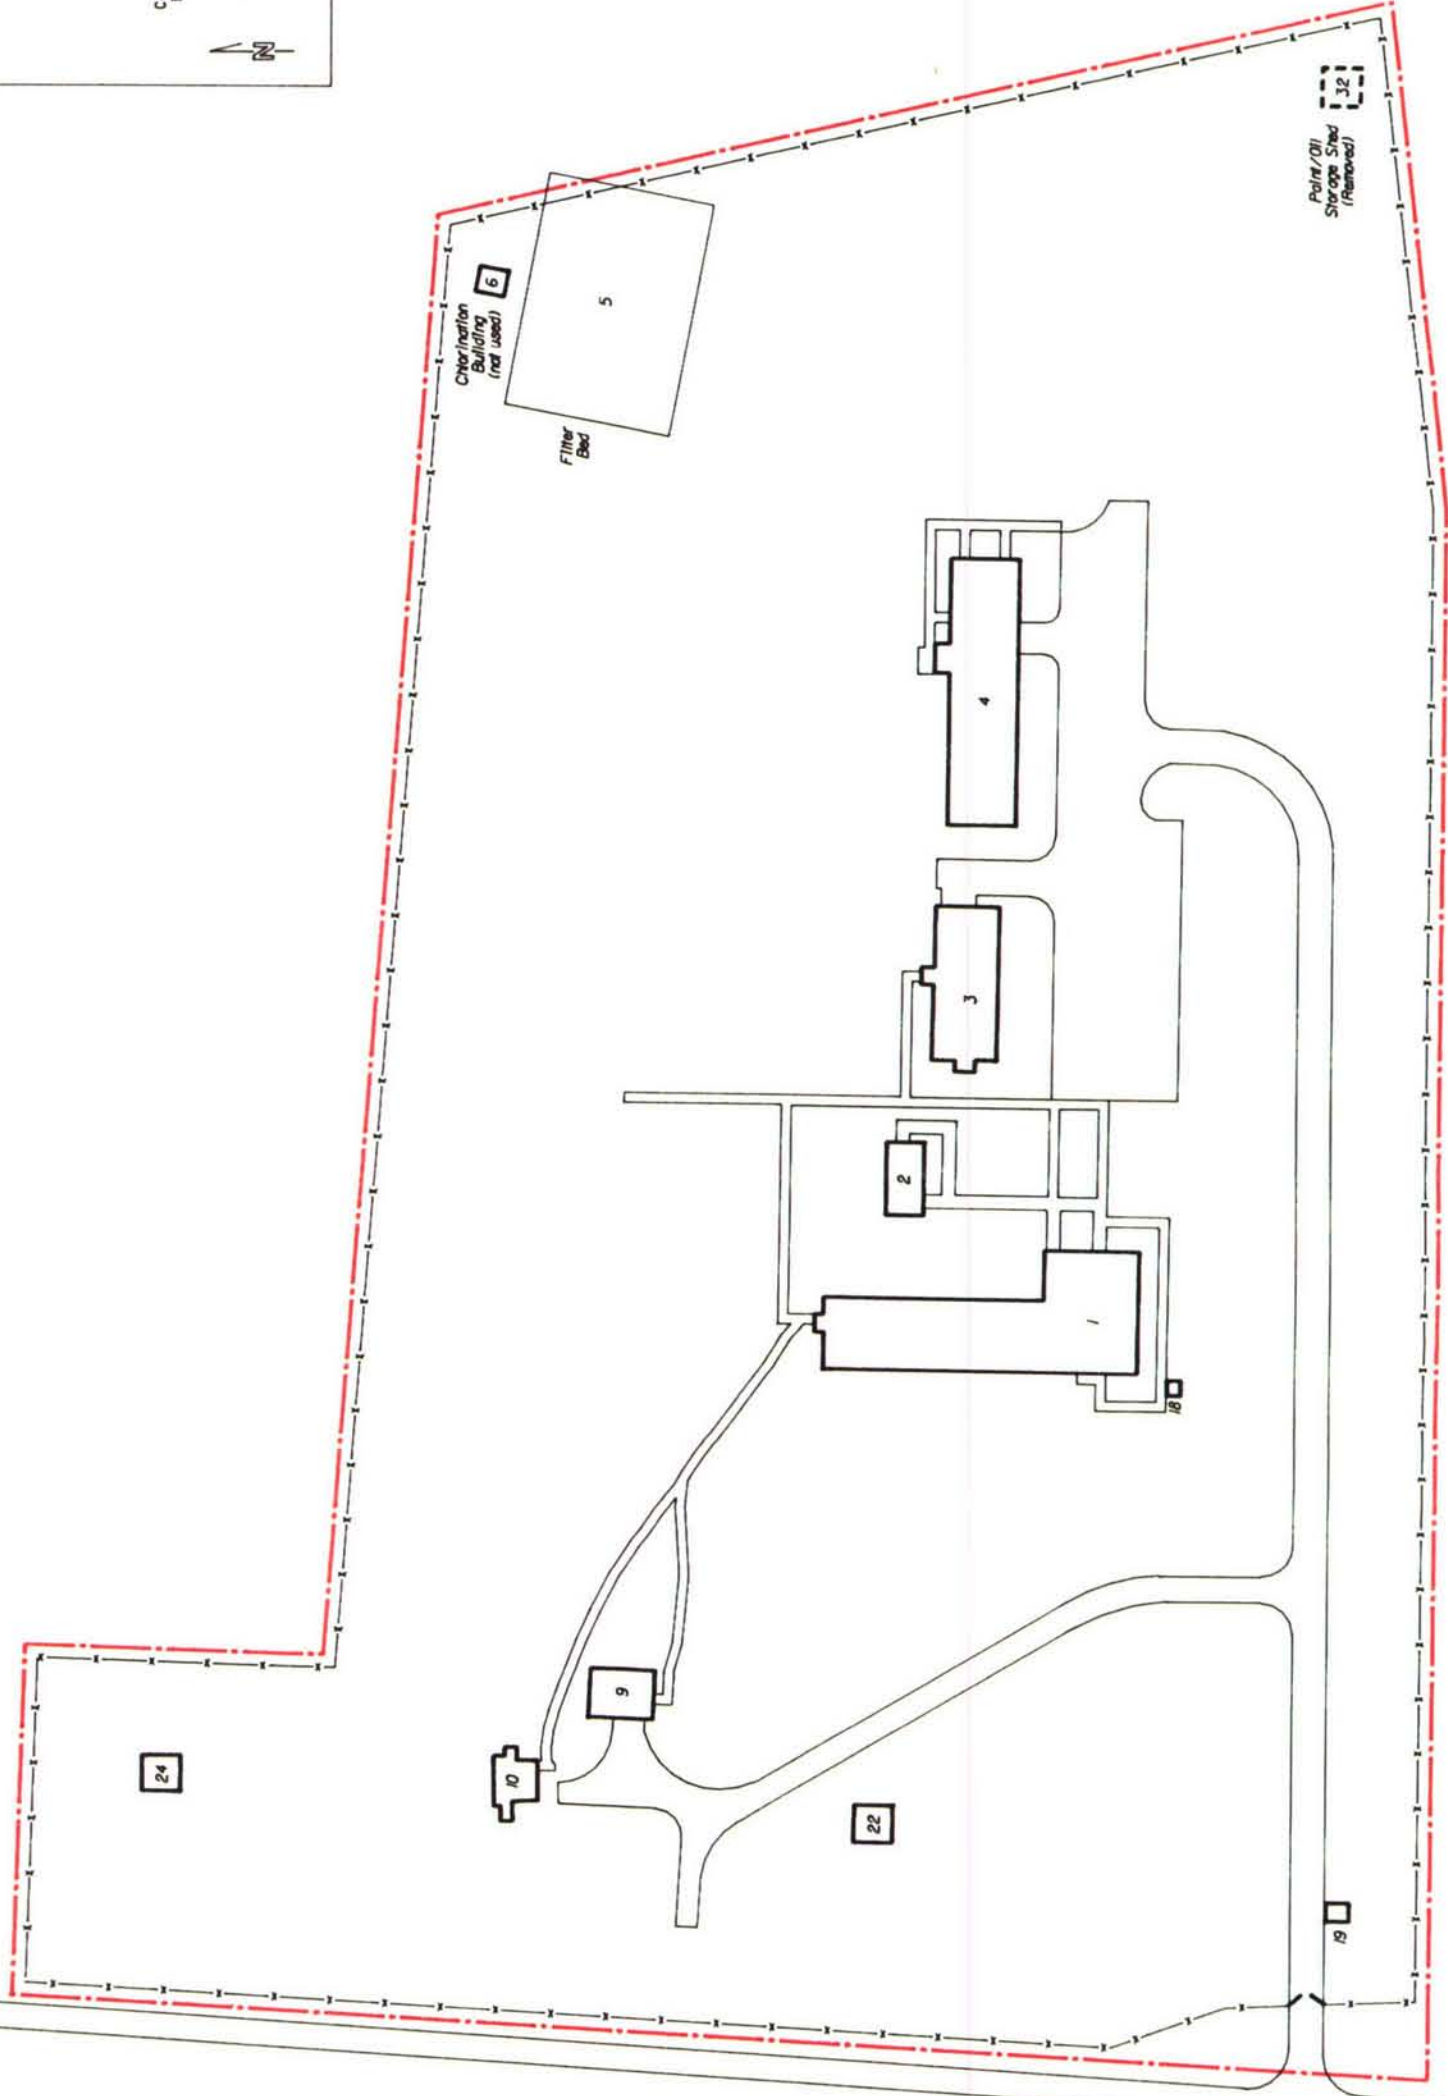
**Figure 2-2**  
**Site Plan**

Figure 2-2 shows a site plan of the DMA property. Of the 11.96 acres on the site, 8 acres are open land, with the remainder under roof. The open land consists of mowed lawn with occasional shrubs and trees and paved areas. Roadways and walkways in the compound are in good repair.
