**FIGHTING VEHICLES  
RESEARCH AND DEVELOPMENT  
ESTABLISHMENT**

REPORT No. F.T. 2239.

MINE DAMAGED TRACKS.

MINE DAMAGED TRACK

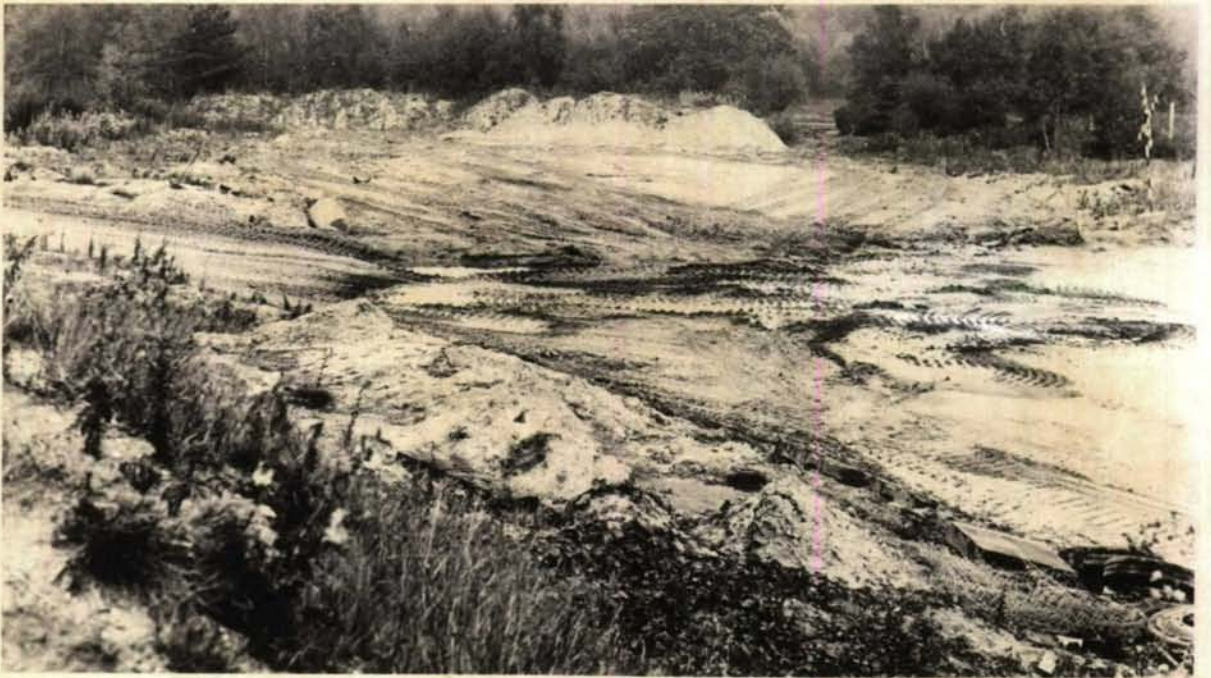
FIG. 3

5.2 After fitting a section the vehicle was moved to give the track one complete traverse. This was done to confirm that the damaged portions would pass over the suspension components. The short cross country course shown in Figs. 4, 5, and 6 was then used, the vehicle was accelerated through the gears along the straight, slowed down for a steered turn and then returned to the starting point. A skid turn on concrete completed the test circuit which brought the vehicle into position for the next section of track to be fitted.

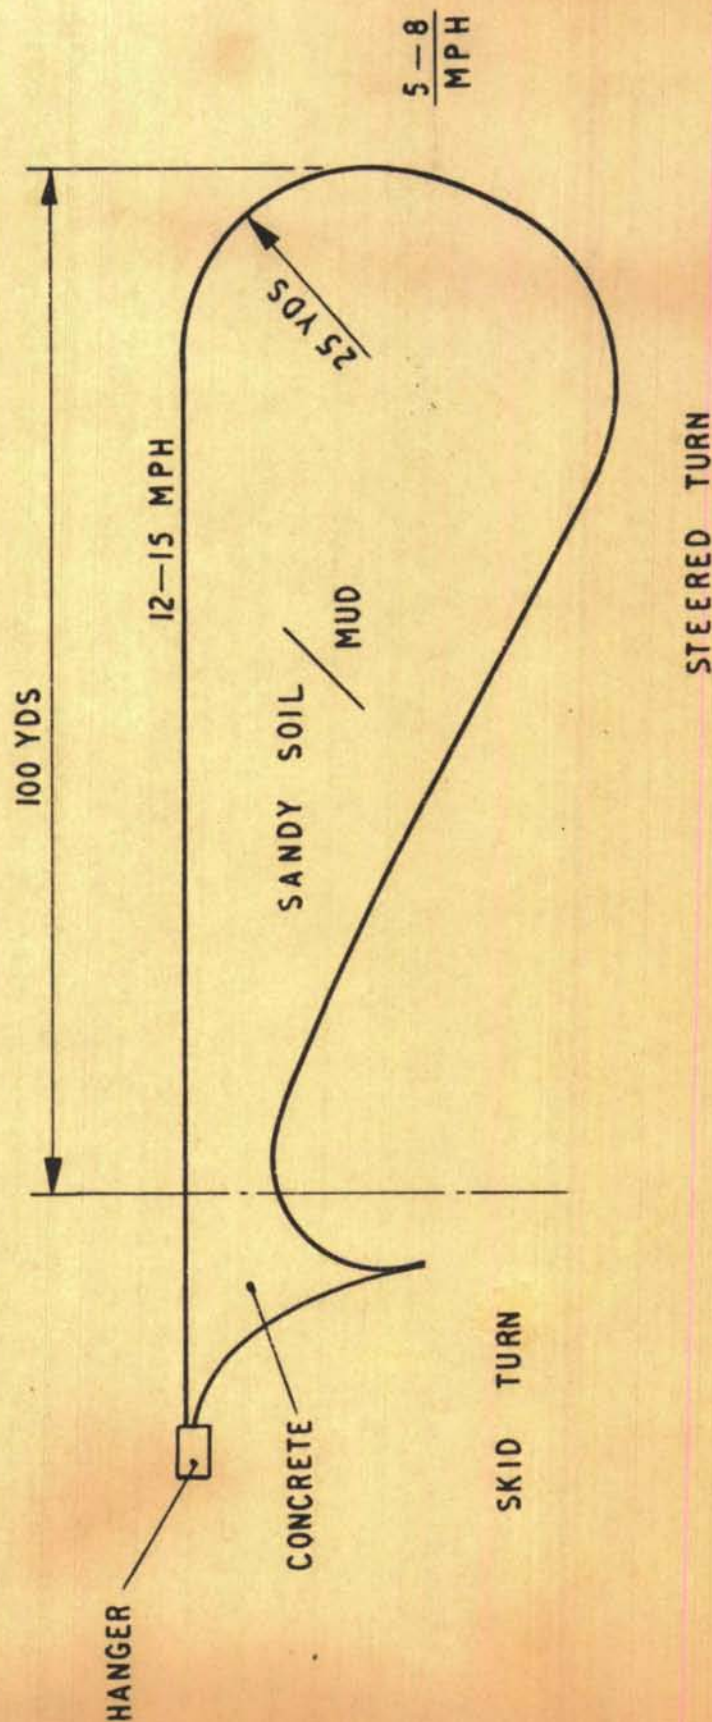
FIG. 5

- 2.4 The running course shown in Fig.6 was arbitrarily chosen as being typical of the type of cross country over which the vehicle was likely to encounter a mine field. After attack, if not immediately disabled, the vehicle would have to move, unaided, to a cleared area to enable the crew to carry out repairs. The length of the course was considered adequate for this purpose and if the damaged track prevented this movement the attack was considered a 'kill'. This trial satisfactorily demonstrated the ability of light track to continue running after sustaining considerable mine damage.

TEST COURSE AT LONG VALLEY USED TO  
TRY OUT MINE DAMAGED TRACKS
