ERDC/CRREL TN-08-1

Ice Jam at the Rio Blanco Diversion Weir on the White River in Colorado

A Case Study of In-Stream Structures and Ice

February 2008

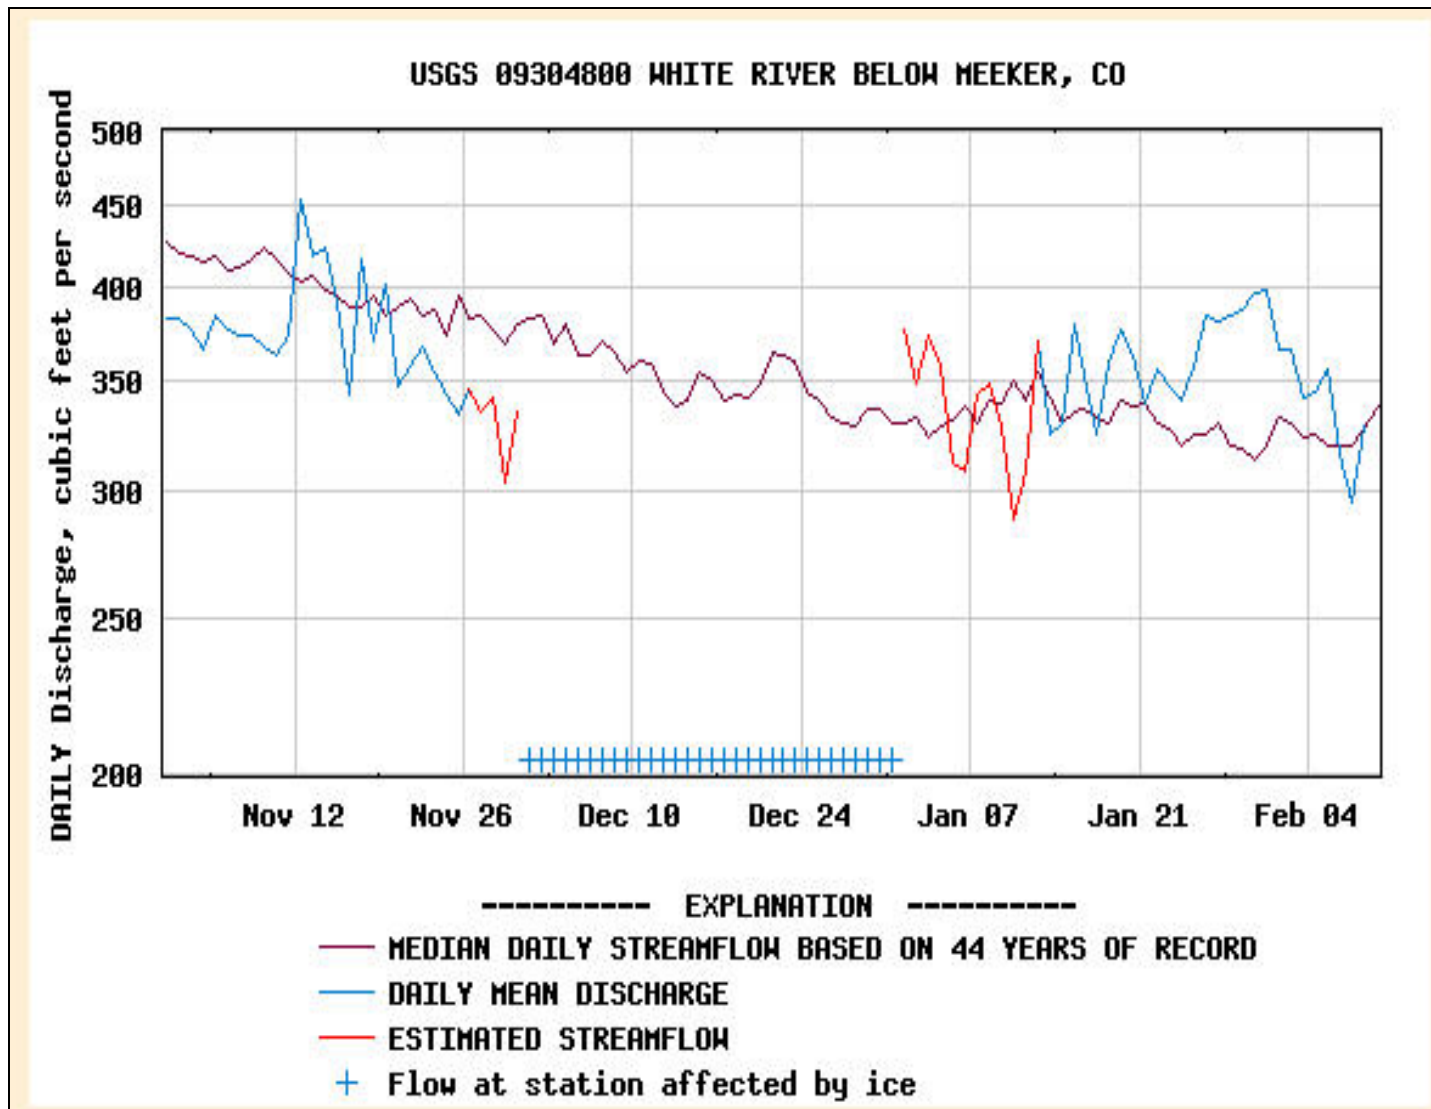
Figure 3. White River discharge below Meeker, Colorado. Note that an ice cover existed at the gage location (eight river miles upstream of the CDOW weir) from 29 November to 30 December 2005.

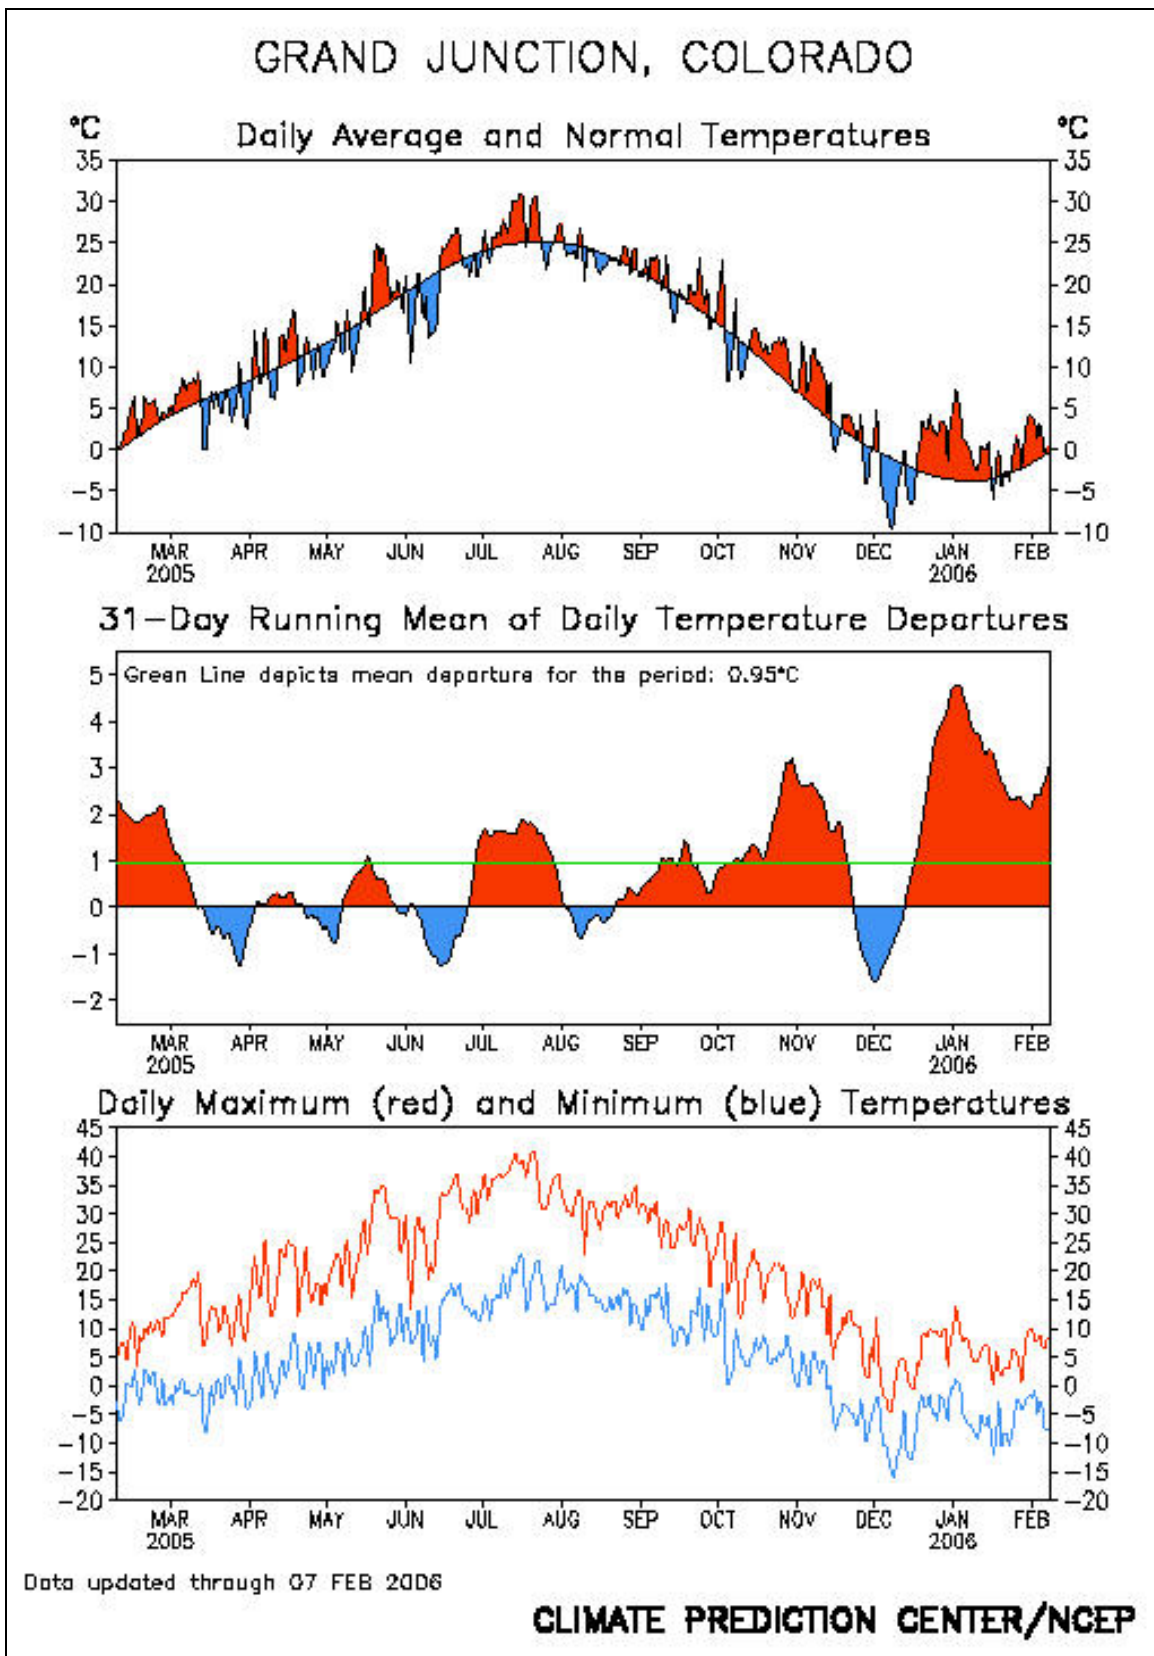
Figure 10. Winter 2005–2006 air temperatures for Grand Junction, Colorado, compared to long-term averages.

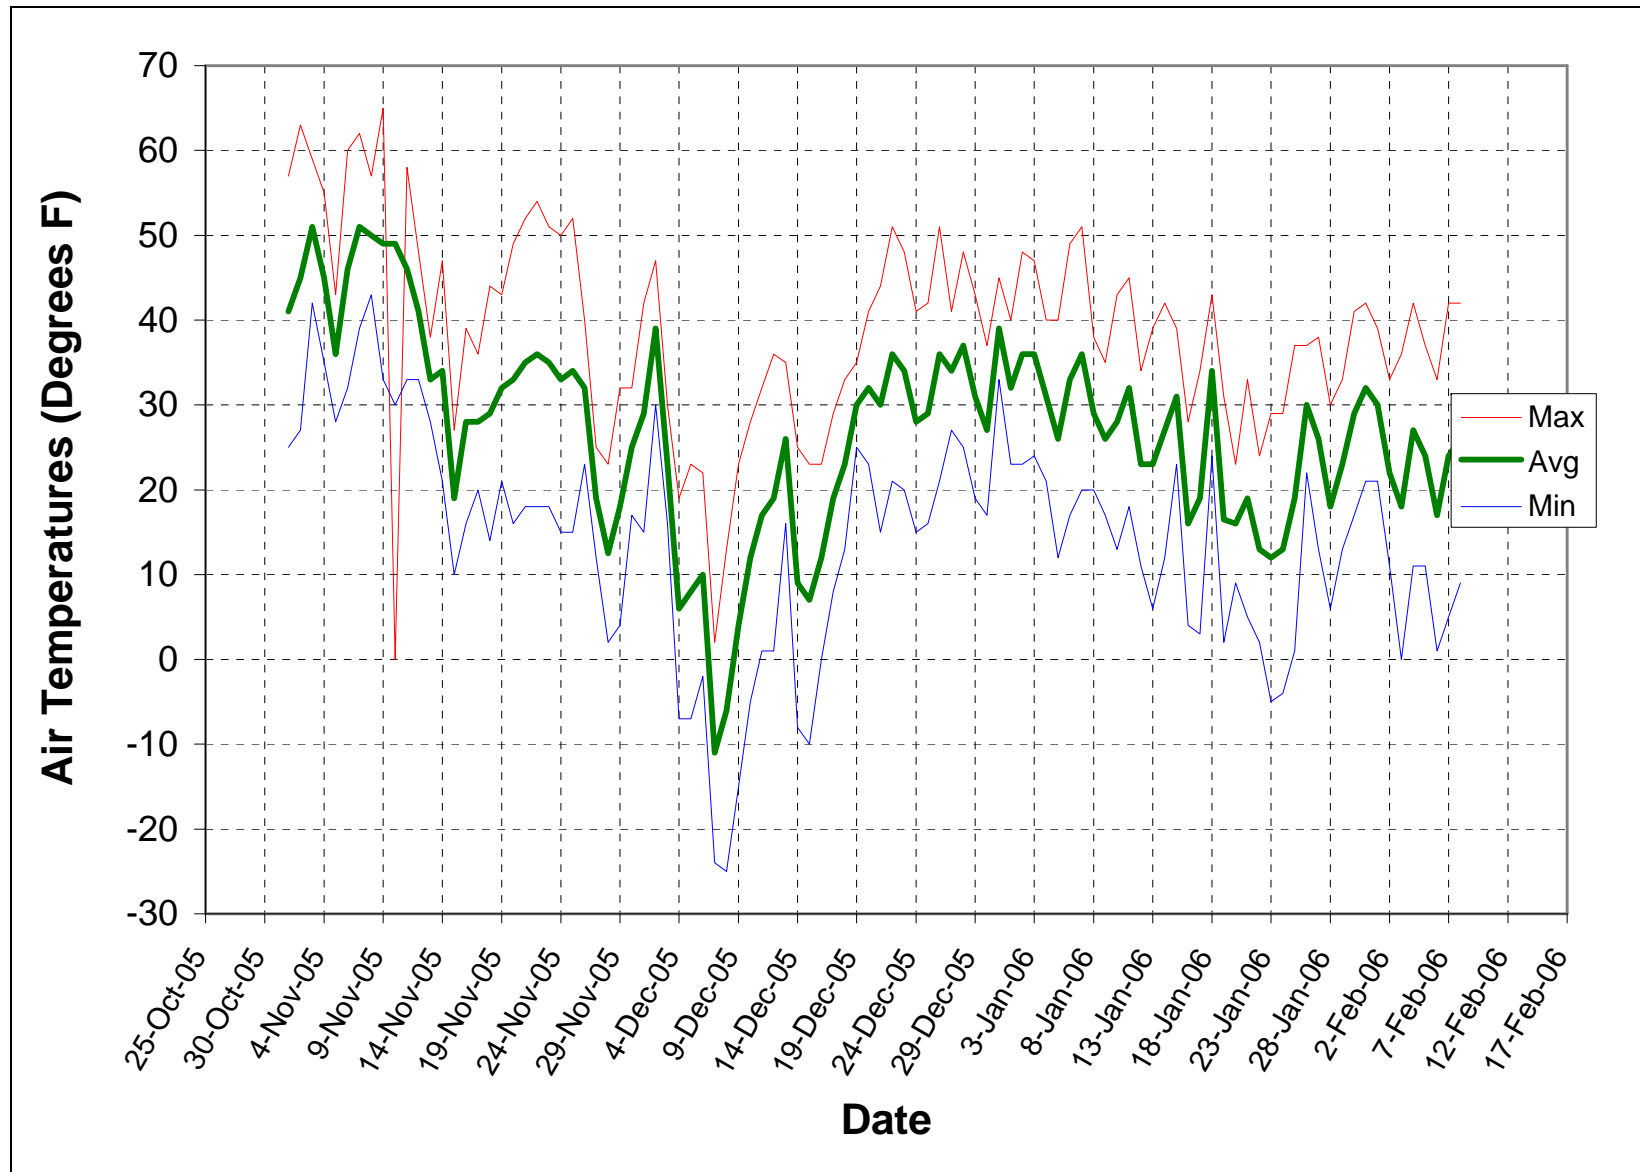
Figure 11. Air temperatures at Meeker, Colorado, airport, showing early December cold spell during which ice jam formed.
