# Structural Health Monitoring of a Bonded Composite Patch Repair on a Fatigue-Cracked F-111C Wing

DSTO-RR-0335

A large fatigue crack in the wing skin of an Australian Defence Force F-111C aircraft was repaired with an adhesively bonded boron/epoxy fibre composite patch. The patch prevented further growth of the crack for 670 flying hours.

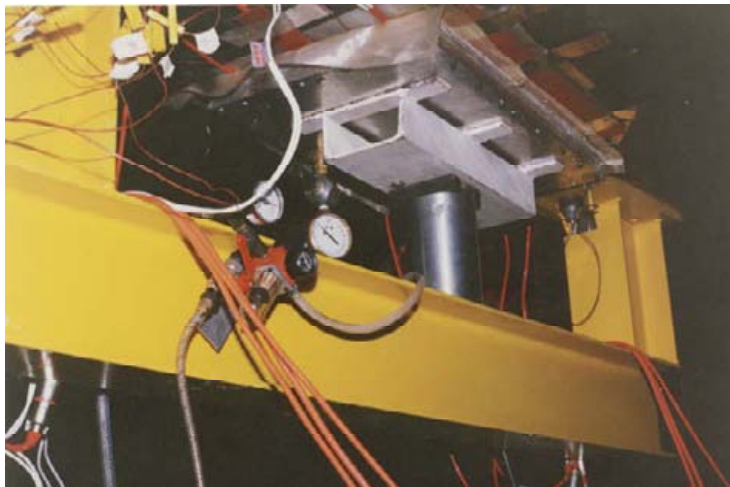
Figure 7 : Ground support equipment used by RAAF for applying pressure to the patch through a caul plate

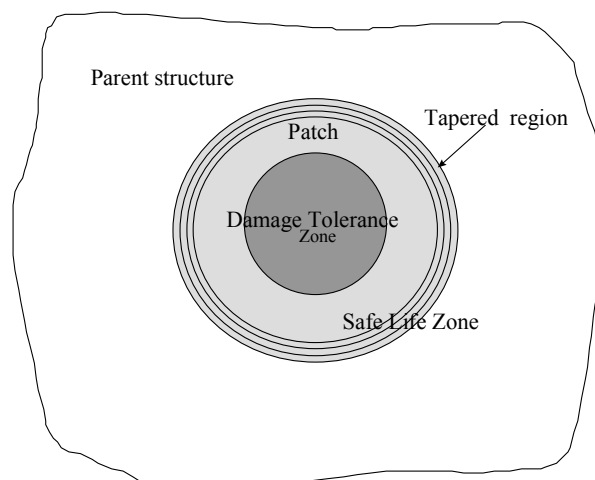
The focus of the measurements was the tapered end regions of the patch in the spanwise direction of the wing, since damage growth in this region results in increasing stresses which could lead to complete loss of the patch. For this reason the tapered region was classified in previous studies [11] as a safe-life zone in which design stresses in the adhesive system should be held below the threshold level for damage growth.

Figure 18: Illustration of the zones in the patch system categorised as safe life or damage tolerant, taken from Reference 11

Another anticipated but less serious, region of potential disbond growth is in the patch over the crack. Although disbonding reduces local stresses in the bond-line, so is stable, it results in a loss in patching efficiency since crack bridging decreases in effectiveness as the region of the patch spanning the crack becomes larger and therefore more compliant. Even with a substantial loss of crack bridging, providing the patch does not disbond from its ends, a significant level of strain reduction will be provided over the cracked region. Thus

this region was previously classified as a damage tolerant zone, so not of prime concern for strain-gauge measurements; Figure 18 depicts these hypothetical regions.
