# Structural Health Monitoring of a Bonded Composite Patch Repair on a Fatigue-Cracked F-111C Wing

DSTO-RR-0335

A large fatigue crack in the wing skin of an Australian Defence Force F-111C aircraft was repaired with an adhesively bonded boron/epoxy fibre composite patch. The patch prevented further growth of the crack for 670 flying hours.

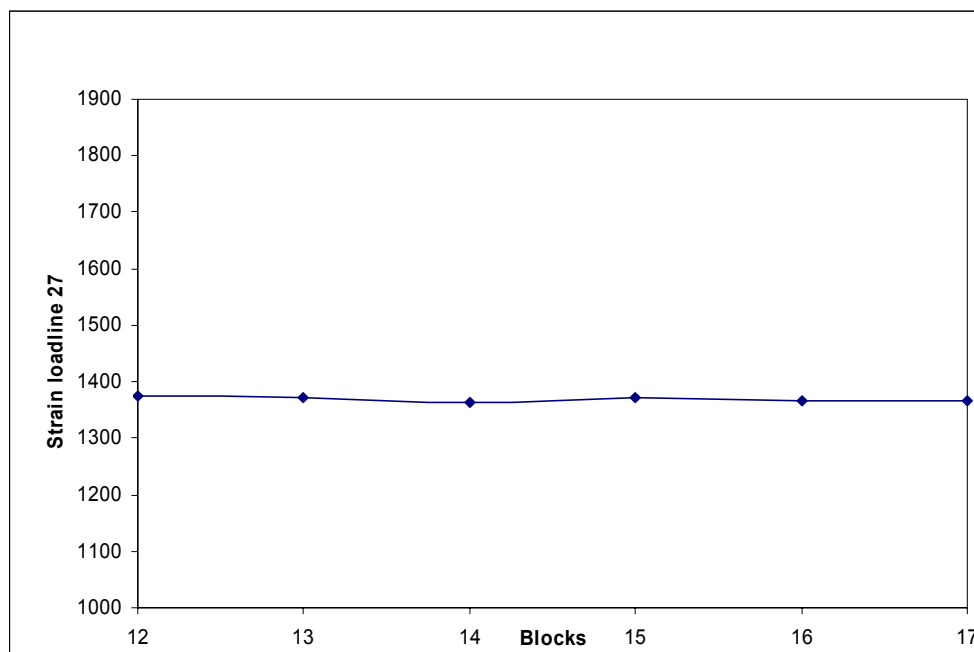
*Figure 22 Strain at load-line 27 versus blocks for gauge 353 bonded on the patch in a region well away from the patch edge*

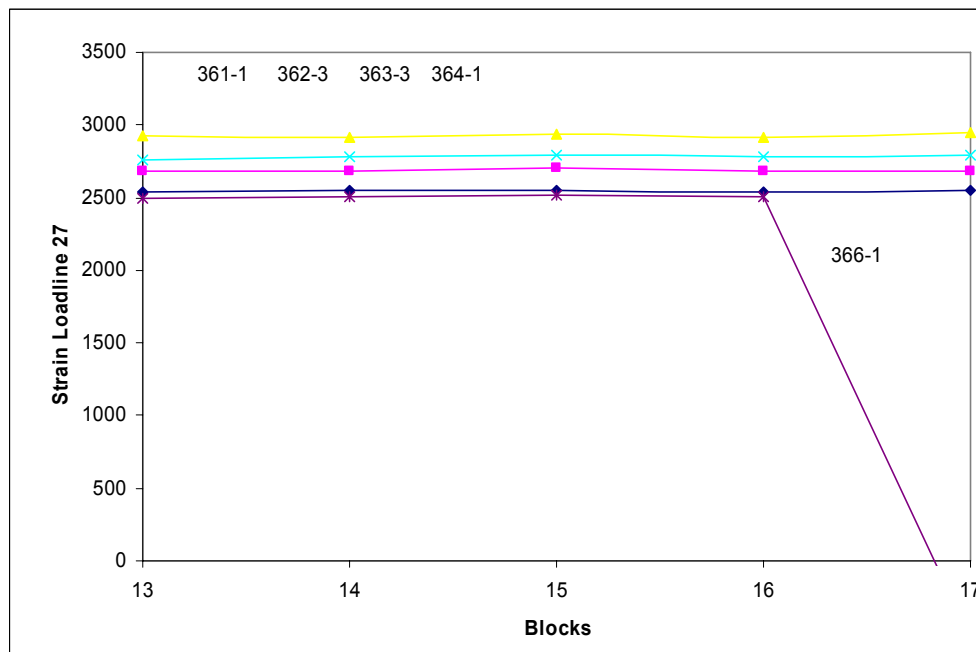
Other than gauge 366, which appears to have failed after 16 blocks of cyclic loading, the readings on the wing skin show excellent consistency and provide a good indication of the repeatability of the loading and reliability of most of the gauges.

It is also notable from Figure 23 that at least for load-line 27, and probably for most of the other loading conditions, that the strain in the wing-skin around the periphery of the patch is quite uniform for load-line 27.

Figure 23 Strain at load-line 27 versus blocks for gauges bonded on the wing skin

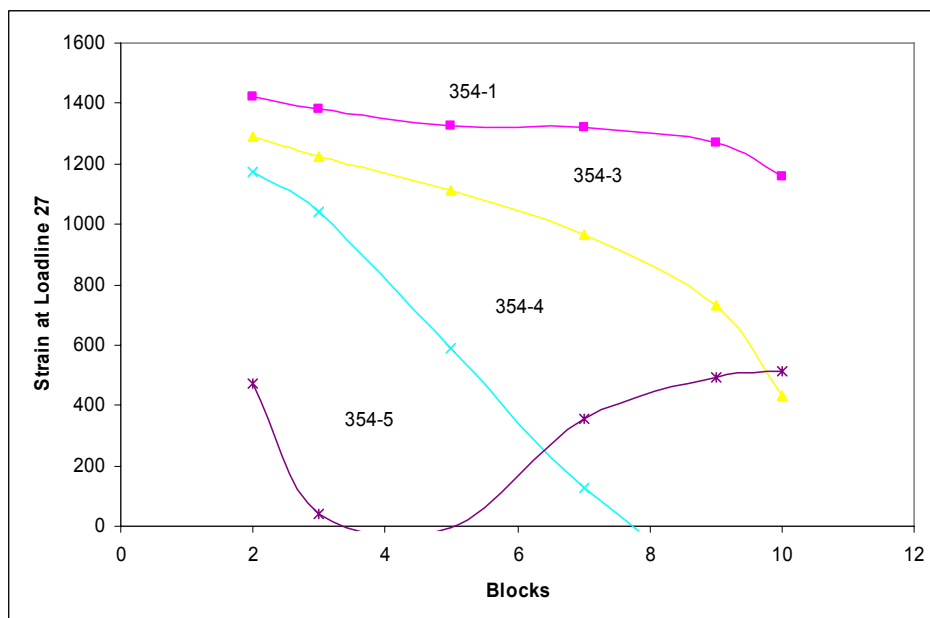
Only the results for the strip-gauge 354-1 to 5 could be located for measurements from Block 2; these are plotted in Figure 24 - location 1 is furthest from the patch edge.

Figure 24: Strain versus block number for strip-gauge 354 for Blocks 2 to 12; the skin gauge location is 364 and patch gauge positions are as indicated in Figure 20

The results should be compared with the disbonds shown in Figure 8 top right (for the region located near the prospective location of wing-skin gauge 364) that corresponds with zero blocks of fatigue loading in the test.

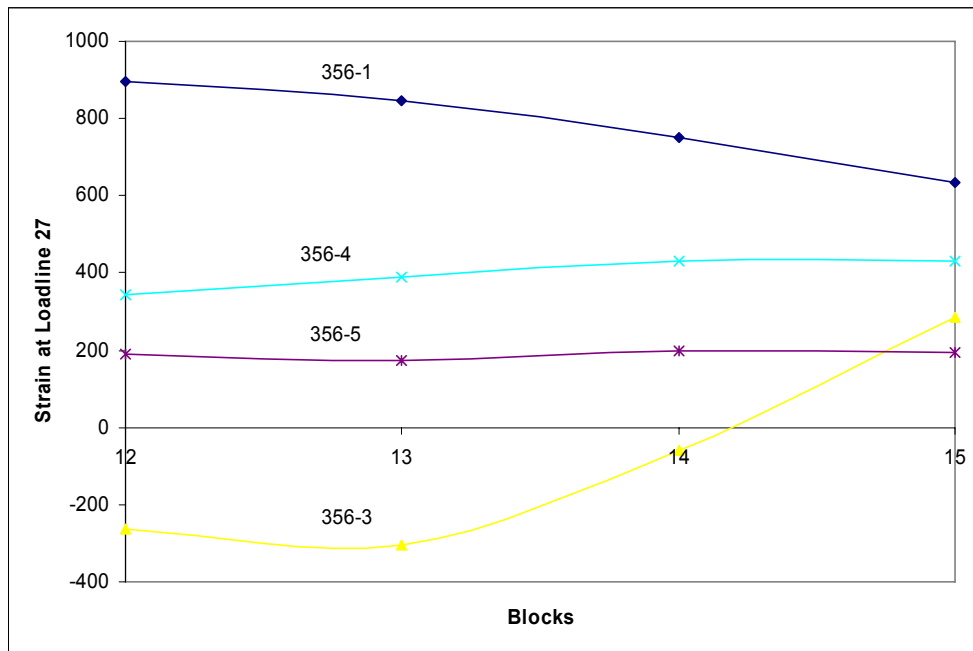
- Strip-gauge 356, Figure 26,
  - The low strain readings from gauges 3 to 4 indicate of the presence of pre-existing disbonds, in agreement with NDI, see Figure 13. Only 356-1, which is

Figure 26: Strain versus block number for strip-gauge 356 for Blocks 12 to 15; the relevant wing-skin gauge location is 364. NDI indications of pre-existing disbonds are shown in Figure 13

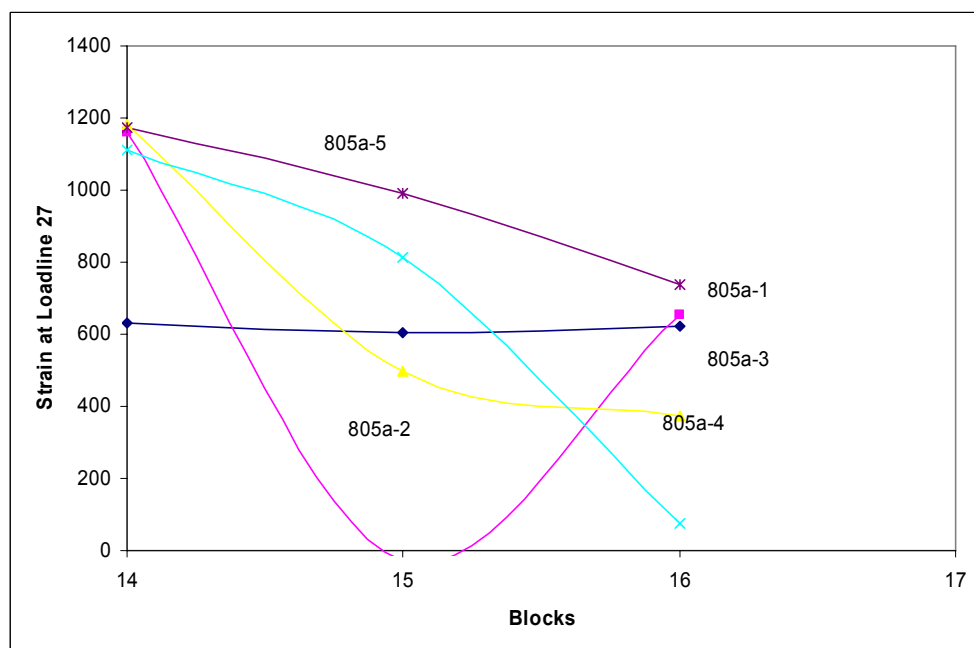
- Strip-gauge 805a, Figure 30
  - This strip gauge indicates damage growth, if the readings from gauge 805a-1 and later readings from gauge 805a-2 are ignored. Gauges 805a-3, 4 and 5 clearly indicate that the disbonds in this region are growing fairly rapidly over this period. Gauge 805a-2 initially indicates disbond growth but later provides anomalous readings. Generally, however, the gauge readings are in accord with the NDI indications close to this region at Block 12, see Figure 14.

Figure 30: Strain versus blocks for strip-gauge 805a for Blocks 14 to 17; the relevant skin gauge location is between 363 and 362

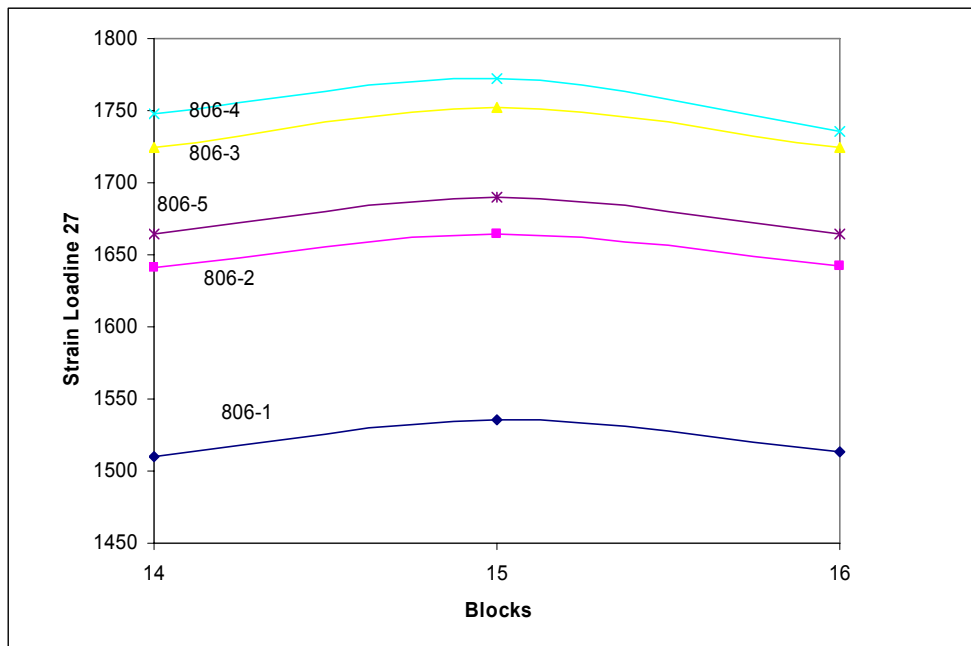
- Strip-gauge 806, Figure 31
  - This strip gauge indicates no damage growth in this region. Gauge 1 indicates the lowest strain as expected; however, gauge 5 not 3 or 4 should have indicated the highest strain readings (these gauges may be incorrectly labelled), otherwise (ignoring the rise at Block 15) no disbonds or disbond growth in this region are indicated. This conclusion is in agreement with the absence of disbond indications from NDI.

Figure 31: Strain versus blocks for gauge 806 for Blocks 14 to 16; the relevant skin gauge location is gauge 366

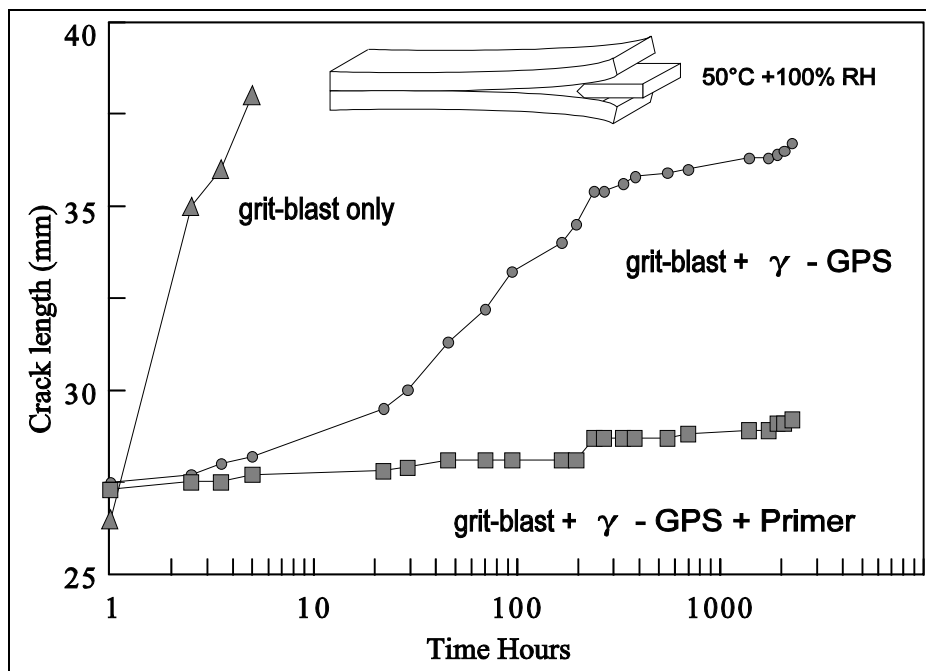
The evidence for this suggestion is shown in Figure 36, which is based on some early work [9] and later confirmed in several other studies, including [15], that the primer increases both the strength and durability of the adhesive bond to the metallic surface.

Figure 36: Plots of crack growth versus time for Boeing-wedge-test specimens (illustrated inset) made of 2024T3 aluminium and subjected to the surface treatments indicated, prior to bonding with adhesive FM73, taken from Reference [1].

However, for several practical reasons, including perceived difficulties with process control of primer thickness and possible OH&S problems, a decision was made by RAAF not to use the primer (despite strong recommendations for its use from DSTO); as discussed later, use of the primer would have markedly improved bond durability and, possibly, bond strength and fatigue resistance.
