## **Evaluation of Minimum Asphalt Concrete Thickness Criteria**

Haley P. Bell and L. Webb Mason

October 2008

Final report

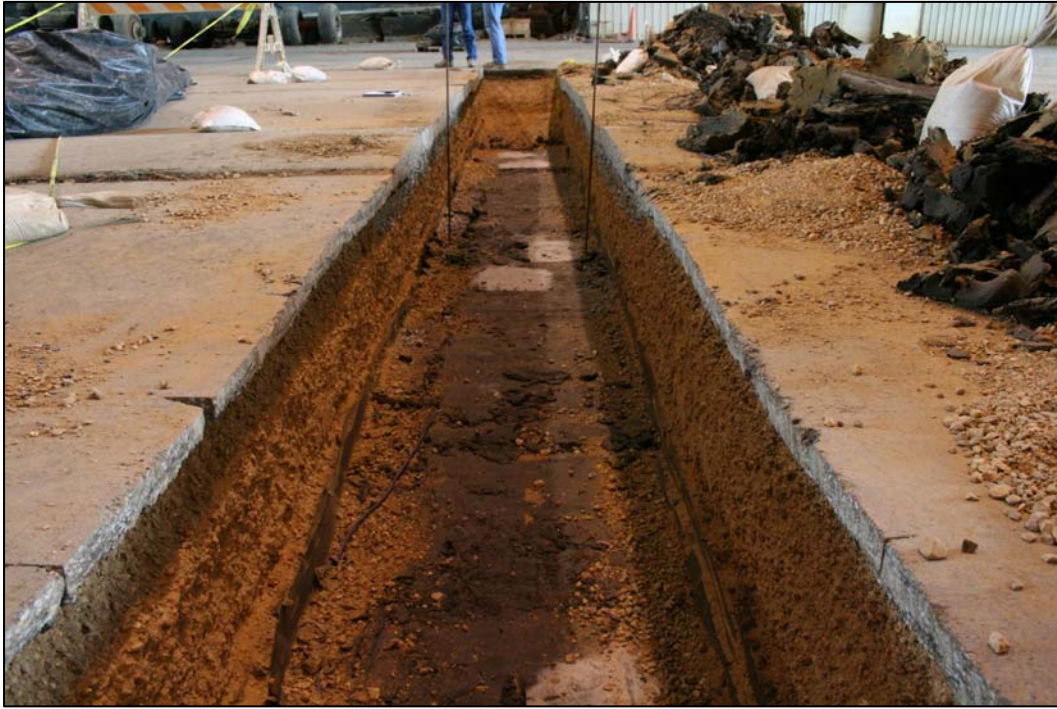
After trafficking of the test section was complete, a 3-ft-wide trench was excavated across the center (Station 25) of each item for forensic investigation (Figure 27). Items 1, 2, 3, and 5 were trenched 9 to 10 months after trafficking was complete, and Items 4 and 6 were trenched 1 to 2 months after trafficking was complete. Each layer of the pavement structure was removed individually and assessed at the center of the rut and outside the traffic lane. DCP tests, CBR tests, nuclear density and moisture measurements, and oven moisture tests were completed at each location on each foundation layer. Furthermore, visual inspection and manual profile

Figure 27. Trench across the center of Items 1, 3, and 5 of the test section.

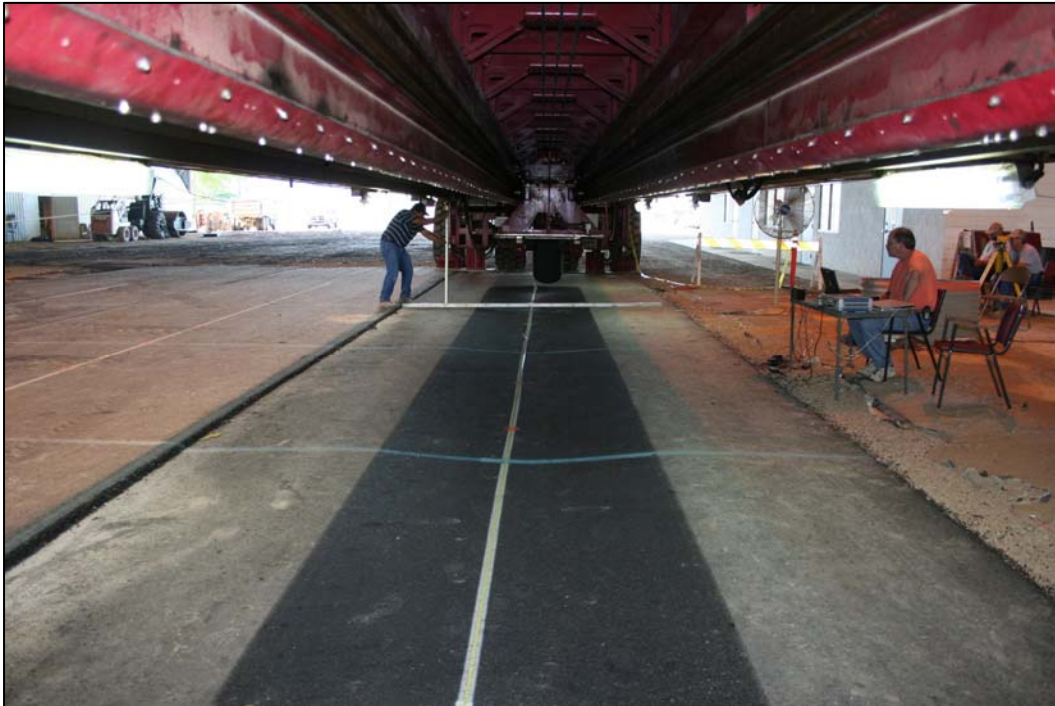
The only surface distress noted from Item 1 was rutting (Figure 28). Item 1 was trafficked with the C-17 wheel until 776 passes when about 2 in. of rutting had occurred. Failure with an average of 1 in. of rutting occurred around 234 passes. Rutting is a load related distress caused by an accumulation of vertical compressions (Collop et al. 1995). The presence of rutting indicated that a permanent deformation occurred in one or more of the layers of the pavement structure. The vertical stresses that occurred under the loaded wheel caused compression of the pavement materials. Figure 29 shows an overall view of Item 1 after trafficking was complete.

Figure 29. Overall view of Item 1 after traffic completion.

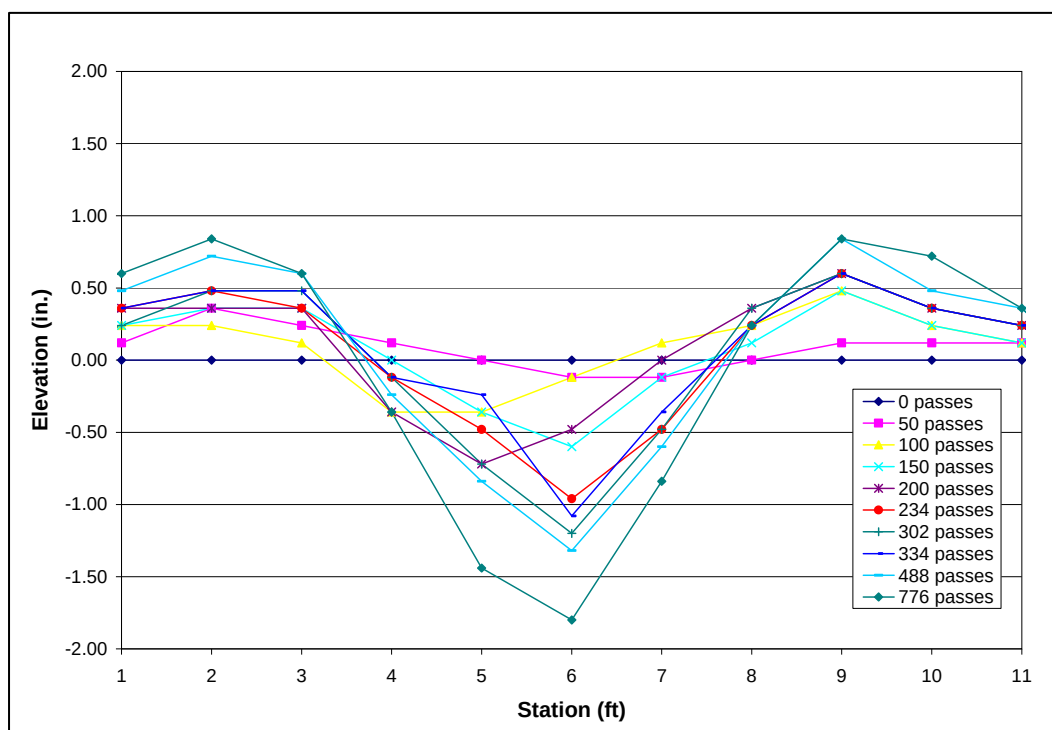
The centerline and cross section profiles of Item 1 showed upheaval on the sides and ends of the traffic lane. Item 1 received a maximum of about 0.50 in. of upheaval at failure (234 passes) and about 0.80 in. of upheaval

after 776 passes. Upheaval typically indicates that there is shear, or an outward movement of material, somewhere within the pavement structure. Figure 32 shows the cross section profiles at Station 37.5, and Figure 33 presents the centerline profiles down the traffic lane. The data for the cross section and centerline profile plots for all items were normalized to zero starting at 0 passes.

Figure 32. Item 1 cross section profiles at Station 37.5.

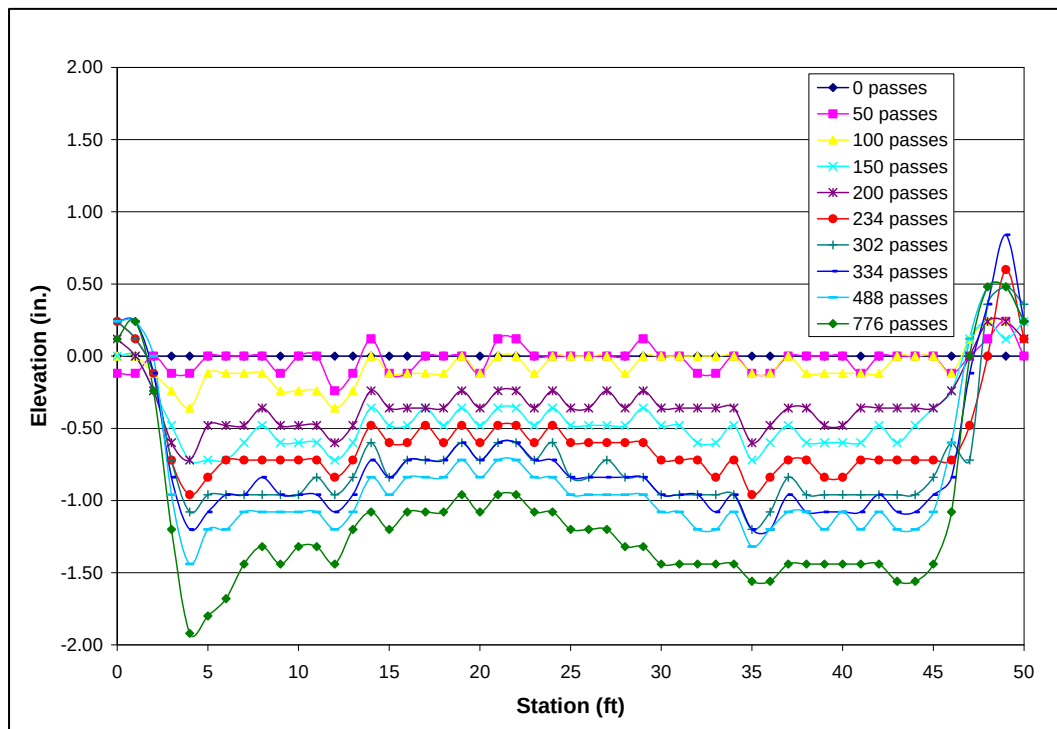
Figure 33. Item 1 centerline profiles.

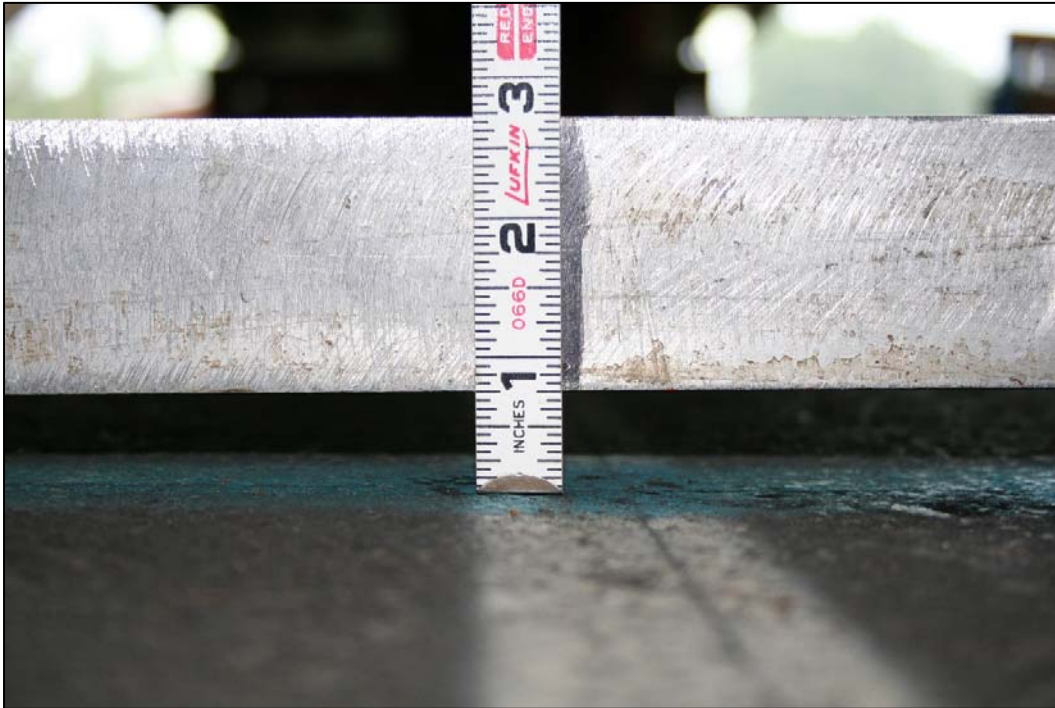
Item 2 was trafficked with the C-17 wheel until 3,600 passes, achieving an average of just over 2 in. of rutting. Pavement failure with an average of 1 in. of rutting occurred around 623 passes. Figure 39 shows a rut on Item 2 after 295 passes. Figure 40 shows polished aggregate on the surface after traffic completion, and Figure 41 shows an overall view of Item 2 after traffic completion.

Figure 39. Item 2 centerline rutting at Station 12.5 after 295 passes.

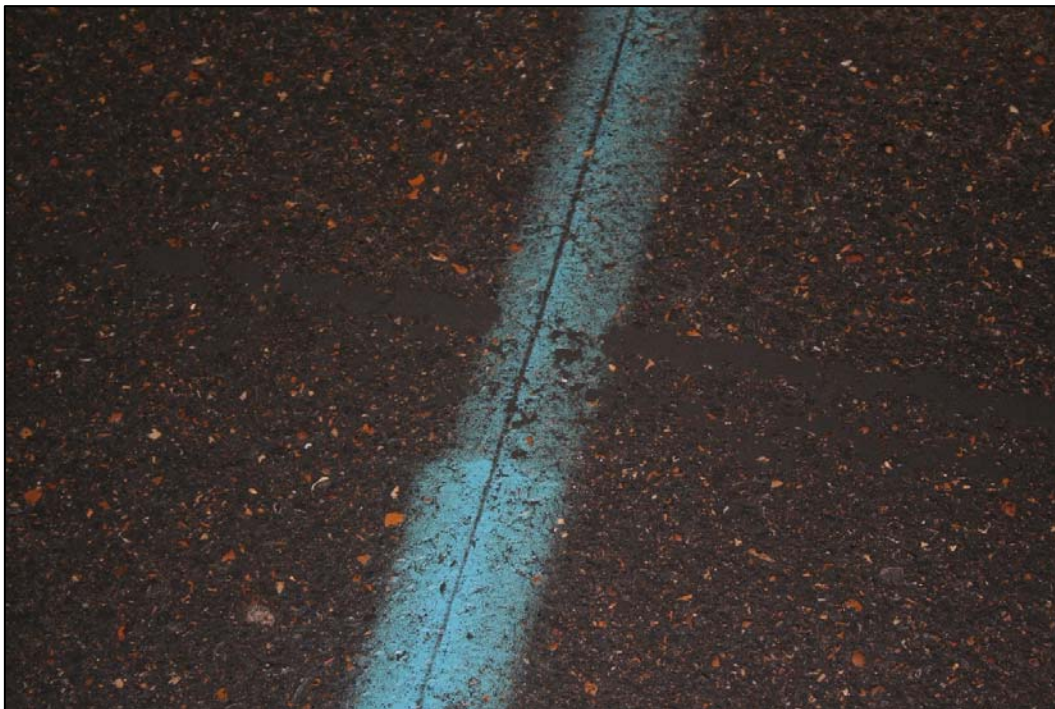
Rutting and a small amount of polished aggregate were the two surface distresses noted from Item 2. Polished aggregate is a flexible pavement distress caused by repeated traffic loadings when using aggregate with polish potential. The aggregate begins to appear above the asphalt concrete, and the surface of the aggregate becomes smooth and slick as a result of repeated traffic. This distress is significant because it causes a pavement to lose its friction (Shahin et al. 1976-1977).

Figure 40. Item 2 polished aggregate after traffic completion (3,600 passes).

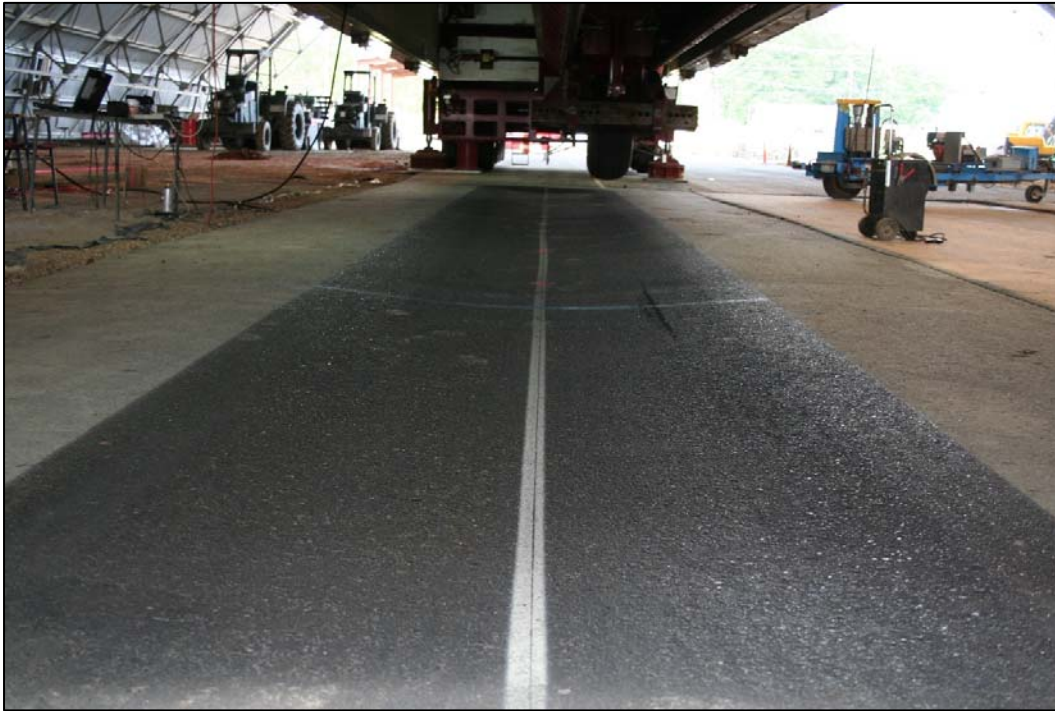
Figure 41. Overall view of Item 2 after traffic completion (3,600 passes).

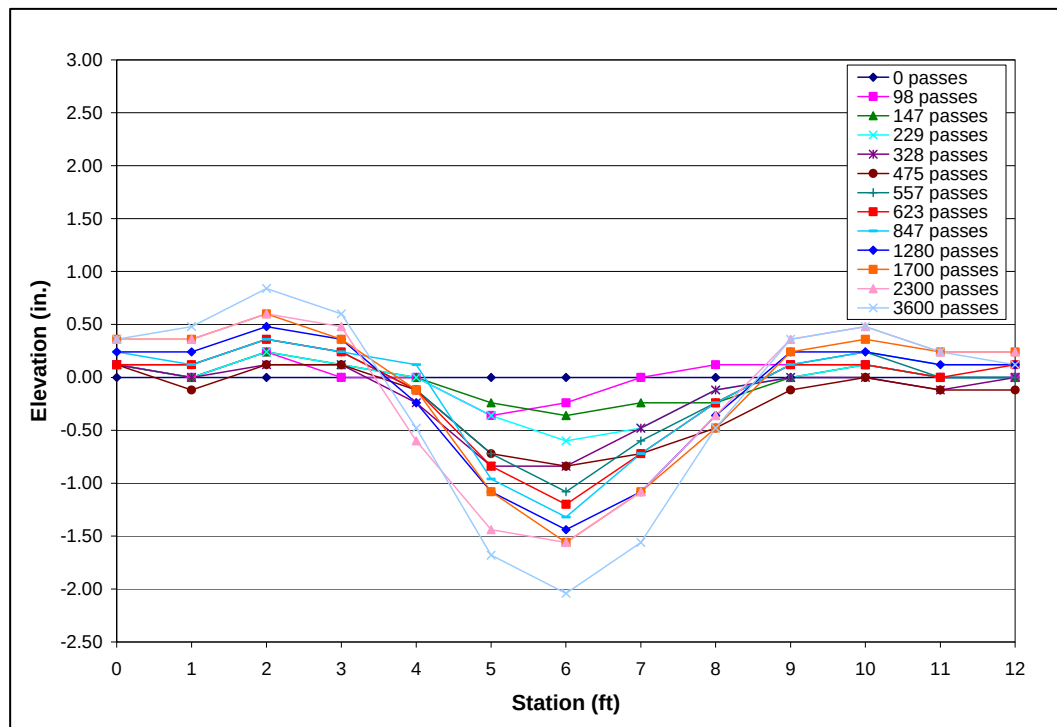
Figures 44 and 45 show the centerline and cross section profiles of Item 2. The plots show pavement upheaval on the sides and ends of the traffic lane. Item 2 received a maximum of about 0.35 in. of upheaval on the sides of the traffic lane at failure (623 passes) and about 0.80 in. of upheaval after 3,600 passes.

Figure 44. Item 2 cross section profiles at Station 25.

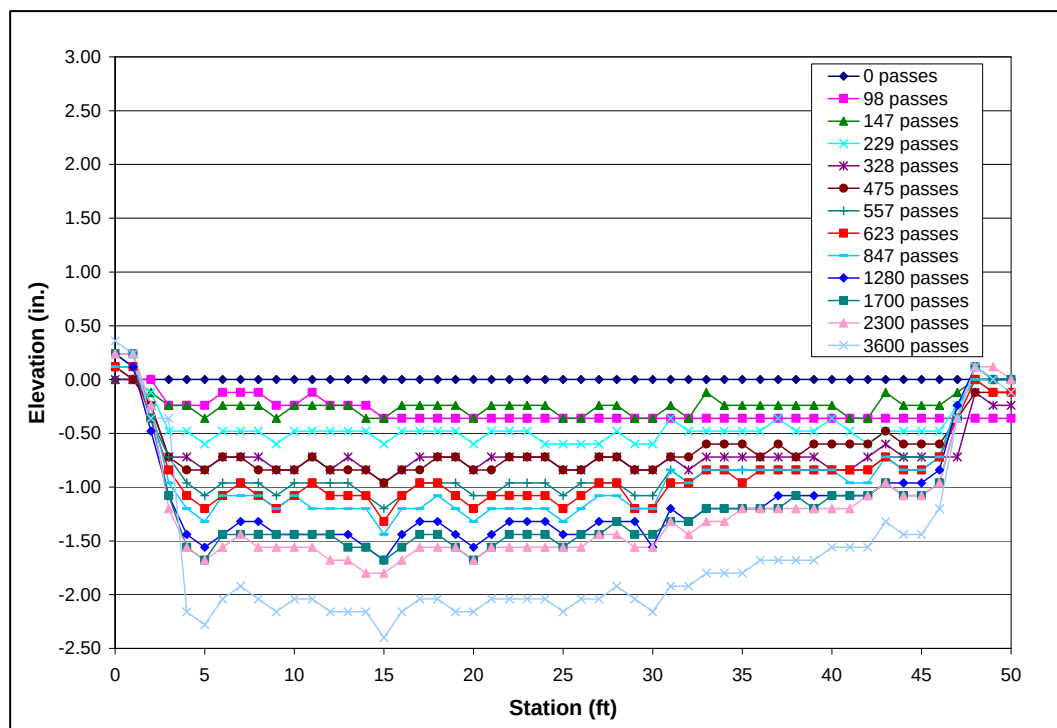
Figure 45. Item 2 centerline profiles.

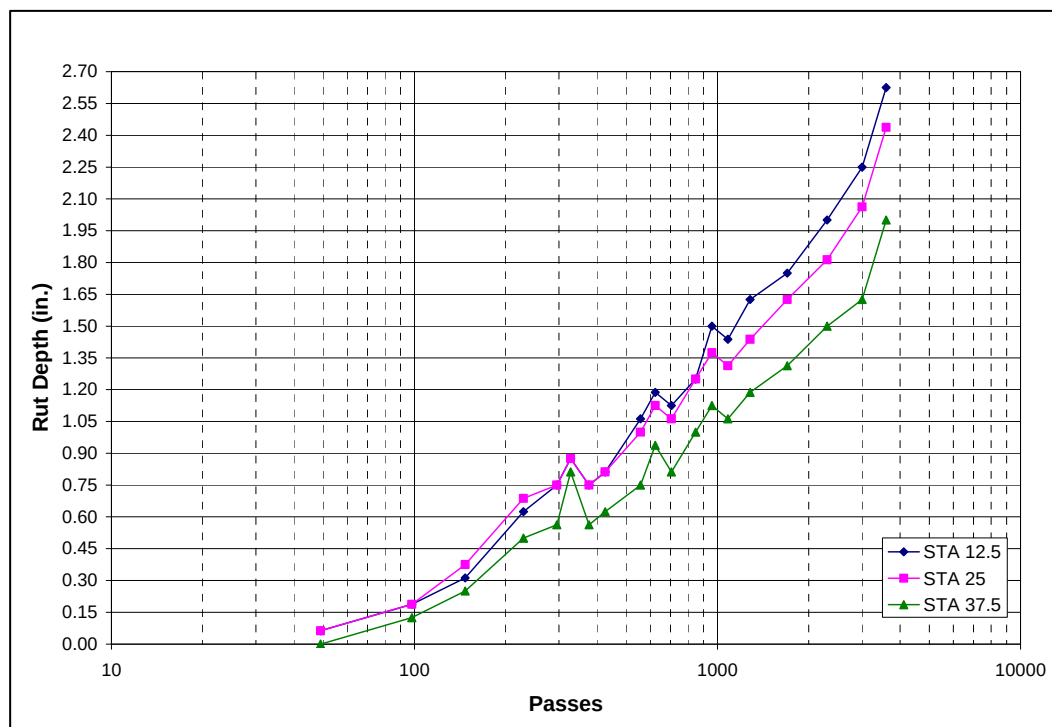
Figure 46 shows the rut depth measurements on the centerline of Item 2. Station 37.5 rutted at a slower rate compared to Stations 12.5 and 25. The pre-test DCP data for Item 2 indicated that the pavement structure at Station 37.5 was slightly stronger (approximately 8 CBR) than the pavement structure at Stations 12.5 and 25. This is most likely due to better compaction at Station 37.5. Figure 46 also shows the rut depth beginning to increase at a greater rate at about 3,000 passes.

Figure 46. Item 2 centerline rut depth measurements.

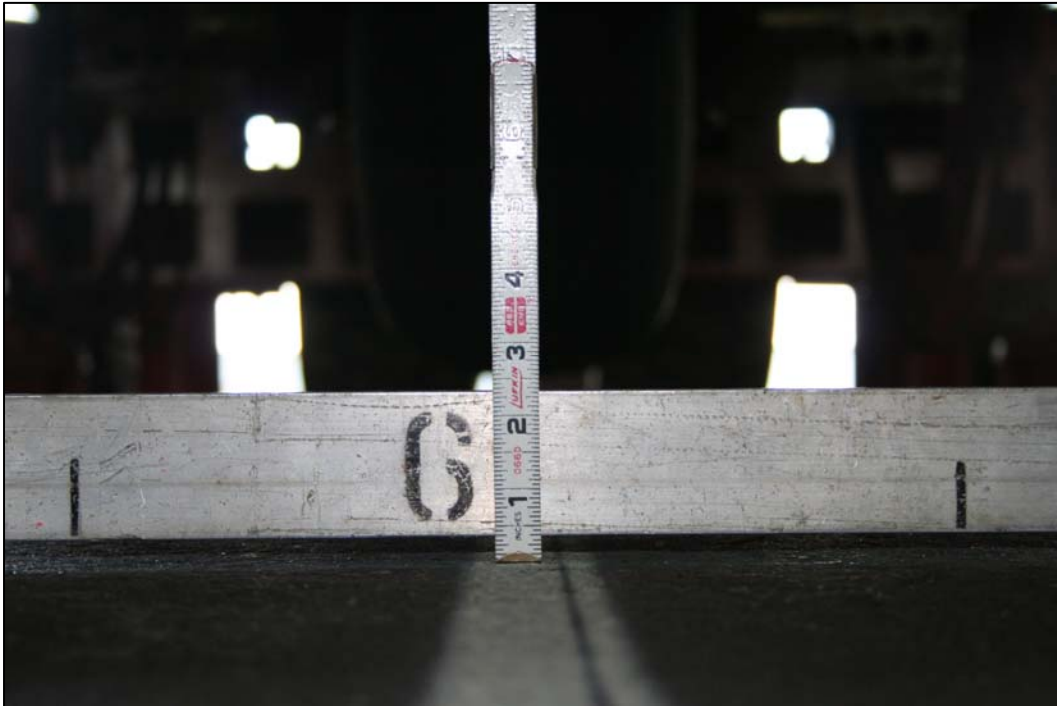
Rutting and polished aggregate were the surface distresses noted from Item 3 (Figures 51, 52, and 53) after trafficking. Polished aggregate was noticeable shortly before 1,000 passes. Item 3 was trafficked with the C-17 wheel until about 14,000 passes. Failure arose around 2,850 passes. Although the item sustained a high number of passes, cracking never occurred. The absence of cracking is an indicator that the surface pavement was performing well. The asphalt concrete was able to flex with the load because the pavement was not too stiff. Of course, the items were trafficked in a sheltered environment without the harsh environmental effects of rain, sun, etc.

Figure 51. Item 3 rutting after 147 passes.

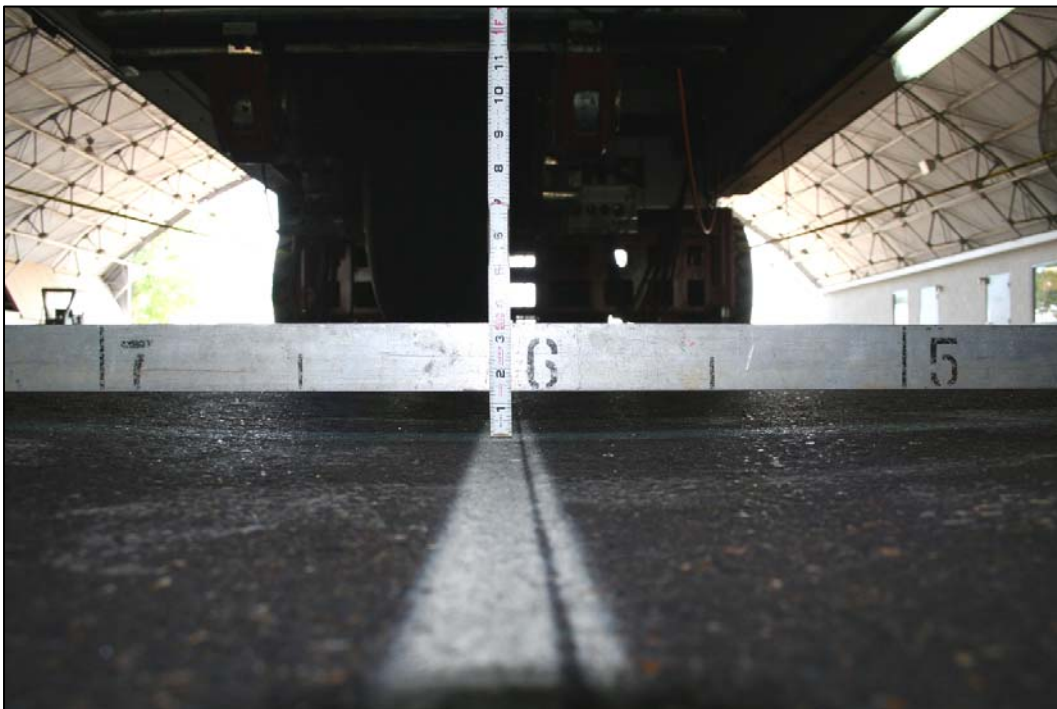
Figure 52. Item 3 rutting after 1,544 passes.

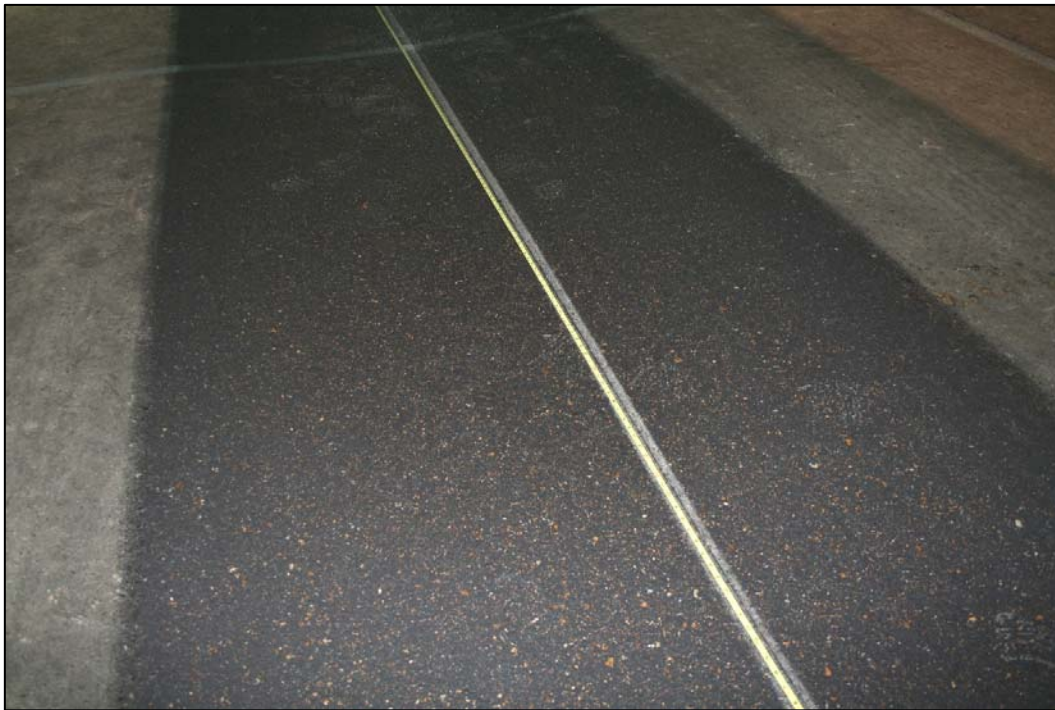
Figure 53. Item 3 polished aggregate after 7,000 passes.

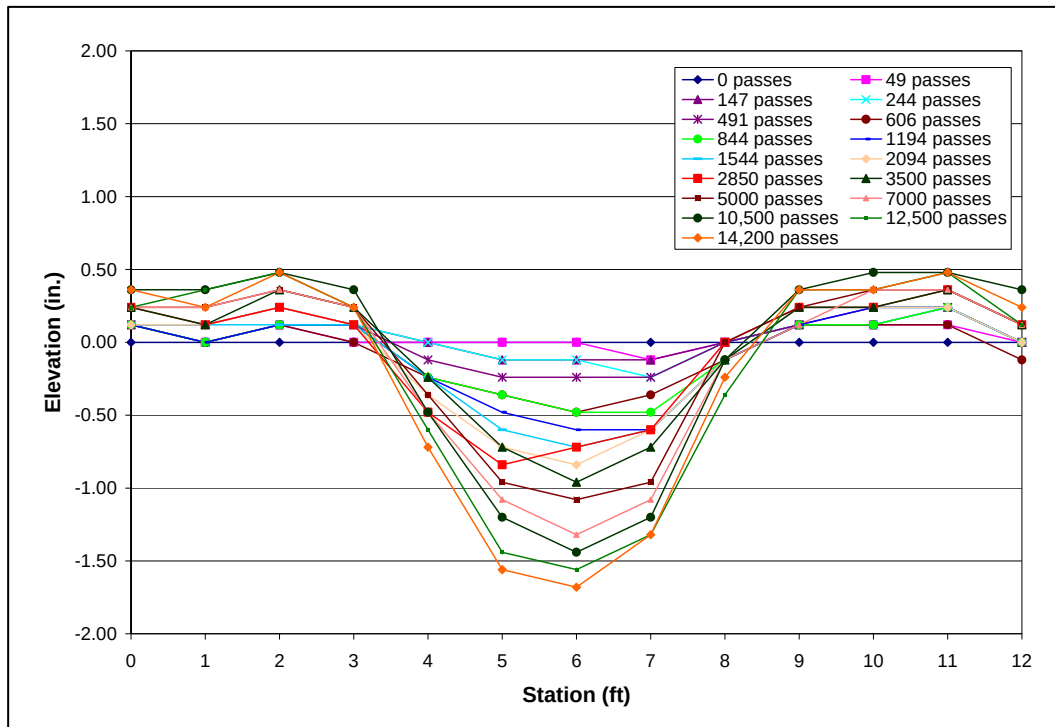
The centerline and cross section profiles of Item 3 showed slight upheaval on the sides and at the beginning and end of the traffic lanes (Figures 56 and 57). Item 3 received a maximum upheaval of 0.50 in. on the sides of the traffic lane after trafficking. At failure (2,850 passes), the maximum upheaval measured on the sides of the traffic lane was about 0.24 in.

Figure 56. Item 3 cross section profiles at Station 37.5.

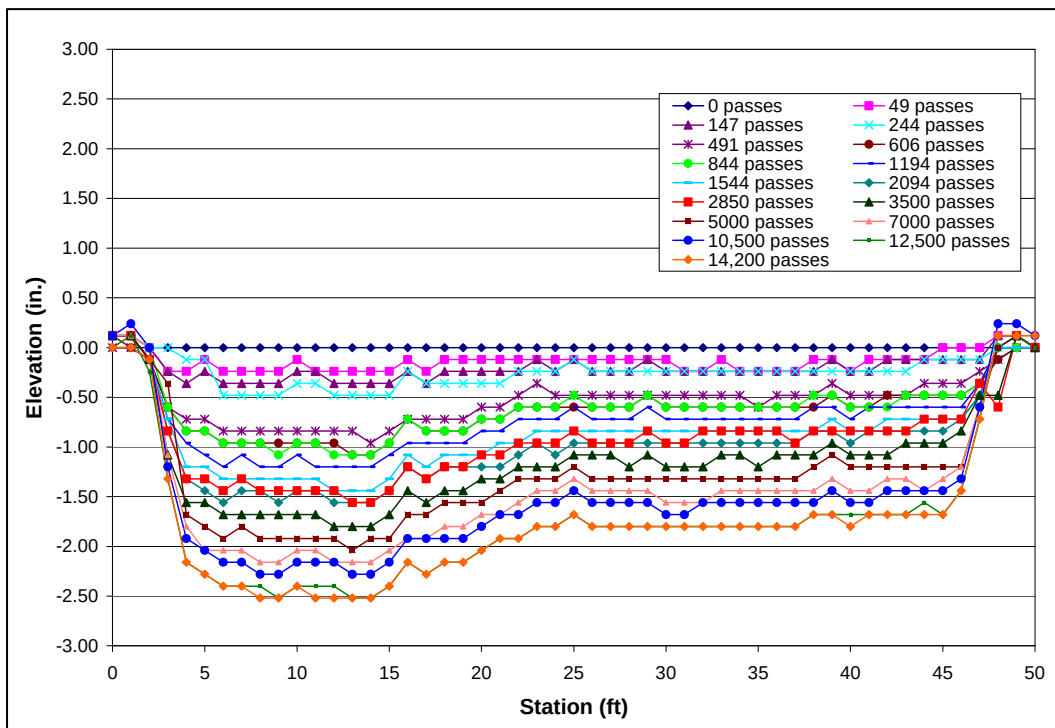
Figure 57. Item 3 centerline profiles.

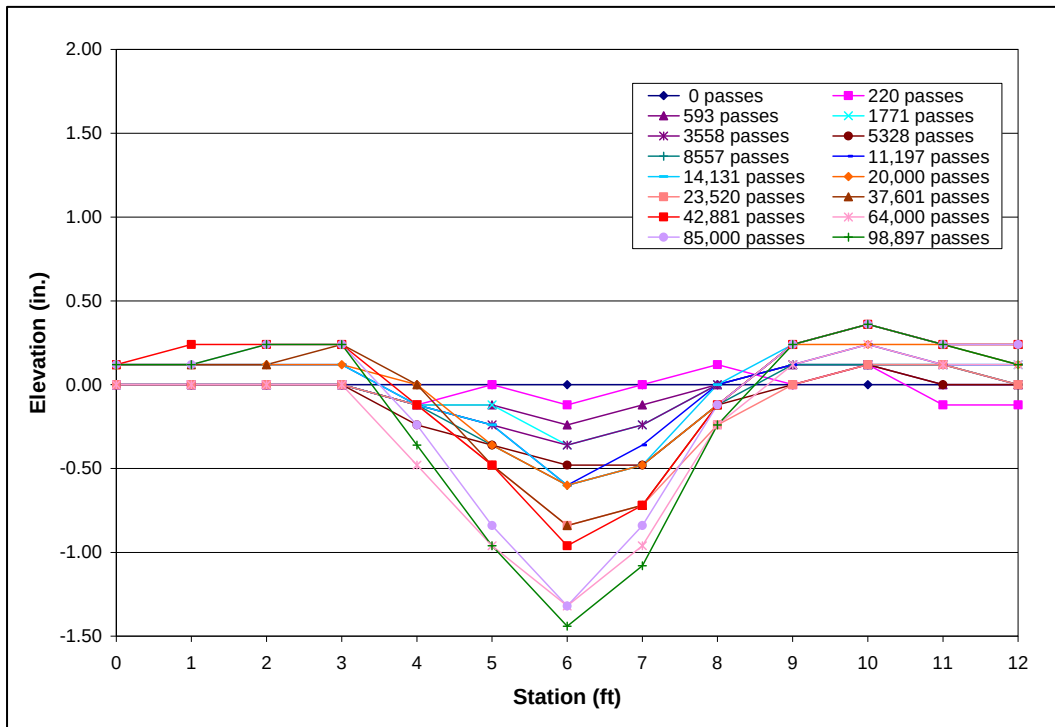
Figures 66 and 67 show the centerline and cross section profiles of Item 4. The plots show upheaval on the sides and ends of the traffic lane. Item 4 received a maximum of about 0.35 in. of upheaval on the sides of the traffic lane at failure (42,881 passes) and after 98,897 passes. The upheaval did not increase once failure occurred.

Figure 66. Item 4 cross section profiles at Station 25.

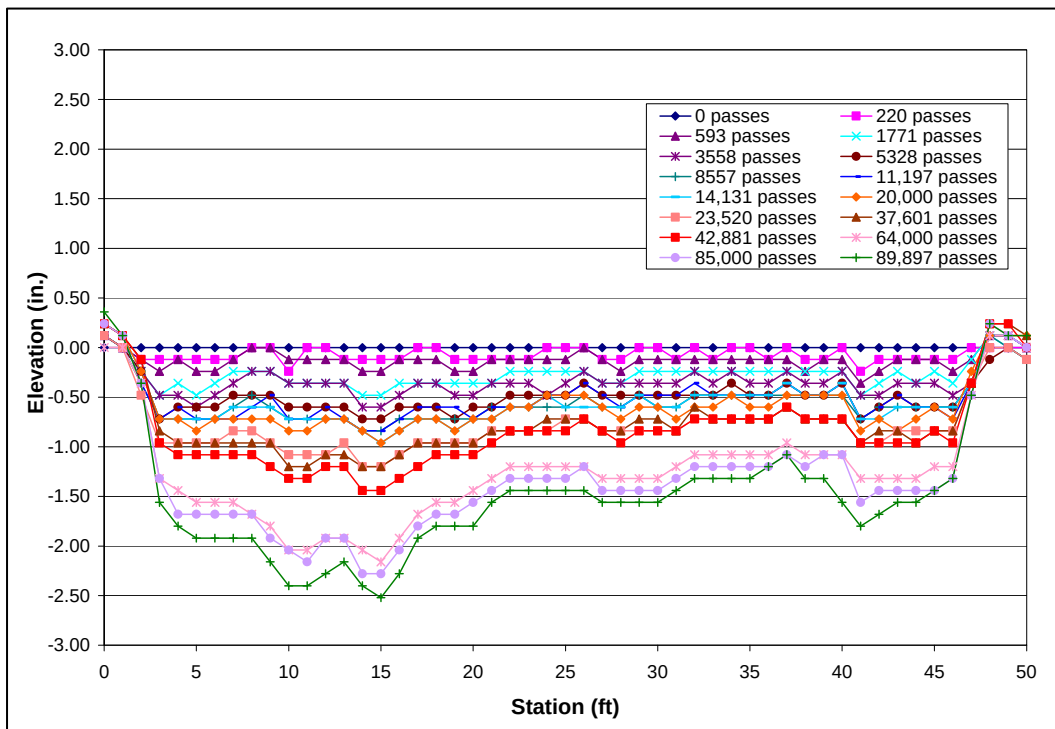
Figure 67. Item 4 centerline profiles.

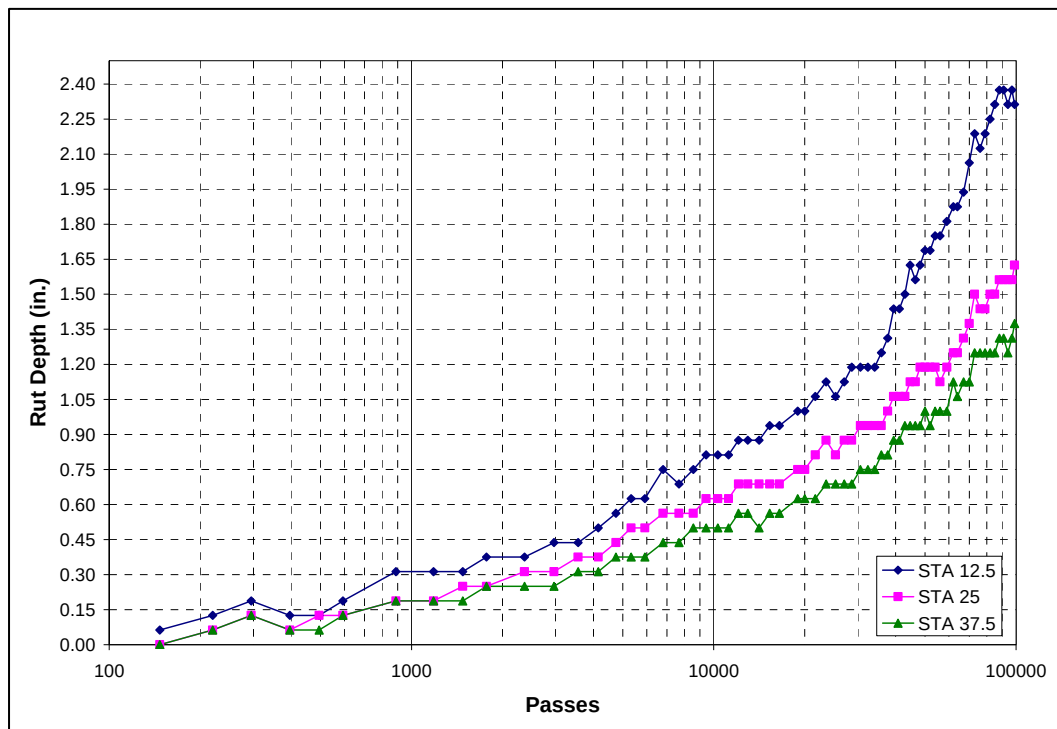
Figure 68 shows the rut depth measurements versus increasing pass level for Item 4. Item 4 failed around 42,881 passes. Figure 68 also shows that the pavement structure at Station 12.5 was slightly weaker than at the other stations. Again, this is most likely due to an inconsistent compaction effort across the item or from the HVS-A “pushing off” at Station 5 after each pass. A higher rate of rutting began around 40,000 passes.

Figure 68. Item 4 centerline rut depth measurements.

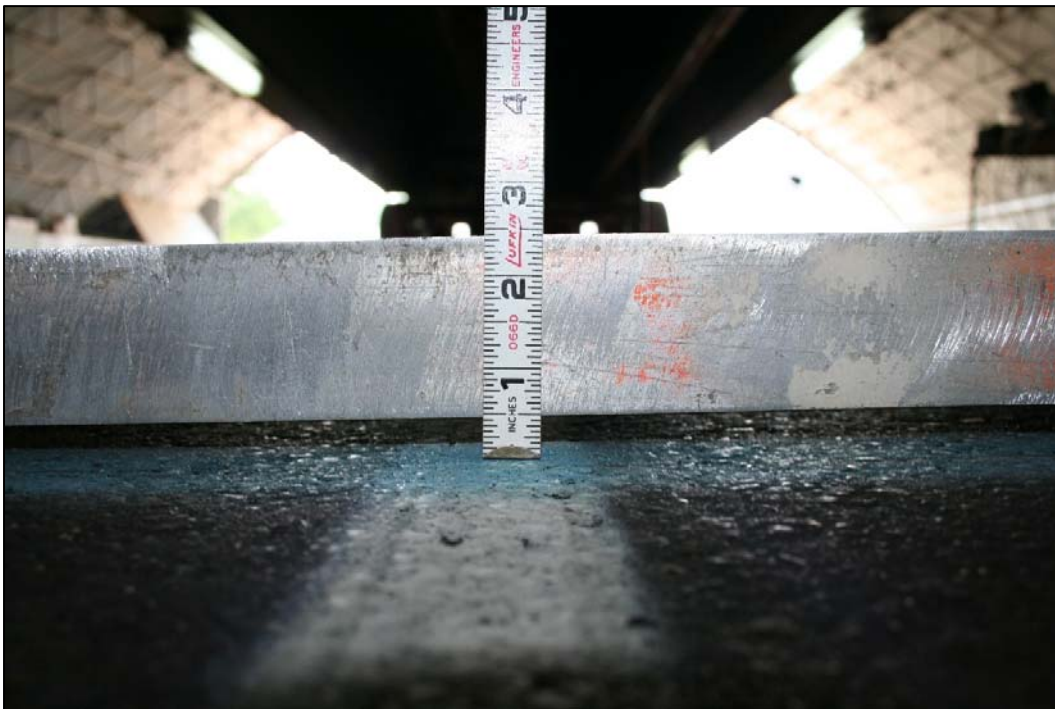
Rutting and polished aggregate were the main surface distresses noted from Item 5 after trafficking. Item 5 was trafficked with the C-17 wheel until about 6,500 passes. Failure of 1 in. of permanent deformation happened around 1,278 passes. Figure 73 shows an overall view of Item 5 before trafficking began. The white line is the centerline of the traffic lane. Each horizontal blue line represents a quarter point (Stations 12.5, 25, and 37.5). The orange dots (Stations 15, 20, 25, 30, and 35) indicate that an instrumentation gauge is directly under that location within the pavement structure. The orange dot locations are also where the FWD tests were conducted. Figure 74 shows a rut depth measurement after 262 passes.

Figure 74. Item 5 rutting at Station 37.5 after 262 passes.

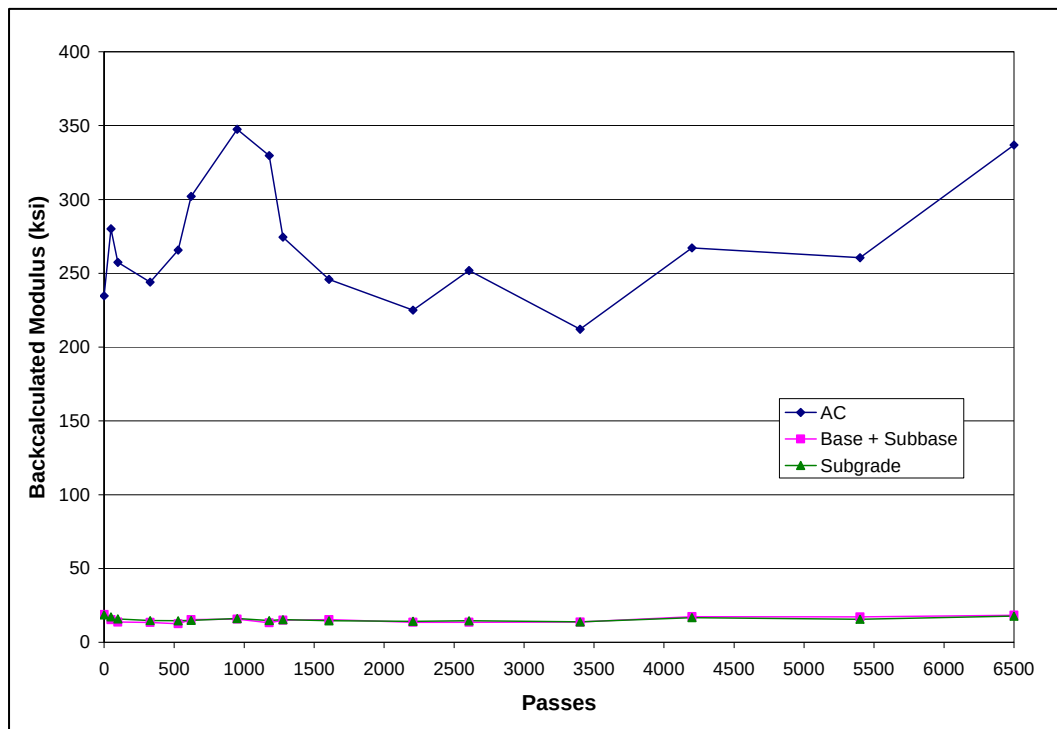
Figure 75 shows the backcalculated moduli of the pavement structure from the FWD testing. The results show that the subbase and subgrade moduli remained consistent throughout trafficking. The base course moduli showed no trend with increasing passes. The backcalculated asphalt concrete moduli were inconsistent. Figure 76 also shows no trend with the stiffness of the pavement structure as the pass level increased.

Figure 75. Item 5 backcalculated moduli results.

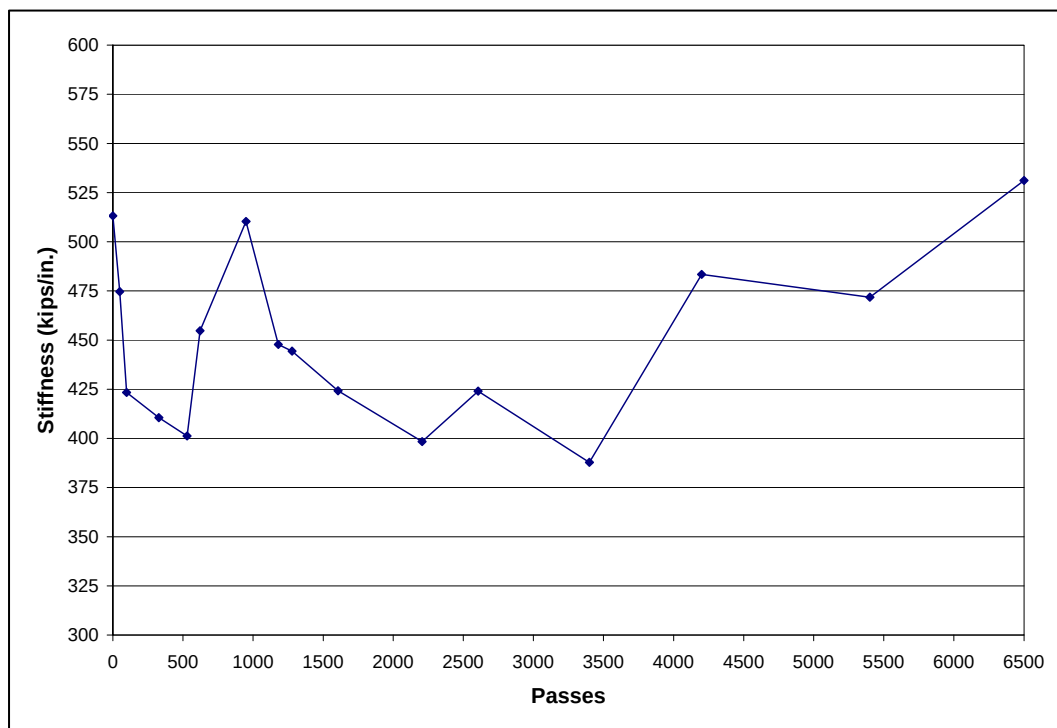
Figure 76. Item 5 stiffness results.

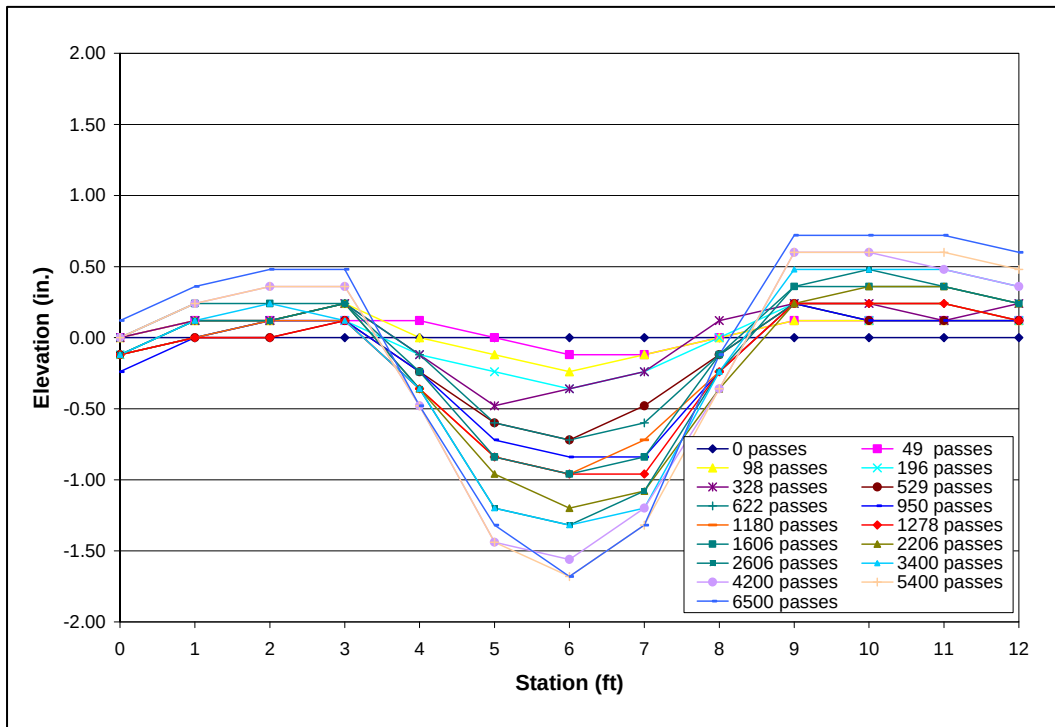
As with the other items, Figures 77 and 78 show upheaval on the sides and ends of the traffic lane of Item 5. Item 5 received a maximum of about 0.24 and 0.70 in. of upheaval on the sides of the traffic lane at failure (1,278 passes) and after 6,500 passes, respectively. There was slightly more upheaval on the east side of the traffic lane for all quarter points.

Figure 77. Item 5 cross section profiles at Station 12.5.

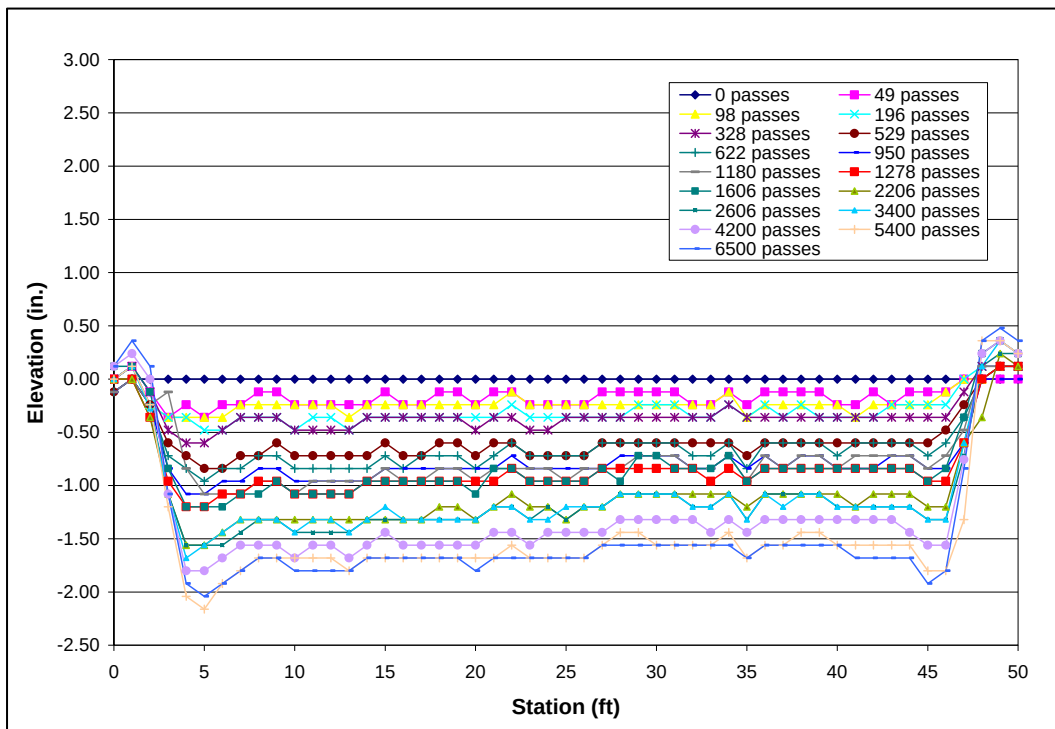
Figure 78. Item 5 centerline profiles.

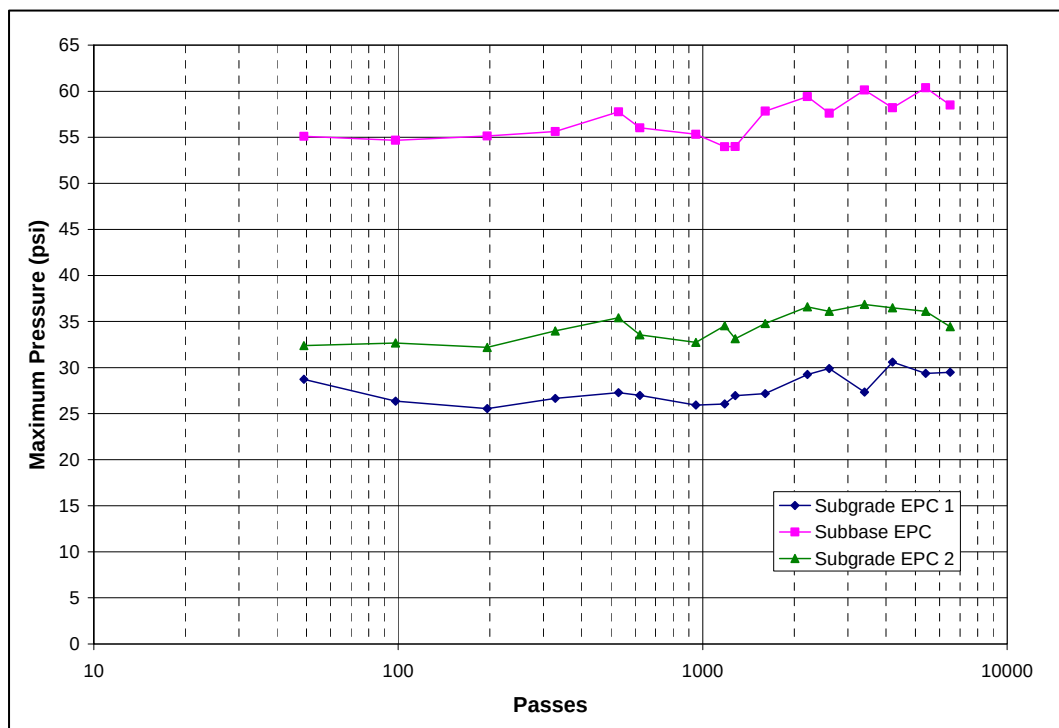
Dynamic pressure measurements were recorded at selected traffic intervals. The EPC installed in the base course layer of Item 5 malfunctioned, so no pressure measurements were recorded. Linear elastic analysis results predicted the pressure measurement in the base course to be approximately 75 psi. Figure 80 shows that the stresses measured in the subbase and subgrade increased slightly after failure of 1 in. of rutting occurred (approximately 1,300 passes). Linear elastic analysis predicted the measurements in the subbase and subgrade to be approximately 55 and 25 psi, respectively. The predictions are comparable with the in situ measurements.

Figure 80. Item 5 maximum pressure measurements.

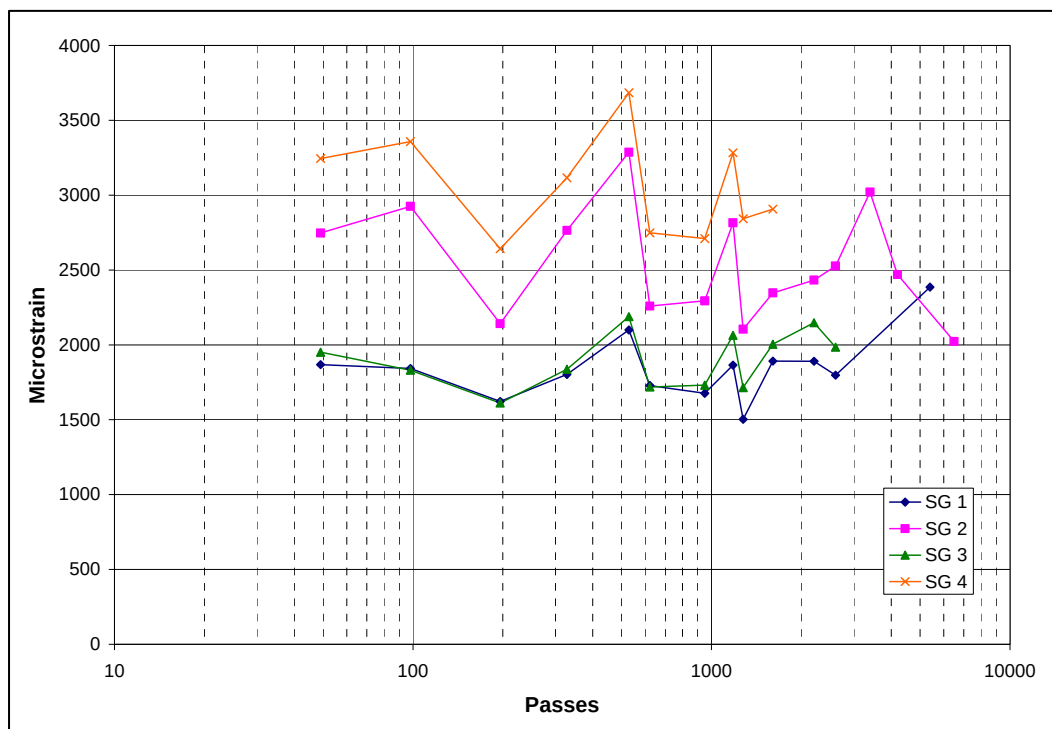
Figure 81 presents the maximum strain gauge measurements recorded at the bottom of the asphalt concrete. There was no response with strain gauges 3 and 4 for a few of the passes. The maximum horizontal strains for Item 5 were higher than expected. Linear elastic analysis using the backcalculated modulus values from the FWD data predicted the strain measurements for Item 5 to be between 900 and 950 microstrain. The gauges under the asphalt concrete pavement parallel to traffic (strain gauges 1 and 3) measured average maximum strains of 1800 microstrain. The gauges perpendicular to traffic (strain gauges 2 and 4) measured average maximum strains of 2,500 to 3,000 microstrain. There was no trend associated with the tensile strain and increasing pass for any strain gauge.

Figure 81. Item 5 maximum strain gauge measurements at the bottom of the asphalt concrete.

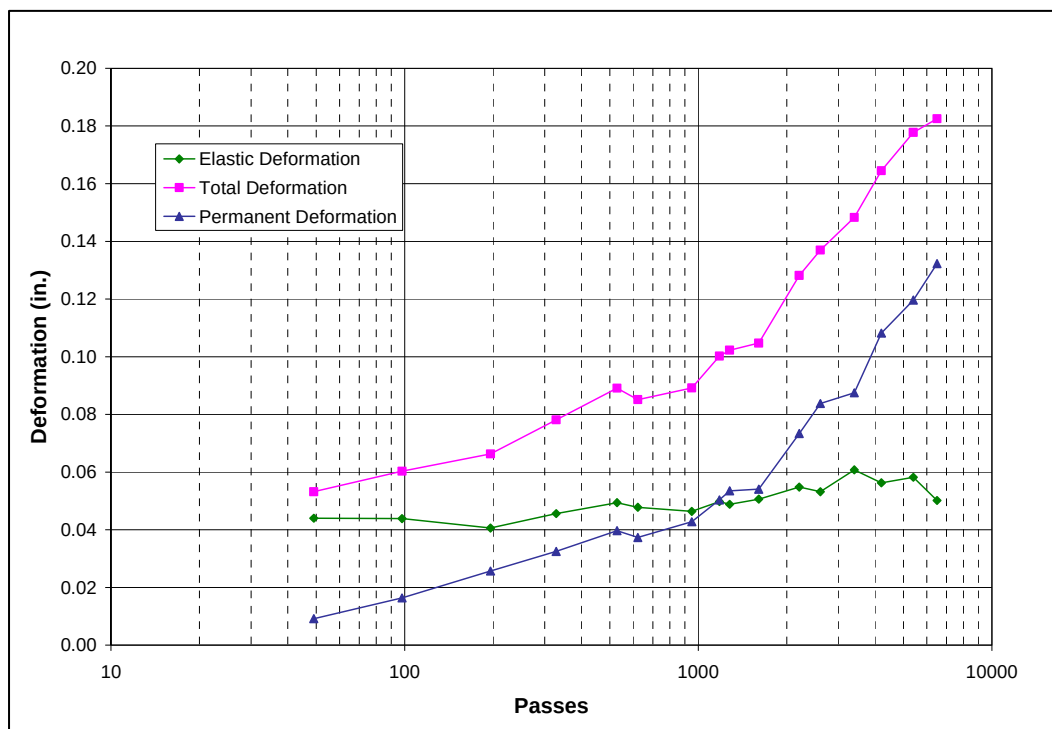
Figure 82 shows the dynamic SDD measurements recorded in the subgrade of Item 5. Figure 82 shows a slow, steady increase until failure of 1 in. of rutting happened. The permanent deformation in the subgrade increased at a greater rate after about 1,200 passes. Failure was around 1,278 passes.

Figure 82. Item 5 subgrade SDD measurements.
