## **Evaluation of Minimum Asphalt Concrete Thickness Criteria**

Haley P. Bell and L. Webb Mason

October 2008

Final report

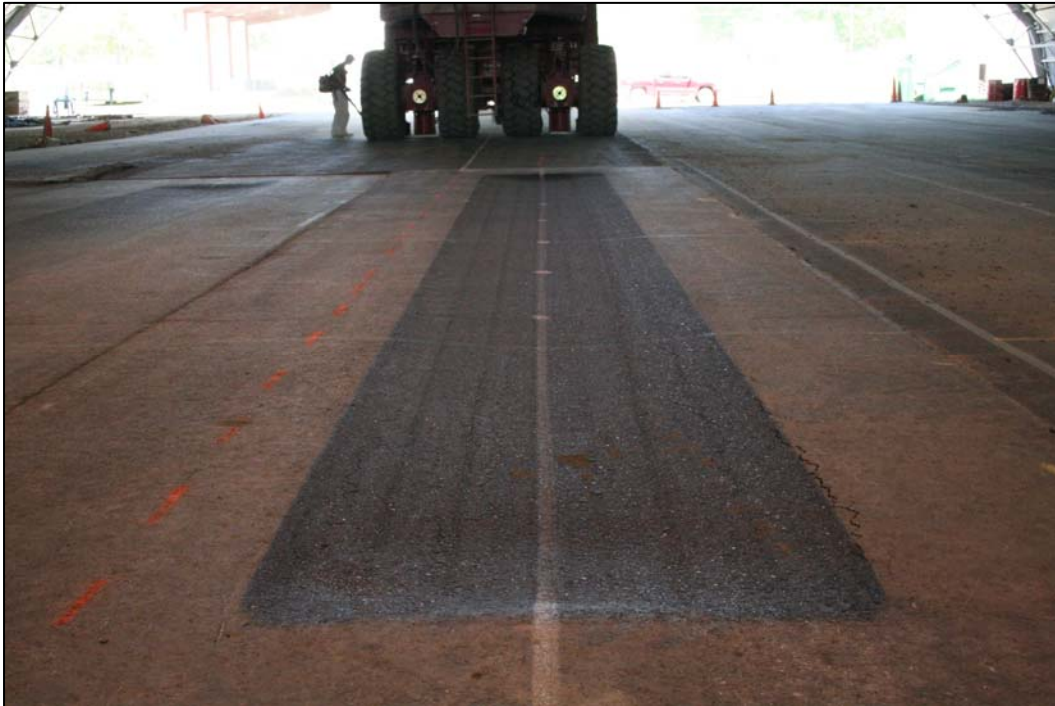
cooler than the surface temperatures of Items 1, 2, 3, and 5. Also, cracking may have occurred because the item was trafficked with the F-15E wheel. Item 6 was trafficked until about 58,500 passes. Failure of 1 in. of permanent deformation happened around 32,500 passes. Figure 86 shows an overall view of Item 6 after traffic completion.

Figure 86. Overall view of Item 6 after traffic completion.

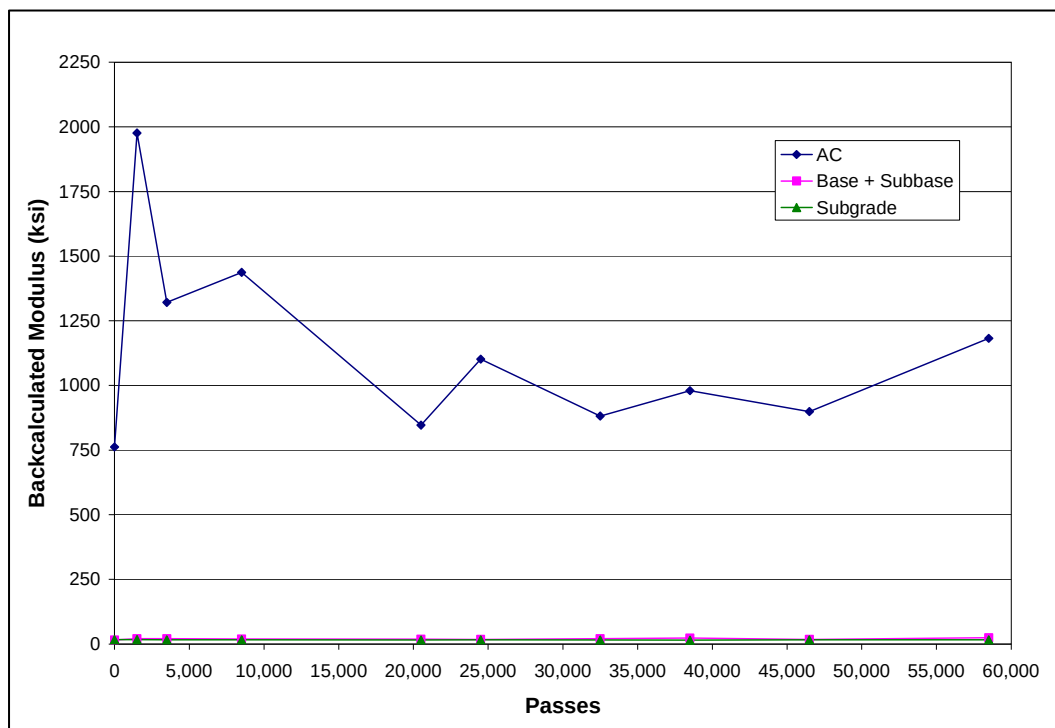
Figures 87 and 88 present the results of Item 6's FWD testing. The backcalculated asphalt concrete modulus values were higher than those measured in all the items. The stiffness values of the pavement structure were also higher. This was expected because the item was trafficked in cooler weather, and the surface was 1 in. thicker than the surface of Item 4.

Figure 87. Item 6 backcalculated moduli results.

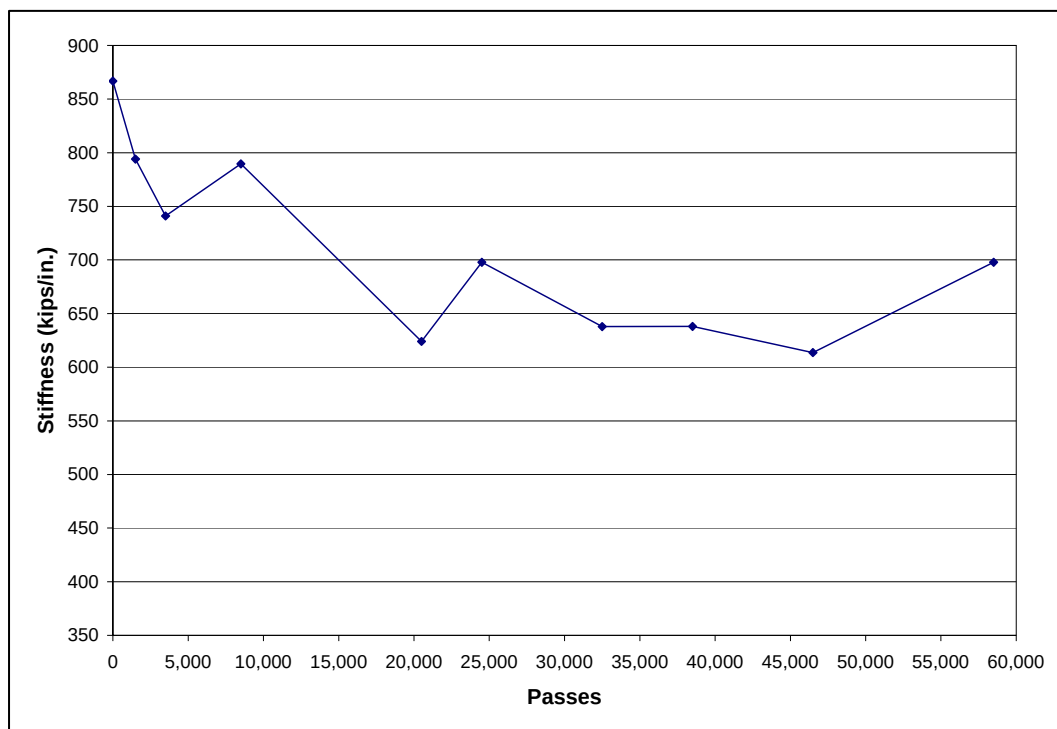
Figure 88. Item 6 stiffness results.

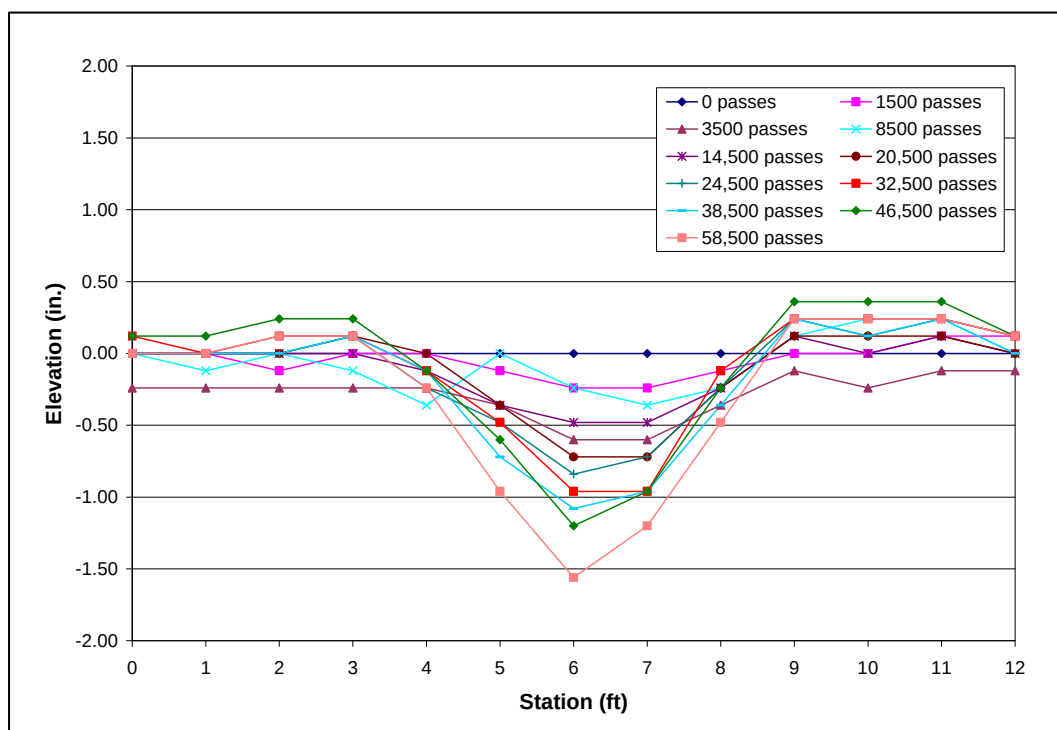
Overall, the centerline and cross section profiles of Item 6 showed slight upheaval on the sides and at the beginning and end of the traffic lane (Figures 89 and 90). Item 6 received a maximum upheaval of 0.36 in. on the sides of the traffic lane after trafficking. At failure (32,500 passes), the maximum upheaval measured on the sides of the traffic lane was about 0.24 in.

Figure 89. Item 6 cross section profiles at Station 37.5.

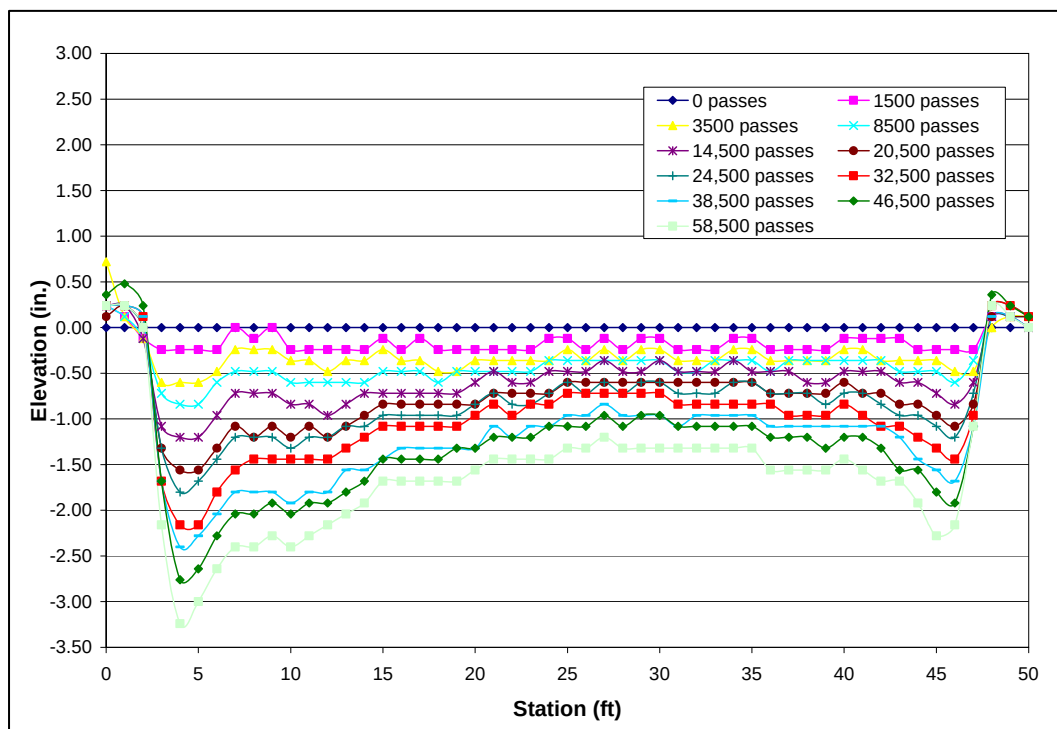
Figure 90. Item 6 centerline profiles.

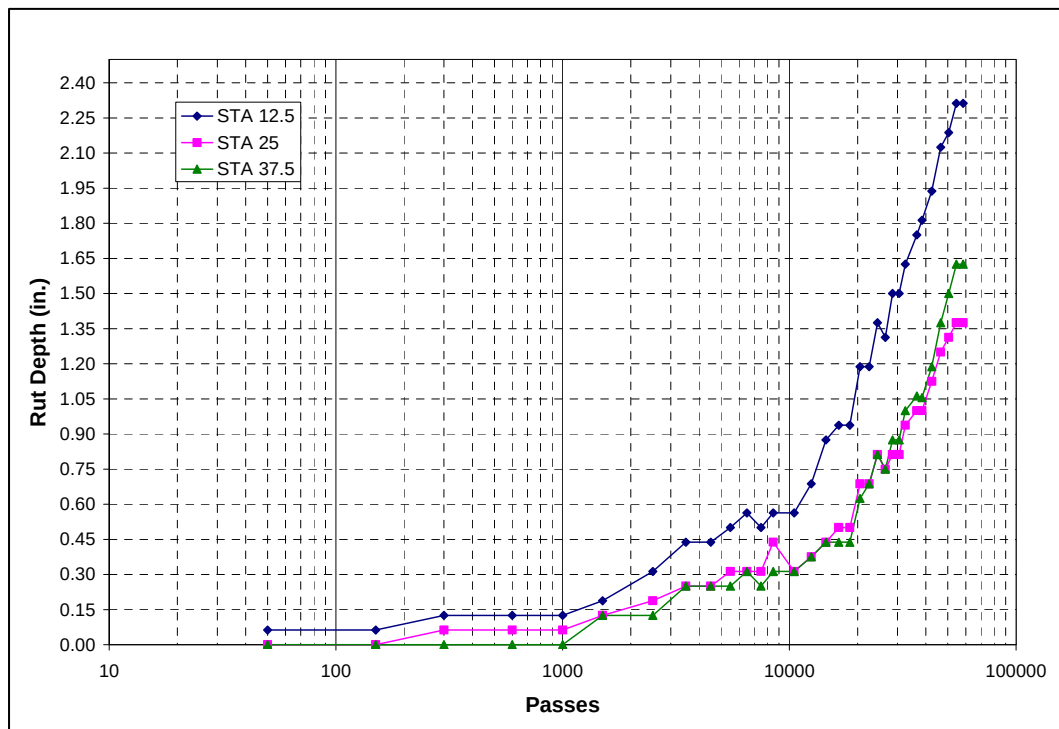
Figure 91 shows the rut depth measurements of Item 6. Item 6 failed around 32,500 passes. The rut depths at Station 12.5 did increase at a faster rate than those measured at Stations 25 and 37.5. Again, this is most likely due to an inconsistent compaction effort across the item or from the HVS-A wheel “pushing off” at Station 5 after each pass. Figure 91 shows a steady increase in rut depths until about 10,000 passes. The rut depth then begins to increase at a greater rate with each pass.

Figure 91. Item 6 centerline rut depth measurements.

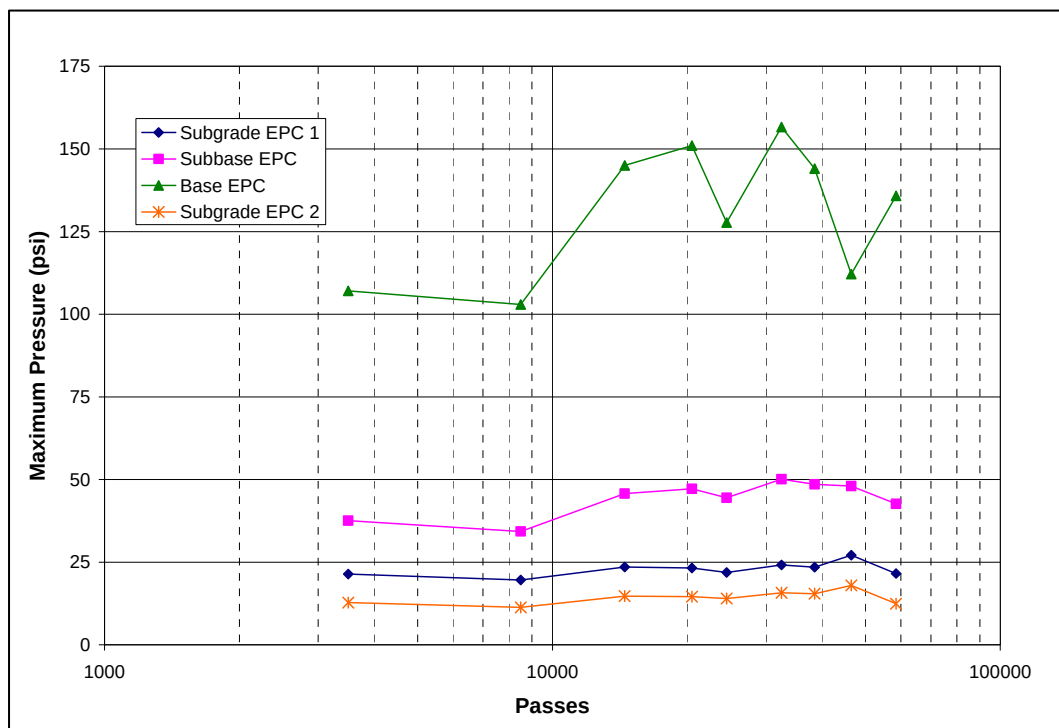
Figure 92 shows the dynamic pressure measurements within Item 6’s pavement structure. The results show inconsistent pressure measurements in the base course and consistent pressure measurements in the subbase and subgrade. Overall, the stresses increased in the base course after about 10,000 passes. The stresses slightly increased in the subbase and subgrade after about 10,000 passes. Linear elastic analysis predicted the vertical stresses in the base, subbase, and subgrade to be approximately 85, 50, and 25 psi, respectively.

Figure 92. Item 6 maximum pressure measurements.

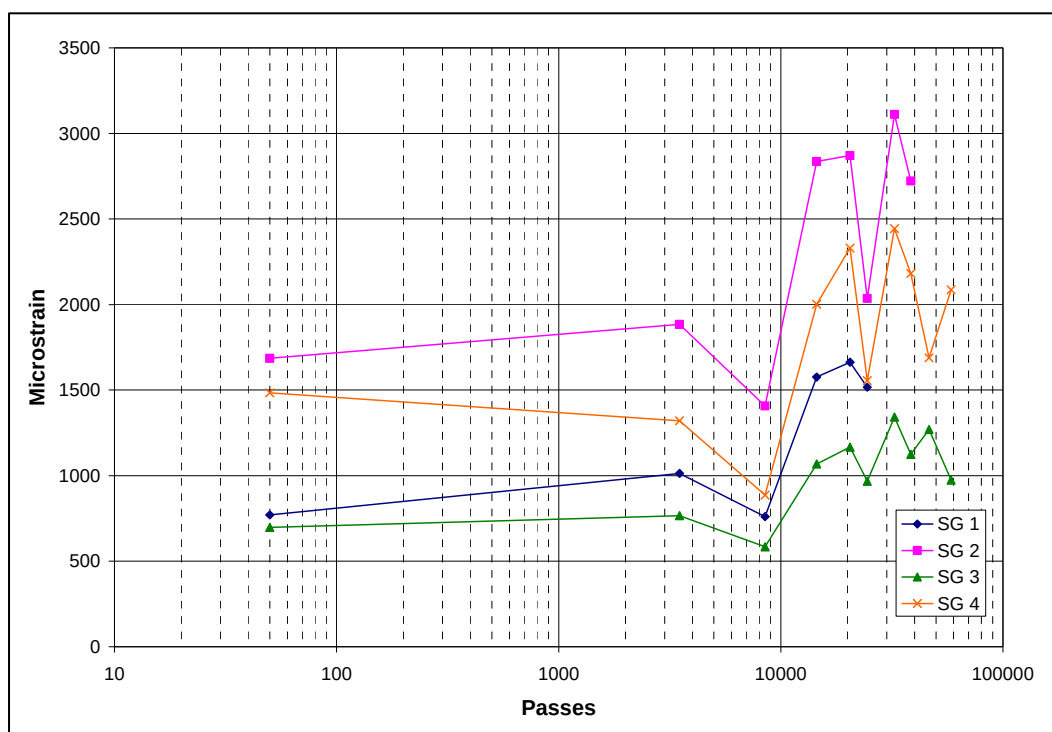
The maximum horizontal strains for Item 6 were much higher than expected. Figure 93 shows the in situ maximum dynamic strain gauge measurements under the asphalt concrete. Linear elastic analysis using the backcalculated modulus values from the FWD data predicted the strain measurements for Item 6 to be between 500 and 800 microstrain. The gauges under the asphalt concrete pavement parallel to traffic (strain gauges 1 and 3) measured average maximum strains of 1,000 to 1,200 microstrain. The gauges perpendicular to traffic (strain gauges 2 and 4) measured average maximum strains of 1,800 to 2,300 microstrain. Overall, there was a slight increasing trend associated with the tensile strain and increasing passes for the strain gauges. Figure 93 shows a noticeable increase in maximum strain measurements after about 10,000 passes. This was not surprising because there was also an increase in the rut depth and EPC measurements after about 10,000 passes.

Figure 93. Item 6 maximum strain gauge measurements at the bottom of the asphalt concrete.
