IRAQI CIVIL DEFENSE
HEADQUARTERS
BAGHDAD, IRAQ

SIGIR PA-06-090
APRIL 26, 2007

SUBJECT: Report on Iraqi Civil Defense Headquarters, Baghdad, Iraq (Report Number
SIGIR PA-06-090)

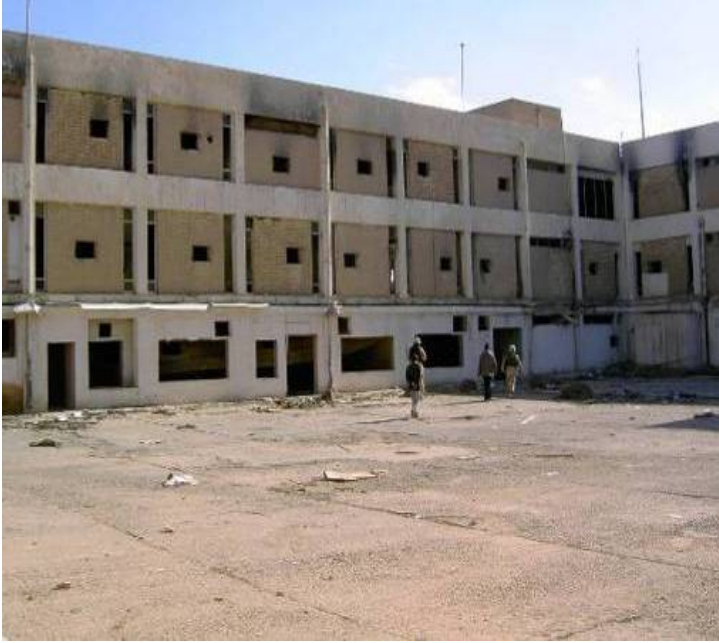
Ministries of Human Rights and Trade, and the abandoned Iraqi National Congress building. The existing facility consists of one three-story main headquarters building, a separate two-story building providing additional office and training space for department personnel, and three small, independent rooms housing the generator, transformer, and pump. The main headquarters building is an L shaped building located on the middle of the complex; while the other buildings are located along the western section of the complex (Figure 1). The original facility was constructed in 1991; however, severe looting and burning after the 2003 war left the ICD HQ buildings severely dilapidated and in need of significant rehabilitation (Site Photos 1 through 4).

**Site Photo 1. Exterior view of the existing ICD HQ building
(Photo courtesy of the USACE)**

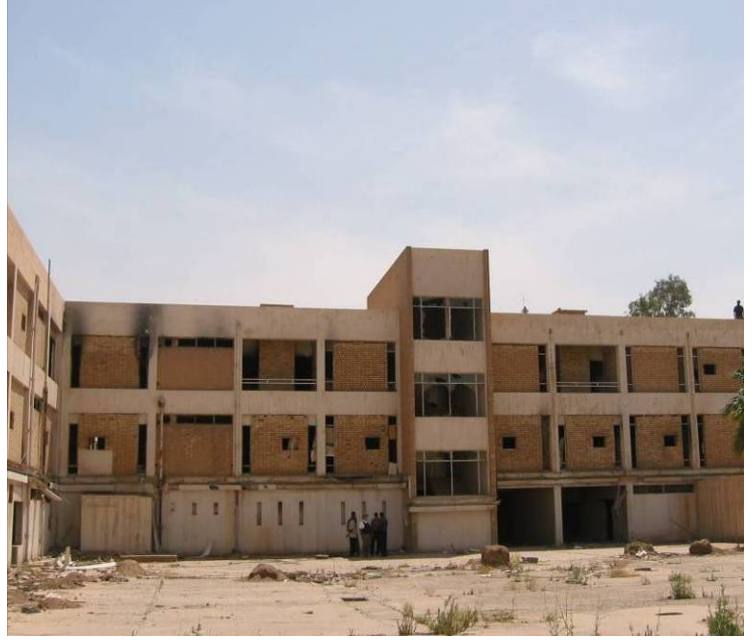
**Site Photo 2. Exterior view prior to renovation
(Photo courtesy of the USACE)**

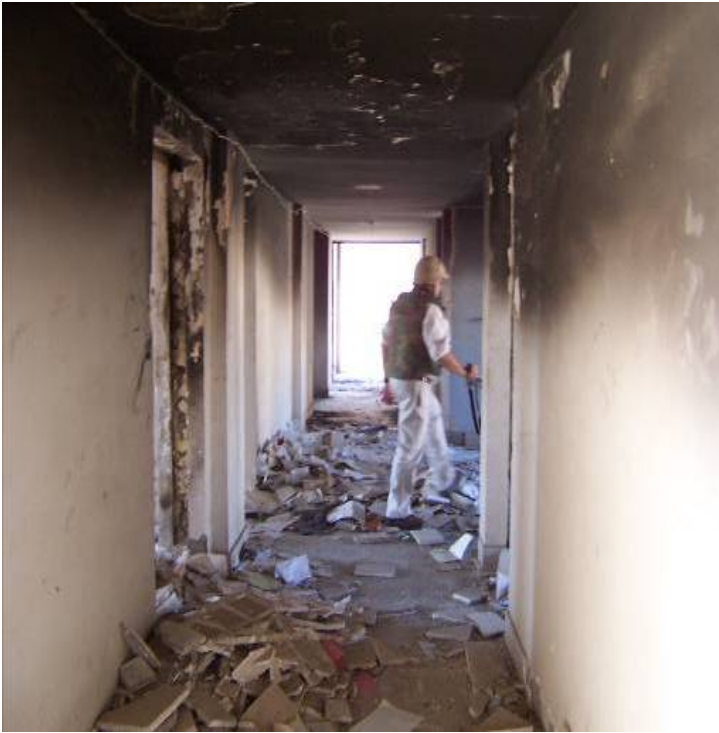
**Site Photo 3. View of ICD HQ hallway after severe looting in 2003
(Photo courtesy of the USACE)**

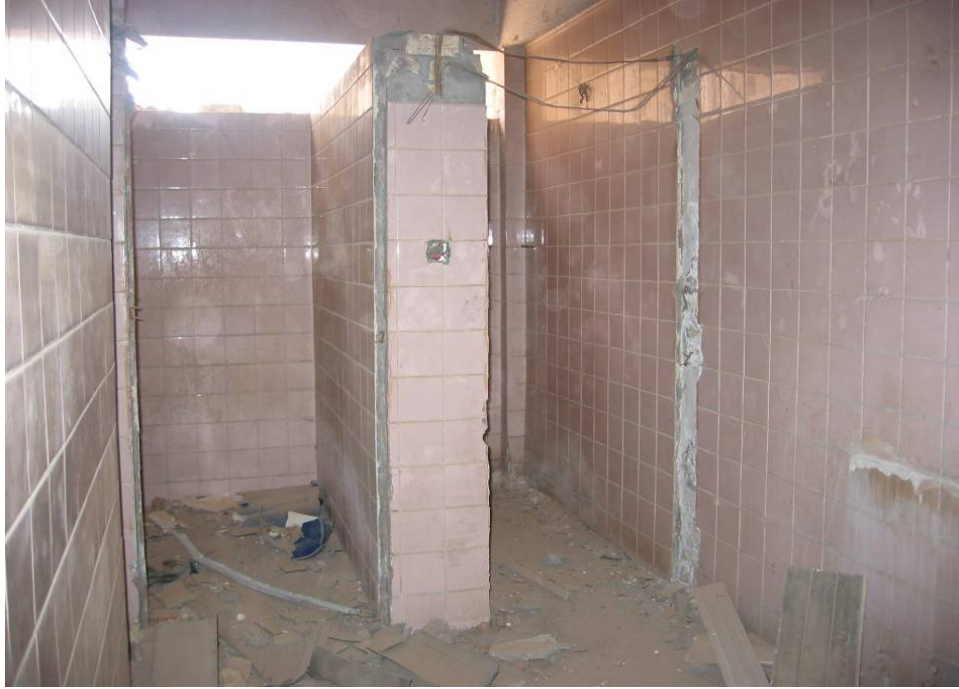
The original ICD HQ bathrooms were destroyed as a result of the looting and burning in 2003 (Site Photos 5 and 6), which required new bathroom facilities. The TO SOW required the contractor to furnish the labor and materials to completely restore the ICD HQ bath and toilet rooms. The TO SOW specifically stated the “design and construction must comply” with the IPC. In addition, the TO specifically stated that the “plumbing system shall be installed and/or repaired complete with necessary fixtures, fittings, traps, valves, drains and accessories to be fully operational and free of leaks.”

Site Photo 5. Condition of bathroom prior to renovation (Photo courtesy of the USACE)

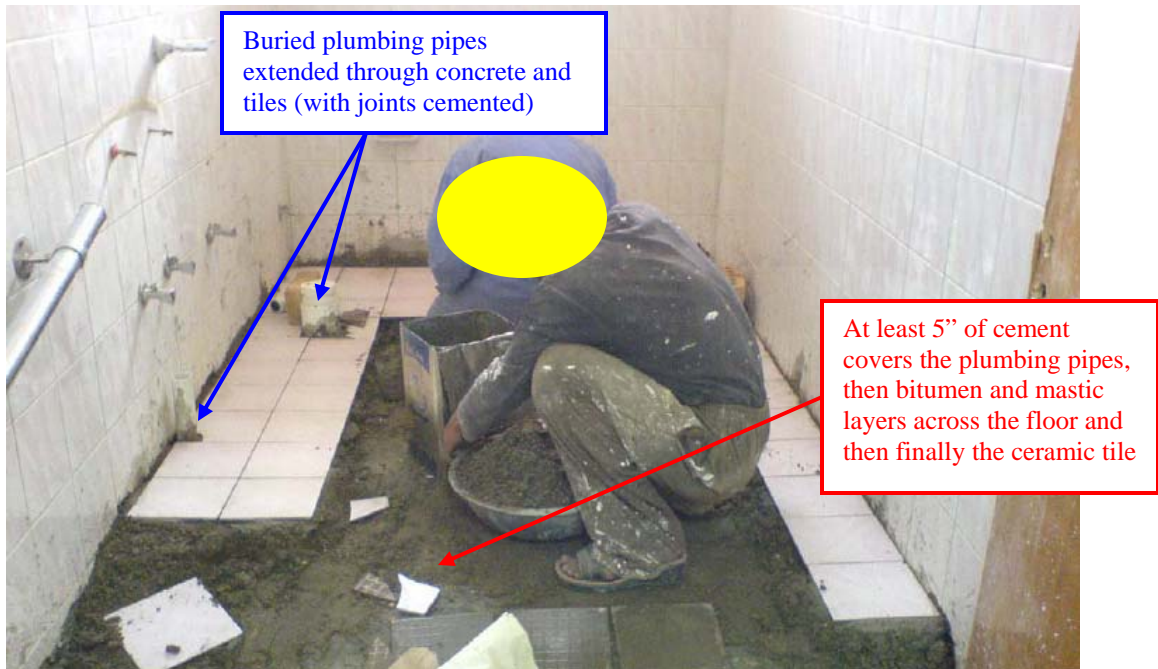
In addition to cementing the joints, the subcontractors buried the sewer pipes under the cement floor. Any leak from a joint or crack allows water to leave the pipe and migrate into the available cracks and voids within a raised concrete floor. Since PVC pipe material cannot bond with concrete, water and moisture migrate along the outer surface of the pipes. This practice not only significantly increases the weight of each floor of the building; it also places additional weight upon the unsupported segments of PVC plumbing pipe and undue stress of joints – both lead to increasing the risk of joint cracks and leaks. The construction methods and techniques used are antiquated and grossly inefficient. This type of construction does not offer the opportunity for routine maintenance or for repairs to the plumbing system without significant and major demolition. For example, any sewer line leak that develops would require the entire floor

Site Photo 12. Bathroom after concrete has been poured and tile being applied (Photo courtesy of the USACE)

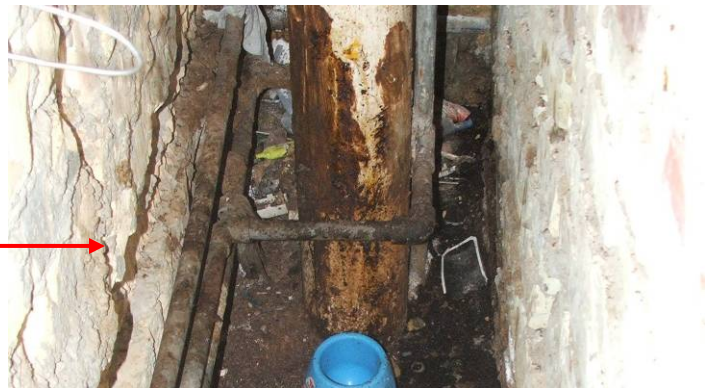
In addition, during our site visits, we identified evidence of water leaks in the first floor chase (Site Photos 32, 33, and 34). The leaks appear at both the ceiling and floor of the chase. The location of the first floor chase is directly on top of the Operations Room pillar. Any water leakage from the first floor chase would drop straight onto the Operations Room pillar and beam.

Site Photo 34. Close up view of bottom of Site Photo 32

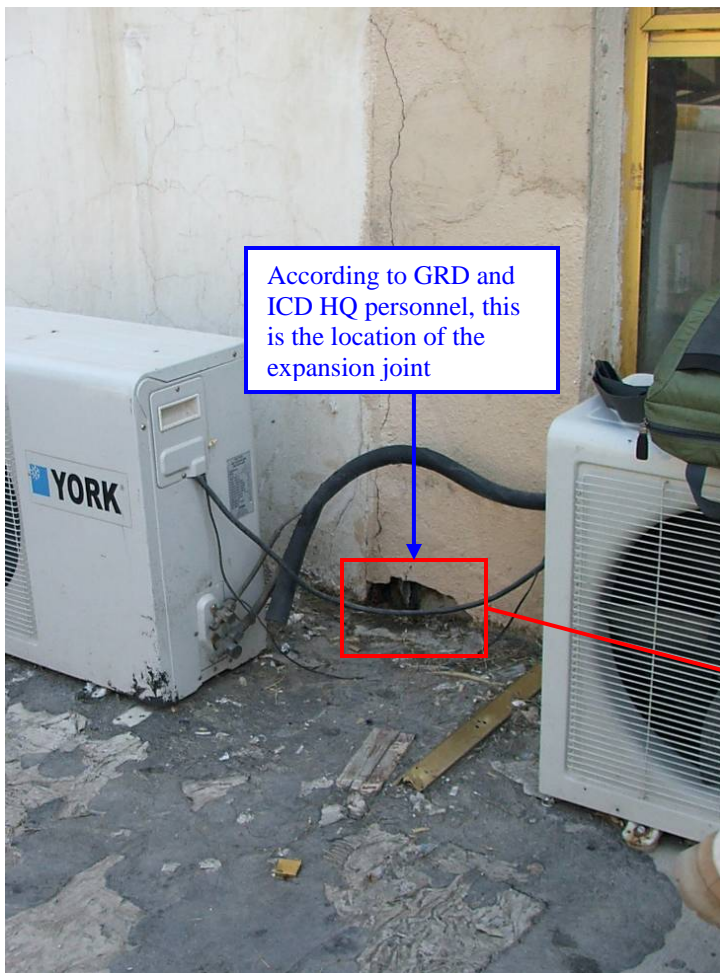
Site Photo 58. Location of the expansion joint
