## **Pythian Powerhouse and Laundry**

Historic Building Survey

## **Final Report**

(Building No. 503)

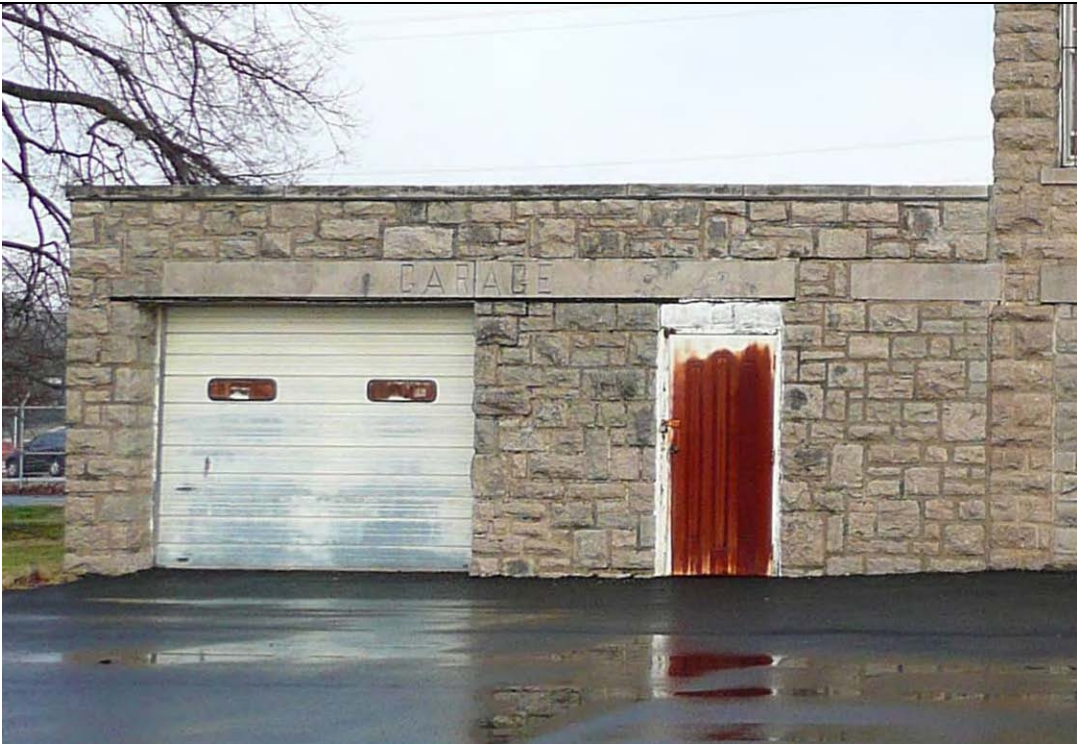
**Photo 2 – south elevation of one-story garage**

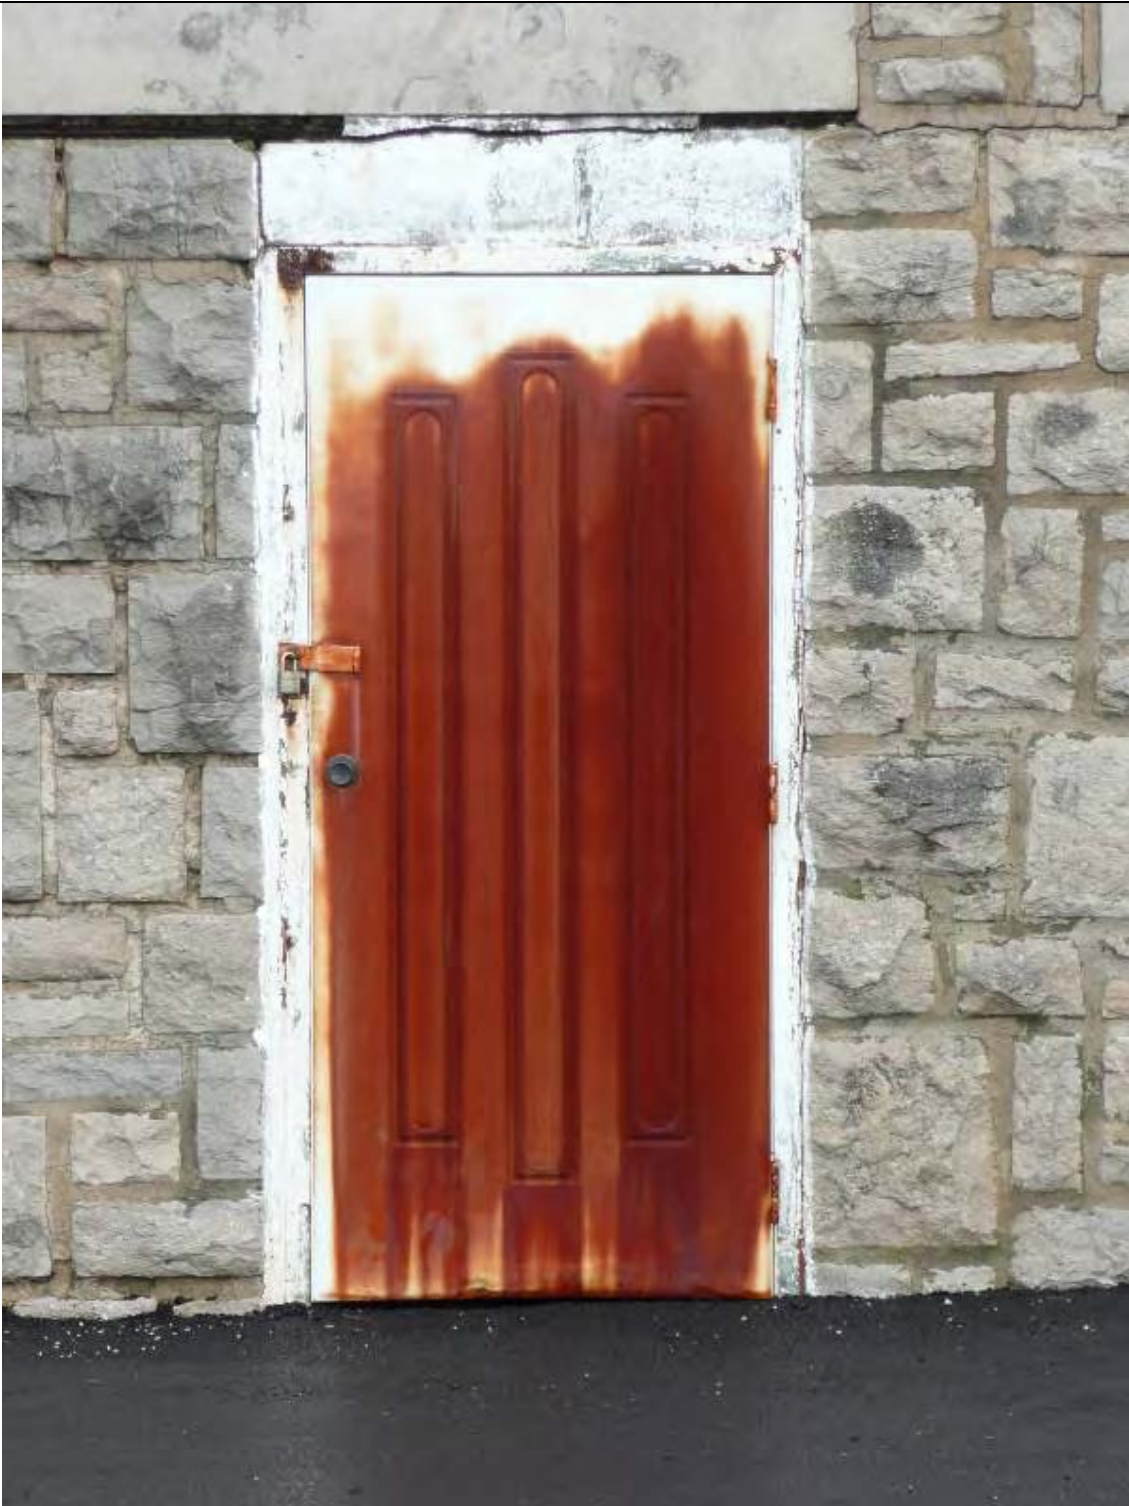
**Photo 18 – metal entry door into garage**

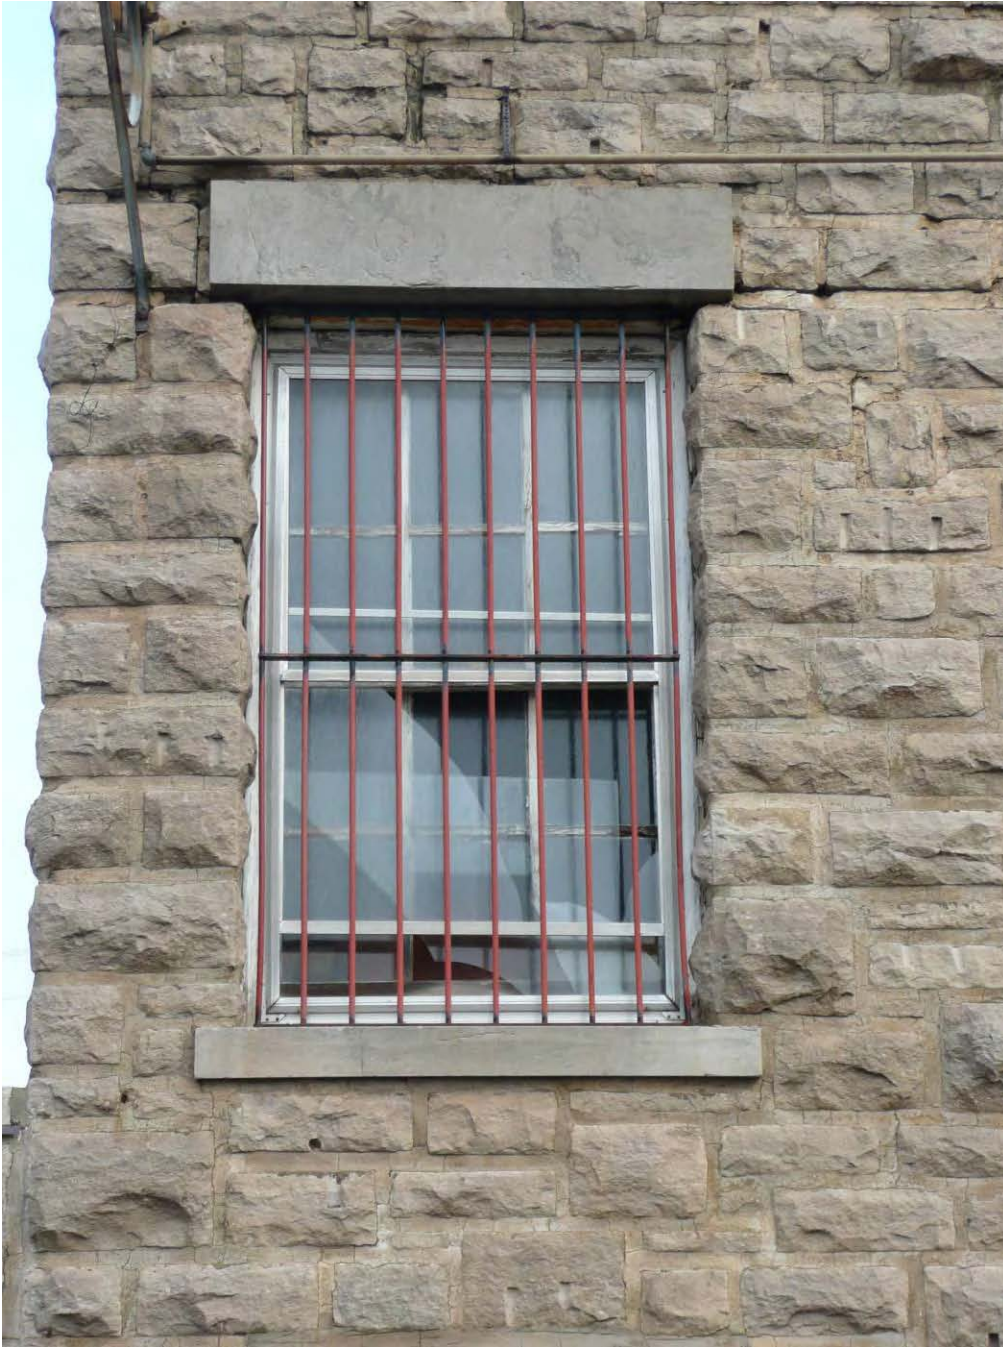
Type 1: A single six-over-six wood double-hung window that measures 3'-7" by 6'-3" with 0'-5½" frame (Photo 18).

**Photo 19 – Type 1 window**

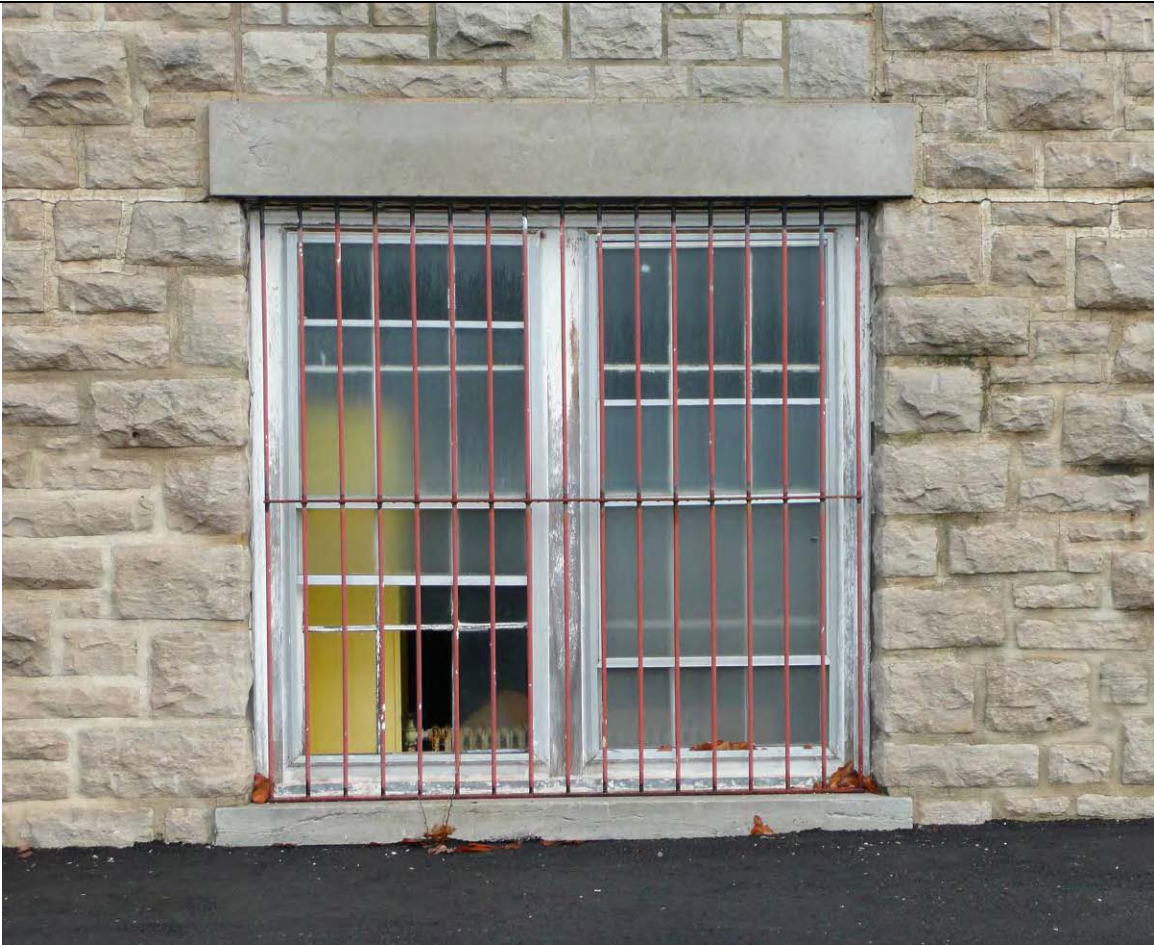
Type 2: Paired six-over-six wood double-hung windows that measure 2'-9" by 6'-1½" each; divided by 0'-5½" frame with a total width of (including framing members) 6'-8½" (Photo 19).

**Photo 20 – Type 2 window**

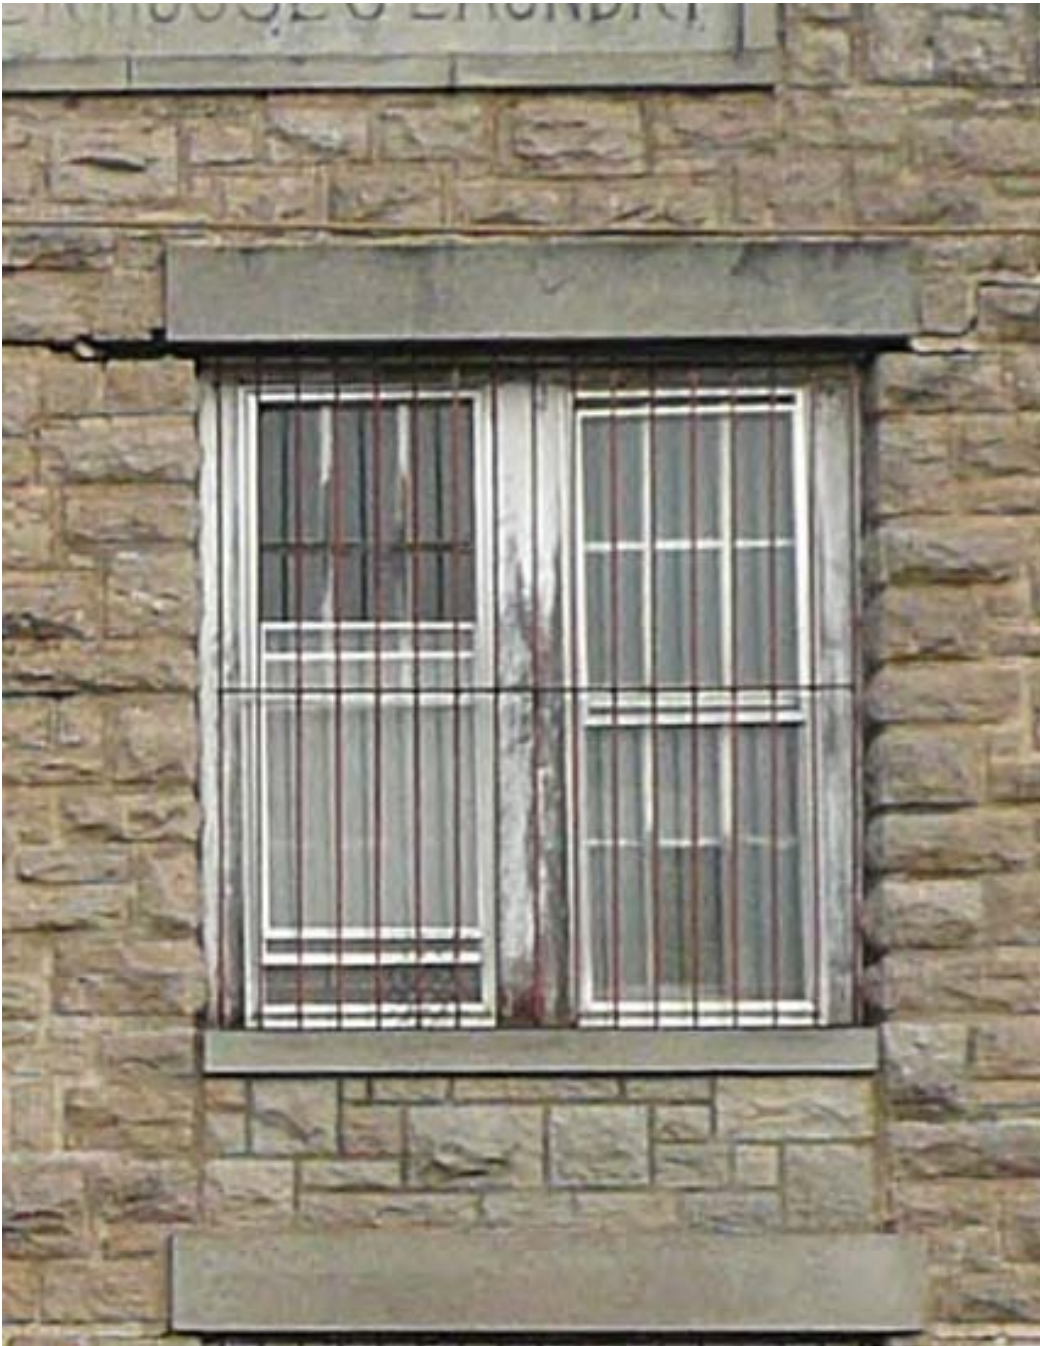
Type 3: Larger paired six-over-six wood double-hung windows that measure 6'-4½" by 6'-5½" (Photo 20).

**Photo 21 – Type 3 window**

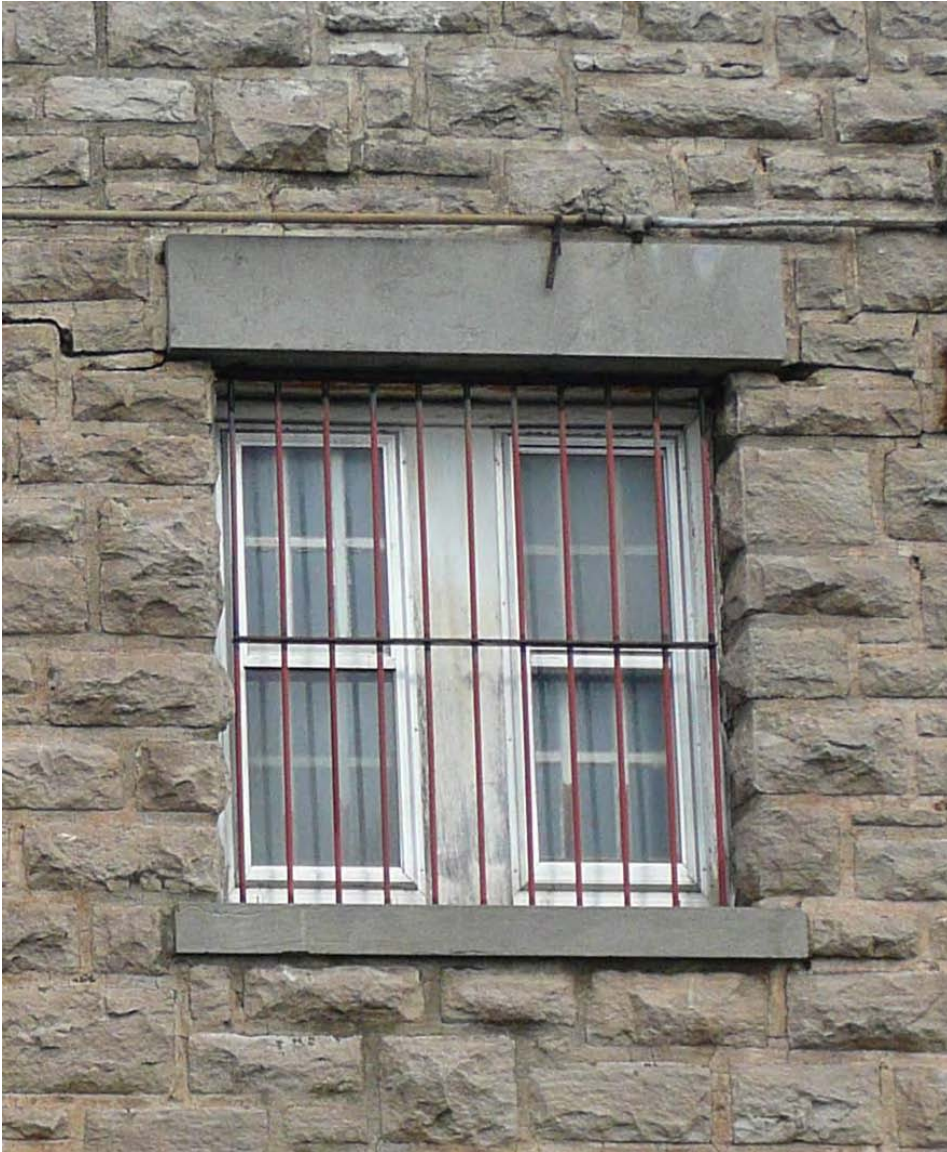
Type 4: Smaller paired six-over-six wood double-hung windows that measure 1'-8 ½" by 4'-1" each; divided by 0'-8 ½" frame with a total width of (including framing members) 4'-11" (Photo 21).

**Photo 22 – Type 4 window**

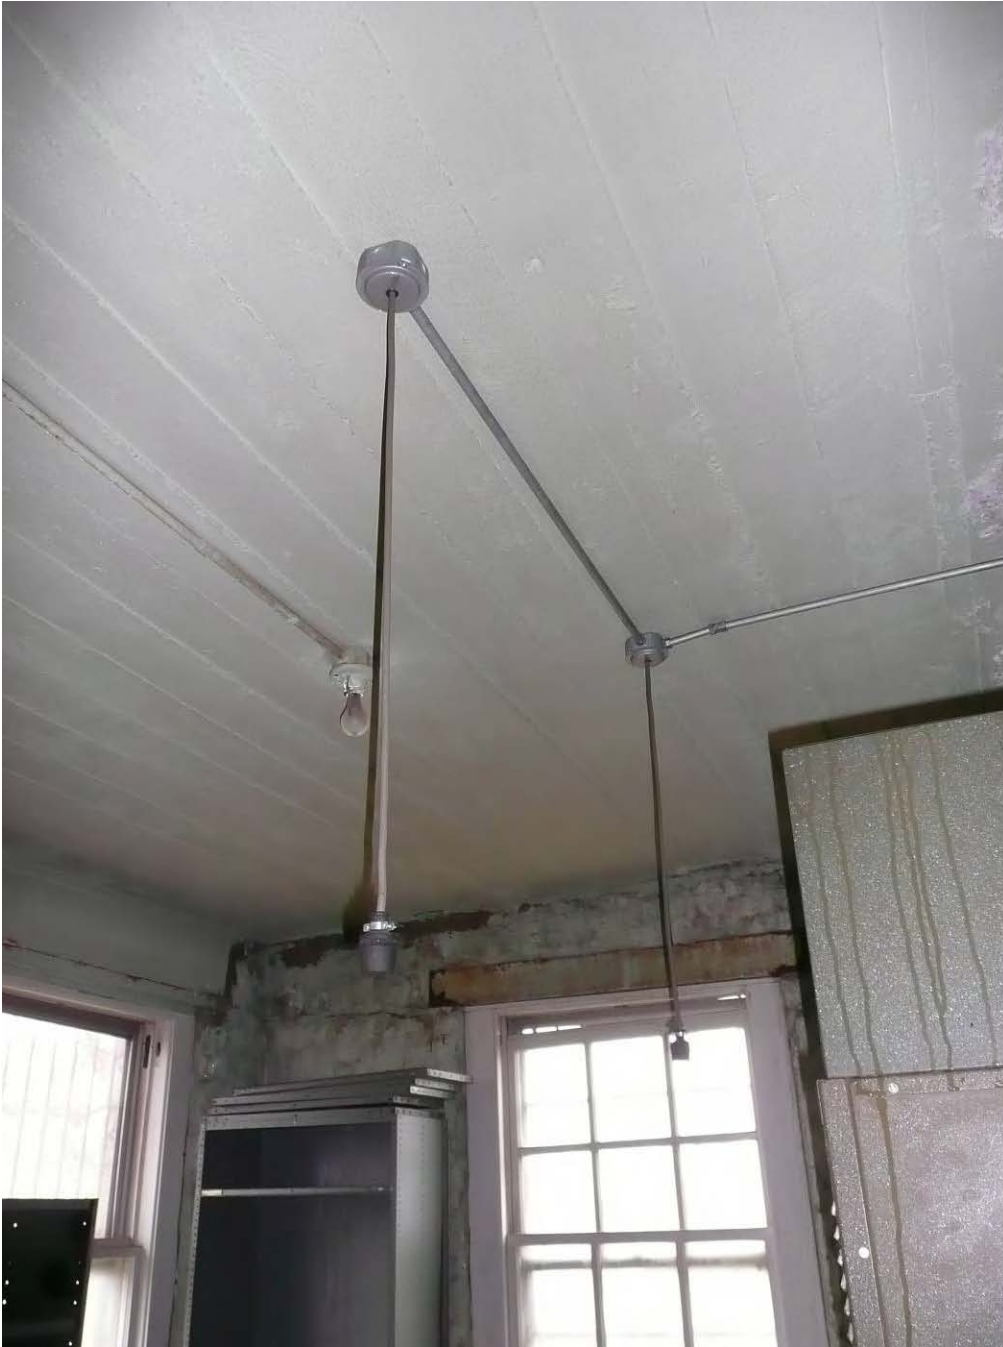
**Photo 39 – view of concrete ceiling**
