# **A BRIEF DISCUSSION OF A RECENT EXPLOSIVE ACCIDENT AT THE NAVAL SURFACE WARFARE CENTER**

M. M. Swisdak, Jr.  
Naval Surface Warfare Center/Indian Head Division

**28<sup>th</sup> DoD Explosives Safety Seminar  
August 1998**

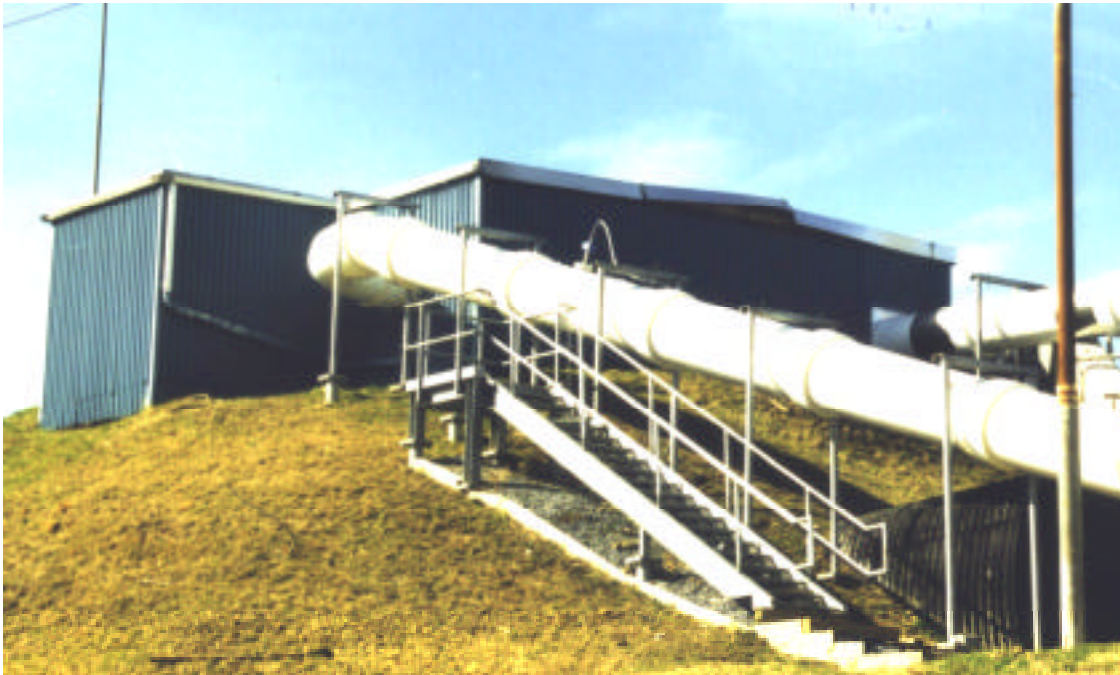
**FIGURE 1. EXTERIOR OF SIMILAR STRUCTURE**

Building 1026 is a multi-story, reinforced concrete, earth-bermed structure with multiple tunnel entrances and a frangible, built-up roof. The ground floor area is approximately 30' x 36'. The wall height is approximately 40 feet. The earth-berm extends from a point about 5-feet from the top of the wall at a slope of 1-1/2 to 1, natural grade. A heavy concrete floor is located about 13 feet above the ground floor of the structure. A lighter, frangible mezzanine is located about 23 feet above the ground floor. Figure 1 is a photograph of the exterior of a similar structure. Figure 2 is a sketch of the interior layout of the building.

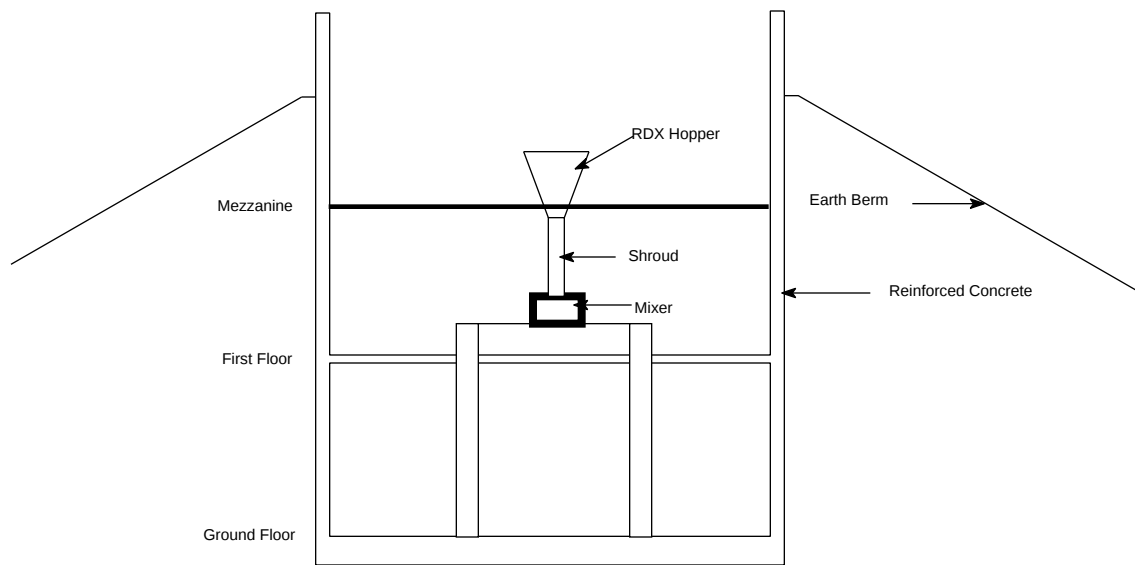
**FIGURE 2. BUILDING 1026 ARRANGEMENT**

The RDX is brought into the building in a wheeled hopper cart. The hopper is positioned on the Mezzanine Level directly above the mixer bowl. A cloth shroud with a conductive liner is attached to the bottom of the hopper and is used to direct the RDX into the bowl. Air-operated vibrators are attached to the exterior of the hopper to facilitate the flow of RDX. The flow of RDX from the hopper is controlled by an air-actuated valve that raises or lowers a seal located at the bottom of the hopper.
