# **Lipari Landfill Piping Network Corrosion Condition Assessment and Service Life Prediction Analysis**

December 2008

Final report

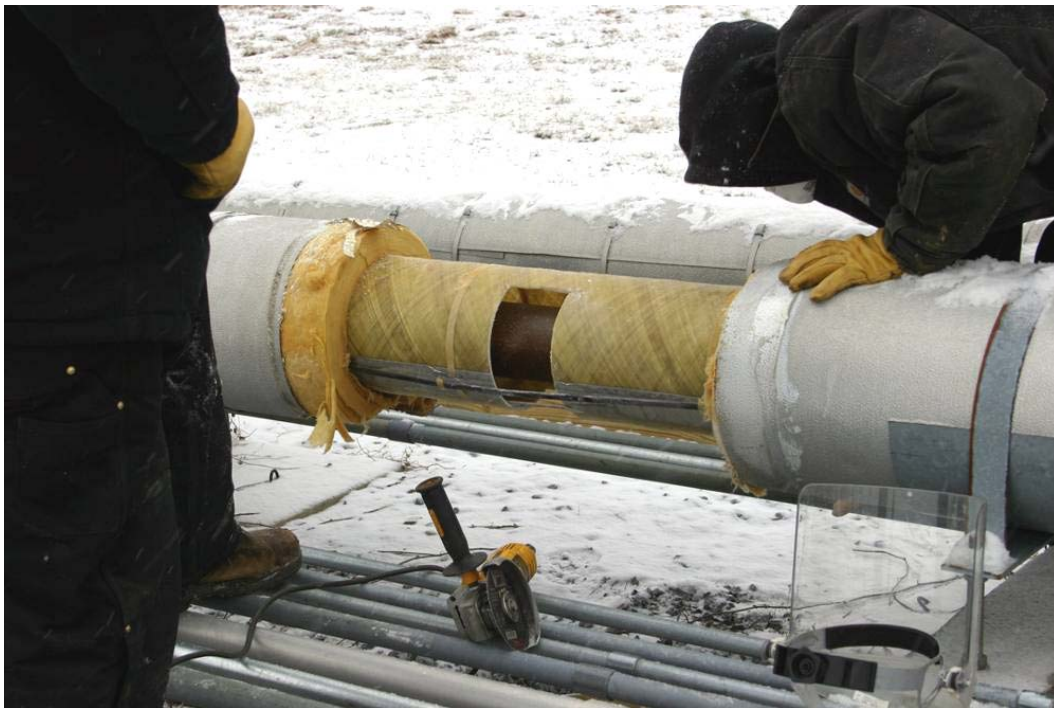
Figure 3. View of the pipe to be ultrasonically tested showing trace wire used to prevent pipe from freezing.

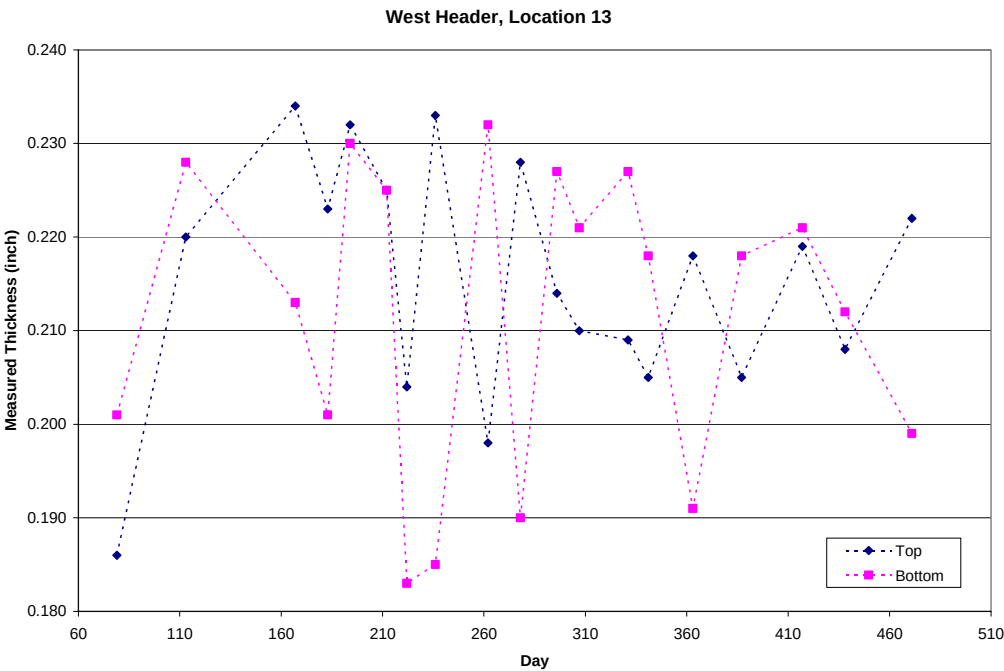
After reviewing the thickness measurements made on the carrier pipe for 15 months (Appendix B, Tables B1 through B23), it was obvious that the data had a large amount of scatter. The thickness values for individual measurement locations were plotted versus time. Selected examples are shown in Figure 7, Figure 8, and Figure 9.

Figure 7. Thickness measurements for the west header taken at location 13.

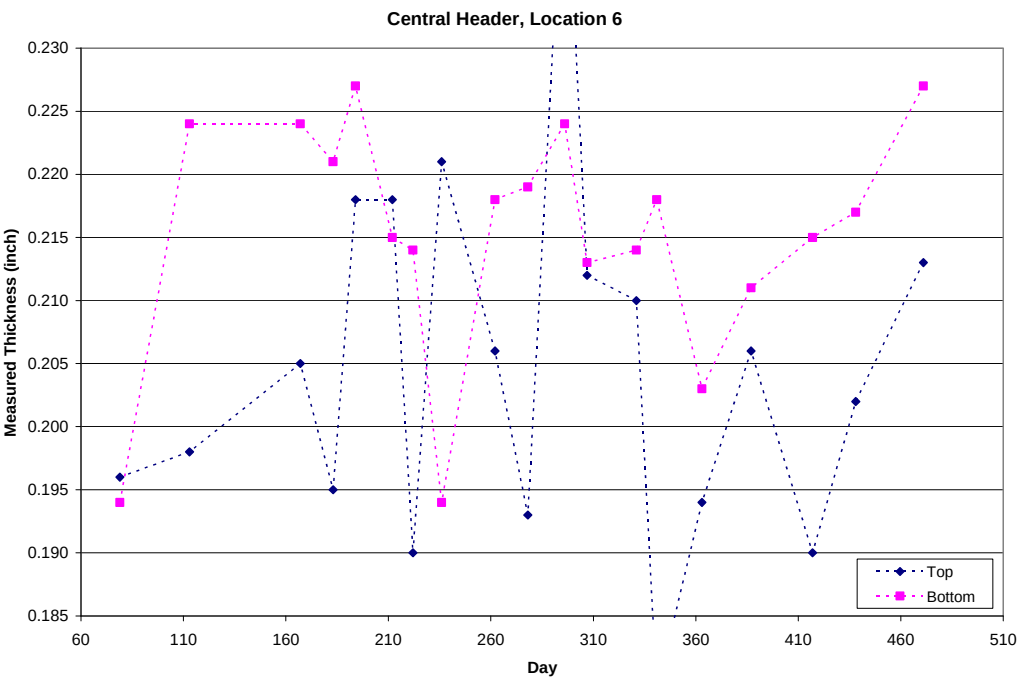
Figure 8. Thickness measurements for the central header taken at location 6.

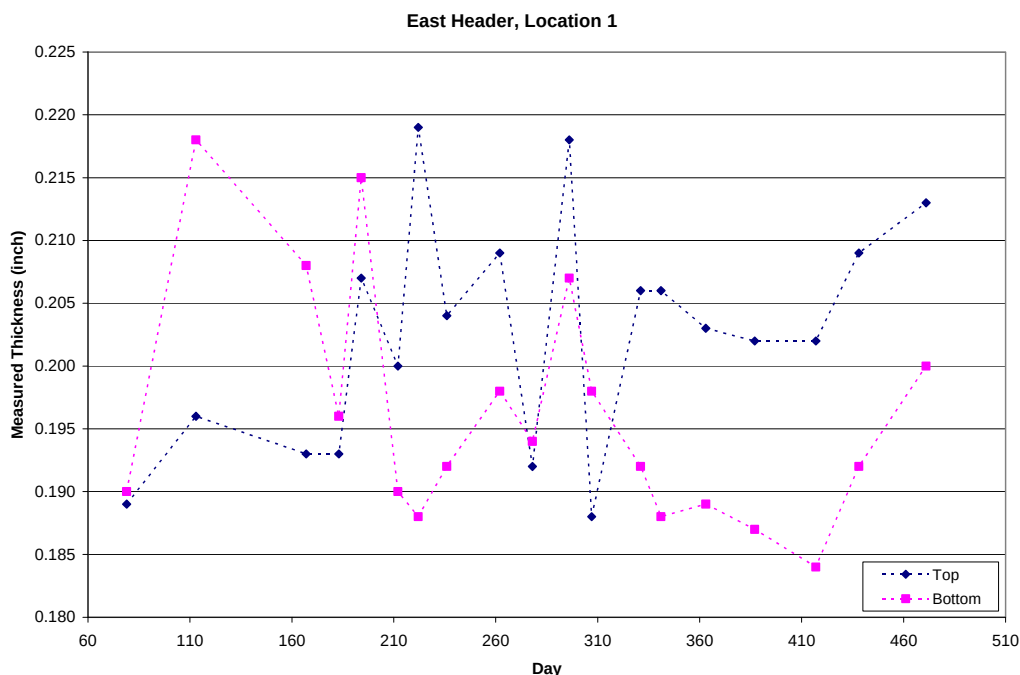
Figure 9. Thickness measurements for the central header taken at location 1.

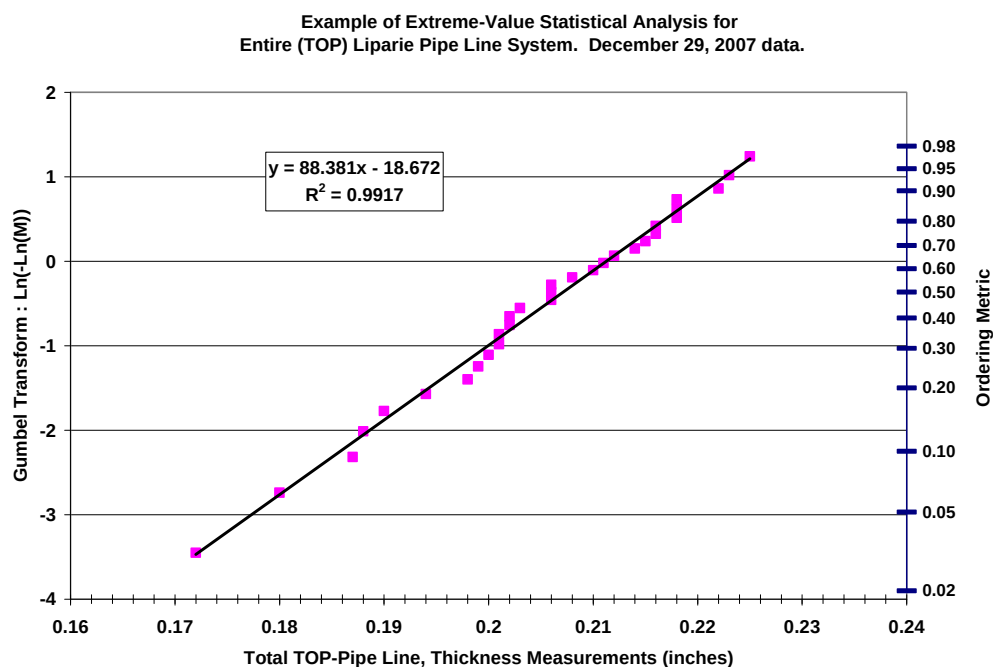
Figure 12 represents data from December 29, 2007 for the top of all three carrier pipes, and is a particularly good representation of an extreme-value distribution for the data collected, following the procedures described by Gumbel (1958). The compilation of the extreme-value statistical analysis for all the measurement dates for the top headers is displayed in Figure 13.

Figure 12. EVS analysis applied to all top header thickness measurements from December 29, 2007.

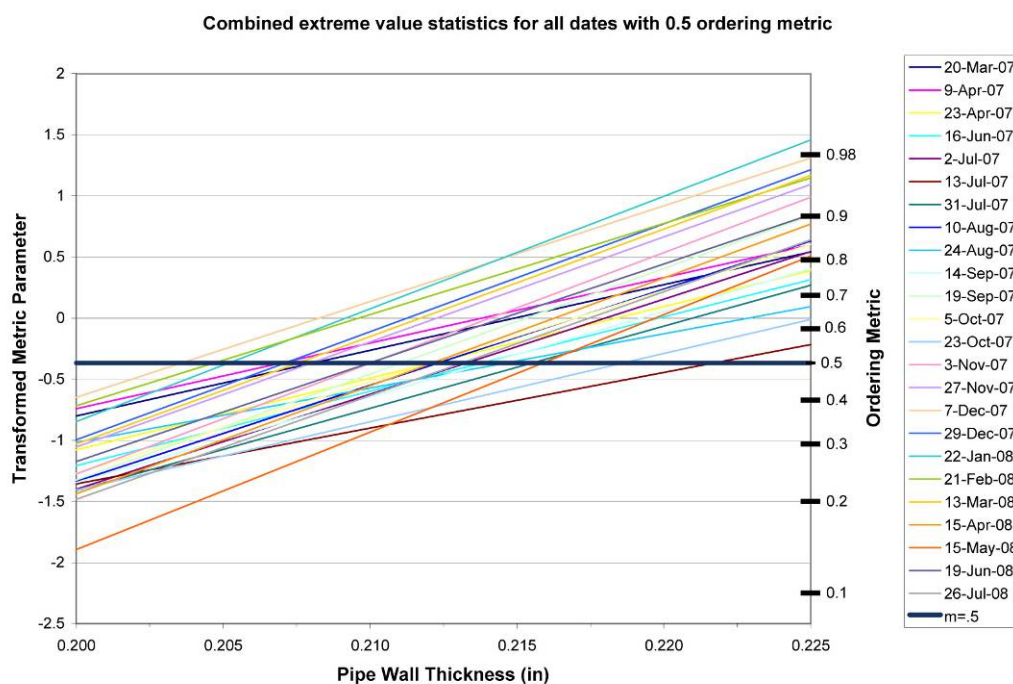
Figure 13. Compilation of extreme-value statistics for all top thickness measurements for all dates measurements were taken.

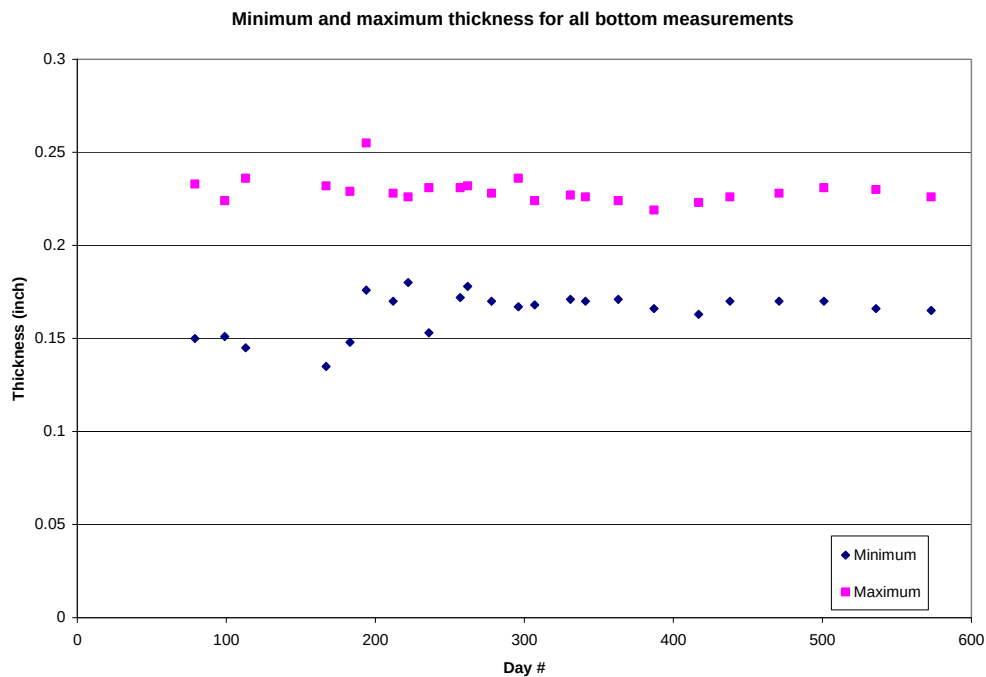
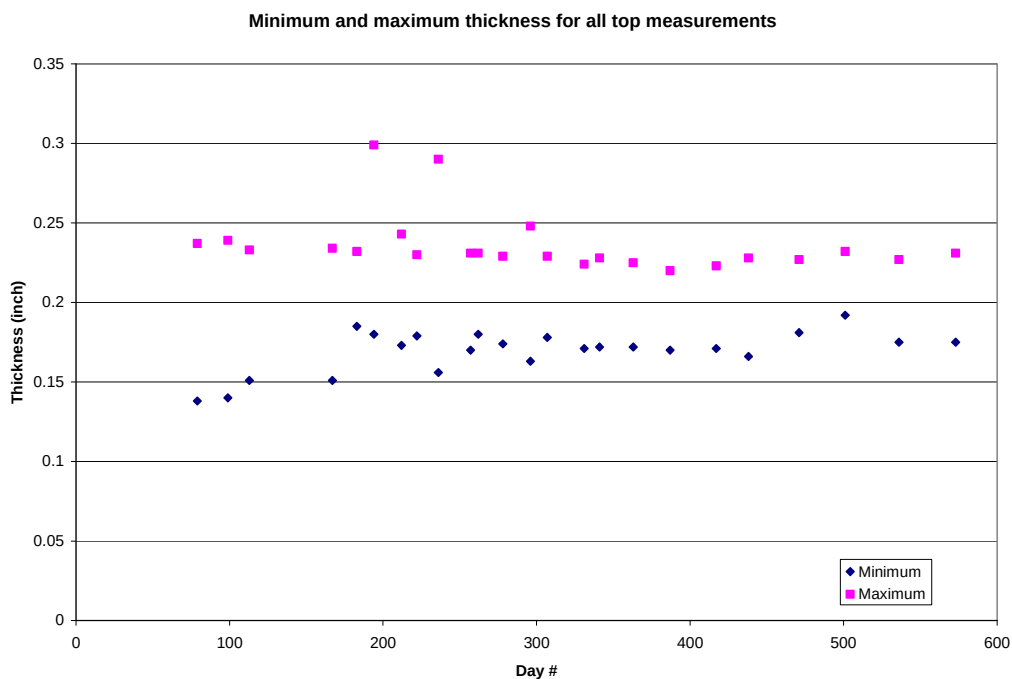
Figure 16. Maximum and minimum ultrasonic thickness readings for all the bottom measurements.

Figure 17. Maximum and minimum ultrasonic thickness readings for all the top measurements.

These figures show no meaningful temporal trend over the 15-month measurement period. A simple average of the minimum and maximum values was calculated to determine the corrosion rate during the previous 14 years of service using a method similar to that described in sections 3.1 and 3.2.3.2. Average thickness values of 0.197 and 0.203 in. were calculated from those readings and assigned as the current average bottom and top thicknesses, respectively. Then corrosion rates were calculated for the bottom and top based on an initial pipe thickness of 0.237 in. The resulting corrosion rate was 2.86 mpy for the bottom and 2.43 mpy for the top. These results were similar to the rate obtained using the extreme-value method for the bottom of the pipes, but they were lower for the top.

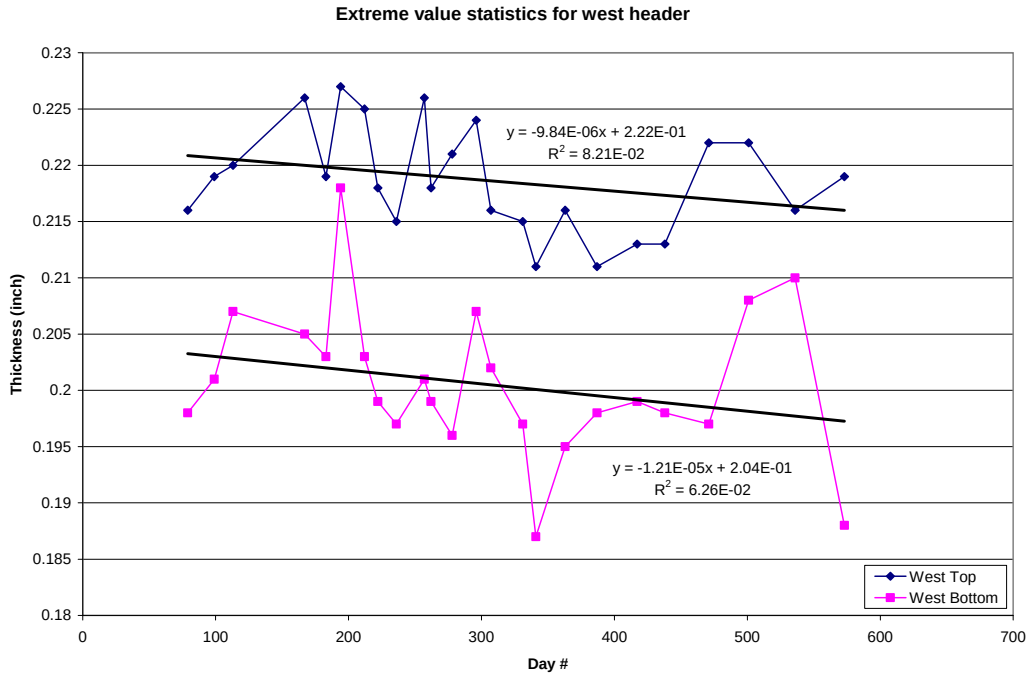
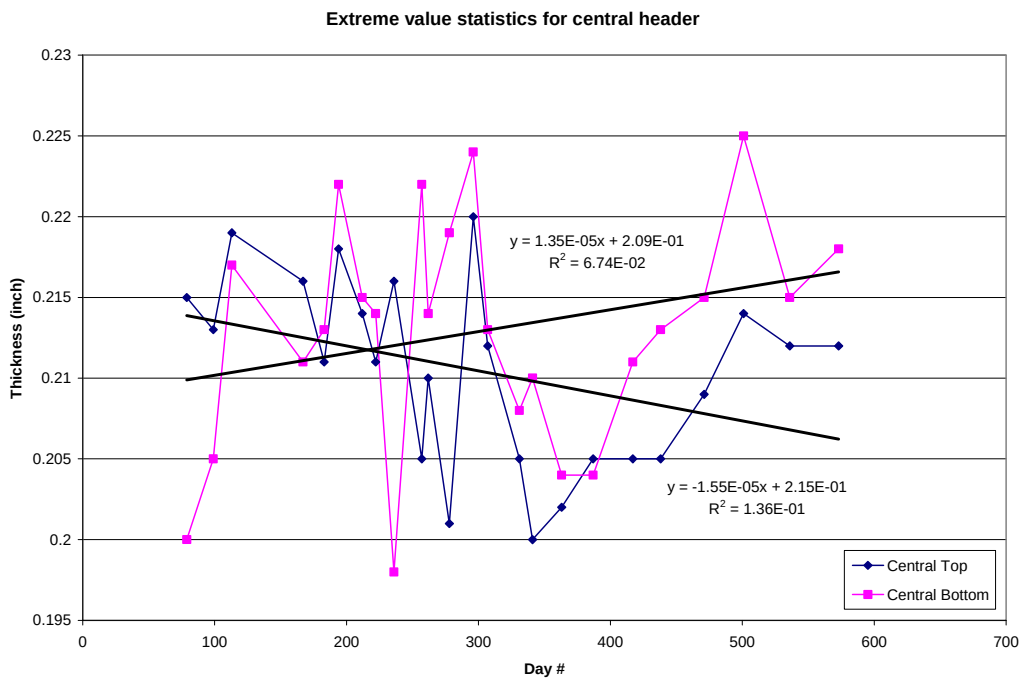
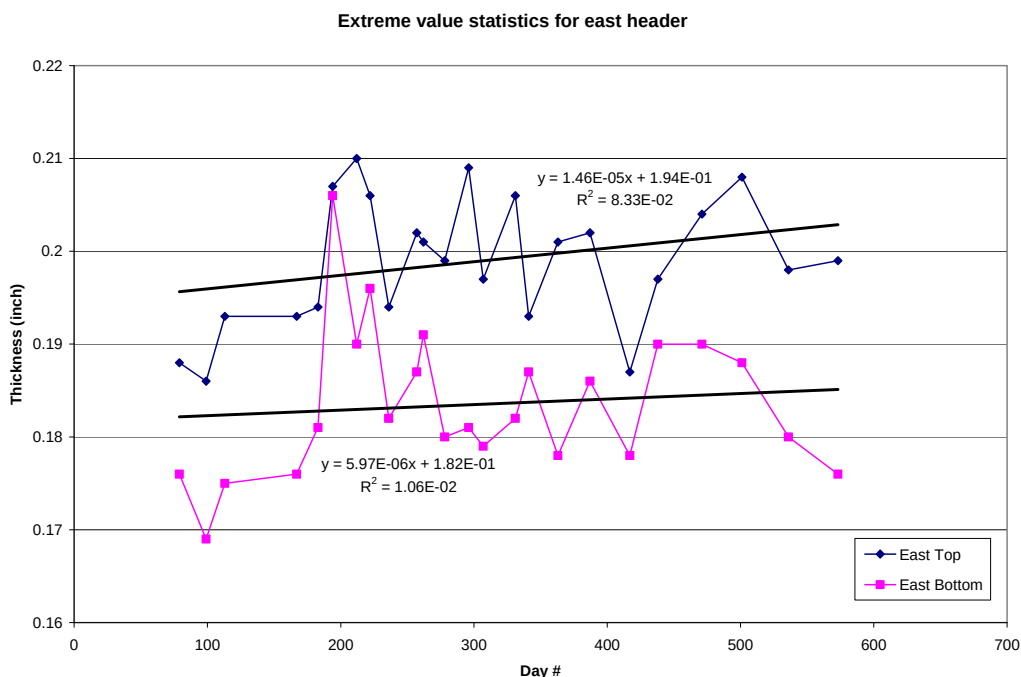
Figure 18. Extreme-value statistics for top and bottom of the west header.

Figure 19. Extreme-value statistics for top and bottom of the central header.

Figure 20. Extreme-value statistics for top and bottom of the east header.

Qualitatively, these trends look very similar to those presented in Figure 4, Figure 5, and Figure 6 in section 3.2.3.1. For purposes of consistency, corrosion rates were calculated only from those trends that showed a decreasing thickness. The corrosion rates for the top and bottom of the west header were 3.59 and 4.42 mpy, respectively. The corrosion rate for the top of the central header was 5.66 mpy. These corrosion rates are similar to those in Table 2 and are consistent with the other corrosion rates found using the EVS method.

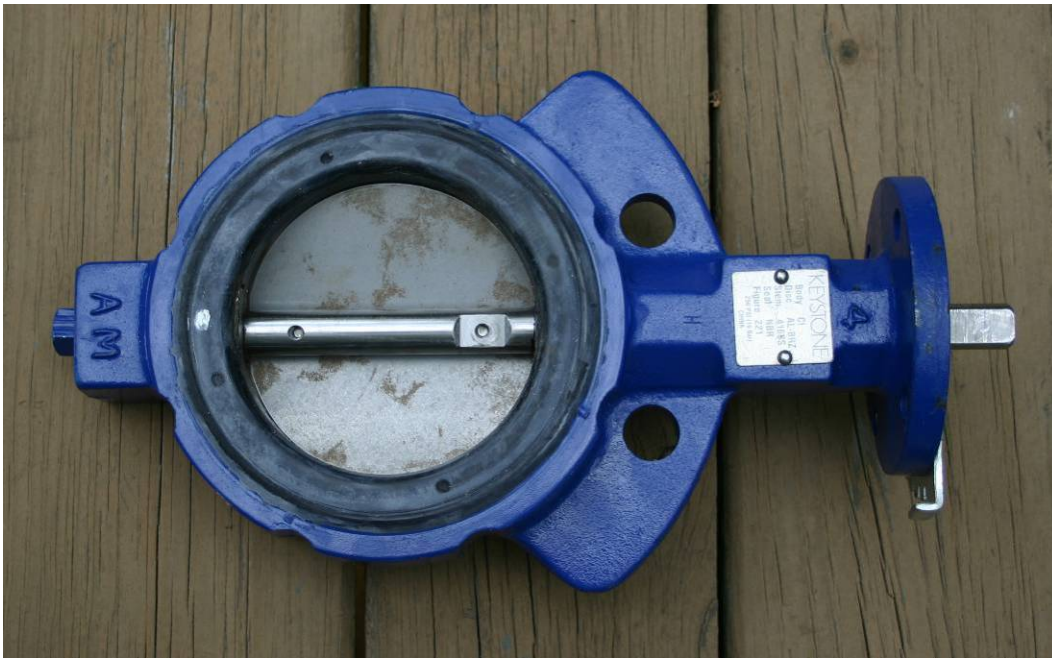
Figure 21. View of the backside of the test coupon attached to the valve stem.

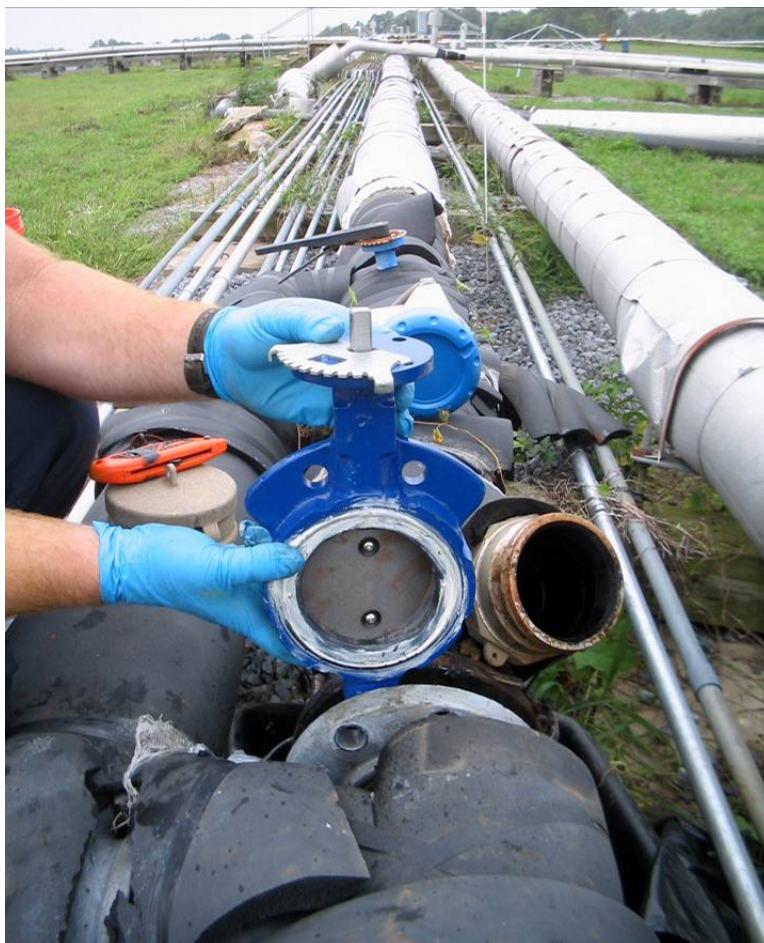
The valve body containing the corrosion coupon was placed into the west header on August 4, 2007. Figure 22 and Figure C11 (see Appendix C) show this installation. Prior to installation, the corrosion coupon had a diameter of 10.6 cm and was machined out of 0.317 cm (0.125 in.) thick carbon steel. After machining the disk, an initial weight of 200.00 grams was determined using a calibrated laboratory scale, and the thickness of the plate, 0.317 cm (0.125 in.), was determined using a calibrated micrometer. The surface area was calculated to be 182.59 cm<sup>2</sup> (28.4 sq. in.).

Figure 22. Photograph of test coupon about to be inserted into the west header.

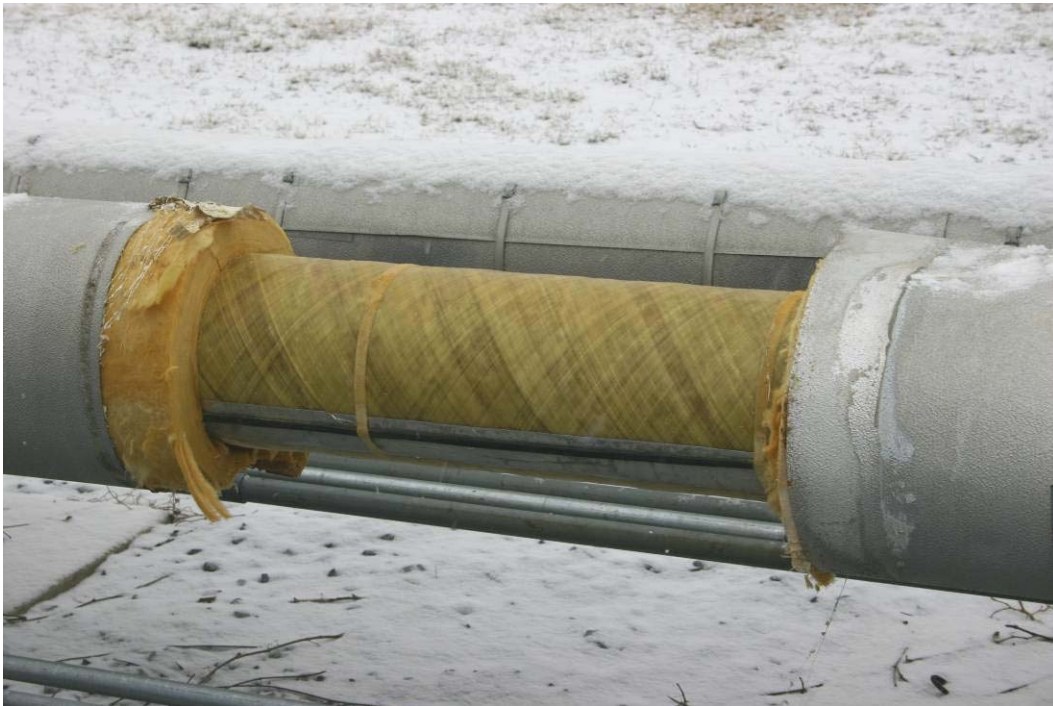
Figure C7. View of west header with aluminum weather shield and fiberglass insulation removed, revealing the fiberglass containment pipe.
