**MISSAN SURGICAL HOSPITAL**  
**UNDER THE ECONOMIC SUPPORT FUND**  
**AL AMARAH, IRAQ**

**SIGIR PA-08-165**  
**SIGIR PA-08-167**

**JULY 16, 2009**

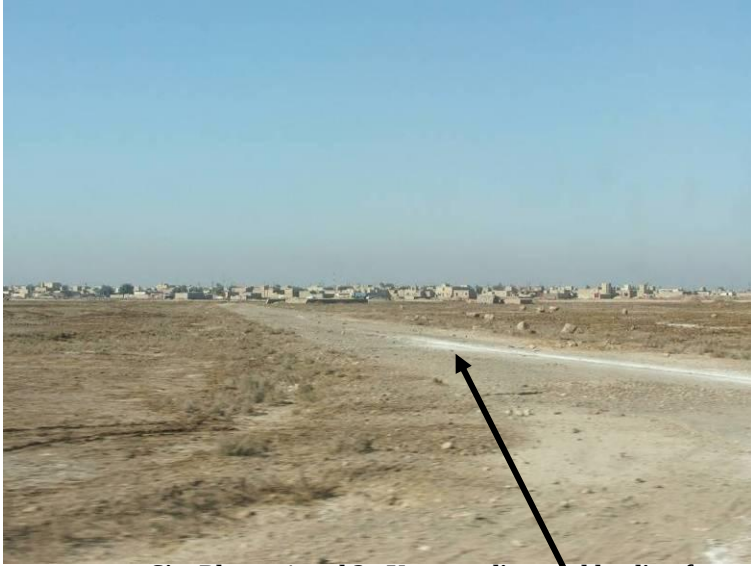
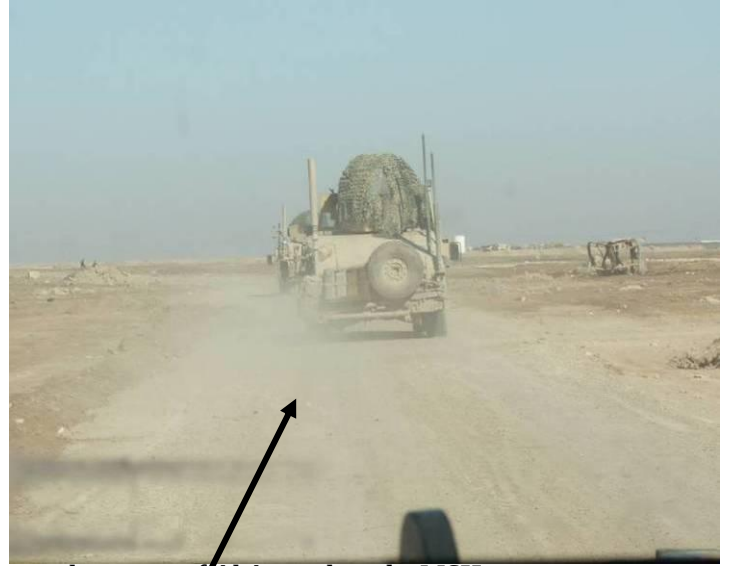
In order to visit the project site, the U.S. Army drove SIGIR inspectors through Al Amarah to the northern outskirts of the city. SIGIR confirmed that there is no existing paved road connecting the city to the hospital; SIGIR traveled 1.5 miles outside the city limits on an uneven dirt road to the hospital location (Site Photos 1 and 2 and Figure 3). According to GRS and ITAO representatives and project file documentation, there were two reasons why the GOI decided to locate the hospital in a desolate area away from the city instead of the city of Al Amarah, which is congested with houses, apartment complexes, and multiple story commercial buildings. First, constructing a new hospital complex in the city would require significant demolition of existing homes, apartments, and commercial buildings, potentially uprooting and relocating Missan residents and presenting a logistics challenge for the contractor to bring all the construction materials to the site through the heart of the city. Second, the cost of the project would have increased to include tearing down the existing structures.

**Site Photos 1 and 2. Uneven, dirt road leading from the northern part of Al Amarah to the MSH**
