## **Corrosion-Resistant Materials for Water and Wastewater Treatment Plants at Fort Bragg**

Final Report on Project AR-F-319 for FY05

L.D. Stephenson and Ashok Kumar

June 2007

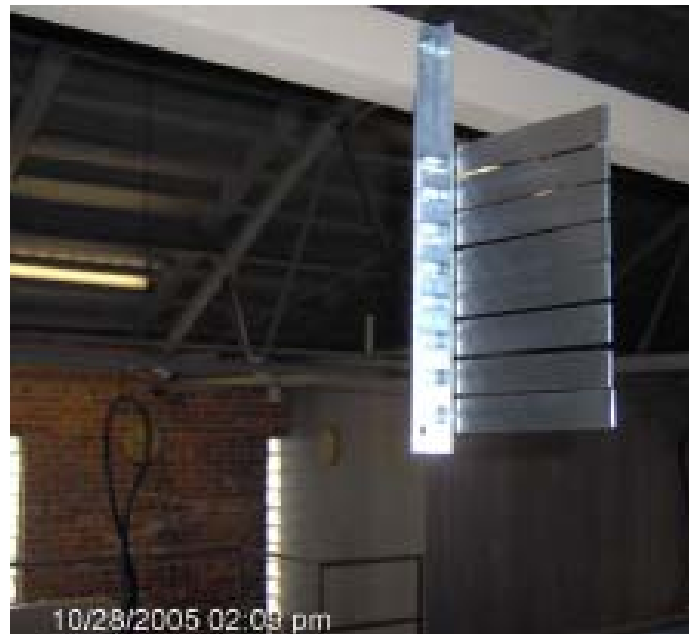
Figure 13a. Above water weight loss coupon at WTP.

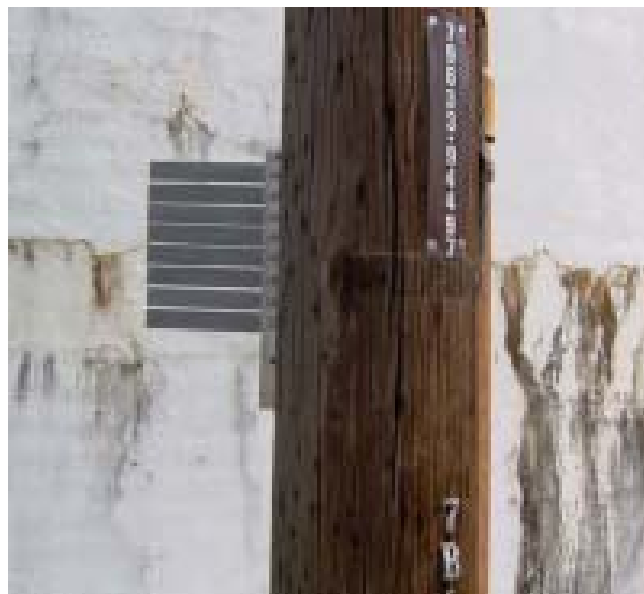
Figure 13b. Atmospheric weight loss coupons at WTP.

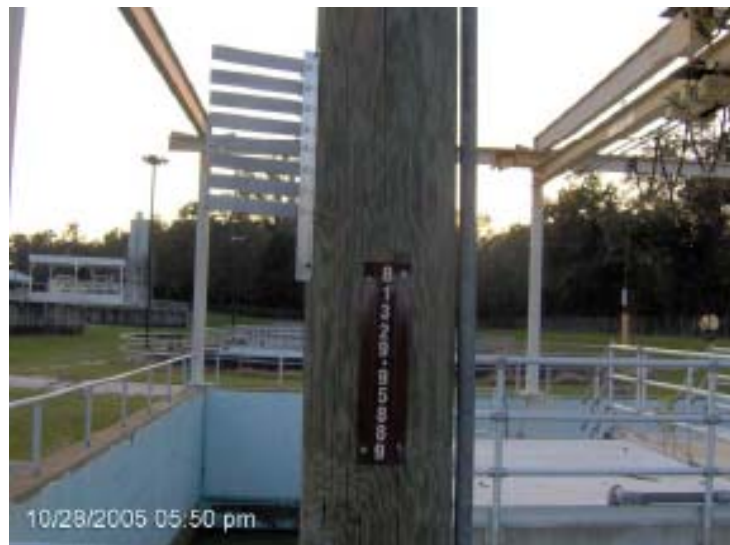
Metrics for this project are based on verification of the atmospheric corrosivity of the Fort Bragg WTP and WWTP. A total of eight exposure racks were fabricated, with eight coupons per rack. The coupons were furnished by Metal Samples, Inc., with precise dimensions and weights recorded at the manufacturing laboratory. The coupons were constructed of mild carbon steel alloy A285-C. Each coupon was stamped with an identification number that corresponded to a precise factory obtained weight. The coupons each had an exposure surface of 12.3563 square inches, and an initial weight of 88 to 92 grams. The coupon racks were mounted at four locations each within both the WTP and the WWTP on October 25, 2005. The intent of the coupons is to be able to accurately monitor the corrosion rates in the various environments. The locations of these coupons are shown schematically in Appendix 5. Photographs of selected coupon racks are shown in Figures 13a, 13b, and 13c in Appendix 2.

Figure 13c. Atmospheric weight loss coupons at WWTP.

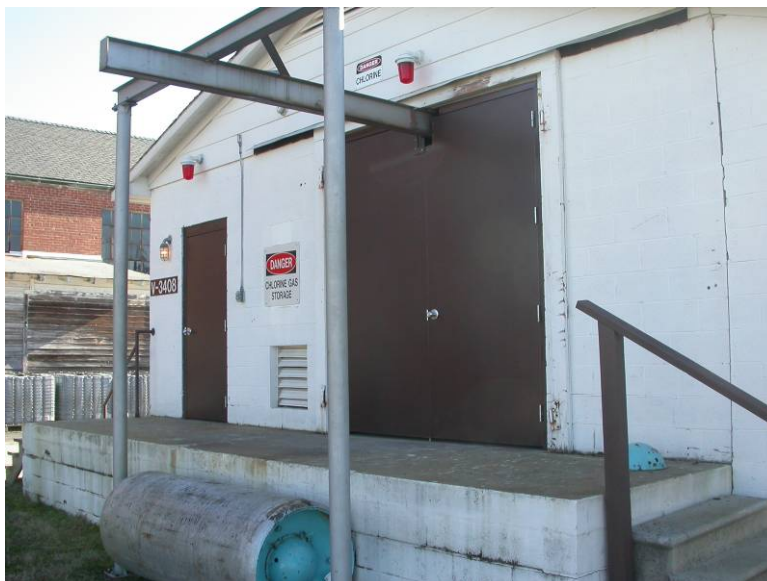
The loading doors at the opposite end of the building are shown in Figures 6 and 7.

Figure 6. Doors on the opposite end of the building from those shown in Figure 5.

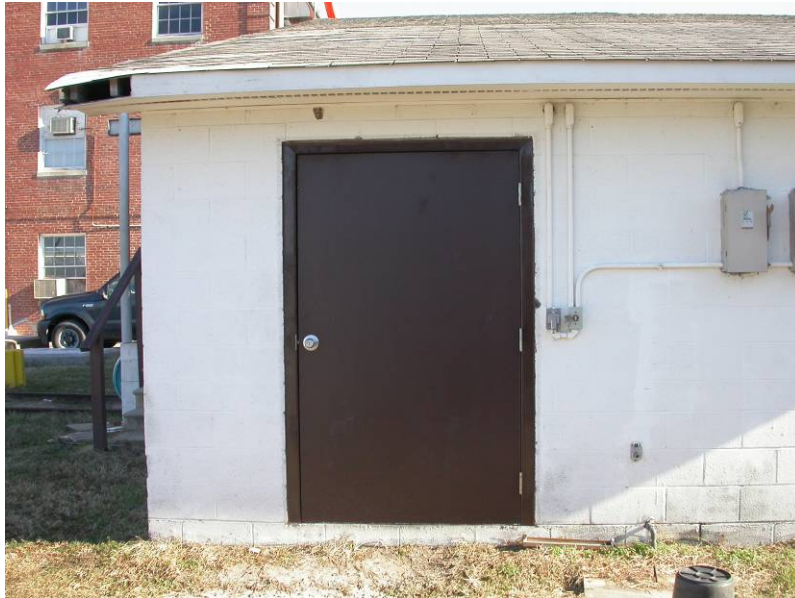
Some of the chemicals shown in the room discussed in Figures 6–11 are mixed and used in the room behind the door shown in Figure 12. The corrosive acids used in water treatment have etched the concrete floor of this room. The floor etching due to chemical spills is apparent in Figure 13.

Figure 12. Pedestrian door leading to chemical room at water treatment plant at Fort Bragg.

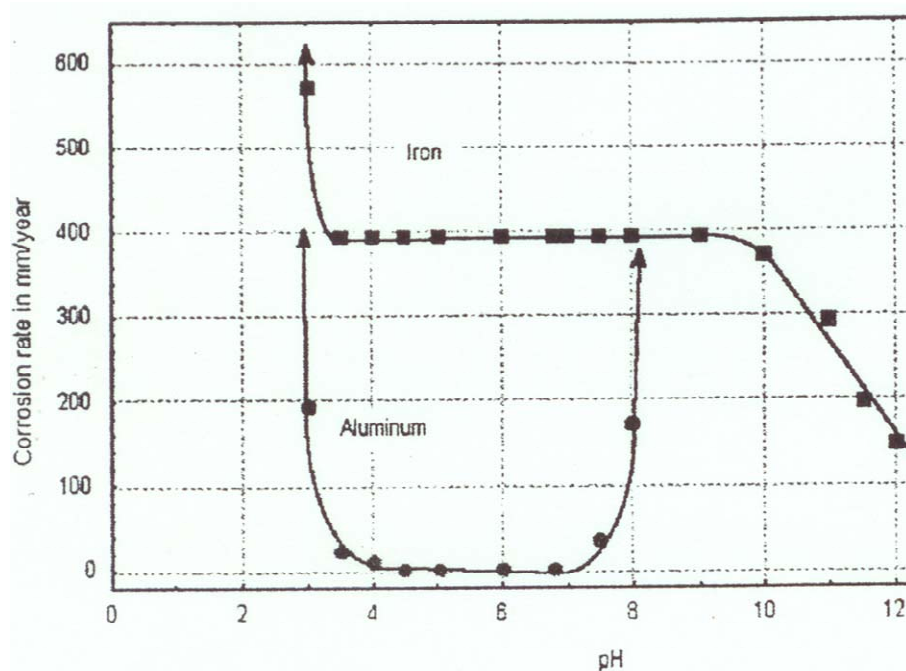
Acids are corrosive to carbon steel and concrete. They are also corrosive to zinc and aluminum, two coating metals frequently specified for retarding corrosion in atmospheric environments. This is emphasized in Figure 15, which shows the relative corrosion rates of aluminum and iron (carbon steel) at varying pH's.

Acids have low pH and bases have high pH. Neutral environments around pH 7 are less corrosive to aluminum and zinc, and, therefore, can be used as protective coatings in many atmospheric environments, but not in acidic atmospheres. The concrete shown on the floor in Figure 13 is a base. That is why it has reacted so strongly with the acid spills onto the floor. Fortunately, the floor is relatively thick and the surface roughening has caused no major problems in this location.

Figure 15. Effect of varying pH of the environment on the corrosion of iron and aluminum.

Stainless steels are the preferred hardware material for doors used in corrosive environments because they are resistant to most acids and bases likely to be encountered by doors and similar construction components.
