**ABATTOIR (SLAUGHTERHOUSE) IN
QALADZE
SULAYMANIYAH, IRAQ**

**SIGIR PA-09-179
OCTOBER 16, 2009**

SUBJECT: Report on the Abattoir (Slaughterhouse) in Qaladze, Sulaymaniyah
Province, Iraq (SIGIR Report Number PA-09-179)

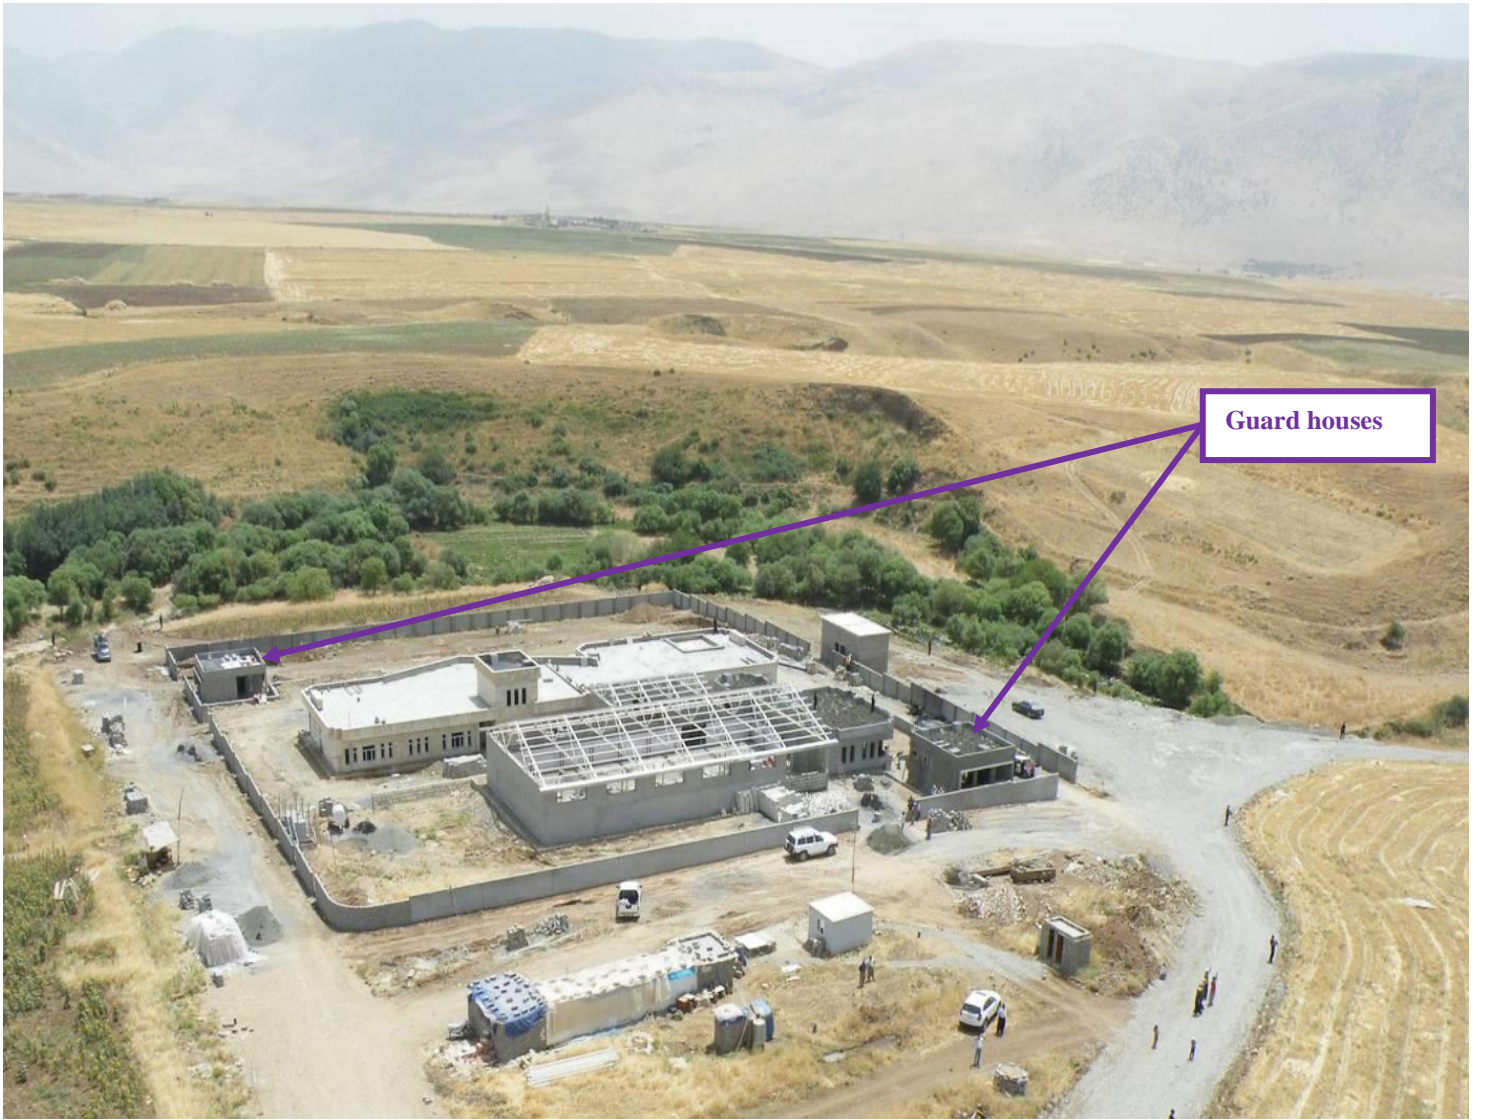
The SOW required the construction of two guard houses (one for each entrance/exit) (Site Photo 6). The designs called for a single-story structure with a kitchen, living room, water closet (bathroom), and storage room.

Site Photo 6. Location of the guard houses within the abattoir facility
