**RABEAA POINT OF ENTRY
SCREENING FACILITY
RABEAA, IRAQ**

**SIGIR PA-09-173
JANUARY 11, 2010**

Summary of Report: PA-09-173

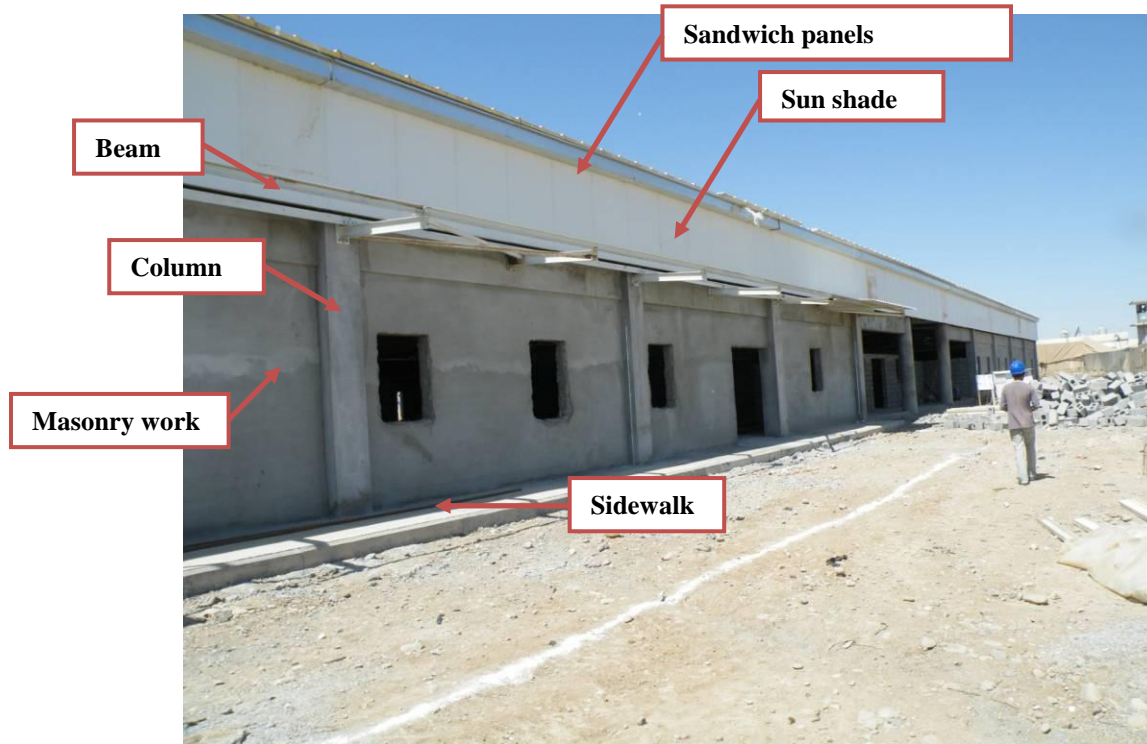
Site Photo 1. Exterior construction of the screening building

At the time of the site assessment, the exterior frame of the screening building was constructed (Site Photo 1). SIGIR observed the construction of the sandwich panels, sun shade, beam, columns, masonry, and sidewalk of the screening building. The interior of the screening building was not complete. The interior walls of the screening area were partially constructed.

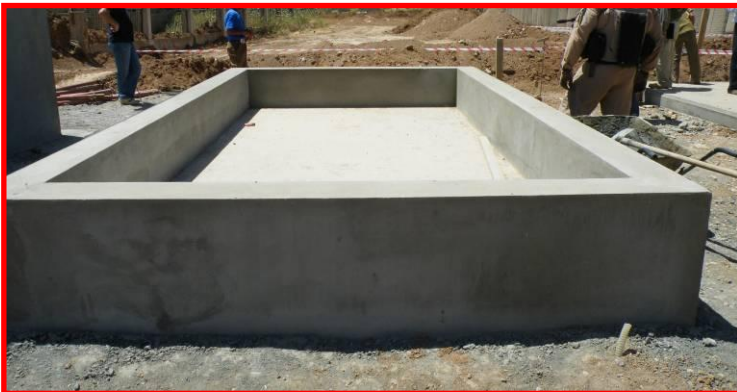
Site Photo 3. Fuel tank base

At the time of the site assessment, SIGIR noted that the contractor installed the generator on the generator pad (Site Photo 2), constructed the fuel tank base (Site Photo 3), and constructed the pump room (Site Photo 4).

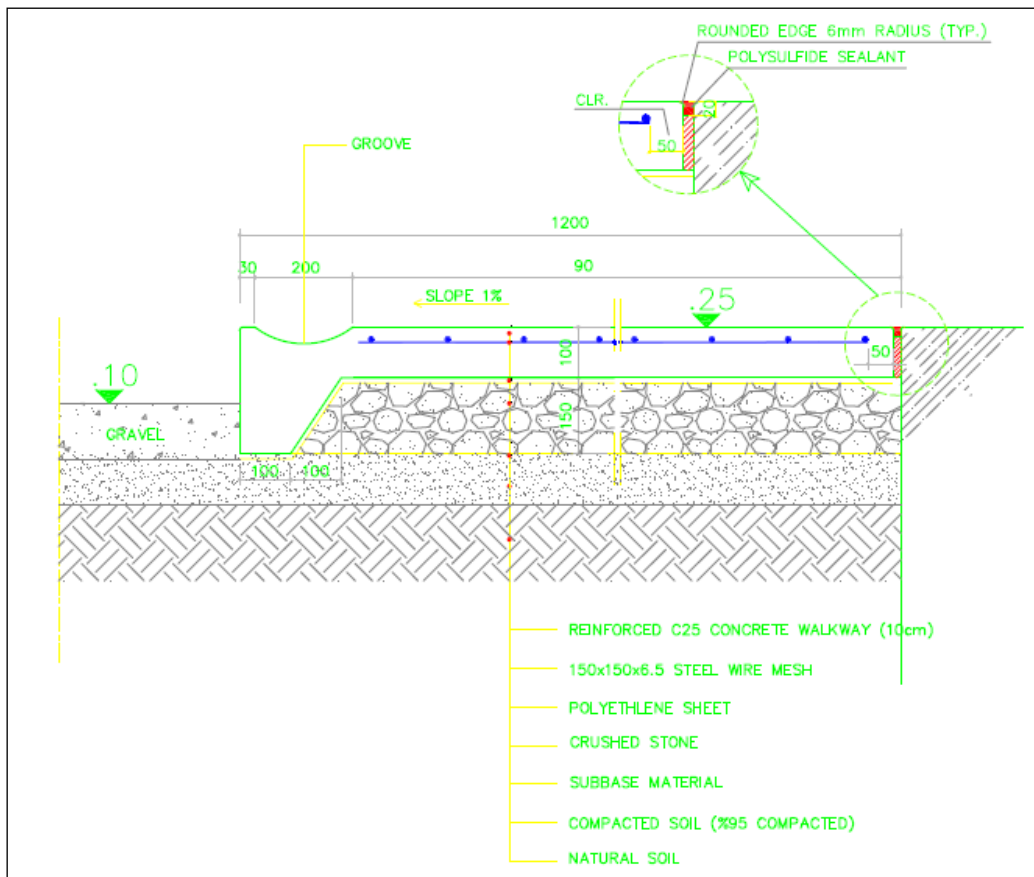
Figure 5. Sidewalk detail per the 100% design drawings (Courtesy of USACE)

At the time of the site assessment, the exterior sidewalk was partially constructed; the construction was determined to be lacking an isolation joint next to the building, control joints, and a 200mm groove (Site Photo 9). Both the isolation joint and the groove were included in the 100% drawings submitted for approval (Figure 5). The control joints (contraction joints) were required every 1.2 meters (m) per a special note on the plans.

- a. Improper jointing and unlevel construction of the concrete floor slab and cracking of the thin mortar overlay.
- b. Exterior sidewalk construction that was lacking control joints, a 200mm groove, and isolation joints next to the building.
- c. Construction of the raised concrete pad of the water pump house floor that was not square and did not allow for access to one exterior wall.

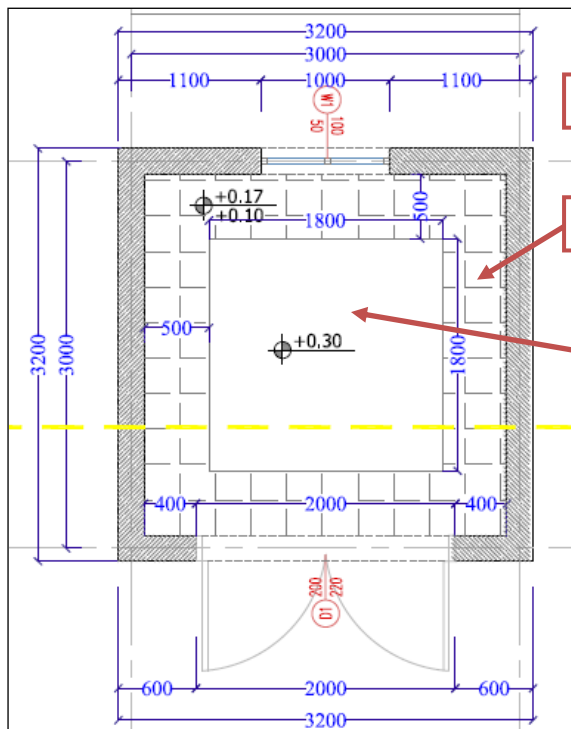
Figure 6. 100% Water pump room floor plan drawing (Courtesy of USACE)

Although the construction of the water pump house was partially completed, SIGIR noted that the construction of the raised concrete pump pad was not constructed in accordance with the drawings (Figure 6 and Site Photo 10). Specifically, the raised floor as submitted on the plans was a 1.8m square raised concrete pad. The actual construction of the raised concrete pad was not configured in a square and did not allow for access against one exterior wall. Once the booster pumps are placed on the concrete pad, the access to the electrical control panel could be impeded. The original design allowed for unimpeded access all around the raised pump pad.
