**ABU GHRAIB DAIRY  
ABU GHRAIB, IRAQ**

**SIGIR PA-09-172  
JANUARY 14, 2009**

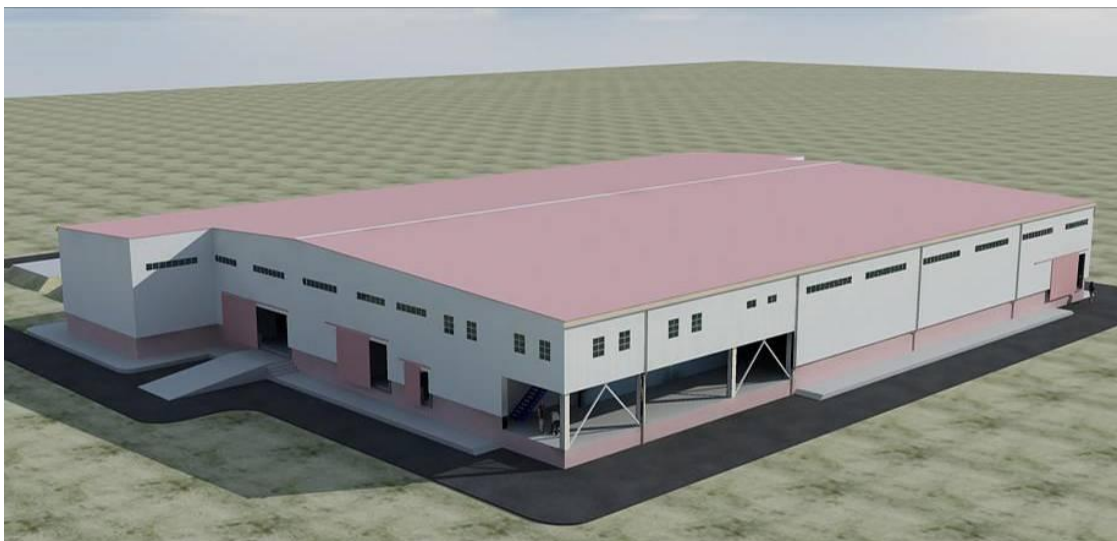
**Figure 1. Rendering of dairy building and surrounding area (Courtesy of TFBSO)**

The contractor designed the construction of an approximately 2,900 square meter facility (Figure 1), including water and fuel storage tanks. The contractor provided detailed architectural plans for the project, including exterior renderings of the facility, exterior elevations, several interior cross sections, and floor plan information regarding building layout and room dimensions.

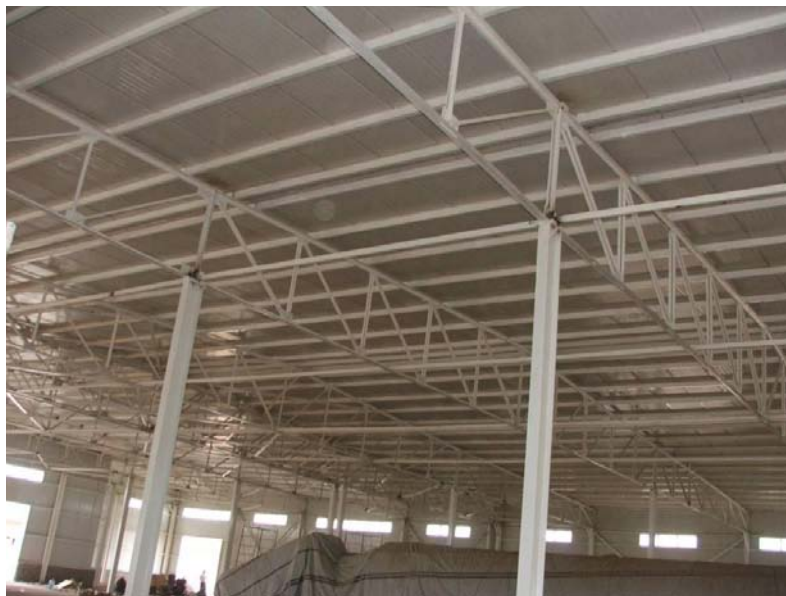
**Site Photo 6. Lateral brace connection at column cap plate**

At the time of the site visit, all structural steel, with the exception of the mezzanine, had been erected. The steel structure for the dairy building consisted of continuous steel trusses supported by steel columns (Site Photo 6). The trusses at the ends of the structure and at either side of the expansion joints were braced with diagonal bracing in the plane of the upper and lower chord. The trusses are also braced transversely in the plane of the lower chord with steel braces running the length of the structure.

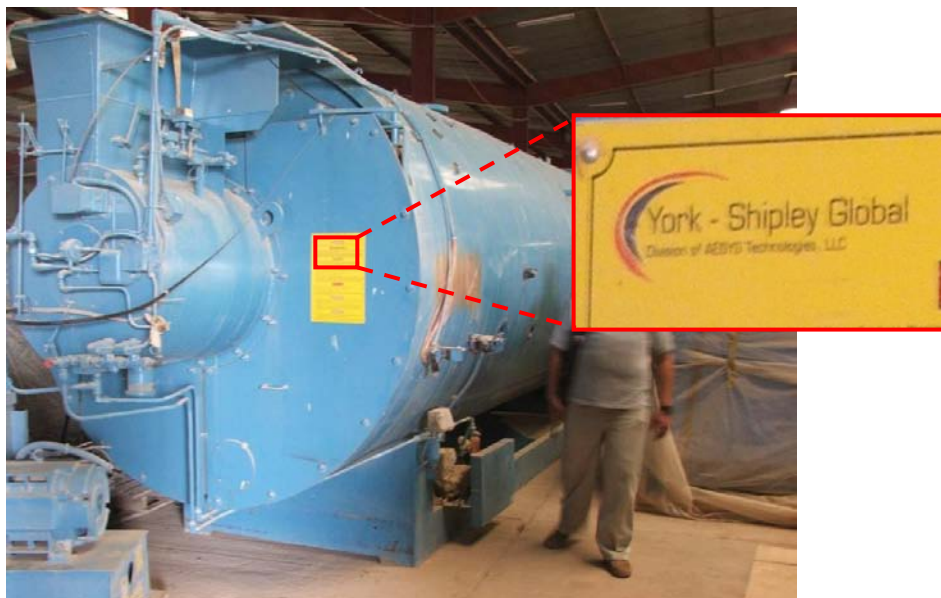
**Site Photo 17. Dairy production equipment**

With the exception of one large piece of equipment already located inside the newly constructed facility, the milk processing and packaging equipment is stored inside a leaking warehouse<sup>23</sup> near the Abu Ghraib Dairy (on the Ministry of Industry and Minerals compound). SIGIR toured the warehouse and found most of the equipment in its original packaging and appeared to be in good condition. One of the pieces of equipment sustained some damage due to either improper storage or handling (Site Photo 16). SIGIR was able to identify several pieces of equipment with visible nameplates (Site Photo 17), and the remainder of the equipment was labeled with shipping labels.

<sup>23</sup> It had recently rained and SIGIR observed a noticeable amount of water on the floor and on the equipment.
