# HADITHA DAM PERIMETER SECURITY HADITHA, IRAQ

## SUSTAINMENT ASSESSMENT

**SIGIR PA-09-192**  
**APRIL 13, 2010**

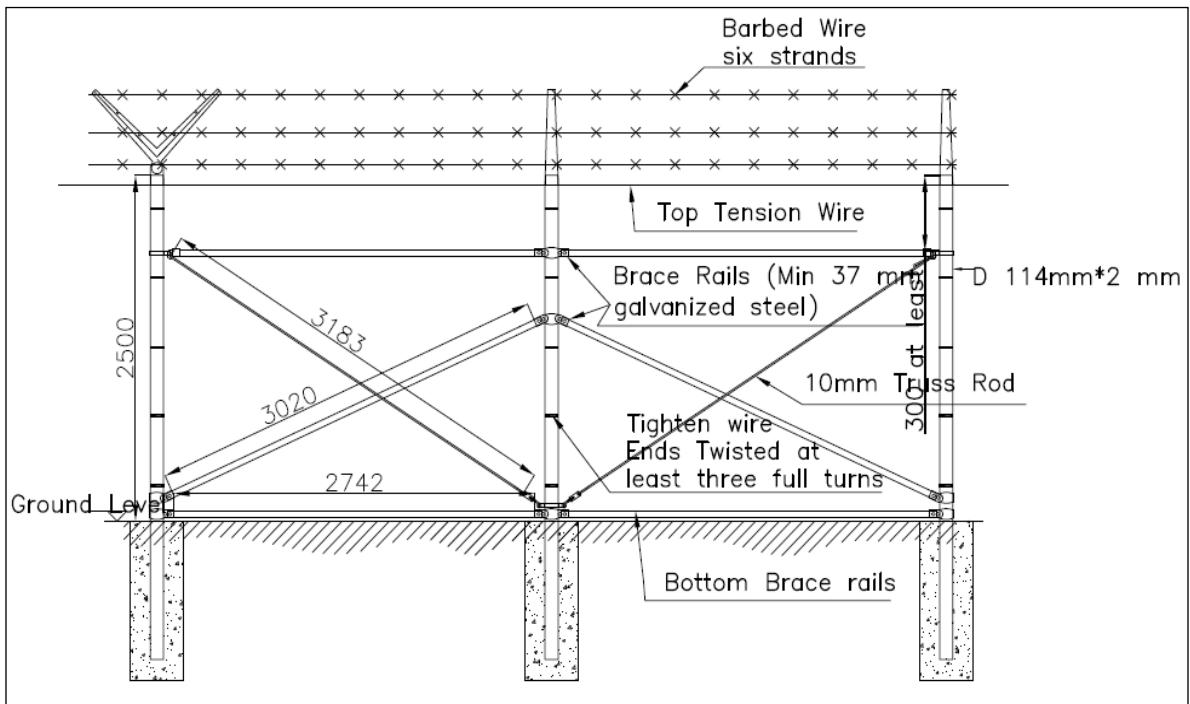
The contractor submitted details in the design drawings for construction of the perimeter fence (Figure 2). These details were based on the standard drawings provided with the contract and provided additional dimensions and details.

Figure 2. Contractor's design of typical fence section  
(Courtesy of GRC)
