**HUMER KWER HEALTH CENTER  
SULAYMANIYAH, IRAQ**

**SUSTAINMENT ASSESSMENT**

**SIGIR PA-09-186  
APRIL 20, 2010**

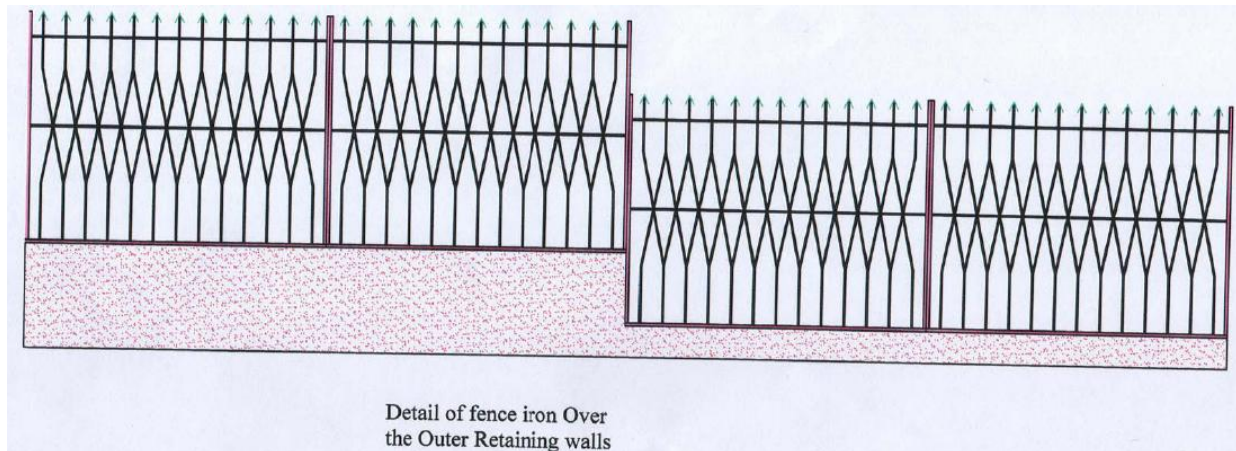
**Figure 2. Steel fence secured to retaining wall  
(Courtesy of GRN)**

The perimeter security wall details provided with the conceptual design drawings included details for the concrete masonry unit<sup>4</sup> (CMU) wall, foundation, and reinforcement for the gates and is identical on the contractor's drawings. In several areas the need for a retaining wall precludes the construction of a CMU security wall. In these areas, the contractor proposed a steel fence mounted to the top of the retaining wall (Figure 2).

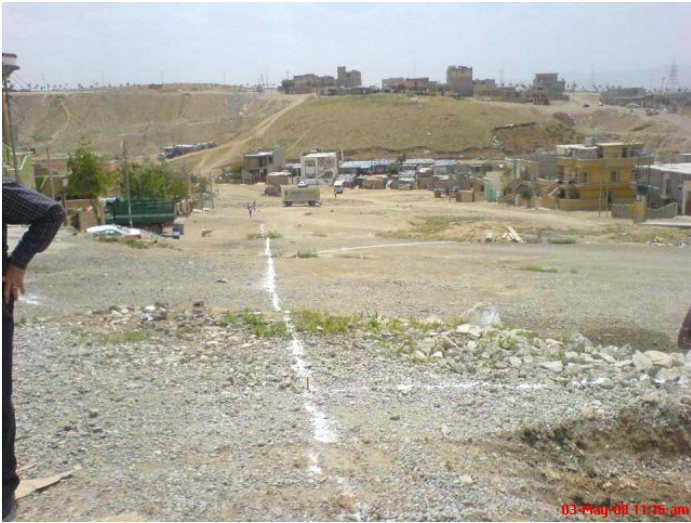
Before new construction could begin, the contractor cleared and excavated the project area. Site Photo 2 shows the obstructed future site of the Humer Kwer Health Center, with debris that required removal, and Site Photo 3 shows the site after the contractor excavated and cleared the area.

Site Photo 2. Site layout before modification (Courtesy of GRN) Site Photo 3. Site after excavation (Courtesy of GRN)

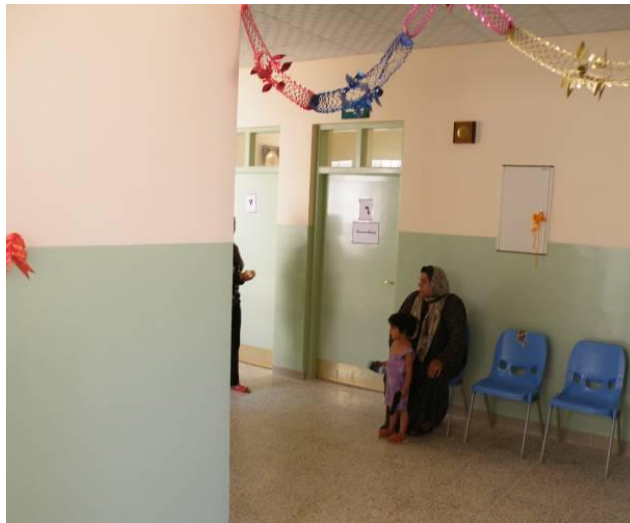
Site Photo 7. Patient waiting area

Upon entry to the health center is a small waiting area (Site Photo 7) and a registration window for incoming patients. The waiting area was furnished with chairs, which were

included as part of the contract. The health center was open at the time of the site visit and several patients were waiting to be seen by the attending physicians.

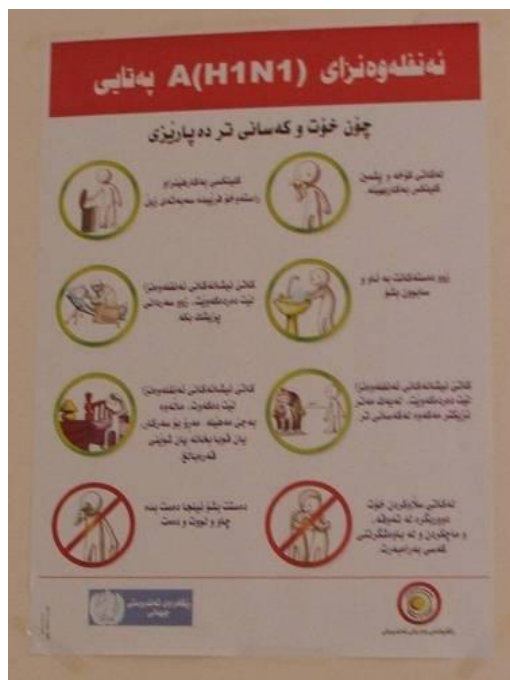
Site Photo 8. Health education poster in Humer Kwer Health Center

Educational posters were placed throughout the facility to promote awareness of public health issues (Site Photo 8).
