AFRL-RX-TY-TR-2009-4608

## **SMOOTHNESS EVALUATION OF EXPEDIENT REPAIRS AT AVON PARK**

APR Consultants, Inc.  
27 Oaklawn Avenue  
Medway, OH 45341-1117

NOVEMBER 2009

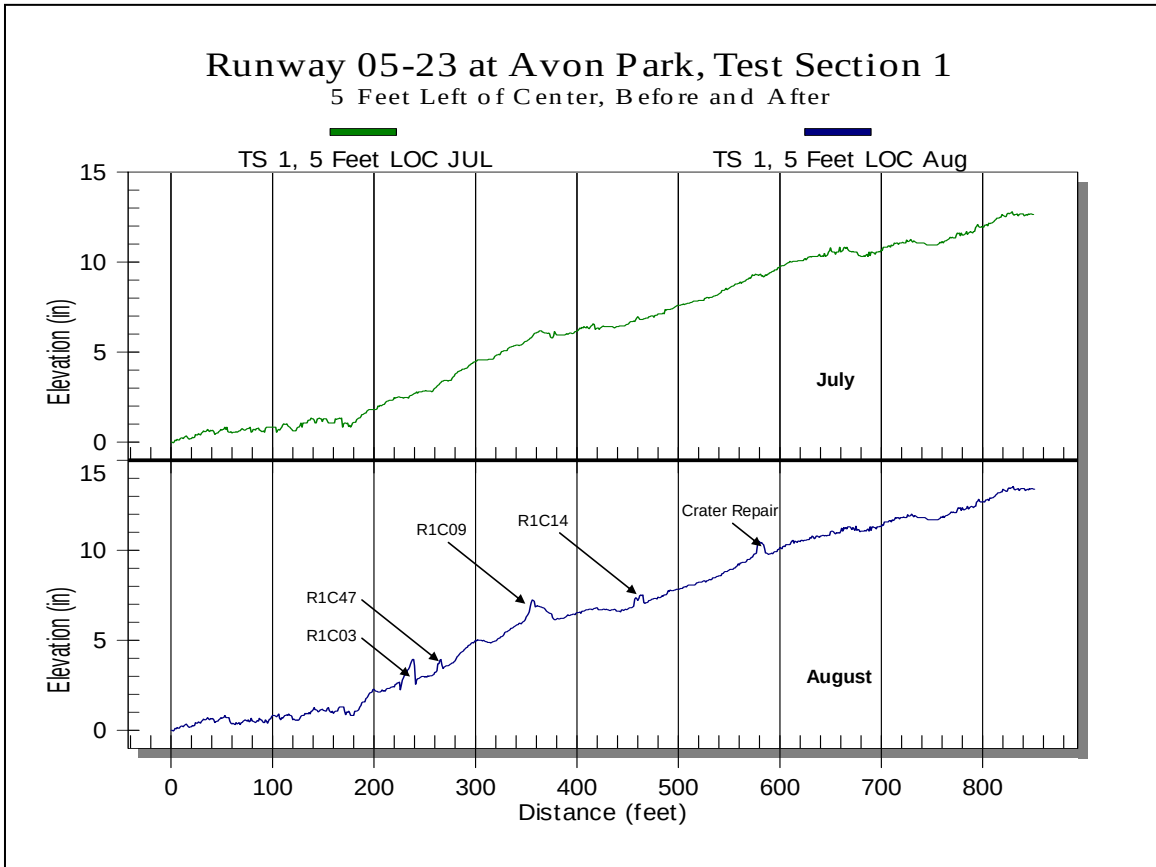
**Figure A-1: Profile Plots of Test Section 1 on Runway 5-23, 5 Feet Left of Center Before and After**

All analysis figures are contained in the appendix. Figure A-1 is a plot of the centerline of the entire runway from threshold to threshold. It shows the full length profile measured in July and in September. Each of the 13 test section lines of survey are plotted with the before and after expedient repairs. The profile plots are followed by 16-foot and 100-foot straightedge plots of the before and after expedient repairs. Figures A-2 through A-45 are the results for test section one. Figures A-46 through A-65 are the results for test section two. The crater repair identifications that were visible during the survey, which are shown on the plots, are also contained in the data files emailed to the AF point of contact (POC).
