## **Reducing Fracture Tendencies in PCBN FSW Tools**

ONR Contract Number N00014-09-C-0288

### **Base Effort Final Report**

David Marshall  
Teledyne Scientific Co. LLC  
1049 Camino Dos Rios  
Thousand Oaks, CA 91360

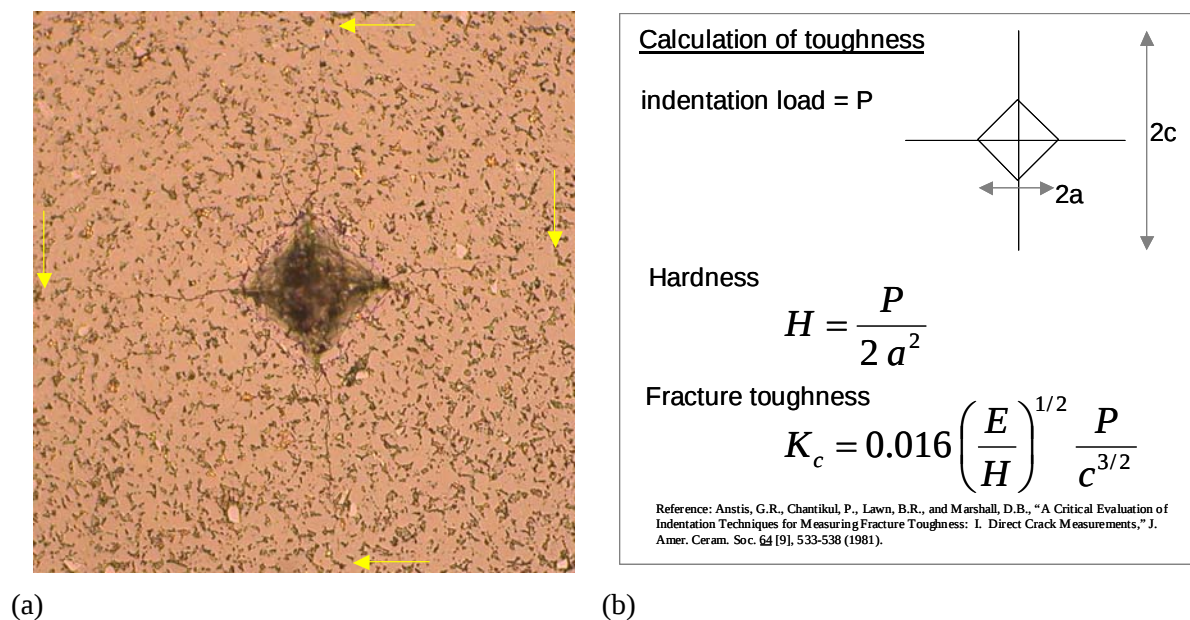
*Fig. 1. Indentation method for measurement of fracture toughness: (a) Vickers indentation (200N load) in polished surface of polycrystalline cubic BN (MS80). Arrows indicate positions of crack tips, which can be readily located in higher magnification optical micrographs; (b) Schematic of indentation and cracks, with fracture mechanics expression from which the fracture toughness can be evaluated.*

This technique has been developed extensively with ceramic materials, although it has not been applied previously to PCBN materials. Indentations in PCBN at loads smaller than ~50 N generally produce irregular crack patterns because of their high hardness and relatively large grain size. However, at higher loads well developed cracks are produced, as in Fig. 1.

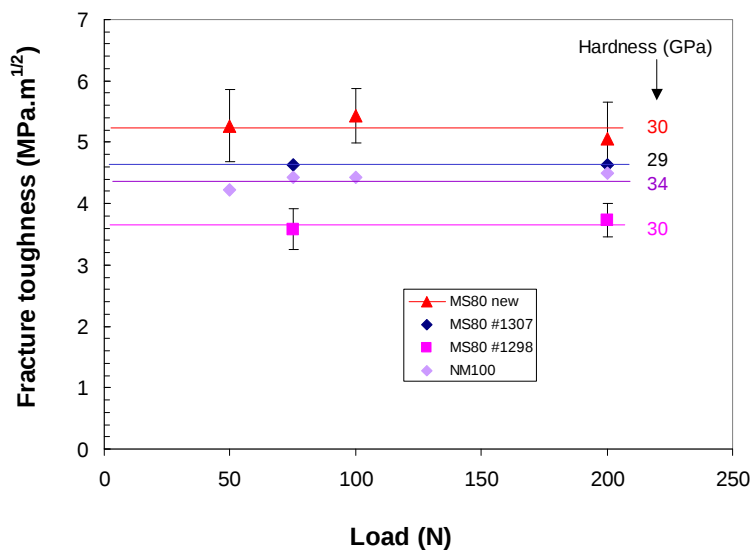
The results of toughness measurements from the three MS80 materials are summarized in Fig. 2. Also shown are measurements from another PCBN material (MN100) which has much higher volume fraction of BN and smaller amount of grain boundary phase (AlN). For each material the toughness was evaluated from indentations at several different loads within the range 50 to 200 N, with each data point being an average of at least 10 measurements. The observation in Fig. 2 that, in all cases, the toughness is independent of the indentation load confirms the functional form of the toughness equation and thus the validity of the underlying fracture mechanics analysis.

Significant differences are evident in the fracture toughnesses of the three MS80 materials. The highest toughness ( $5.2 \text{ MPa}\cdot\text{m}^{1/2}$ ) is observed in the new material which was also much more difficult to grind and polish than the other two materials. However, the relative ranking for the other two materials is opposite to their relative performance in FSW: the material with lower toughness (#1298) is the one with the longer FSW life. Further measurements will be made to investigate whether this trend is followed in other materials.

The hardness of these materials is expected to scale with the volume fraction of BN and be relatively insensitive to subtle microstructural variations that influence fracture toughness. The measured hardnesses listed in Fig. 2 are consistent with this expectation: the values for the three MS80 materials are indistinguishable (30 GPa) whereas the value for the MN100 material is higher (34 GPa).

Fig. 2. Indentation fracture toughness measurements from several PCBN materials. Error bars indicate standard deviations.

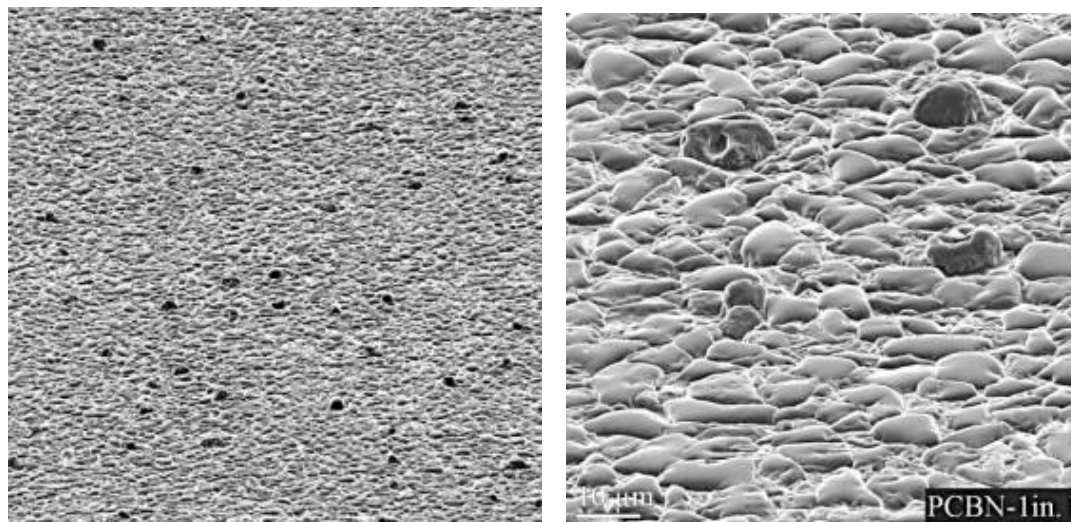
The new MS80 material was much more difficult to cut and polish than other PCBN materials. After initial attempts to polish the surface of this material using a relatively soft cloth that produced a good polish on other PCBN materials, we found that strong relief was produced, with some grains remaining raised significantly above the majority of grains. Images of these grains are shown in Fig. 3. EDS analysis indicated that these grains were carbon. Analysis by Raman microprobe spectroscopy confirmed that the grains are diamond (Fig. 4). The diamond grains were distributed very uniformly throughout the material, with a volume fraction of several percent. Their size is similar to that of the BN grains.

*Fig. 3 SEM micrographs of new MS80 material showing surface after polishing with diamond impregnated cloth which produced relief of diamond particles (same area at different magnifications). Dark grains in (a) are diamond*

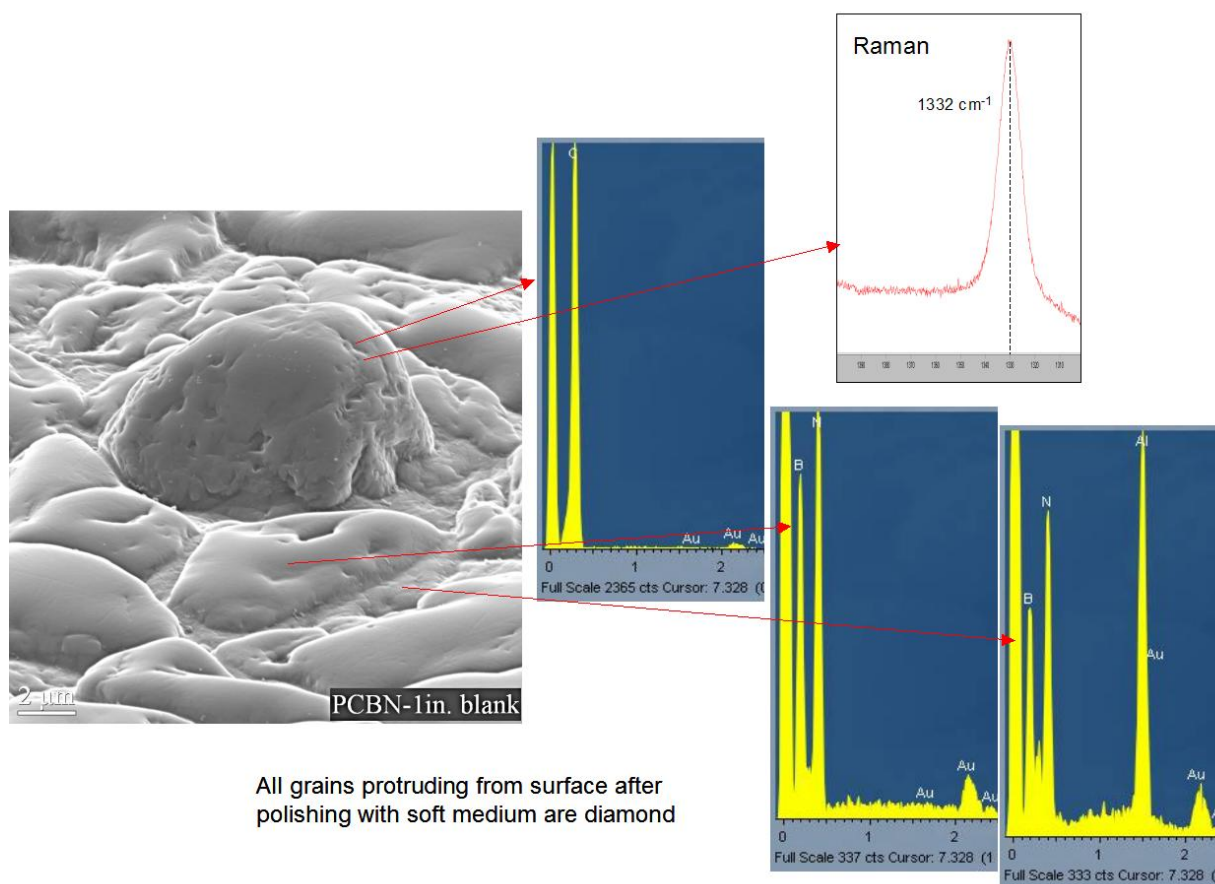
*Fig. 4. SEM, EDS and Raman spectroscopy of diamond grains in new MS80 material*

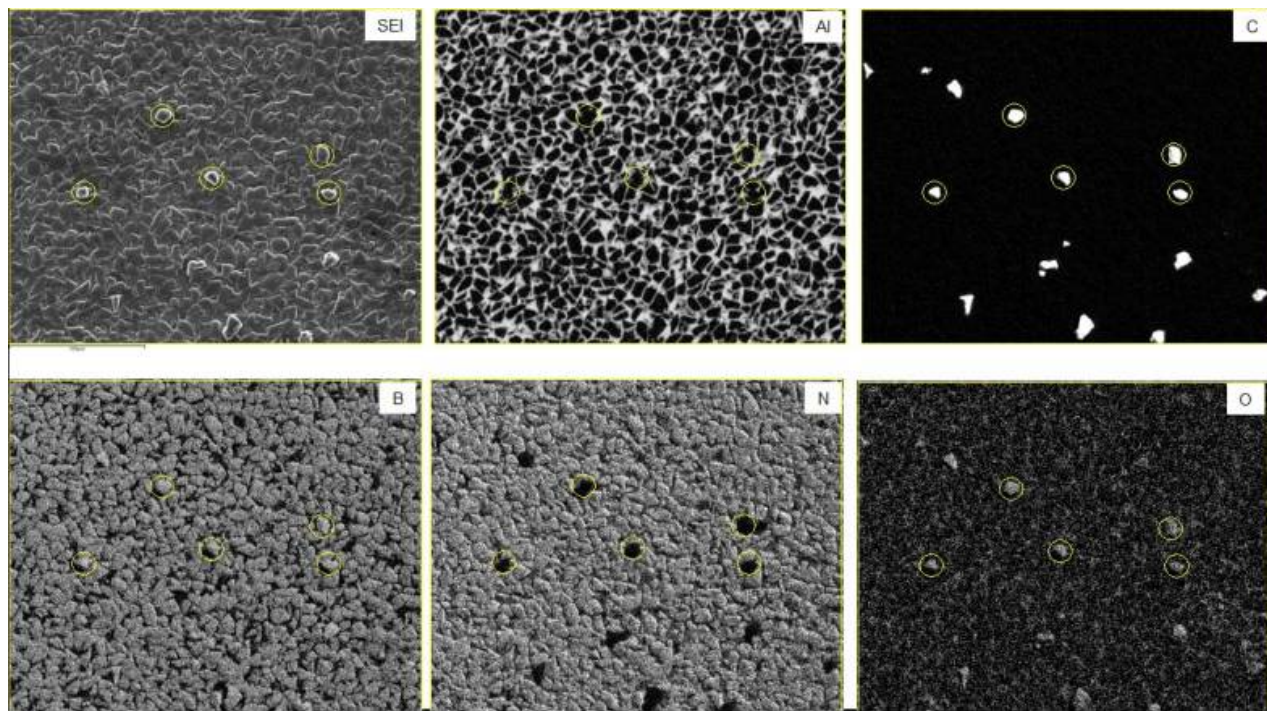
EDS mapping was carried out to assess whether other impurities were present. Typical results are shown in Fig. 5. The results showed a one-to-one correlation between grains showing large surface relief after polishing and carbon composition, indicating that the diamond grains were the only significant impurities. The remainder of the material consisted of BN grains with an AlN grain boundary phase, as expected. The oxygen map shows slightly higher oxygen concentration in the diamond particles than in the remainder of the material. However, we note that this map has been enhanced for visibility: the true intensities of the O signals are orders of magnitude lower than the B, N, and C signals.

*Fig. 5. EDS maps from polished surface of new MS80 material (yellow circles are references for fixed positions)*

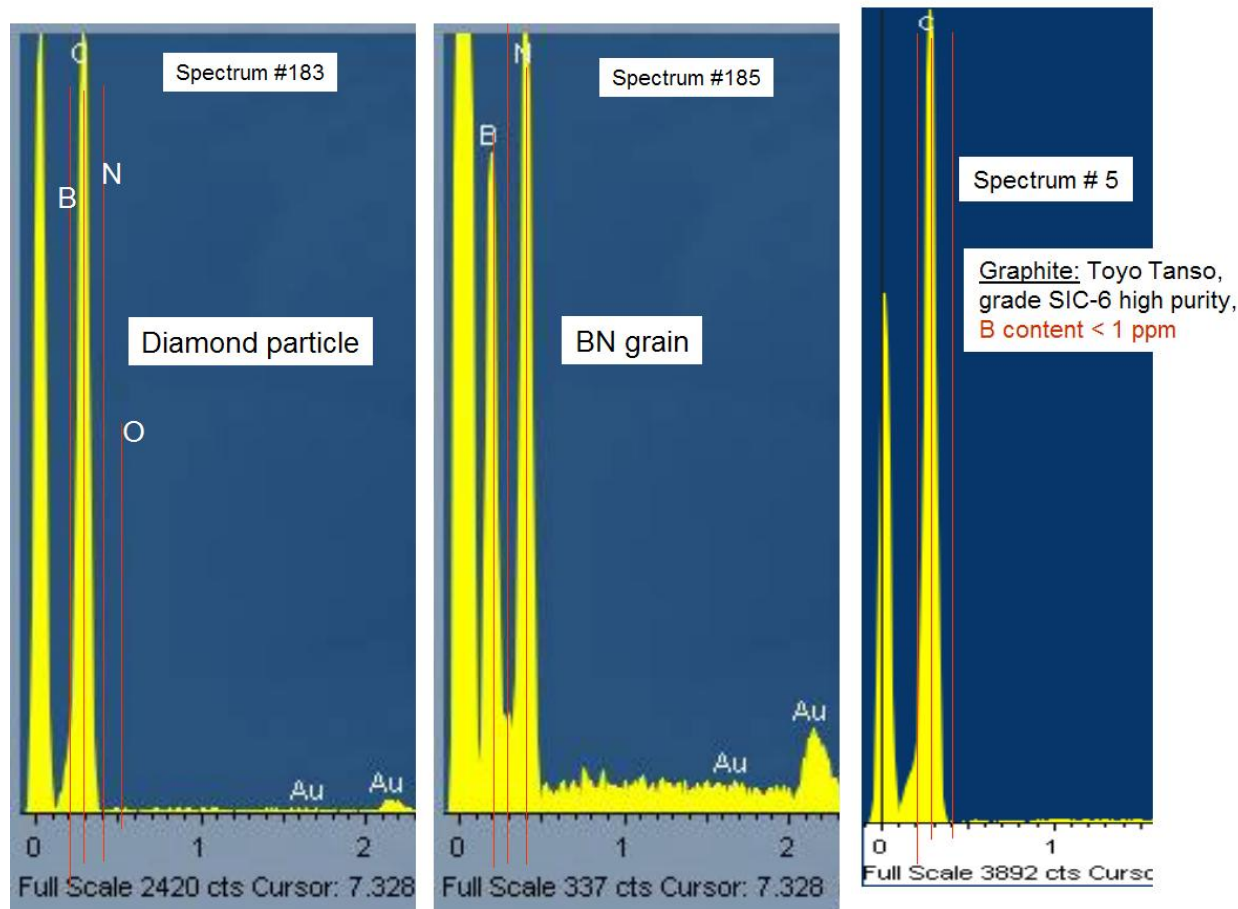
The boron map was at first sight puzzling, with the C grains showing a B signal with intensity slightly higher than the intensity of the B signal from the BN grains. However, this was shown to be an artifact due to finite width of the carbon peak and overlap with the position of the boron peak. EDS spectra from diamond and BN grains are shown in Fig. 6, with positions of B, N, and C peaks marked. The carbon peak from the diamond grain is slightly asymmetric, with intensity at the boron position approximately 10% to 15% of the peak value. The absolute intensity at this position is approximately the same as the absolute intensity of the boron peak from the BN grain, consistent with the EDS map (note the intensity scales for the diamond and BN grains in Fig. 5 differ by a factor of  $\sim 8$ ). An EDS spectrum from a high purity graphite standard is shown in for comparison in Fig. 6. The carbon peak has shape and width identical to that from the diamond grain, thus confirming that the asymmetry of the carbon peak is due to an instrument characteristic and not due to overlap with a genuine boron peak.

Fig. 6. Comparison of EDS spectra from diamond and BN grains in new MS80 and high purity graphite standard.

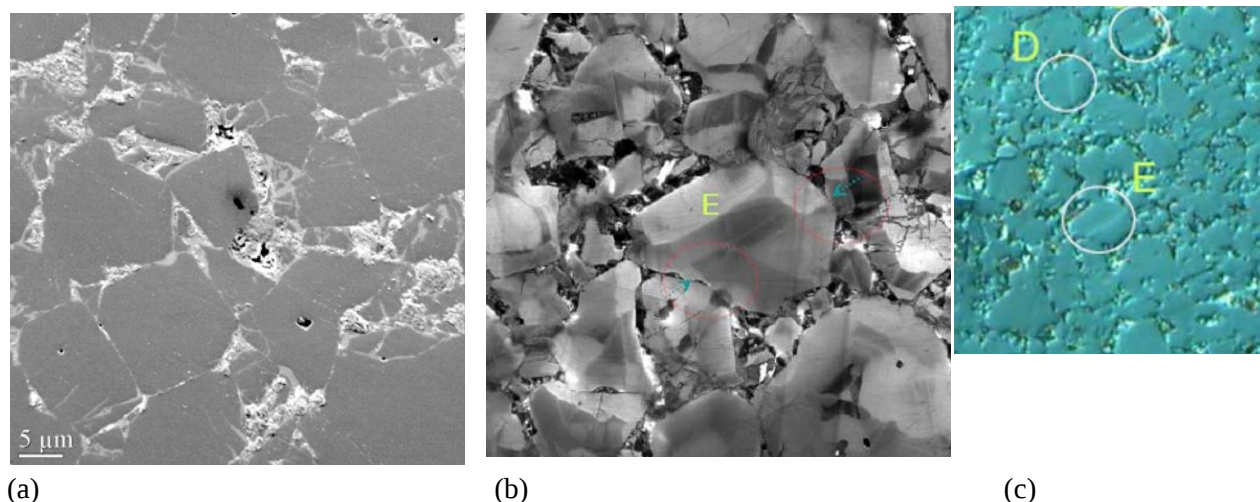
In the course of SEM examination of these materials we discovered (in collaboration with Megadiamond) an imaging method that reveals internal crystallographic structures in BN grains, which are not normally detectable by SEM. An example is shown in Fig 7. When imaged with secondary electrons, with a thin conducting layer of gold deposited on the surface to prevent charging (the usual procedure for insulating materials), the BN grains are featureless and the AlN grain boundary phase shows lighter contrast (Fig. 7a). Similar contrast is seen in backscattered electron images (Fig. 9). However, when imaged with secondary electrons without a conducting layer on the surface, dramatically different contrast is observed (Fig. 7b): crystallographic features resembling twins are clearly evident, more contrast detail is visible within the grain boundary phases, and there is a general reversal of contrast between the grains and the

grain boundary phase (the BN grains being lighter than the grain boundary phase). In many grains, there is a one-to-one correspondence between these crystallographic features and lines of surface relief visible by Nomarski interference (Fig. 7c). The surface relief may result from different polishing rates in regions of different crystallographic orientations.

*Fig. 7. Polished surface of MN100 material: (a) SEM image from surface coated with conducting layer of gold; (b) SEM image from uncoated surface (micrograph from Qingyuan Liu, Megadiamond); (c) Nomarski interference micrograph from area in (b), showing surface relief features in some grains.*

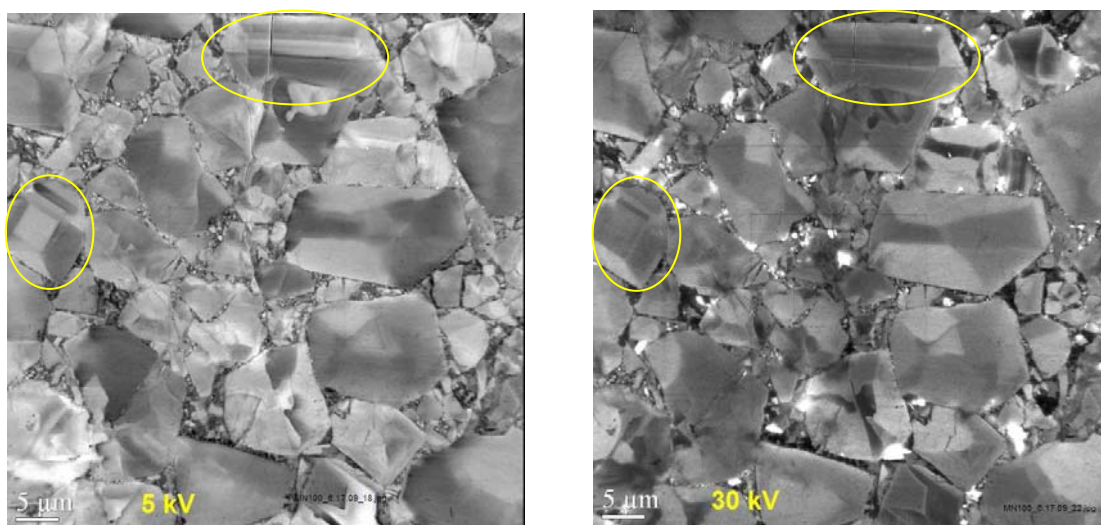
The detailed contrast in images such as Fig. 7b was found to be sensitive to the accelerating voltage, with reversals of contrast occurring within some grains when the voltage was changed (Fig. 8). This and the observation that the contrast within the BN grains disappears when surface is coated with conducting gold suggests that contrast may be associated with charging. (The image contrast also disappears when the surface is coated with carbon (Fig. 9b), thus eliminating the possibility that the contrast is obscured by scattered electrons from the gold coating.)

*Fig. 8. Reversal of contrast in secondary electron images from uncoated surface of MN100 material at two different accelerating voltages: (a) 5 KV; (b) 30 KV.*

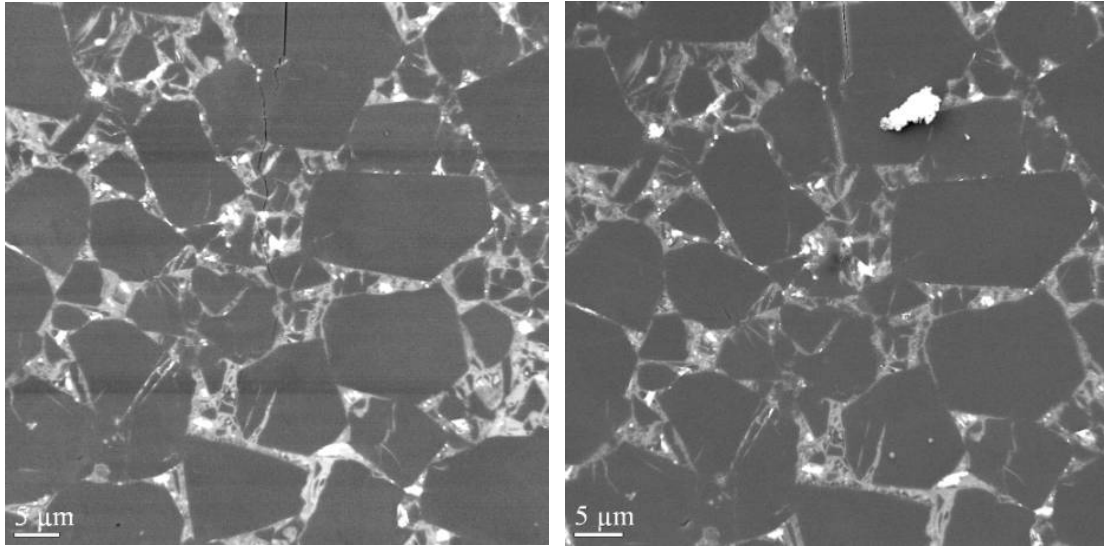
*Fig. 9. Images from area of Fig. 8: (a) backscattered electron image, uncoated surface; (b) secondary electron image after coating the surface with carbon.*

We hypothesize that these contrast features may correspond to internal twins or other deformation structures in BN grains, possibly caused local contact forces due to grain-to-grain contact during high pressure consolidation. Similar contrast features are observed in the MS80 materials, although only a small fraction of grains show internal features (consistent with expectation that, with the higher binder content, less damage occurs in MS80 from neighboring grains being in direct contact during densification).
