INVESTIGATION OF AN EXPLOSIVE  
ACCIDENT USING SIMULATION AS A TOOL

J.F. DROLET, G. COUTURE AND R. FARINACCIO

DEFENCE RESEARCH ESTABLISHMENT VALCARTIER  
P.O. Box 8800, COURCELETTE  
QUEBEC, CANADA, G0A 1R0

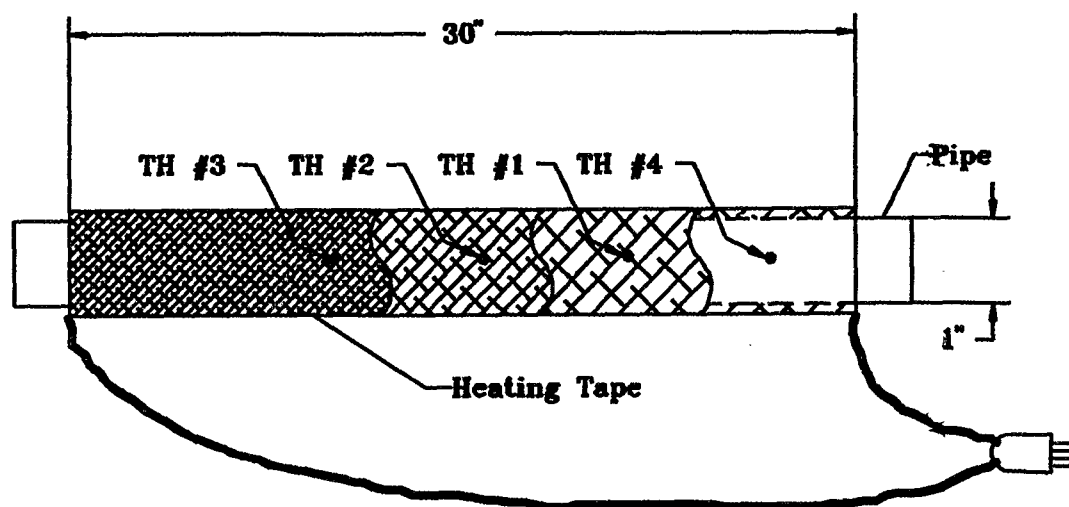
FIGURE 6: First simulation test

A schematic of the simulation test is shown in Fig. 6 and the results appear in Fig. 7. It can be concluded from the results that the number of layers has a strong effect on the temperature of the pipe but in this case, it does not seem to bring it high enough (170°C) to explain the ignition of EXP.

- Thermocouple #1 - under one layer of heating tape
- Thermocouple #2 - under two layers of heating tape
- Thermocouple #3 - under four layers of heating tape
- Thermocouple #4 - inside closed pipe

Note: Pipe was filled with air and closed at both ends.

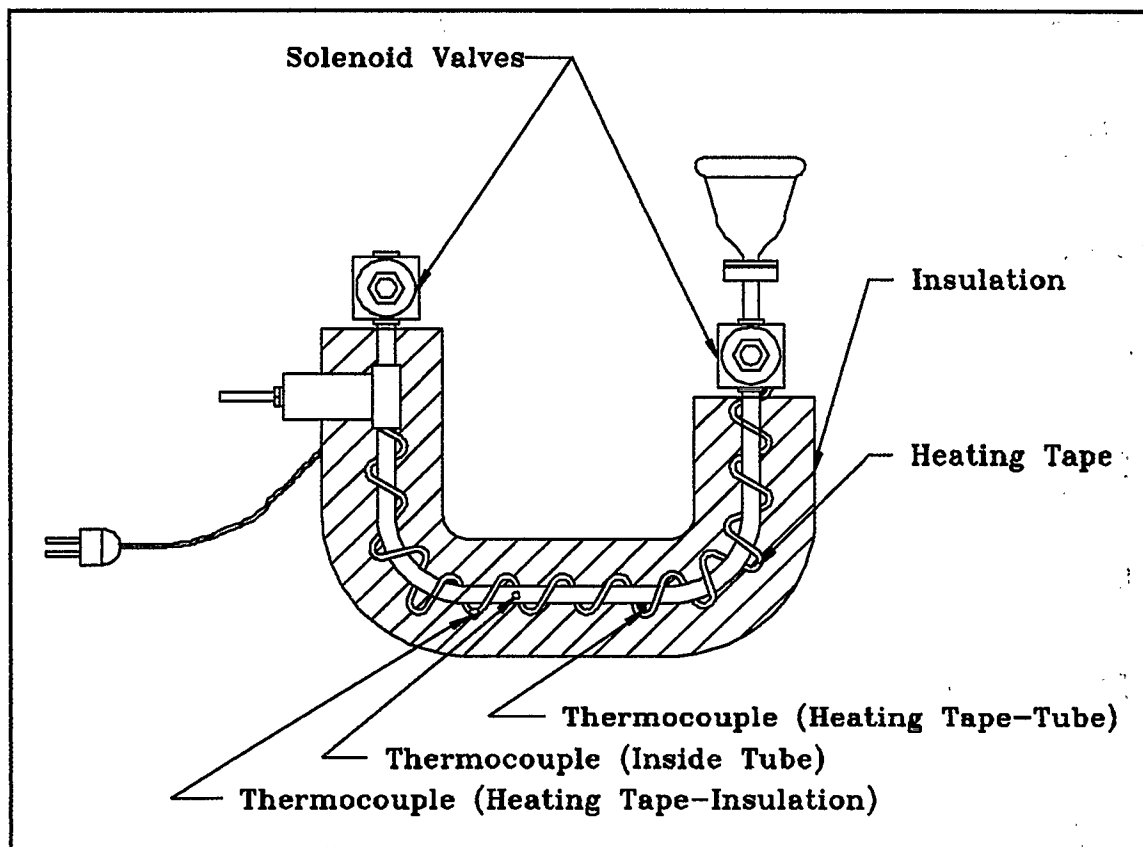
Figure 8: Second simulation of heated pipe.

A closer examination of the conditions that prevailed at the moment of the accident revealed that a short section of the pipe that was heated with heating tape was also insulated.

A second simulation similar to the one just described above but with the addition of insulation over the heating tape (see Fig. 8) was prepared. As shown in Fig. 9, this simulation revealed that the temperature inside the piping could have reached, after equilibrium, a temperature as high as 370°C, a temperature more than sufficient to cause the auto-ignition of EXP (auto-ignition of EXP is  $214 \pm 2^\circ\text{C}$ ).

- 1) installation of a safety valve in the equipment;
- 2) not using heating tape as a source of heat in the presence of energetic materials;
- 3) formation of a team of experts to study the risks associated with new processes or new equipment and make the proper recommendations.
- 4) writing of SOPs even for a one time operation when the level of risk is high.
- 5) operation of equipment by remote control whenever possible.
