OFFICE OF THE SPECIAL INSPECTOR GENERAL FOR IRAQ RECONSTRUCTION

HADITHA GENERAL HOSPITAL
UNDER THE ECONOMIC SUPPORT FUND PROGRAM
HADITHA, IRAQ

SIGIR PA-08-132
JANUARY 23, 2009

SUBJECT: Report on Project Assessment of the Haditha General Hospital, Haditha, Iraq
(SIGIR Report Number PA-08-132)

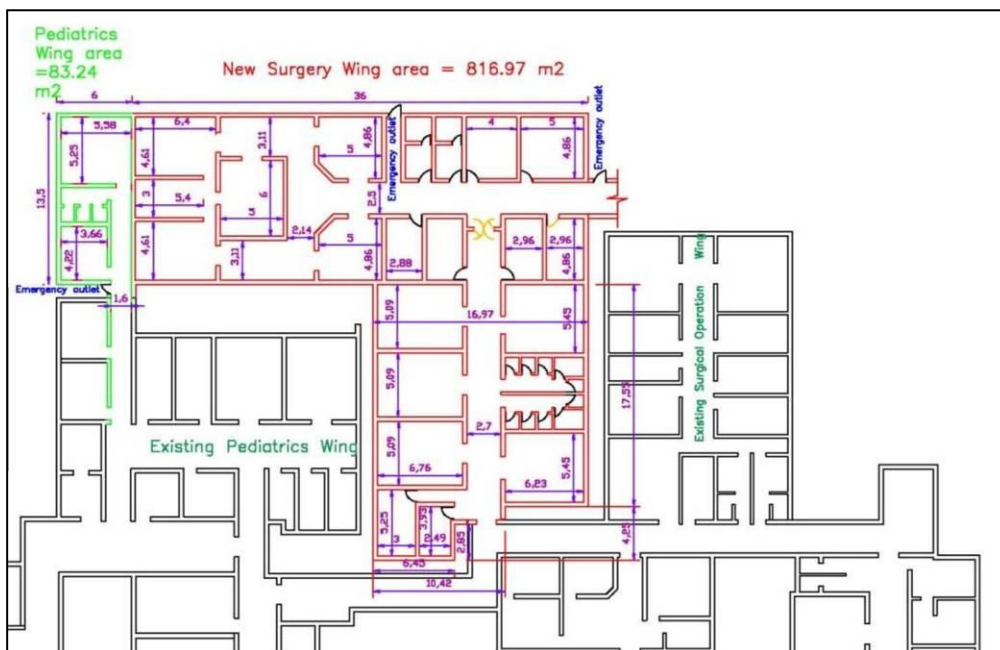
Figure 3. Preliminary floor plan of the new surgery wing addition

On 29 May 2008, the contractor submitted the revised proposal for the renovation and additions to the Haditha General Hospital project. The contractor included several preliminary floor plans for the proposed additions (Figures 3 and 4). The contract's BOQ provided enough information and detail for the contractor to renovate the hospital without detailed designs.
