## Hatteras Breach, North Carolina

*by Ty V. Wamsley, Kent K. Hathaway, and Michael Wutkowski*

**PURPOSE:** This Coastal and Hydraulics Engineering Technical Note (CHETN) is intended to document the rapid response of the U.S. Army Corps of Engineers to engineer and construct a breach closure and the lessons learned. The note also documents the short-term morphologic evolution and hydrodynamic characteristics of the breach based on an analysis of collected data. Researchers are utilizing this important data set in the development of numerical models of coastal breaching and to further the Corps' understanding of the breaching process.

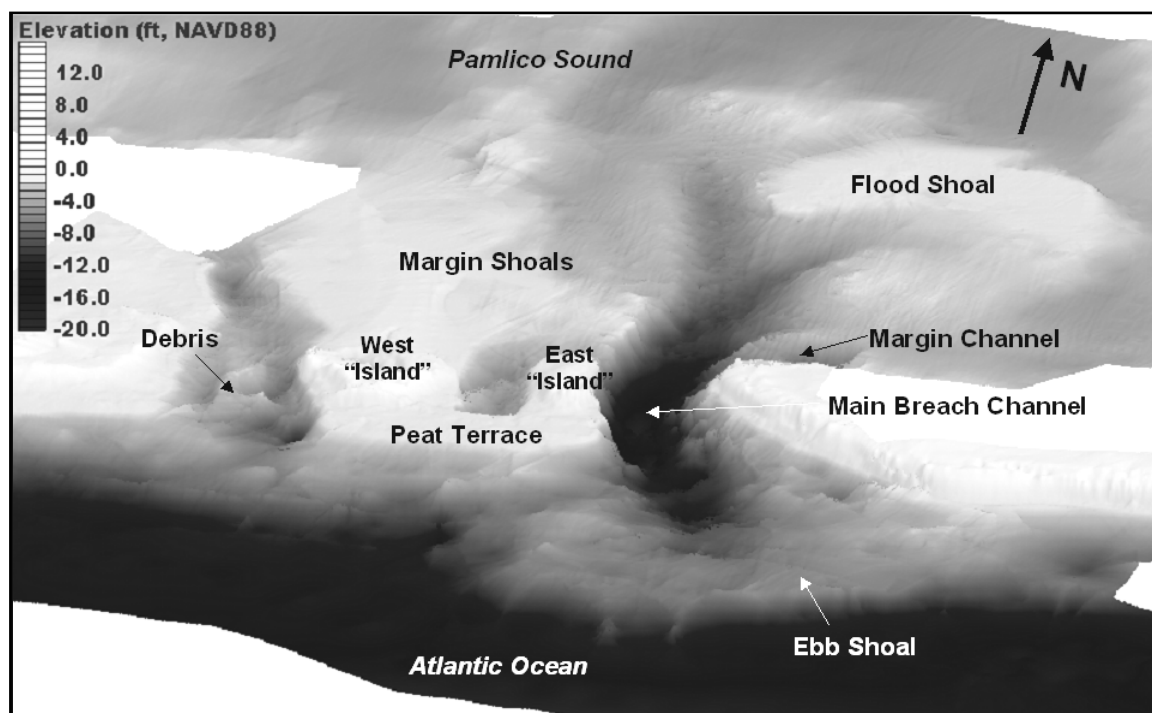
Figure 5. Digital elevation model of Hatteras Breach.

The peat terrace restricted flow in the middle breach channel, which was about 225 ft wide. Water flowed through the middle channel and over the peat terrace only at higher tide elevations. The restricted flow resulted in little scour of this channel. Maximum depths in the middle channel were about 5 ft NAVD88 (1988 North American Vertical Datum). The west channel was about 350 ft wide and littered with debris (Figure 6). Pilings from the bridge partially constructed in the 1930s extended across the channel on the ocean side. Large chunks of asphalt and roadbed material were visible at lower tide elevations, particularly on the west side of the channel. Near the center of the channel was a peat outcropping with large chunks of asphalt resting on top. The flow through the west channel was somewhat greater than that of the middle channel. Survey 2 maximum depths in the west channel were 7 to 10 ft NAVD88. The eastern-most breach channel was approximately 325 ft wide on the sound side and 350 ft wide on the ocean side and was the main channel as it captured a majority of the tidal prism. The unrestricted flow through this channel created scour depths down to 20 ft NAVD88.

The flood shoal is readily identifiable in Figure 5. The Survey 1 DEM showed that a flood shoal formed within 2 weeks after the breach opened with the centroid approximately 1,750 ft from NC12. The shallowest water over the flood shoal was less than 0.5 ft NAVD88 and had to be surveyed by wading, as depths were too small even for the waverunner system. The second survey showed little growth of the flood shoal. A volumetric analysis indicates that the flood shoal gained on the order of 10,000 cu yd of sand over the 10-day period. A well-defined ebb shoal also formed by 5 October (Figure 5). The ebb shoal extended offshore as far as 1,250 ft from the former location of the highway. Depths over the ebb shoal were 4 to 6 ft NAVD88. Waves were often observed breaking on the ebb shoal.

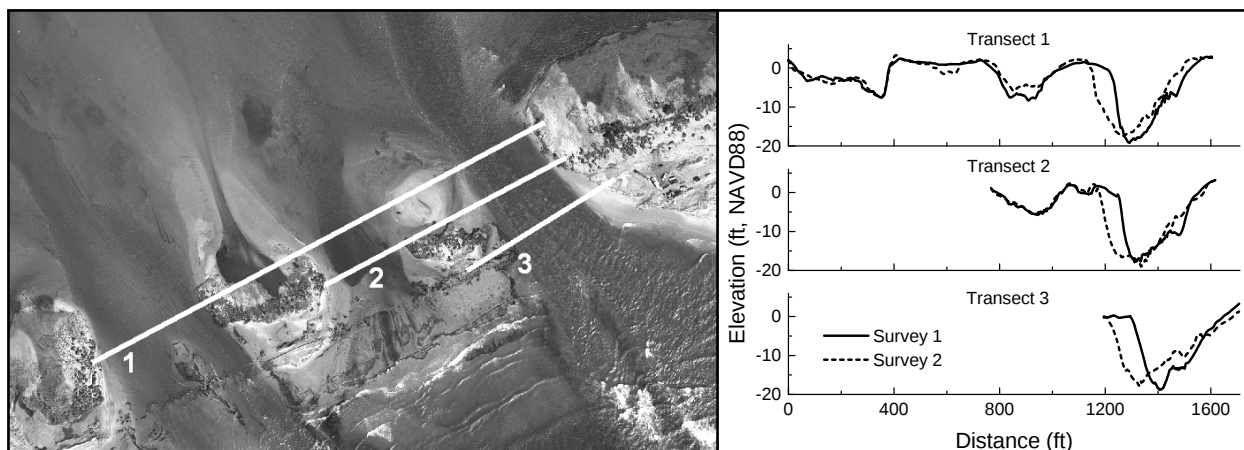
The DEM analysis indicates rapid morphology change. Figure 7 is a comparison plot of breach cross sections from Surveys 1 and 2. Comparisons are made only where sufficient coverage of the channel was captured by both surveys. Due to debris and wave conditions, the seaward end of the west breach channel was not measured in Survey 1. As Figure 7 shows, there was little change in the west channel, because of the substantial amount of armoring by debris and peat. Flow velocities were significantly weaker than observed in the main channel. The sound end of the middle channel shoaled approximately 2.5 ft in the 10 days between surveys. The sediment likely originated at the margin shoals on the sound side and could not be flushed out by flow restricted by the peat terrace. The central and seaward portions of the middle channel did not change between Surveys 1 and 2.

Figure 7. Comparison of Survey 1 and Survey 2 breach channel cross-sections (NCDOT photograph).

The main breach channel experienced the greatest amount of change. Defining breach width as the distance across the channel between the NAVD88 0-contour (which corresponds to +0.44 ft mean sea level), the breach widened by approximately 125 ft on the ocean side, 65 ft through the middle part of the channel, and 25 ft on the sound side. From the center of the barrier toward the sound, the main channel migrated approximately 20 ft to the west over the 10-day period while on the ocean side the channel migrated over 80 ft to the west. The average channel depths were maintained and maximum channel depths generally increased through the middle part of the channel and decreased on the sound side over the 10-day period. The average cross-sectional area of the breach channel increased from 3,400 to 4,000 sq ft.

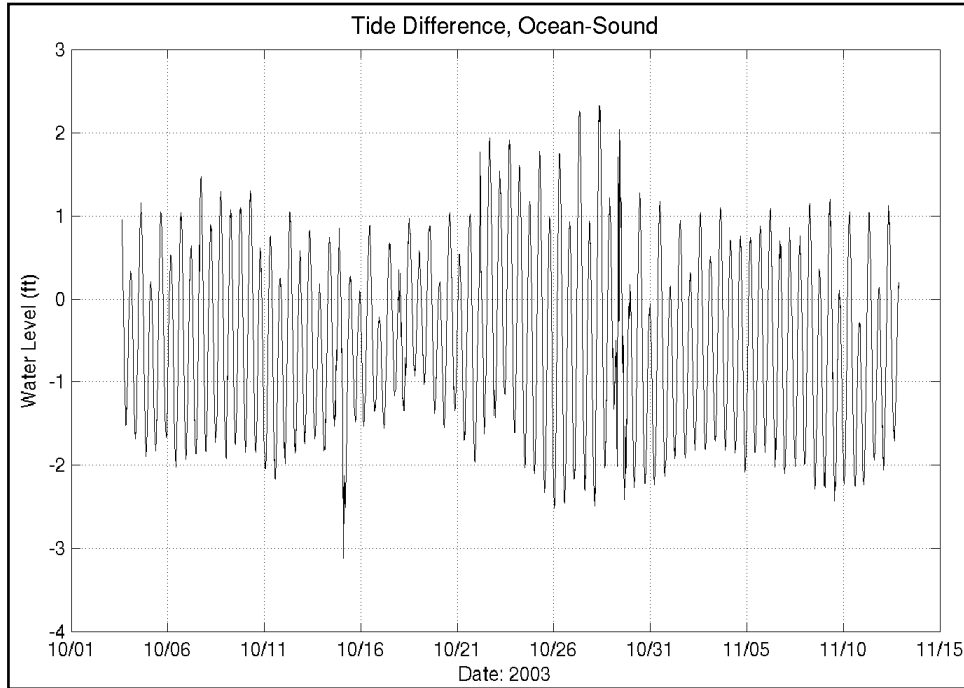
The measured water level (head) difference between the ocean and sound are plotted in Figure 9. Water level head differences exceeding 2.3 ft were observed on both flood and ebb currents. Water levels for the pier, sound, and the head difference from 14-18 October are plotted in Figure 10 along with wind measurements from the Hatteras Weather Service (Mitchell Field, 2.5 miles east of the breach). Wind contributes to head difference, particularly in determining sound water levels. Pamlico Sound, having a large surface area and shallow water, can experience large wind-driven setup. On 15 October, the wind switched from having a west component to an easterly component, resulting in setup in the sound and a large negative head (ocean levels lower than the sound) of -3.1 ft. There was a gap in the wind data on 15 and 16 October, but based on measurements at the FRF (66 miles north of the breach), the wind continued to be directed toward the east and south, favorable for setup in the southeast corner of the Pamlico Sound near the breach. As a result, a nearly continuous ebb current flowed for approximately 32 hr.

Figure 9. Pamlico Sound and ocean water level difference, 3 October to 12 November 2003.

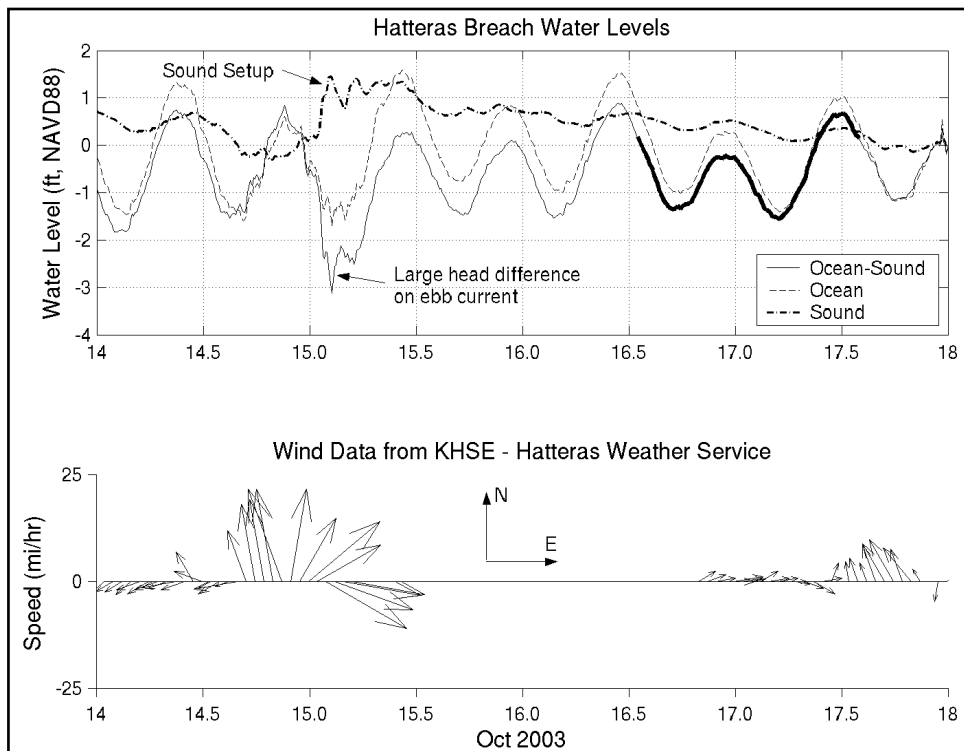
Figure 10. Ocean and sound water levels, head difference, and wind vectors.  
Bold line indicated times when bottom mounted ADCP was operational.

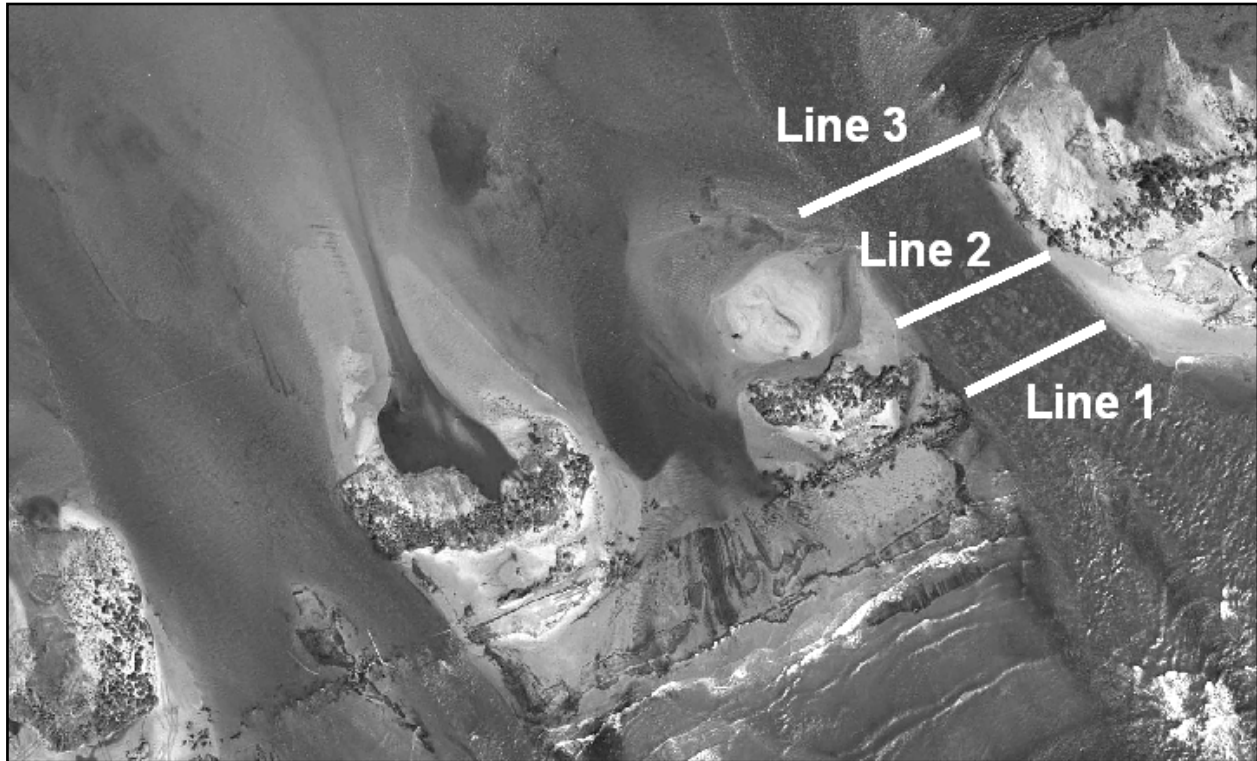
Transect lines were chosen along three locations: approximately at the ocean end of the breach, near the middle, and on the sound side (Figure 11). The Zodiac crabbed (at an angle to the current) across the breach at a best attempt of constant speed, with each transect taking 2 to 3 min. Typically, two or three transects were made at each location before proceeding to the next line. Approximately 140 total transects were completed during both deployments. In addition, 12 current measurements were made using the boat as a drogue and currents computed from the recorded GPS time and position.

Figure 11. Approximate location of ADCP transects (NCDOT photograph).

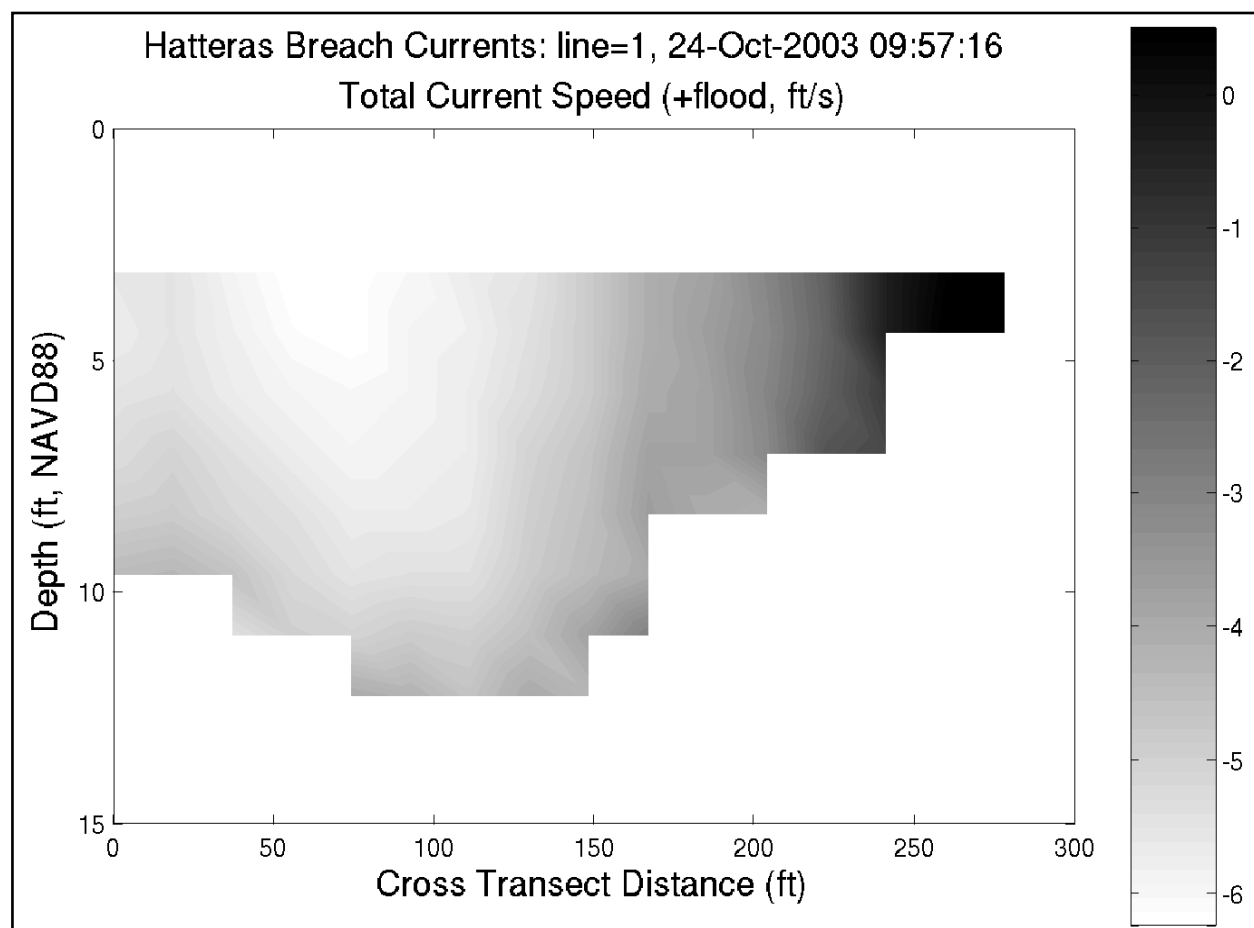
An example of an averaged ADCP ebb current transect is shown in Figure 12 for Line 1 on 16 October. Strongest currents are to the west (left) of the channel center. Ebb current transects for Line 2 indicate that the strongest currents tend towards the channel center. On Line 3, the strongest currents are observed to be east of the channel center and sometimes have two distinct maxima, one that parallels the main channel and another from the margin channel on the north-east side of the breach. This preliminary analysis of ADCP transect data corresponds to visual observations of surface currents, namely, that on ebb flow two distinct currents merged at the breach, and on flood flow there was a strong current through the main channel with a more diffuse current spread out over the area between the flood shoal and margin channel.

Figure 12. Example ADCP current transect at line 1.

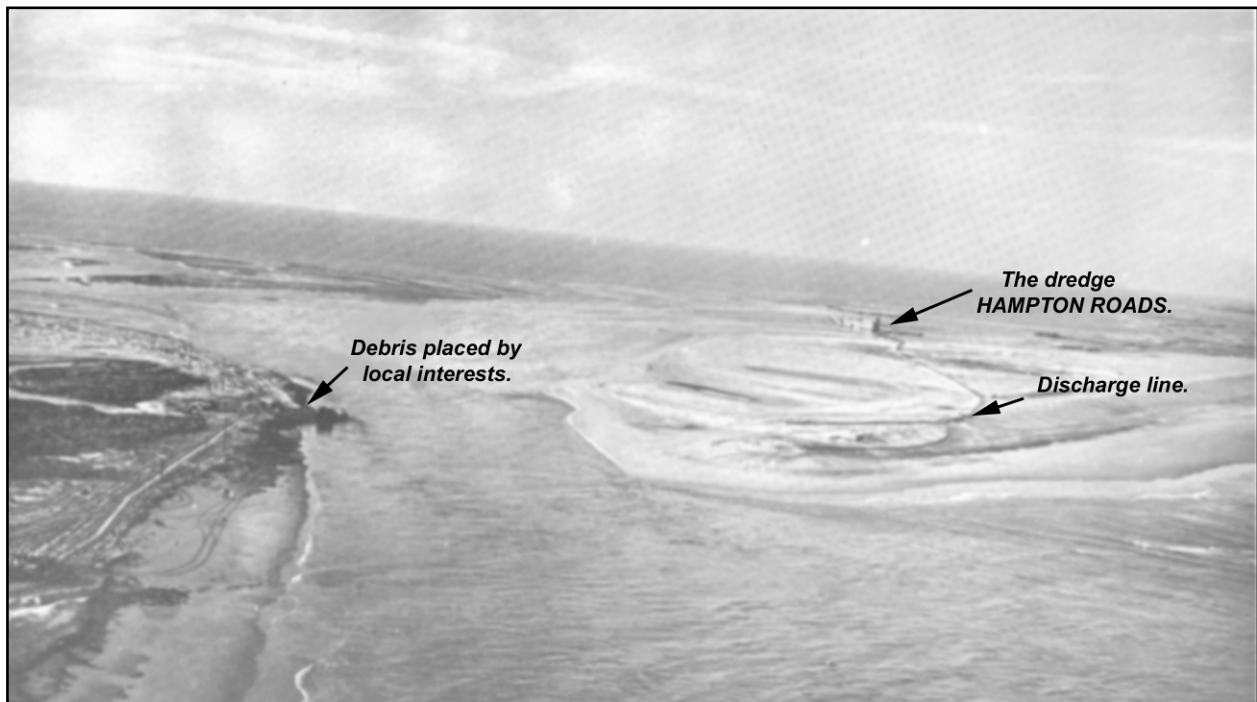
The closure of Buxton Inlet demonstrated that the Hatteras breach could be closed by discharging dredged material into the breach without additional measures, such as the sheet-pile dike used in the closure of the breach on the south shore of Long Island, NY, at Moriches Inlet

(Sorensen and Schmeltz 1982). It also showed that erosion of the opposite shoulder of the breach could pose a problem. Based on the Buxton Inlet pumping volumes, the minimum discharge capacity to close the Hatteras breach was estimated to be between 9,000 and 18,000 cu yd/day.

Figure 13. Buxton Inlet, 29 January 1963, looking towards sound.

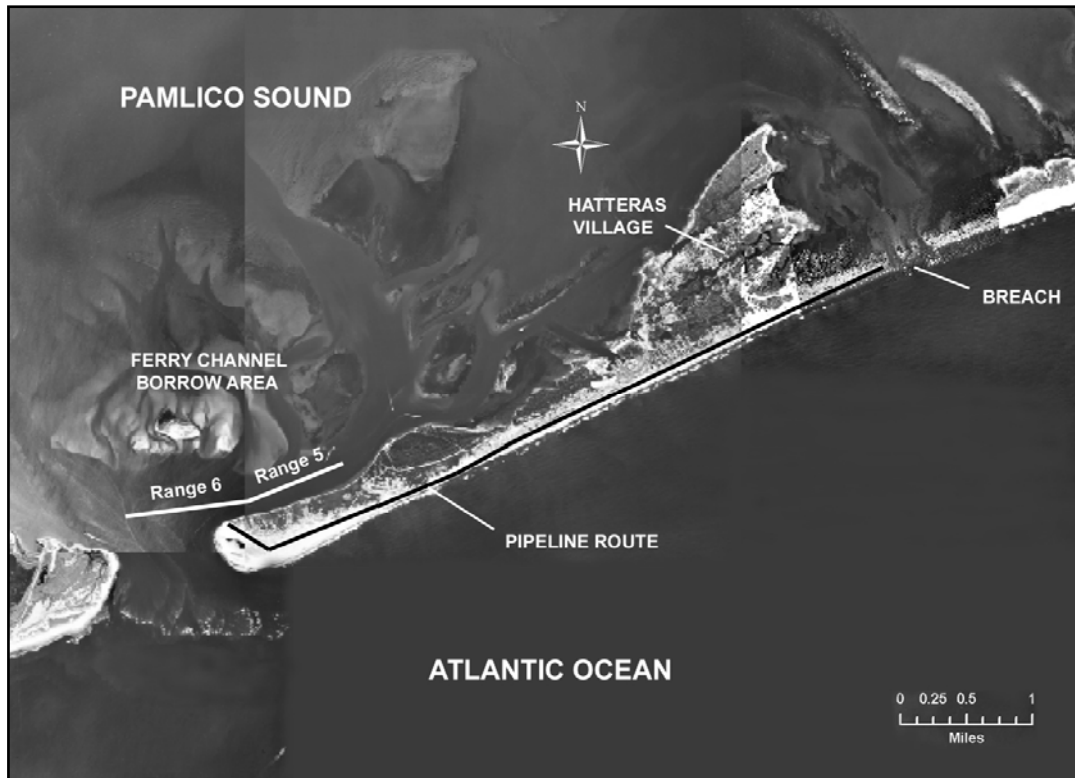
The borrow area for the Hatteras breach closure were Ranges 5 and 6 of the State ferry channel, which are adjacent to Hatteras Inlet (Figure 14). In order not to disturb bottom habitat, the borrow area stayed within the footprint of the 150-ft-wide channel and went down from the channel's project depth of -12 ft mean low water (MLW) to -22 ft MLW. Sieve tests indicated that the borrow area sand had a median grain size of about 0.28 mm. The fill material was medium-coarse sand, as shown in Figure 15, which was desirable since it would help limit losses during the breach filling operation. The color, compaction characteristics, and low shell content of the borrow material also would not interfere with turtle nesting. A low percentage of fine material made it suitable for generating a low turbidity during placement.

Figure 14. Plan view showing borrow area, pipeline route, and breach location.

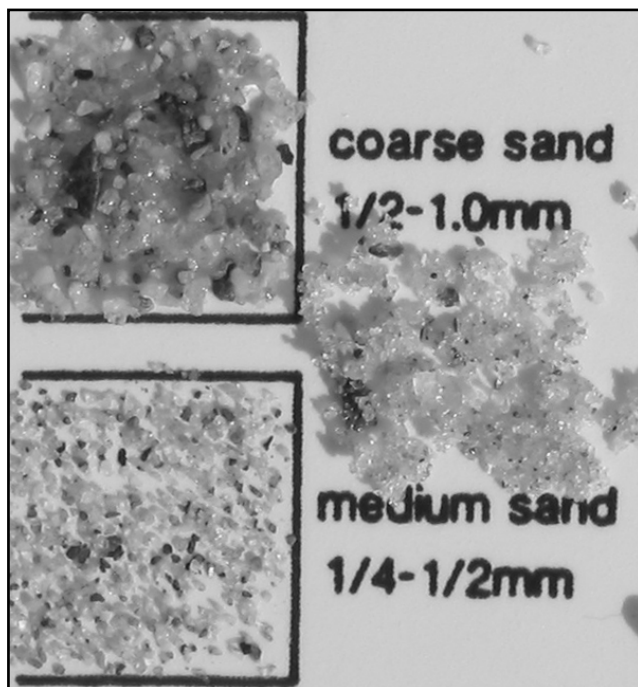
Figure 15. Sand taken from discharge area on sand classification card.
