AL SUMELAT  
WATER NETWORK  
VILLAGE OF AL SUMELAT, IRAQ

**SIGIR PA-05-004**  
**MARCH 15, 2006**

## Al Sumelat Water Network Village of Al Sumelat, Iraq Synopsis

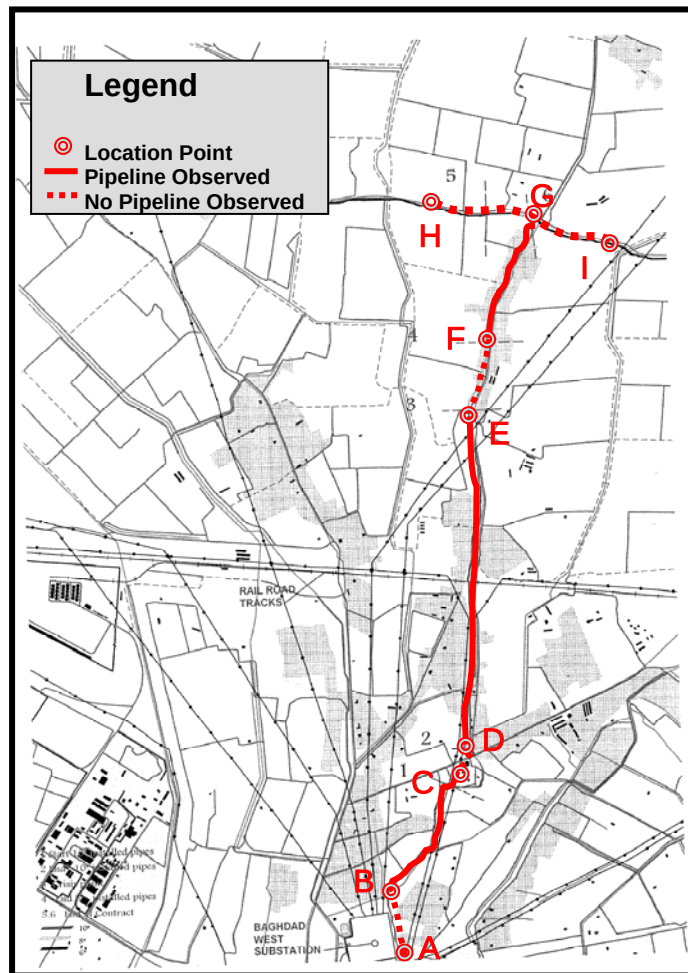
**Figure 1: Al Sumelat Pipeline Location Map**

**Point A to B:** The approximate length of the pipeline from point A to point B (see the locator map in Figure 1 on page 4) is 840 meters. Disturbed soil leading in the direction of the pipeline route was observed from point A. The disturbed soil appeared to be the result of a recent trench excavation and subsequent backfilling of the trench (Site photo 2). It could not be determined how far this excavation continued. The starting point of the pipeline was not visibly protruding from the disturbed soils and could not be located at point A. An observation at point B leading back toward point A along the proposed pipeline path was of an open field showing no recently disturbed soil (Site photo 3). Consequently, no evidence that the pipeline had been installed between points A and B was found.

**Point B:** Point B on the locator map in Figure 1 on page 4 is the point at which the pipeline route crosses underneath an irrigation canal. A recently excavated tunnel approximately 1 meter by 1/2 meter was observed underneath the irrigation canal. The pipeline was not visible leading into (Site photo 4) or exiting the

**Point B to C:** The approximate length of the pipeline from point B to point C (see the locator map in Figure 1 on page 4) is 1,495 meters. Uncapped endpoints of the pipeline were observed at both points B and C (Site photos 5 & 6). The pipe diameter looked to be approximately 225 millimeters, but accurate measurements were not obtained at this location. Disturbed surface soil was observed continuously between points B and C along the proposed pipeline route. The disturbed soil appeared to be the result of a recent trench excavation and subsequent backfilling of the trench. A sand base was not present at the endpoints of the pipeline. A significant amount of unconsolidated soil was observed above grade along the pipeline path. Lack of compacting during backfilling operations would result in the presence of the observed excess soil. The surface of the disturbed soil was uneven with several feet variation in height along the pipeline route. This indicates that final surface grading was not completed. It appeared, based on site assessment observations, that the pipeline had been installed between points B and C, but the pipeline installation was not consistent with contract requirements.

**Point D to E:** The pipeline leg from point D to point E (see the locator map in Figure 1 on page 4) is approximately 3,389 meters in length. This section parallels the road and crosses underneath a set of railroad tracks. The endpoint could not be located at point D and an uncapped endpoint of 225 millimeter diameter pipeline was observed at point E. Disturbed surface soil was observed continuously between points D and E along the proposed pipeline route. The disturbed soil appeared to be the result of a recent trench excavation and subsequent backfilling of the trench. A sand base was not present at the endpoints of the pipeline. A significant amount of unconsolidated soil was observed above grade along the pipeline path. Lack of compacting during backfilling operations would result in the presence of the excess soil. The surface of the disturbed soil was uneven with several feet variation in height along the pipeline route. This demonstrates final surface grading was not completed. It appeared, based on site assessment observations, that the pipeline had been installed between points D and E, but the pipeline installation was not consistent with contract requirements.
