SUMMARY REPORT  
GROUND PROJECT SURVEYS  
FOR THE QUARTER ENDED  
MARCH 31, 2006

**SIGIR PA-06-052**  
**JULY 31, 2006**

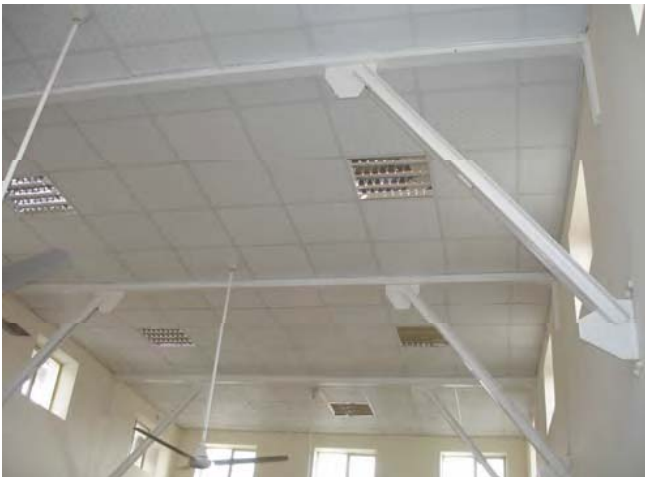
- The structural steel retrofit required due to deflection of I-beams was complete. Site Photo 5 shows the structural steel retrofit.
- Potable water was reported trucked in for use from adjacent village and users reported they are concerned about the quality and quantity of the water. No filtration or sterilization (except boiling) of the water was available.

**Site Photo 5: Completed structural retrofit (Project 12807)**

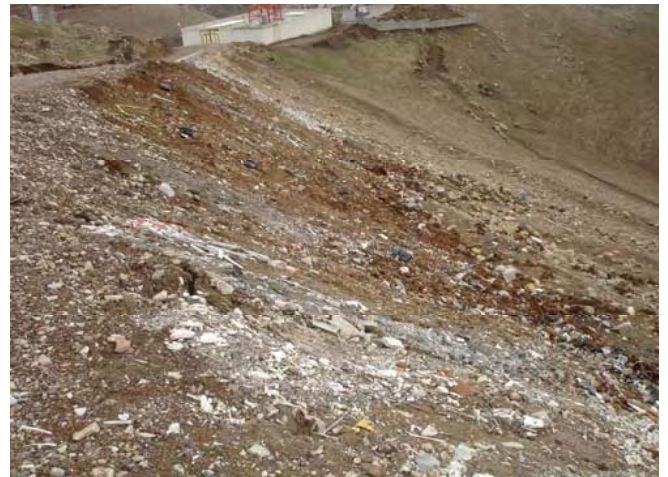
- Spot welds on the generator roofing appeared to be of poor quality.
- The facility is located approximately 20 feet up gradient from a steep slope. Retaining walls were not installed to stabilize the slope and signs of lateral movement were observed. Site Photo 6 shows the steep slope.

**Site Photo 6: Down gradient slope with signs of lateral movement (Project 12807)**

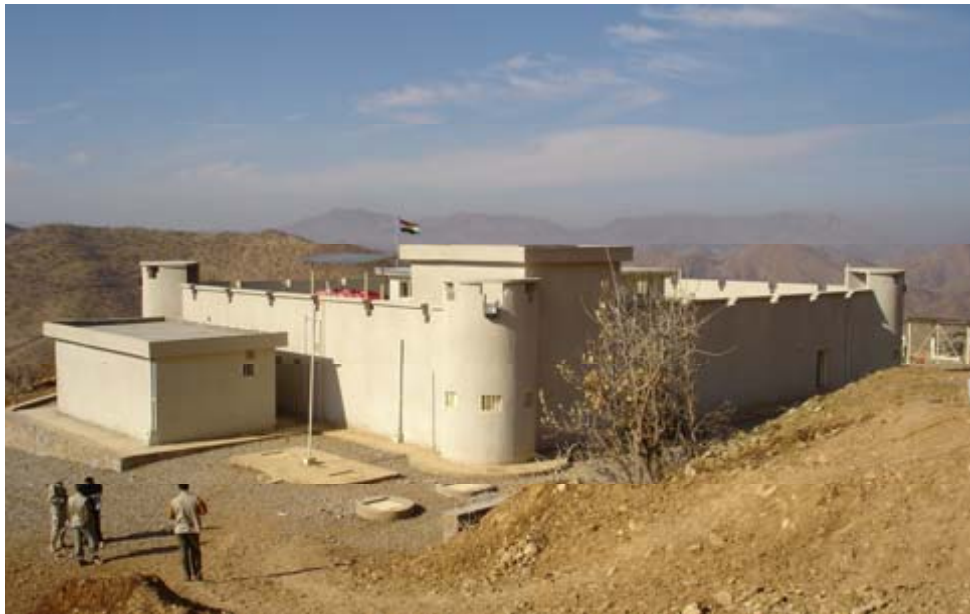
- In general, the quality of construction of this border post was noticeably better than the other border posts inspected. Exterior finishing and welding showed no discrepancies. Site Photo 19 shows the exterior view of the border post.
- No perimeter security fences or gates were present.
- The road to the border post was reported as difficult to access during the rainy or snowy seasons.
- Potable water was reported trucked in for use and users reported that they are concerned about the quality and quantity of the water. No filtration or sterilization (except boiling) of the water was available.

**Site Photo 19: Exterior view of border post – Project 12836**

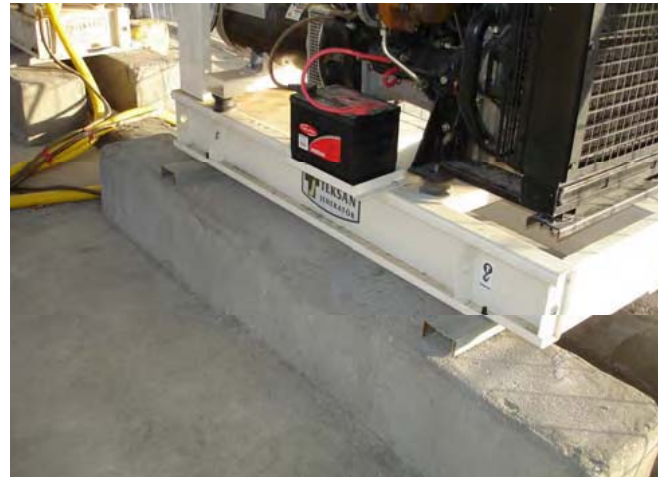
**Site Photo 21: Generator on concrete base (Project 12850)**

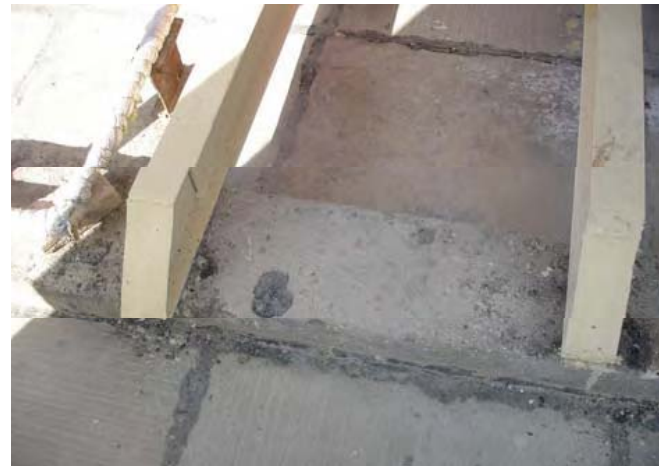
- No perimeter security fences or gates were present.
- The generator was not anchored to the concrete base. Site Photo 22 shows the generator and concrete base.
- Spot welds on the generator roofing appeared to be of poor quality.
- Poor finishing and broken concrete was observed at the septic tank cover.
- Roof water tanks base girders were not fastened to the concrete foundation. Site Photo 23 shows the water tank base.

**Site Photo 23: Roof mounted water tank base (Project 12855)**

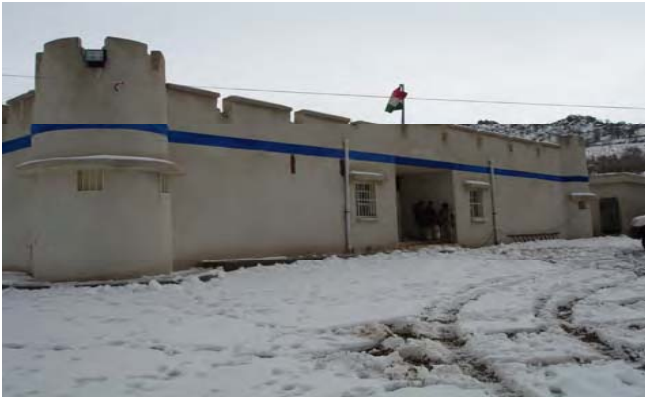
- No perimeter security fences or gates were present. Site Photo 24 shows the exterior of the border fort.
- The generator was not anchored to the concrete base.

**Site Photo 24: Front exterior of border post (Project 12884)**

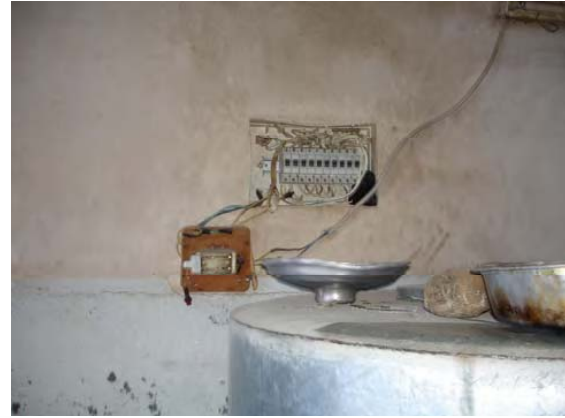
- Electricity is supplied by a 15 KVA generator.
- Two septic systems were observed on site. One of the tanks was reported to have collapsed shortly after delivery to the site and the other one was full. The full septic tank is overflowing sewage close to the building. Site Photo 37 shows the location of overflowed sewage (border post in top right corner of photo).
- Cracks in the concrete were observed extensively throughout the exterior of the buildings and sidewalks, possibly due to differential settling of the foundation and/or poor construction.
- Security fences were not present.
- The electrical system and wiring had numerous exposed wires and uncovered panels. Site Photo 38 shows an electrical panel in the kitchen area.
- The facility showed a lack of any recent maintenance or remodeling.

**Site Photo 38: Electrical panel (Project 20575)**

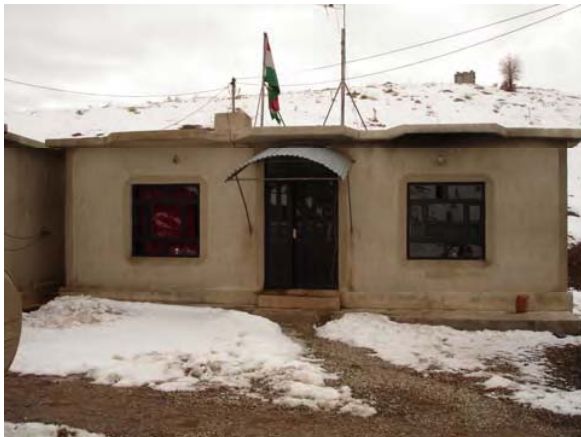
- Site Photo 39 shows the exterior front of the border post.
- Electricity is supplied by a 12 KVA generator. The generator was reportedly broken and was not on site. The border post did not have electricity at the time of the visit.

**Site Photo 39: Exterior front of border post**

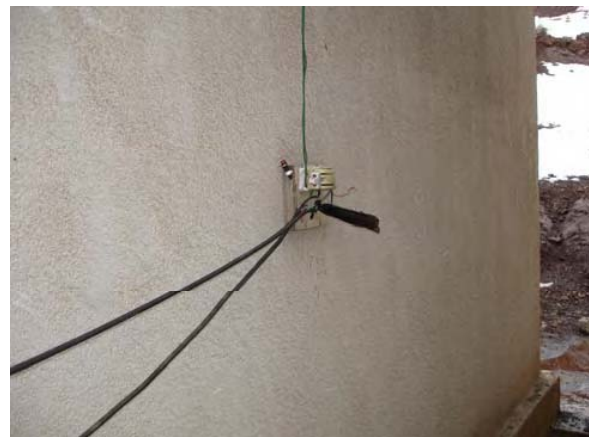
- The electrical system had exposed wires. Site Photo 40 shows an example of exterior wiring.
- The ceilings showed staining, an indication of roof leaks.

**Site Photo 40: Exterior electrical wiring**

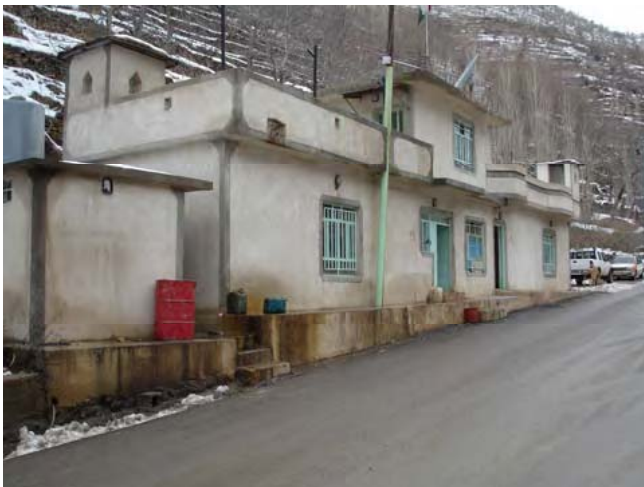
- Site Photo 41 shows the exterior of the border post.
- A 12 KVA generator was on-site, although reportedly broken. Electricity was obtained from a village generator located nearby.
- Source of water is a water spring close to the site. The spring is uncovered and water is transferred to the site through plastic water pipes. No filtration or sterilization existed and the water quantity was not enough for the requirements of the border post.
- Numerous cracks were observed in the exterior walls.
- The electrical system had exposed wires and uncovered panels. Site Photo 42 shows an example of the electrical wiring.
- Security fences were not present.

**Site Photo 41: Exterior front of border post (Project 20577)**

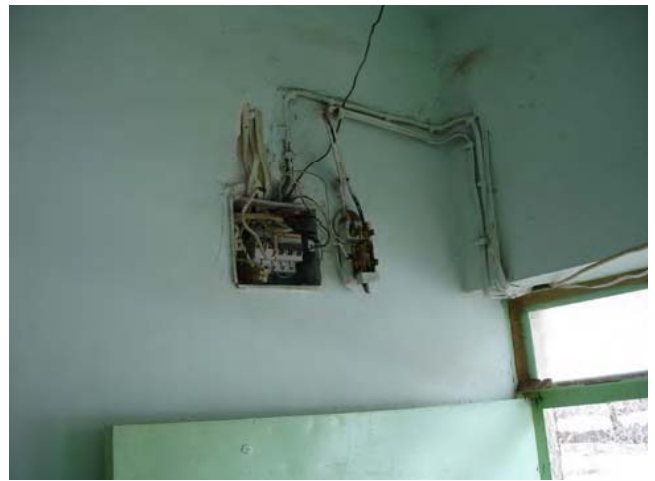
**Site Photo 42: Interior electrical panel (Project 20577)**

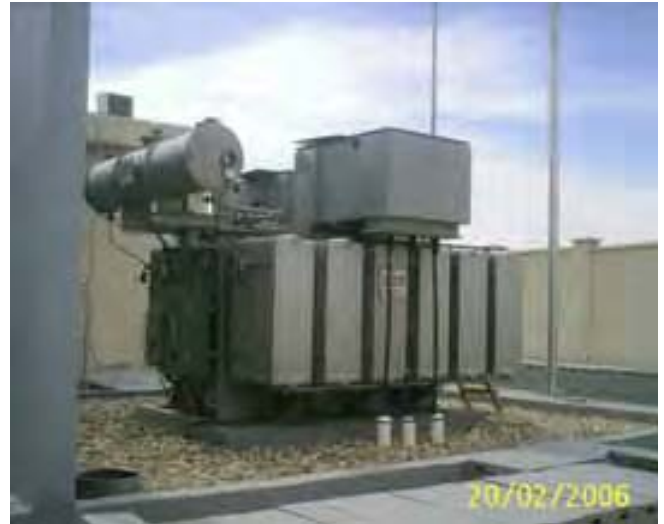
- The site visit verified new construction of the main building, sidewalks, perimeter security and guardhouse, entrance gate, and the generator shed. Site Photo 43 shows the front entrance gate.
- Two exterior located transformers (assumed 33 kilovolt (kV) / 11 kV) were observed mounted on concrete pads. A firewall was located between the transformers. Site Photo 44 shows the main transformers.
- Switchgears (assumed incoming and outgoing) were observed inside the main building. Site Photo 45 shows the switchgears.
- Thirteen split air conditioning condensing units were mounted on the roof of the main building. Site Photo 46 shows the roof mounted air conditioning condensing units.
- Exterior light poles were located throughout the facility.
- No discrepancies were reported at this location.

**Site Photo 44: Transformer (Project 1861)**

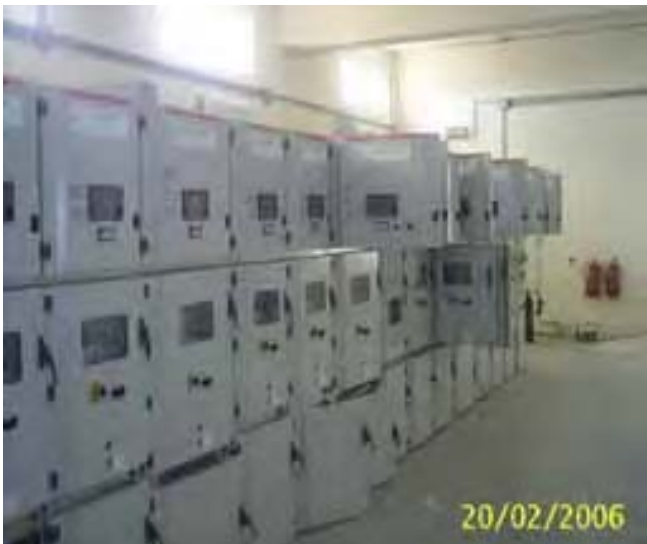
**Site Photo 45: Switchgears (Project 1861)**

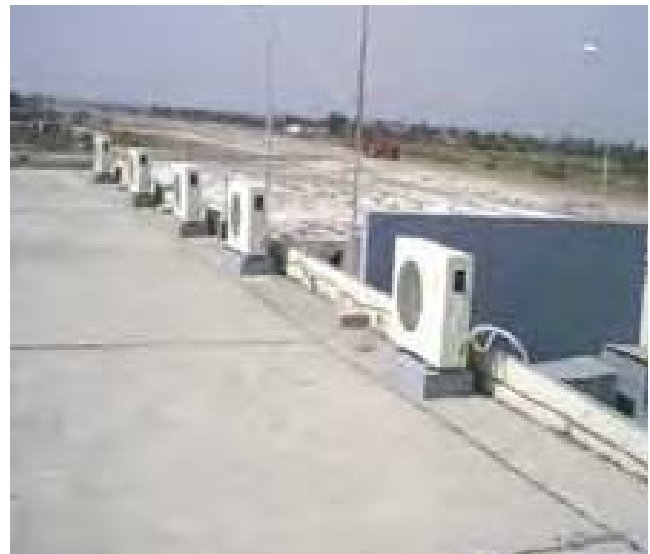
**Site Photo 46: Roof mounted AC Units (Project 1861)**

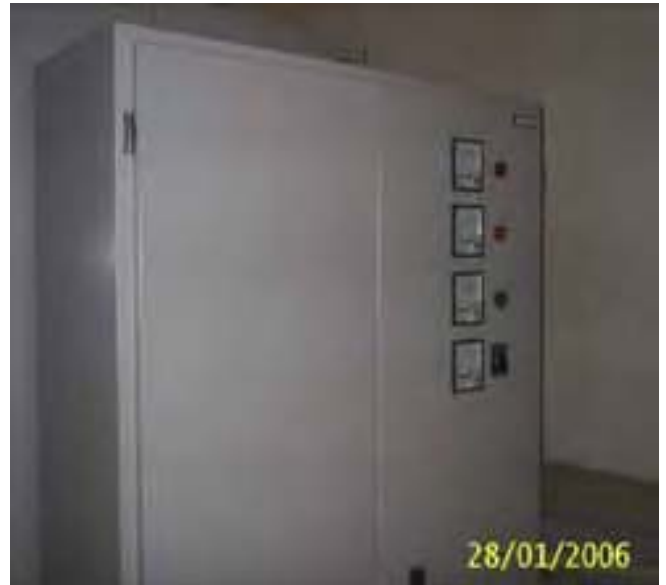
New construction was in progress at the time of the site visit and 87 construction workers were reported on site. The building was constructed with the majority of the windows, electrical, heating and air conditioning units, and septic systems in place. Remaining work included mostly finishing including completing the electrical, installation of doors and windows, installation of walkways, and painting. No significant discrepancies were noted during the site visit. Site Photo 56 shows the front exterior of the clinic and Site Photo 57 shows electrical control panels. Site Photo 58 and 59 show interior finishing underway.

**Site Photo 57: Electrical controls (Project 11913)**

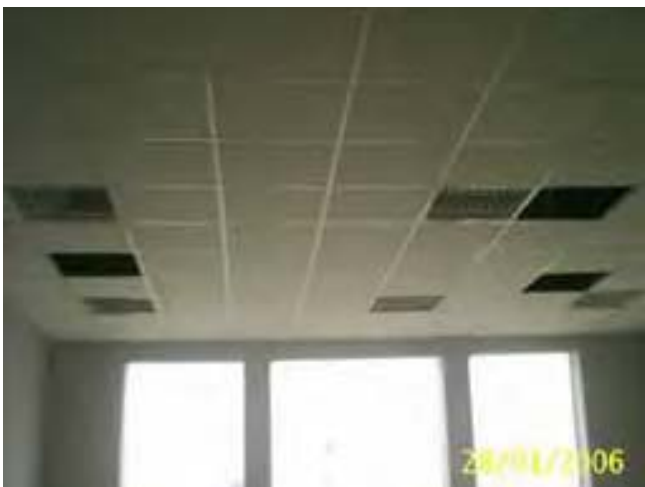
**Site Photo 58: Suspended ceilings (Project 11913)**

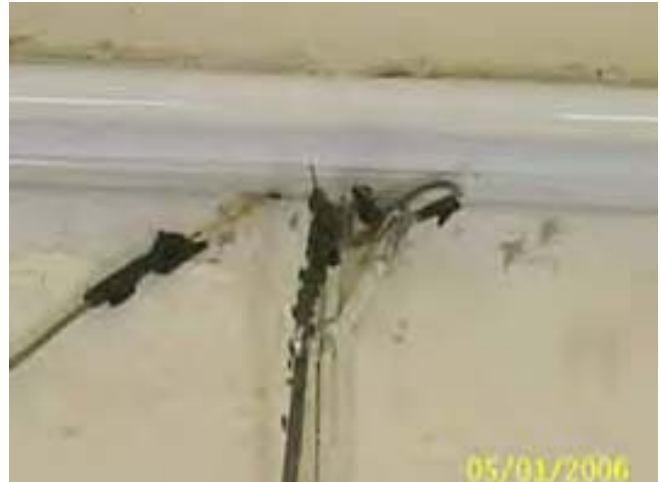
- Electrical systems had exposed wiring, broken fixtures, improper connections, and missing electrical covers throughout the entire police station. Site Photos 74 and 75 show examples of the electrical system deficiencies.

Site Photo 75: Interior electrical light with exposed wiring (Project 19181)
