## Aging Weapons Systems Repair using Friction Stir Welding

Bryan M. Tweedy<sup>1</sup>, William A. Arbegast<sup>2</sup>, Robert H. Hrabec<sup>1</sup> and James M. Hutto<sup>1</sup>

Keywords: Friction stir, repair, aging aircraft, FSW

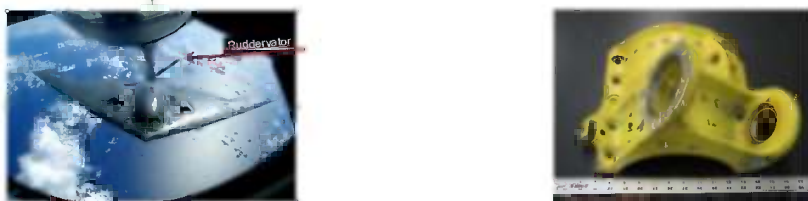
Figure 1. KC-135 Re-Fueling Boom (left) and Ruddervator Fitting (right)

The purpose of this FY07 Aging Aircraft Study [1] was to investigate the use of advanced processing technologies such as friction stir welding and processing, laser deposition and cold spray in repair/remanufacturing applications of aging weapons systems. In particular, friction stir welding and processing presented some unique opportunities to repair worn or cracked components. One of the chosen parts for this remanufacturing study is the ruddervator fitting for the KC-135 re-fueling boom (Figure 1). This structural component is responsible for connecting the re-fueling boom to the rudder shaft. The component has two ears, each with a bearing race. When the bearings are installed, it is common to use a punch and hammer to deform the part and stake the bearing in place. Unfortunately, these stake marks are stress concentration points and form fatigue cracking when placed into service. A picture of the typical stake marks in the ruddervator fitting is shown in Figure 2.

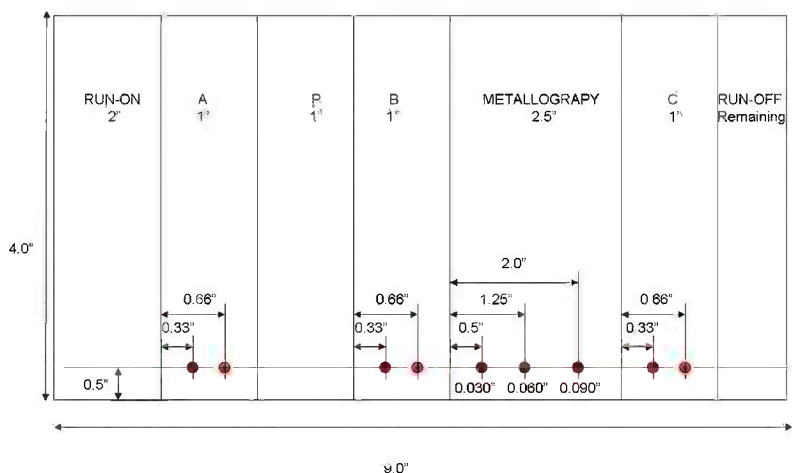
Figure 3. Defect Location for Process Development

The defect processing study “stake-marks” were simulated with holes drilled into a piece of 0.125” 7075-T6 sheet stock. These 0.065” diameter holes are similar in diameter to the defects found on the defective parts and were made to be 50%, 100%, and 150% of the observed defect depth (0.030”, 0.060”, and 0.090” respectively). Hole spacing and depth were controlled using a vertical mill with digital readout.

All defect locations remained constant in the coupon specimens. Two evenly spaced defects were made in a 1.0” lap-shear specimen. Defect size for lap-shear specimen locations was ordered using design of experiments (DOE) to identify any trend in specimen location. A metallographic specimen was taken for all processing parameters with the 0.030”, 0.060”, and 0.090” defects 0.5”, 1.25” and 2.25” into the specimen, respectively (Figure 3).

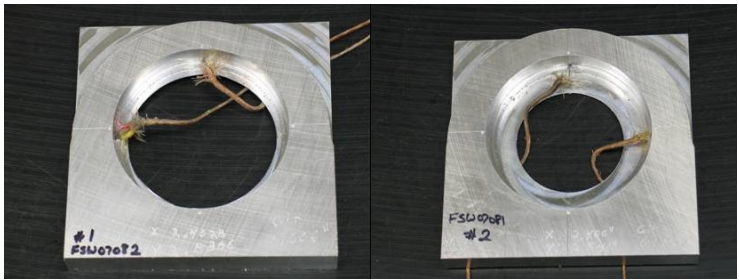
Figure 5. Surrogate Plugs

The pathfinder experiment utilized two surrogate parts, similar in geometry to the Ruddervator fittings, and two plugs machined from 7075-T753 barstock (Figure 5). Four defects, 0.065” in diameter and 0.090” deep were installed in the four quadrants of each bore. Defects were installed approximately 0.060” on center, radially from the edge of the bore.

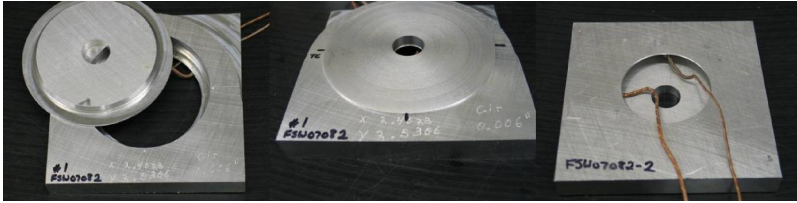
Figure 7. Installation of Plugs and Thermocouples

Parts were fixtured on the FSW table and were elevated on 1.5" tubing from a tooling system from Marino Gauge. The only clamping holding the parts in position was a single 5/8" bolt through the center of the plug (Figure 7). To test the weld program, a 4-pass test-weld was made on a piece of 0.25", 6061-T6 aluminum fixtured in a similar manner to the surrogate parts. A two-pass weld (Figure 8) was completed on the first surrogate part with success. On the exit radius however, a lack of consolidation (LOC) defect formed through the radius (Figure 9). A four-pass weld (Figure 10) was completed on the second surrogate part with success. The travel speed was reduced through the exit radius, which reduced the LOC defect, but did not totally eliminate it.

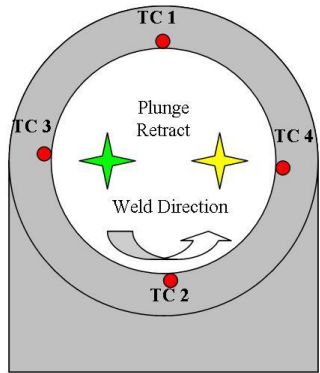
Figure 13: Thermocouple Placement Schematic for Ruddervator Prototype Fitting

Four plugs, two large and two small, were machined from 7075-T753 bar stock. Thermocouples were mounted to the part in quadrants (Figure 13) at the base of the bearing stop and were placed with high temperature thermocouple cement.
