Defence Science and  
Technology Organisation

# **Non-destructive Evaluation of Aircraft Structural Components and Composite Materials at DSTO Using Sonic Thermography**

**DSTO–TN–0986**

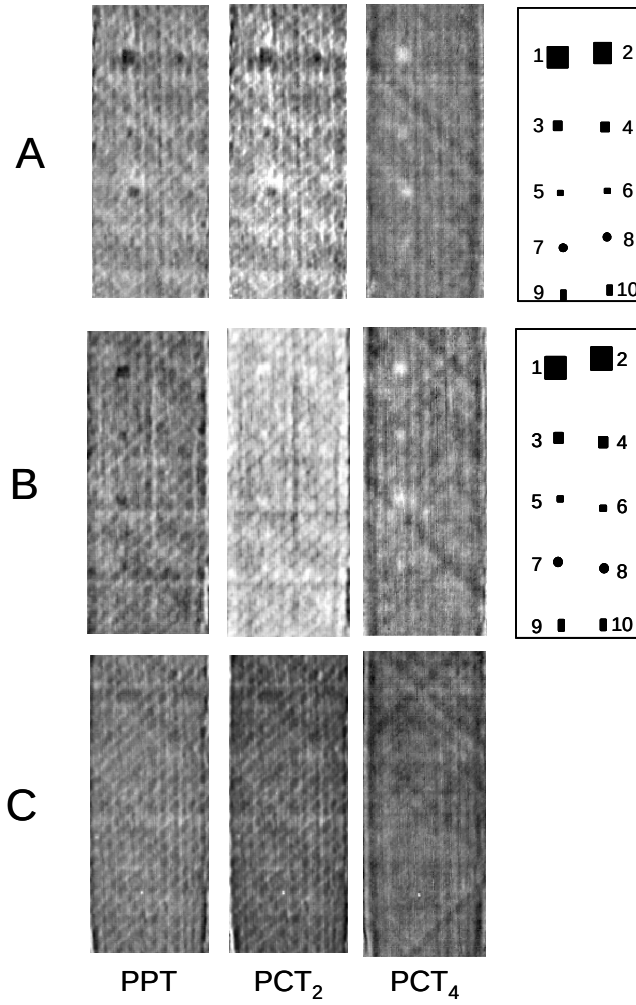
**Figure 6:** FT inspection of the thin film insert specimens. Specimens A, B and C are indicated, and the PPT, and PCT results for modes 2 and 4, are shown. The defect positions for specimens A and B are shown to the right of the thermographs.

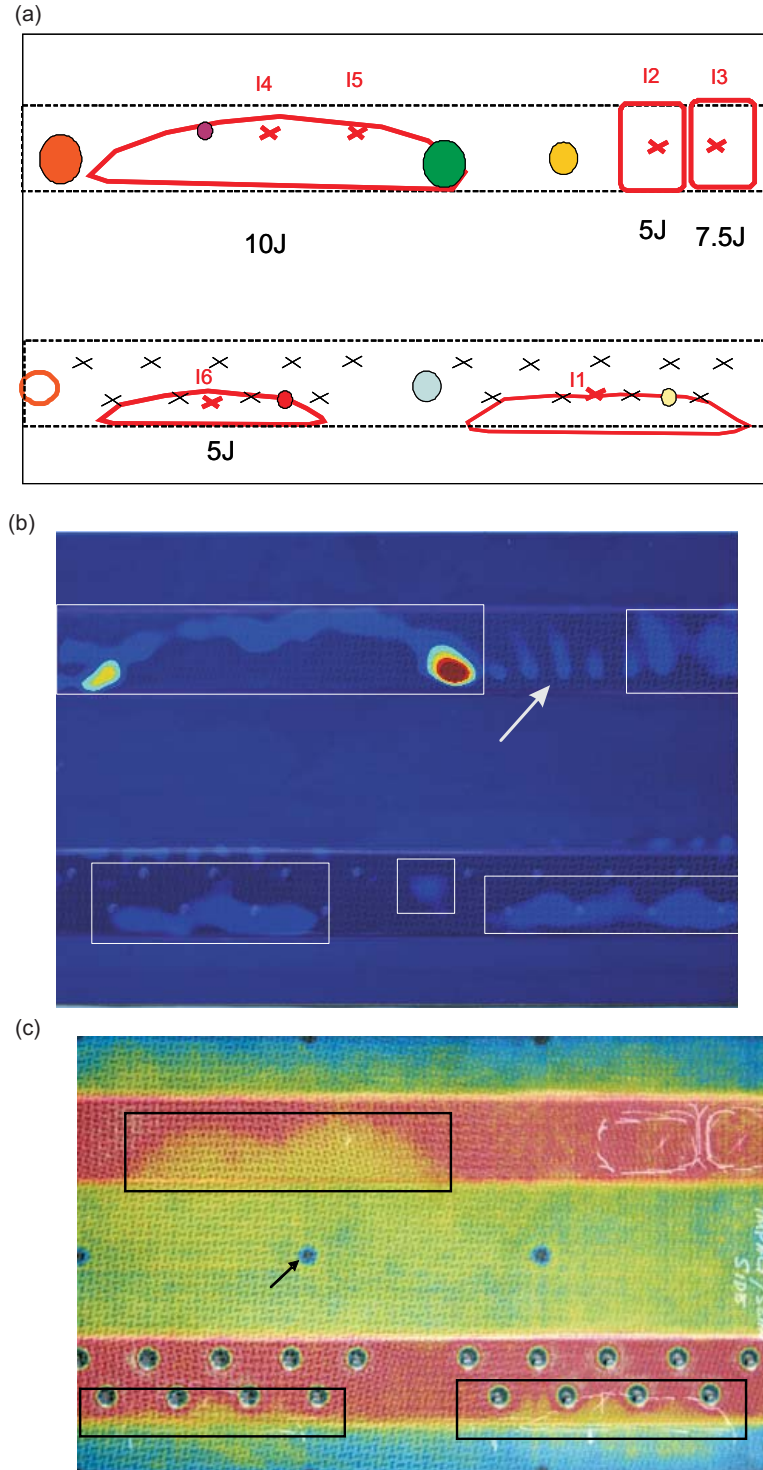
Sonic thermography was conducted with a nominal input power of 480 W over 1 second duration. The thermal data was acquired at a frame rate of 50 Hz over 750 frames giving a total inspection time of 15 s. Figures 9(a) and 10(a) show the damage maps of specimens 1 and 2, respectively, which combine the known location of the vaseline inserts and point of impact positions with the result of a C-scan of the specimen, which revealed the true extent of the impact damage. The circular areas correspond to vaseline inclusions, the red crosses are the impacted sites and the larger red outlines indicate the regions of damage as disclosed by the C-scans. The ST result obtained for specimen 1, superimposed with a photograph, is shown in Figure 9(b). The detected defect regions are highlighted by the

boxes. Insonification was applied to the central left of the specimen. The impact damage caused by I1, I4, I5 and I6 was detected. Frictional and/or anelastic heating occurs around the edges of the impacts as shown by the outline of the impact damaged regions of I4 and I5. This also suggests that the impact damage has caused large air gaps, and this is confirmed by the FT results (Figure 9(c)), which indicate a larger thermal resistance within the outlined region. The strong localised thermal signature at the bottom right of the impact damage and region corresponding to I4 and I5 coincides with the position of one of the vaseline inclusions. Indications of impacts I2 and I3 and the centrally positioned vaseline inclusion in the lower flange (flange 1), located at the centre of the fastener region (highlighted by the box) are also evident in the ST result. It should be noted that these indications also exhibit a periodic modal signature which contributes some uncertainty to the identification of these as defects. The reason that the other vaseline inclusions were not detected may lie in the fact that, like Teflon, vaseline may hinder the production of frictional heating during insonification. Thermal indications were also observed along the upper edge of the riveted flange panel, indicating frictional heating between the flange and the skin. Also, indicated by the arrow, are vibrational mode patterns due to anelastic heating.

**Figure 9:** (a) Damage map, (b) ST result (PCT<sub>3</sub>) and (c) FT result of specimen 1. The results shown in (b) and (c) are of the respective thermographs which have been superimposed with a photograph of the panel. In (a) the coloured circles correspond to the vaseline contamination in the bondline, red crosses indicate impact fractures and areas marked by the red outline indicate damage disclosed by C-scans. In (b) the arrow indicates vibrational mode patterns due to anelastic heating. Note that the blue circles in (c) (an example of which is indicated by the arrow) are markers used for alignment of the thermographic images.

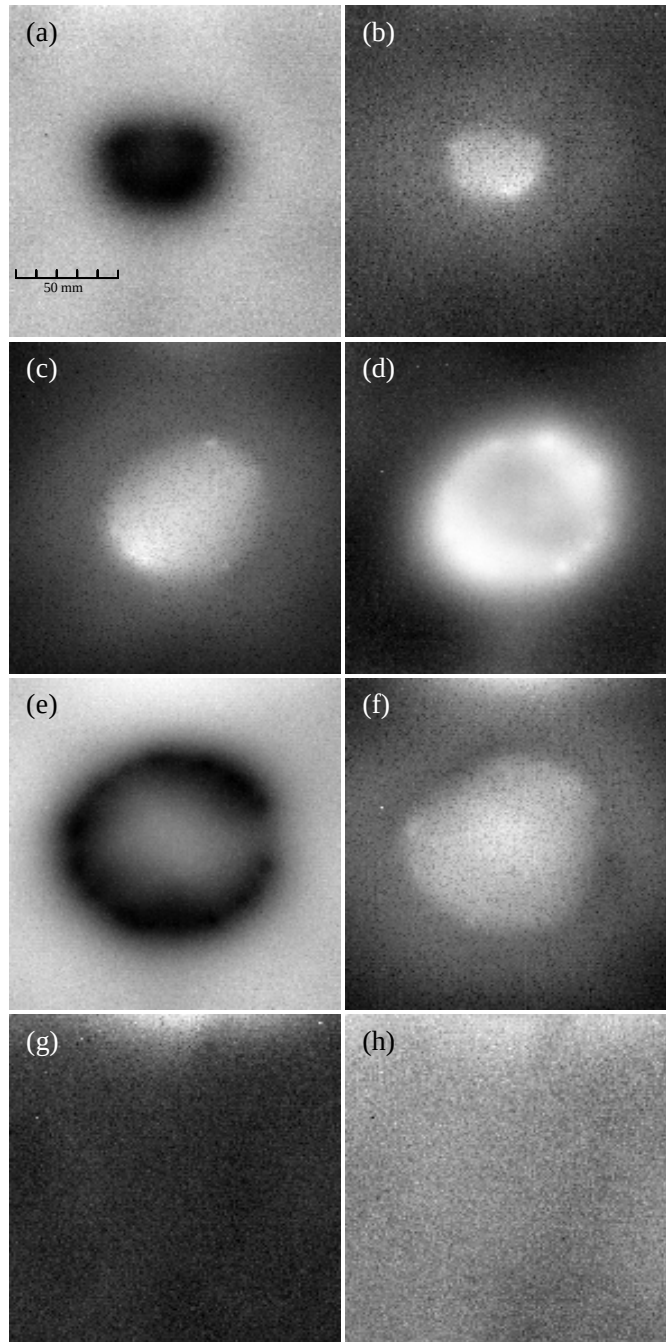
**Figure 11:** Sonic PPT (left) and  $PCT_2$  (right) results of glass reinforced aluminium specimens with embedded Teflon inserts with varying diameters of (a-b) 40, (c-d) 80 and (e-f) 100 mm respectively. (g-h) correspond to a reference specimen.

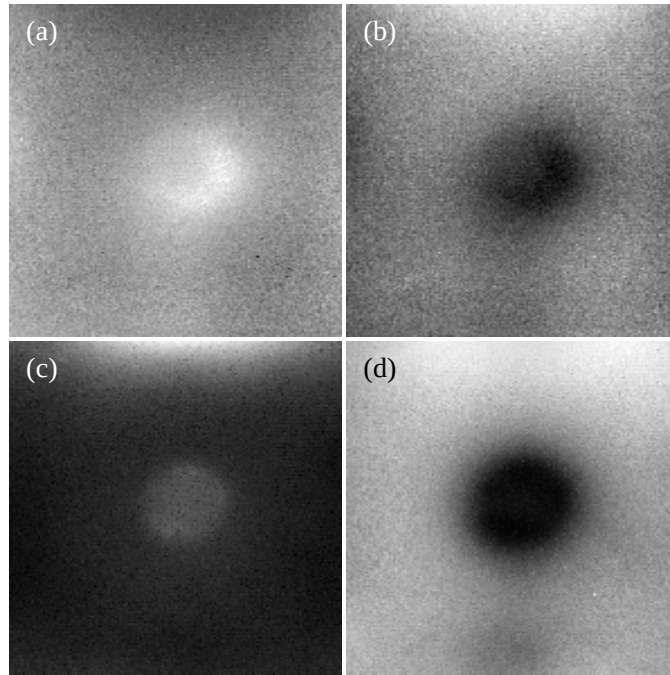
**Figure 12:** *PPT (left) and  $PCT_2$  (right) results of glass reinforced aluminium specimens with embedded Teflon inserts captured with the inserts below the E-glass-fibre (a-b) and above the E-glass-fibre (c-d).*

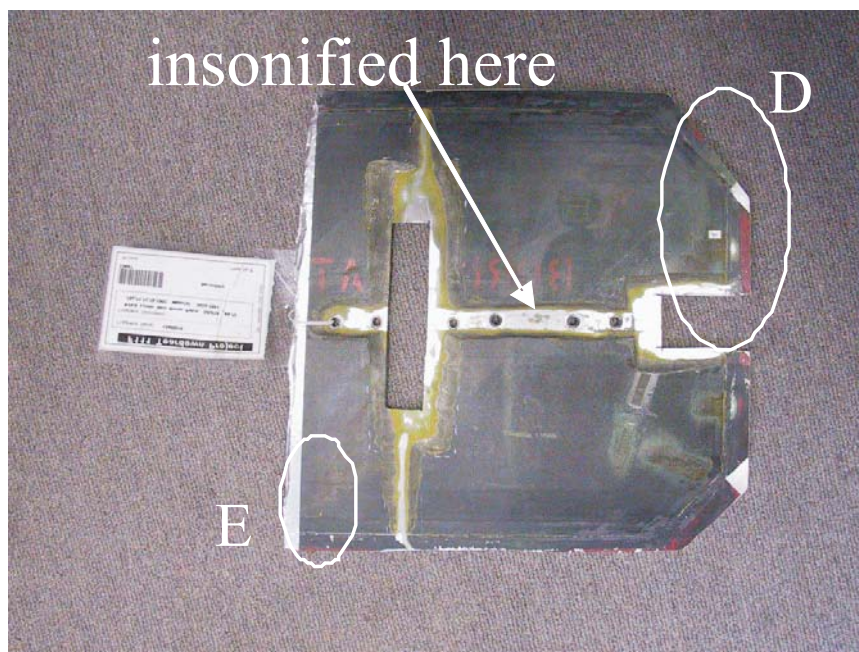
A photograph of the other LWS fragment, 12W951X, is shown in Figure 18 and Figure 19 shows the PCT results (a, b, d and e) and corresponding flash thermographs (c and f) for regions D and E, as indicated. It is noted that a non-grey colour map is used in this case merely to accentuate indications, and does not indicate relative temperature; that is whether a region is hotter or colder. The PCT results show clear indications of disbonding (circled) which are not as strong in the FT results (c and f). Once again the spatial detail is superior in the ST results.

**Figure 18:** Photograph of fragment 12W951X, indicating regions of interest, D and E and point of insonification.

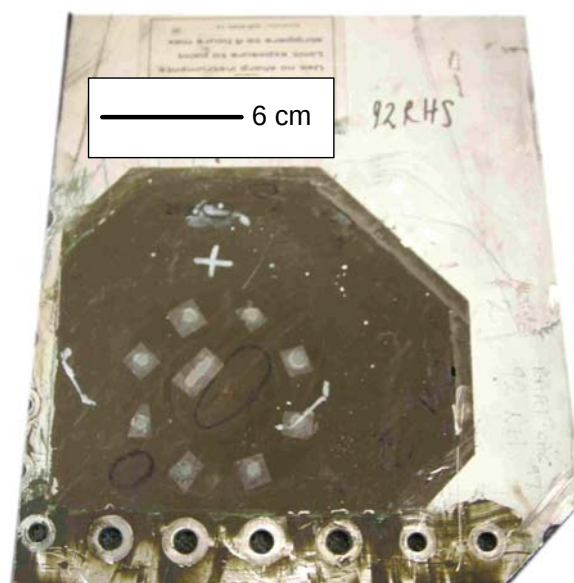
Figure 21 shows a photograph of a typical Mirage patch under investigation. Figures 22(a) and (b) show the flash PPT and sonic PCT<sub>2</sub> results of the patch, respectively. Figures 22 (c) and (d) show the results obtained using the bandicoot system, in which the peak defect index was set to 4% at 9-15 kHz in (c) and 2% at 25-35 kHz in (d). The indicated areas in Figure 22(b) show regions of elevated heat generation corresponding to possible defects. While the FT scan does contain some contrast in the regions shown by ST to be flawed, the indications are quite diffuse and difficult to interpret. The BaNDIcoot system

**Figure 21:** Photograph of a typical Mirage III boron patch under investigation.

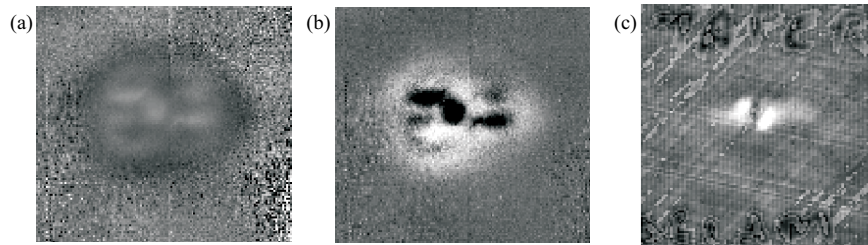
The second C/Ep specimen had a single BVID also with 8 J initial impact energy. The specimen was also insonified for 5 s with the acoustic horn set to 500 W with 300 frames captured at a frequency of 10 Hz. Figure 24 shows the specimen with the impact region marked by the square. Figure 25 shows the (a) sonic PPT, (b) sonic PCT<sub>3</sub> and (c) flash PPT results. Normally, processing the raw thermographic data would eliminate most emissivity related features, however in this case, the ink markings on the specimens are still apparent in the FT result, though this has had a negligible impact on the detectability of the flaw.

**Figure 25:** The ST (a) PPT and (b)  $PCT_3$  results and the (c) flash PPT result of the impact damaged region of the composite specimen.

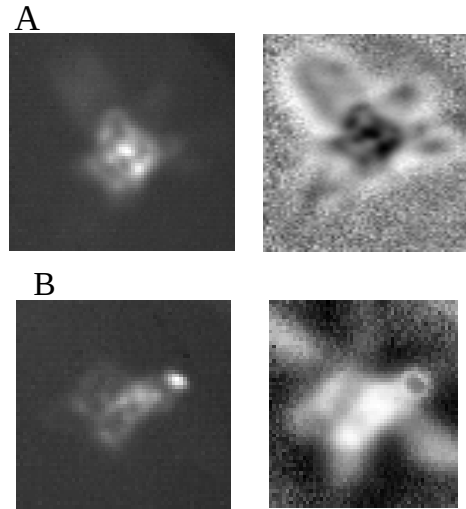
**Figure 27:** Raw ST (left) and  $PCT_2$  (right) results, respectively, for Syncore specimens A and B.

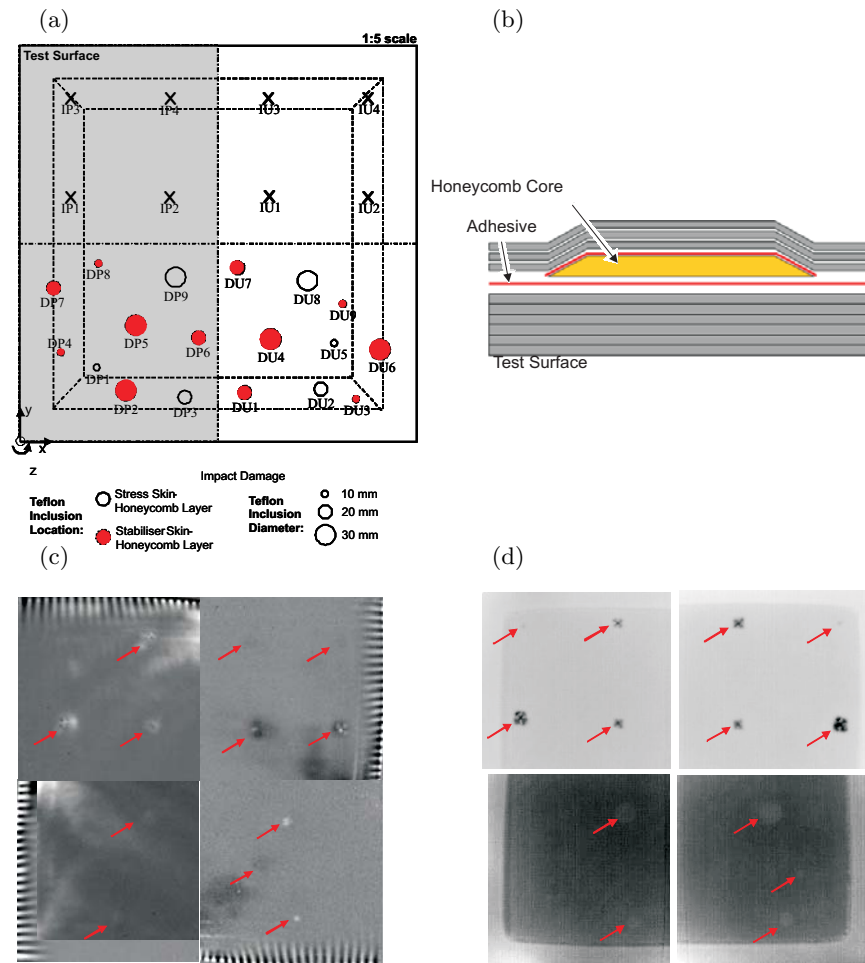
**Figure 30:** (a) Damage map, (b) profile image of layup, (c) sonic and (d) flash thermographs showing the four quadrants of specimen 2A and the corresponding damage locations. (Specimen layout courtesy CRC-ACS.)

Figure 30 shows the ST and FT results for specimen 2A and the corresponding damage map. Specimen 2A is a honeycomb reinforced panel with the reinforcement confined to the region of the panel within the outer dashed line of Figure 30(a). The area between the dashed lines corresponds to a sloping section of the honeycomb structure as shown in Figure 31. Inclusions were located between the honeycomb core and stabilising skin, as well as between the honeycomb core and the stress skin, both shown in Figure 31. Inclusions were also located on the sloping edge between the honeycomb core and stabilising skin. Table 7 shows the theoretical detectability of disbonds based on the rule of thumb described in section 3.2. These results indicate that all disbonds located in the stress skin/honeycomb layer are, in principle, detectable. Disbonds located in the stabiliser skin/honeycomb layer, are not detectable, however 30 mm defects located in the sloping edge should be detectable and 20 mm defects in this region should be partially detectable. The thermographs indicate this to be the case with only DP1 not detected. DP2 was located using ST only. As with specimens 1A and 1B, the addition of the Cu mesh in the skin reduces the detection rate for the reasons already outlined for specimen 1B (see Figure 32).

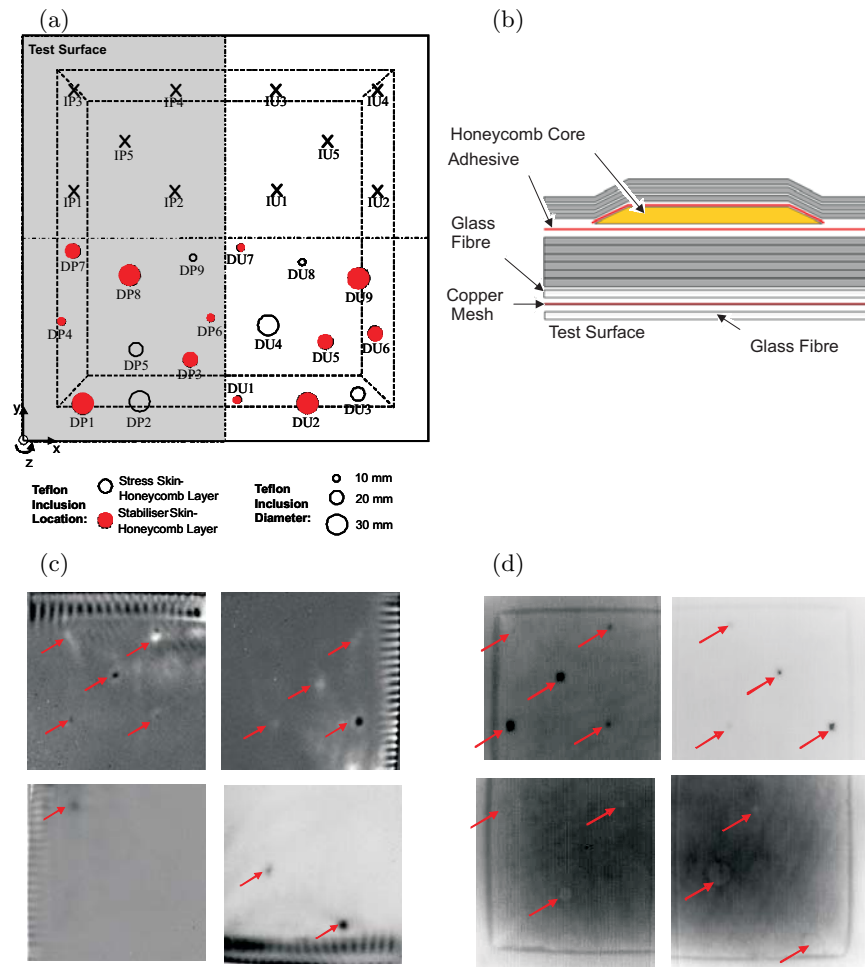
**Figure 32:** (a) Damage map, (b) profile image of layup, (c) sonic and (d) flash thermographs showing the four quadrants of specimen 2B and the corresponding damage locations. (Specimen layouts courtesy CRC-ACS.)

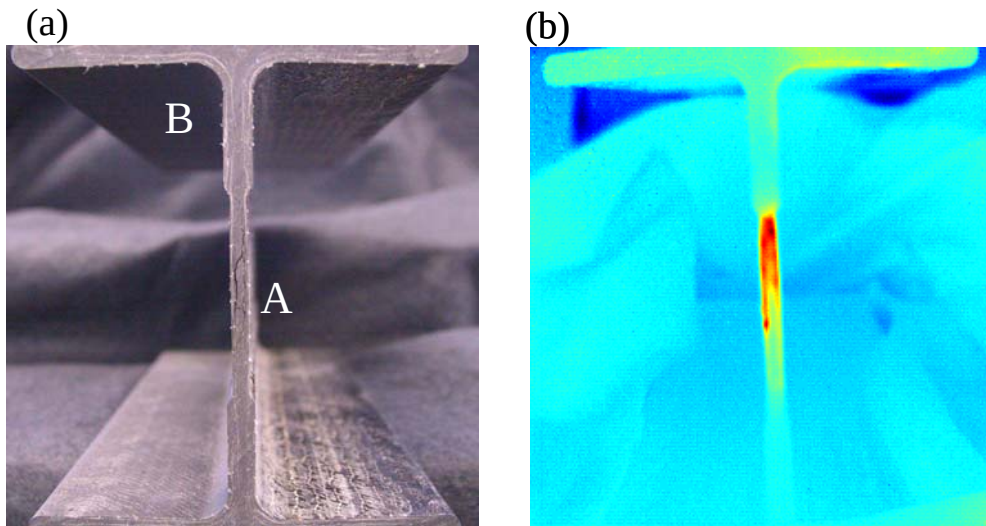
Region A of the first I-beam inspected showed visible damage in the web and during insonification this damage was clearly observed as a region of increased heat production as shown in Figure 34(b). For this particular I-beam no damage was found in region B. Region B of the second I-beam showed some signs of cracking along the exposed surface of the flange. During insonification further internally located damage was detected. Figure 35 shows a photograph of the section under investigation (top) along with the sonic PCT<sub>3</sub> result (middle). The bottom image shows the sonic PCT<sub>3</sub> result for a reference specimen with no observable cracks.

**Figure 34:** (a) Photograph of I-beam showing the regions of interest, A and B, and (b) the corresponding sonic thermograph.

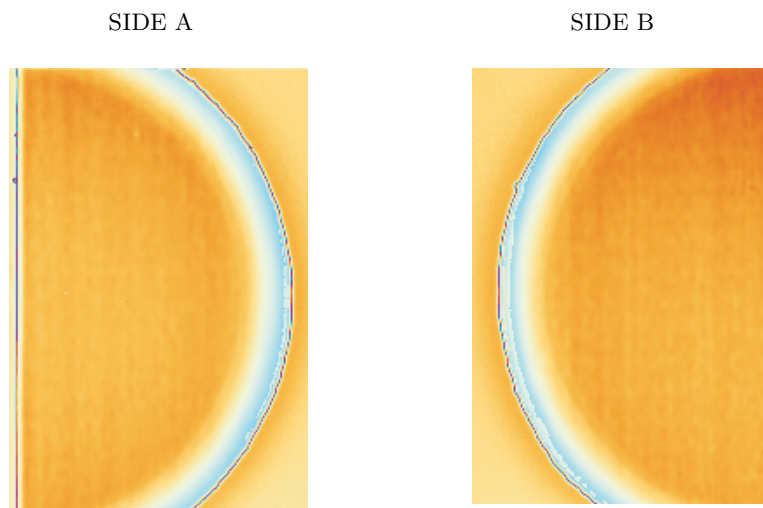
Figure 37 shows the flash PPT results for sides A and B (as indicated). No indications of a defect are present. Figure 38 shows the ST raw image, PPT and PCT<sub>2</sub> results pertaining to sides A and B for insonification at point a and Figure 39 shows the ST raw image, PPT and PCT<sub>2</sub> results for insonification at point b. The differences between the two points of insonification are marked. Two distinct mode shapes are evident in the series: the horizontally banded pattern in Figure 38, and the more complex pattern shown in Figure 39. It is important to note, however, the consistency of the vertical indication extending upward from the base of the patch. This indication corresponds well to the location and length of the underlying crack. Figure 40 shows the results (both PPT and PCT) of insonification at the four different points (as indicated in Figure 37) on side A. The result suggests that defect indications may be distinguished from vibrational mode patterns by performing a cross-correlation between inspections where different mode shapes are excited (also mentioned in Section 3.7).

**Figure 37:** FT PPT results of sides A and B of the B/Ep patched honeycomb panel.

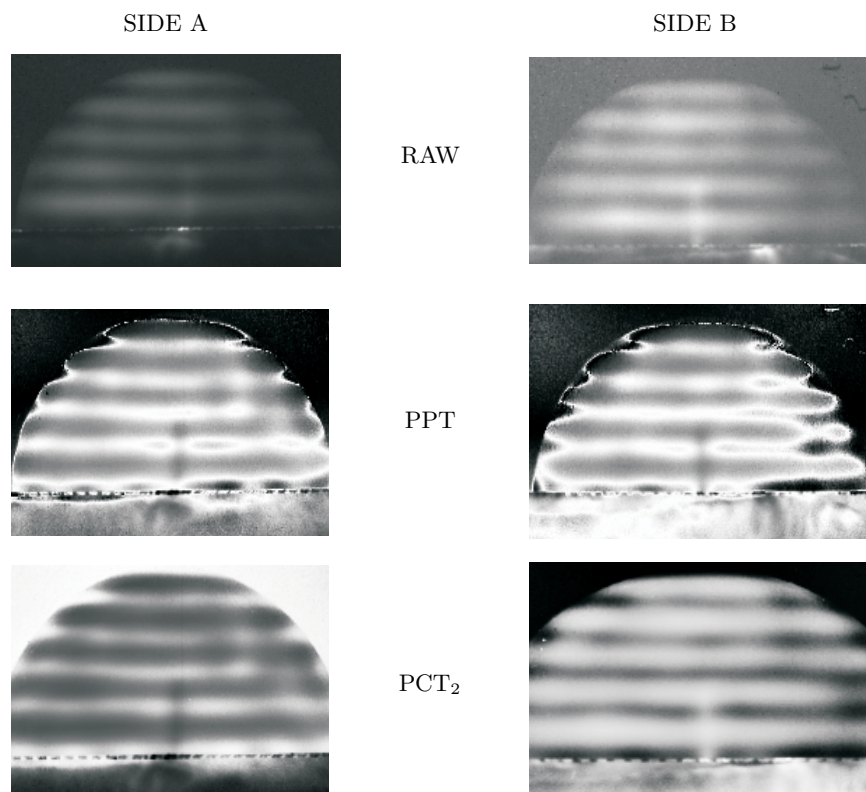
**Figure 38:** *ST raw, PPT and PCT<sub>2</sub> results of the B/Ep patched honeycomb panel insonified at point a (indicated in Figure 36).*

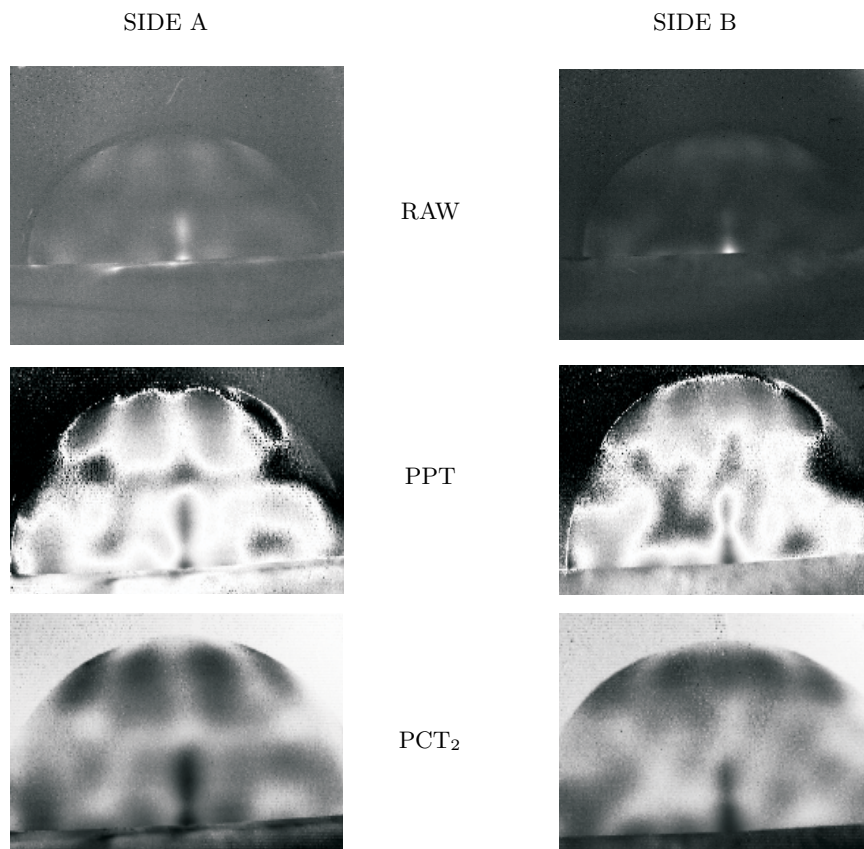
**Figure 39:** *ST raw, PPT and PCT<sub>2</sub> results of the B/Ep patched honeycomb panel insonified at point b (indicated in Figure 36).*

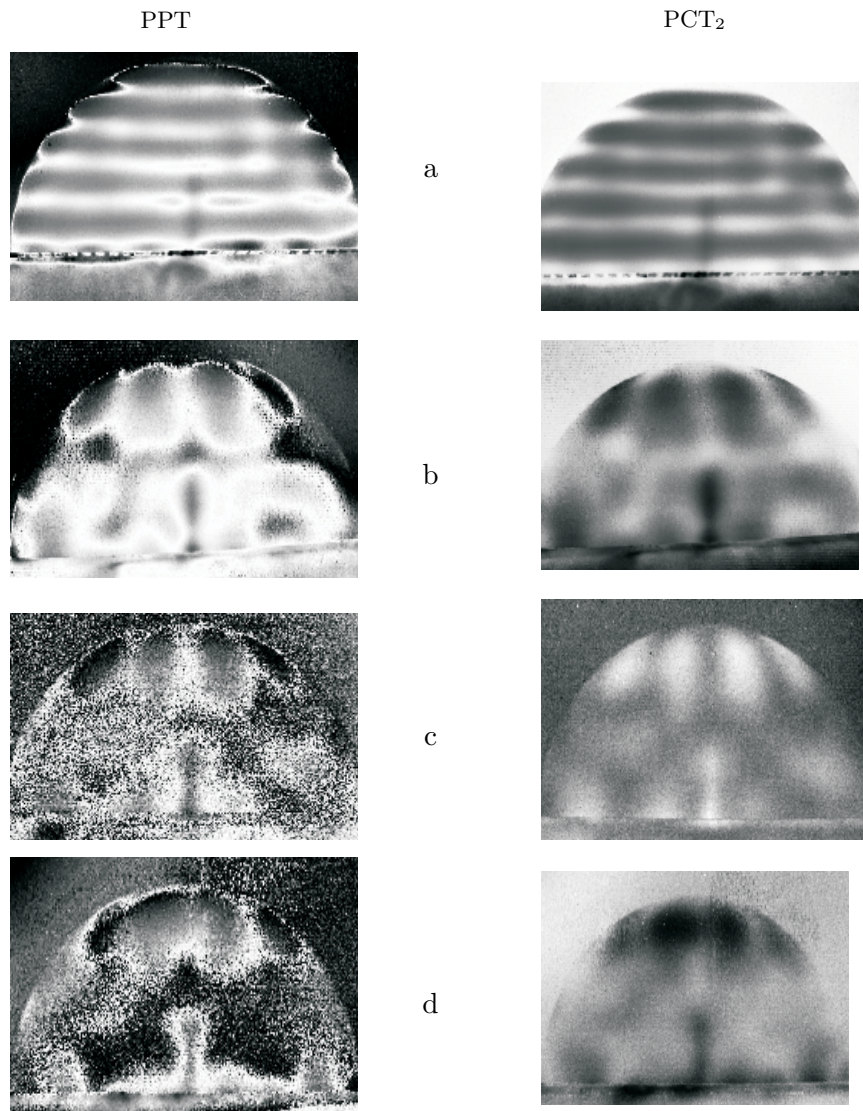
**Figure 40:** *ST PPT and PCT<sub>2</sub> results of B/Ep patched honeycomb panel insonified at four locations (a, b, c and d) on side A, as indicated, corresponding to Figure 36.*

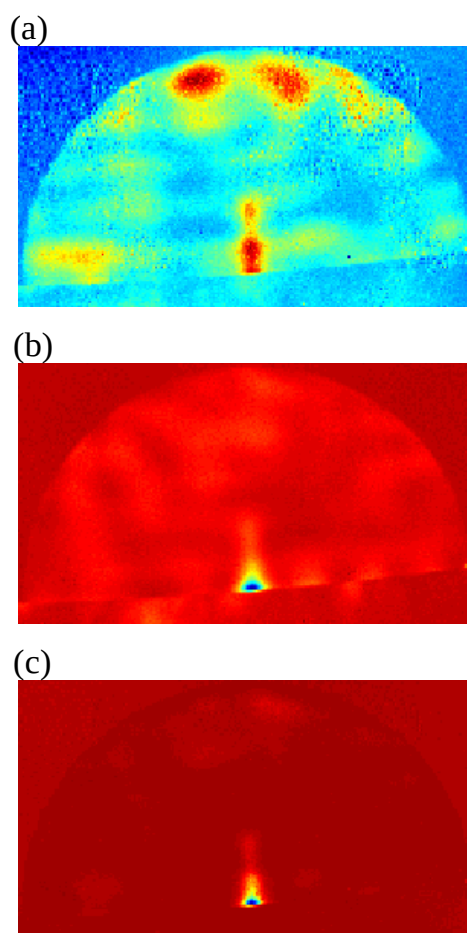
Figure 41 shows an example of a cross-correlation between two PCT<sub>2</sub> results. The two results were drawn from insonifications at points a and e, as indicated in Figure 36. The result shows the effectiveness of this simple image processing step in delineating the crack signature from the vibrational mode patterns.

**Figure 41:** (a) and (b) show the  $ST\ PCT_2$  results of  $B/Ep$  patched honeycomb panel insonified on side A at locations a and e, respectively, corresponding to Figure 36. (c) is the cross-correlation result of the two  $PCT$  results.

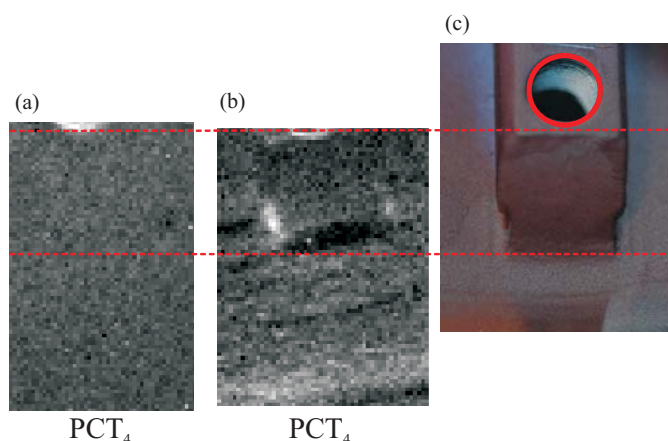
The position of the horn tip during insonification was found to have a large influence on whether or not the cracks were observable. This was of particular importance in the detection of the smaller cracks observed in stems 1 and 2, which are not visible to the naked eye. To determine the best location for the injection of acoustic energy, several areas on the main wheel rim were investigated. Due to the location of the cracks, at the bottom of the stem, the horn tip was positioned just above the main bulk of the stem shown as position 1 in Figure 44. However, no IR signal was detected at the location of the smaller non-visible cracks (Figure 45(a)). This suggests that only a small amount of energy is transmitted into the zone of the crack. The horn was repositioned on the edge of the stem, indicated by position 2 in Figure 44 and the inspection repeated. The IR signature from the smaller cracks was significantly improved. Two indications are furnished by the excitation at position 2 (Figure 45(b)). In effect, the stem serves as a wave guide directing the acoustic energy towards the cracked region.

**Figure 45:** PCT results corresponding to insonification positions (a) 1 and (b) 2 of stem 2. (c) shows a photograph of the region. The parallel lines are used to align the thermal images with the photograph.

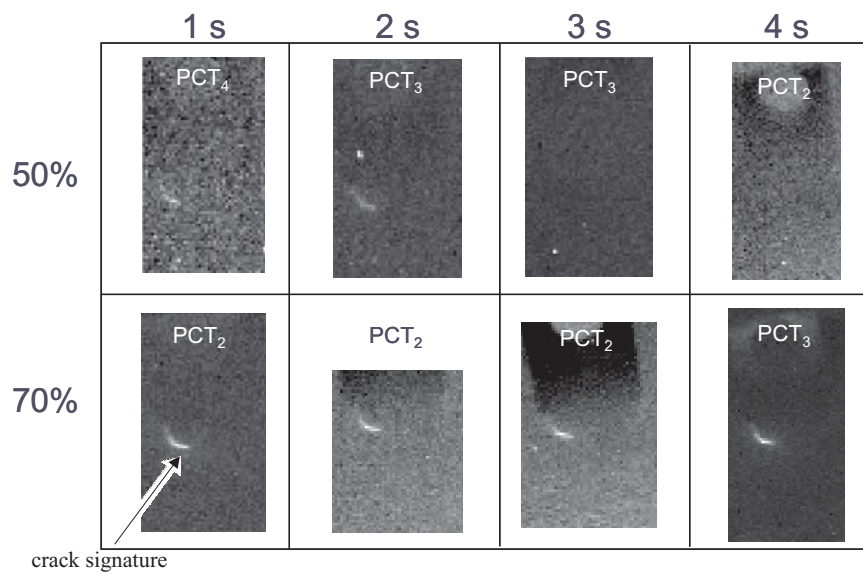
A study on the effect of power level on the IR signature was conducted. Levels of 600 W (50% of the total available power), 840 W (70%) and 1200 W (100%) were considered. Stem 1 was made the subject of the study as this stem had cracking which was not visible. The interface material was found to disintegrate at the 1200 W (100%) level and was, therefore, not considered a useful level for routine inspection. The results, shown in Figure 46, indicated that 840 W (70%) was sufficient to obtain a clear, reliable IR signature from the cracks and had a negligible effect on the interface layer. This power level was used for all inspections of the wheel.

A sensitivity study was also undertaken on stem 1 to examine the effect of insonification time on signal quality. The results are also shown in Figure 46. Generally, an insonification time of 1-2 s was enough to produce reliable indications, however a 4 s duration was found to provide marginally stronger signals and was therefore used throughout this study.

**Figure 46:** PCT results for stem 1 indicating varying insonification times (1 s, 2 s, 3 s, 4 s) and power levels (50% and 70%).

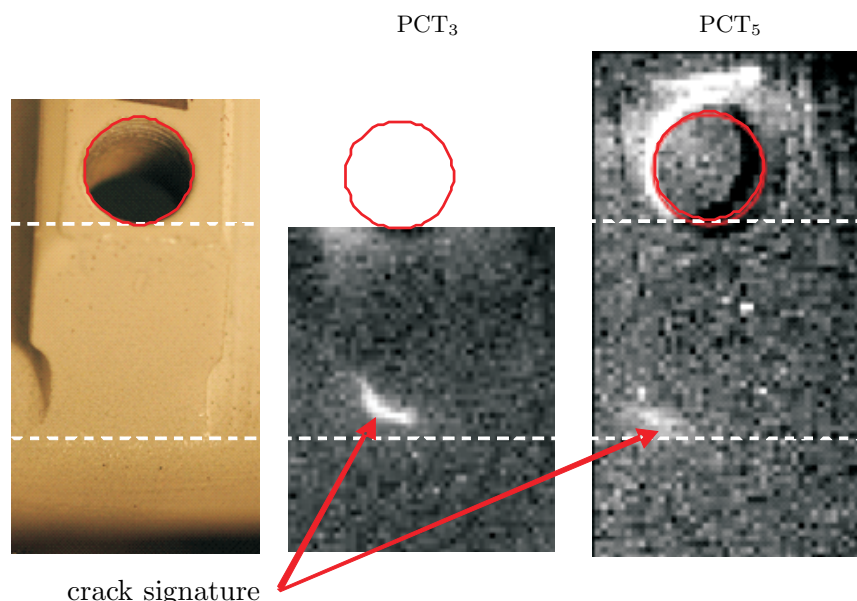
**Figure 47:** Stem 1: photograph and PCT results for the painted (left) and unpainted area (right), respectively.

Figure 47 shows a photograph of the area of interest and the PCT results for the painted and unpainted cases, respectively. The parallel white lines are used to align the photograph with the PCT results and the red circles indicate the position of the hole at the top of the stem. There was no visible evidence of cracking and it should be noted that any existing cracks may be masked by the white surface coating of the rim. The PCT results for the painted and unpainted cases show the thermal indication of a crack on the bottom left corner of the stem. Although the painted case shows greater definition, the unpainted case also provides evidence of the crack.

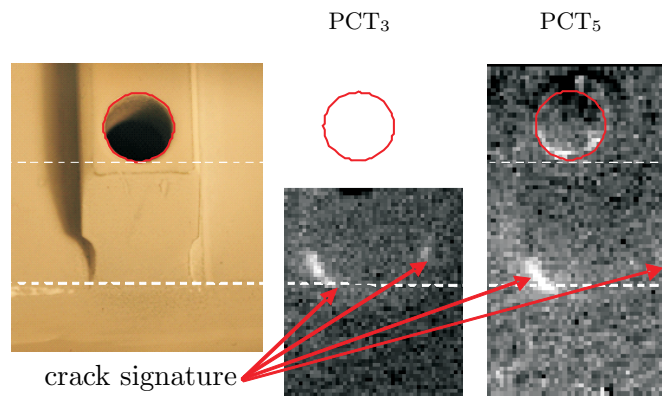
Figure 48 shows a photograph of stem 2, and the PCT results for painted and unpainted cases. Once again, no visible evidence of cracking is observed. The PCT results indicate cracking on both corners of the stem, with little difference between the painted and unpainted cases.

**Figure 48:** Stem 2: photograph and PCT results for the painted (left) and unpainted area (right), respectively.

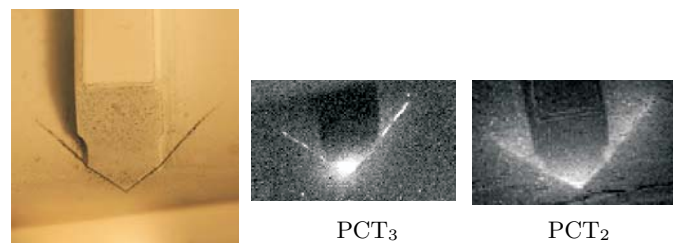
**Figure 49:** Stem 3: photograph and PCT results for the painted (left) and unpainted area (right), respectively.

Figure 49 shows stem 3, along with the painted and unpainted PCT results. This stem exhibited a large, visible crack. The crack had grown through the wall of the main wheel rim. The PCT results for both painted and unpainted cases show a substantial thermal response from the crack, as expected from a defect of this size.

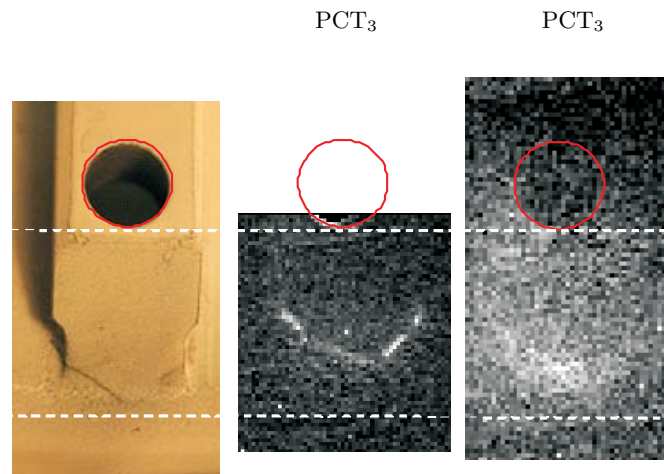
Figure 50 shows a photograph of stem 4 and the PCT results for the painted and unpainted cases. This stem had no visible cracking. For the painted case insonification provided a strong indication of cracking at both corners of the bottom of the stem. Although a thermal indication also appears for the unpainted results, it is not as well defined as for the painted results.

**Figure 50:** Stem 4: photograph and PCT results for the painted (left) and unpainted area (right), respectively.

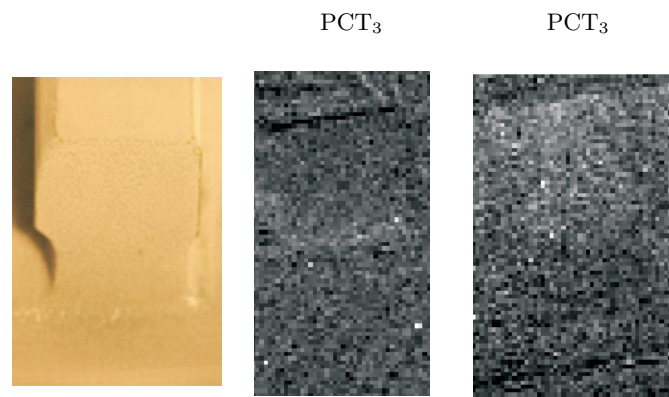
Figure 51 shows the photograph of stem 5 and the PCT results for the painted and unpainted cases. This stem had no visible cracking. The PCT results gives no indication of cracking at the corners of the stem.

**Figure 51:** Stem 5: photograph and PCT results for the painted (left) and unpainted area (right), respectively.
