Engineering Assessment of Big House at Summit Station, Greenland

Final Report

April 2011

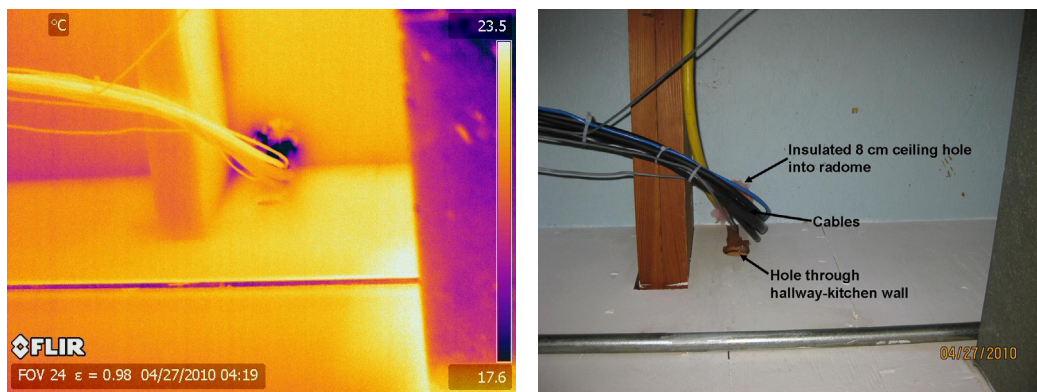
Figure S-5. Well insulated cable pass-through into radome.

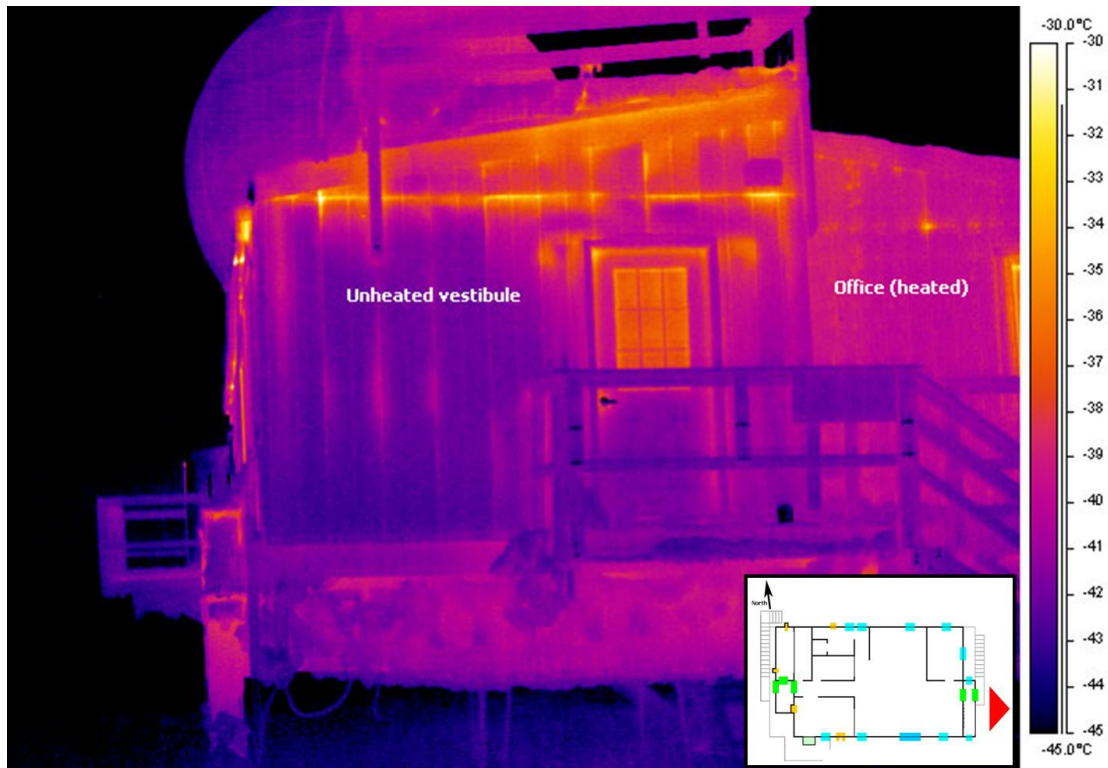
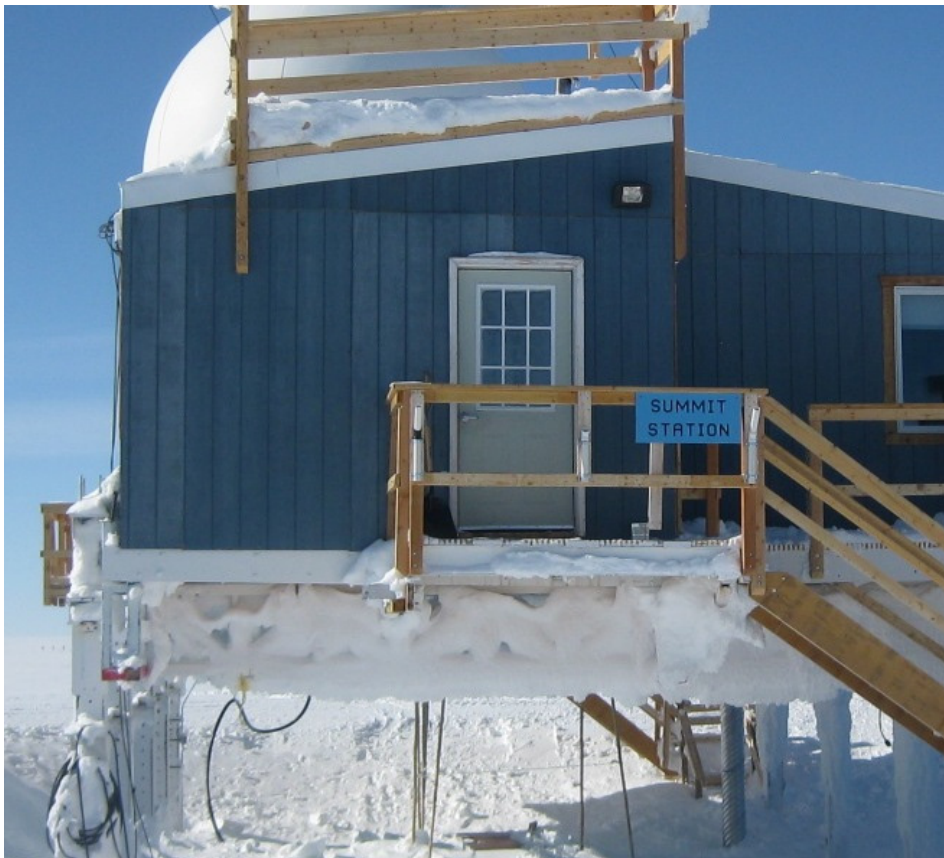
Figure 18. View 6 showing location (inset), thermal, and visual image of the eastern end of the Big House.

View 6, shown in Figure 18, is the southern portion of the eastern end of the Big House, and highlights the unheated entry vestibule. Again, the bright horizontal line at the interface of the T-111 siding indicates heat loss from the upper ceiling of the vestibule. The ceiling in the vestibule is open and slanted. The access hatch to the roof is located in the ceiling of the vestibule. During the visit, there was a substantial amount of frost built up on the access hatch on the inside of the vestibule.

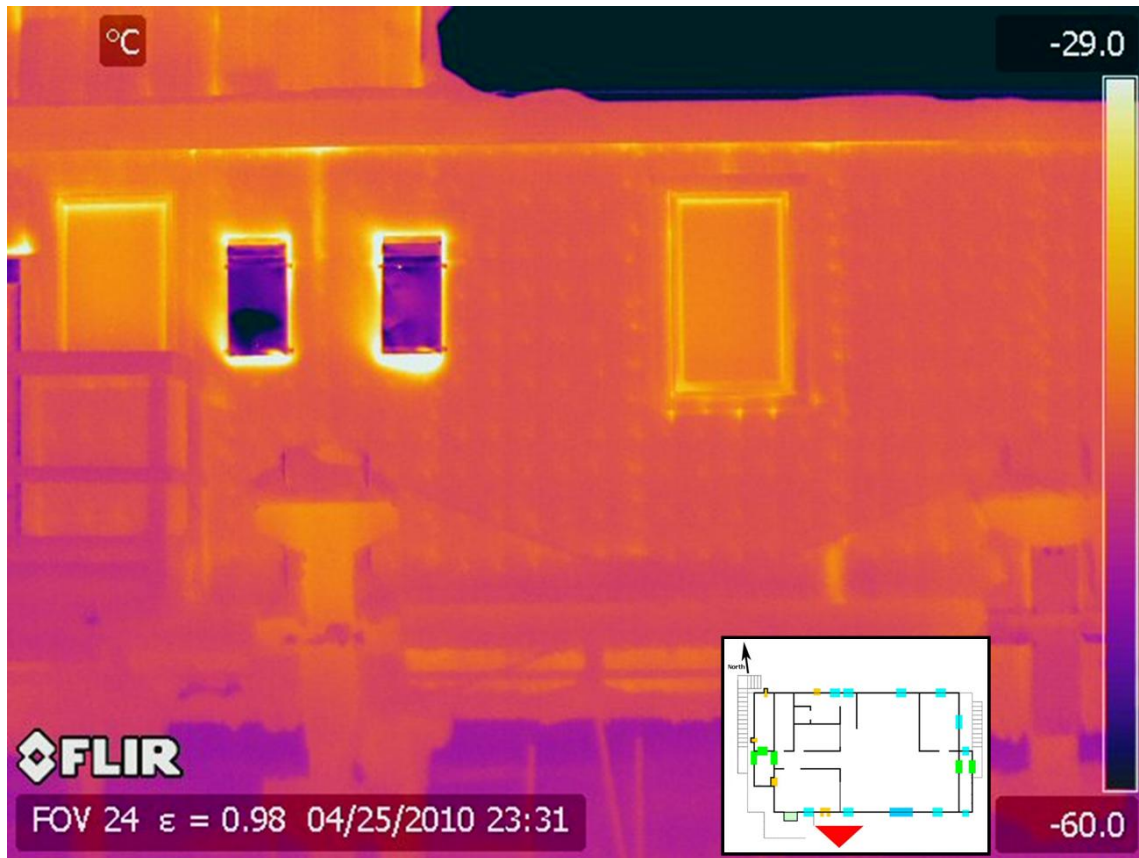
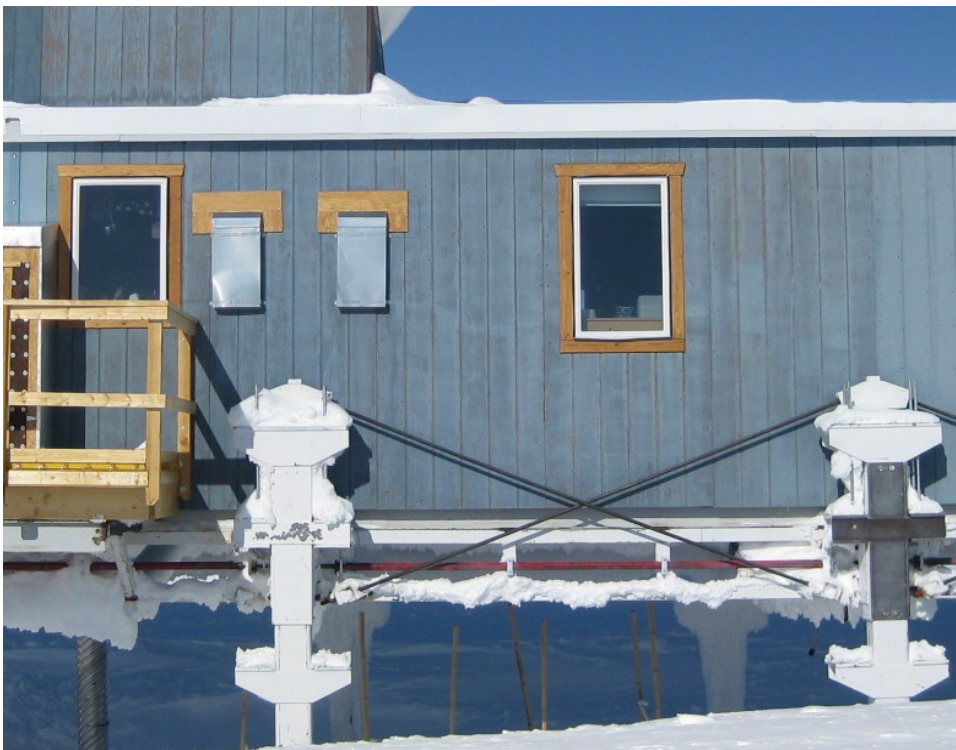
The images in **View 10** (Fig. 21) include the kitchen stove vents and double-pane window (left) and the double-pane window in the main room dining area (right).

Figure 21. View 10 showing location (inset), thermal, and visual image of the south exterior wall in the vicinity of the kitchen.

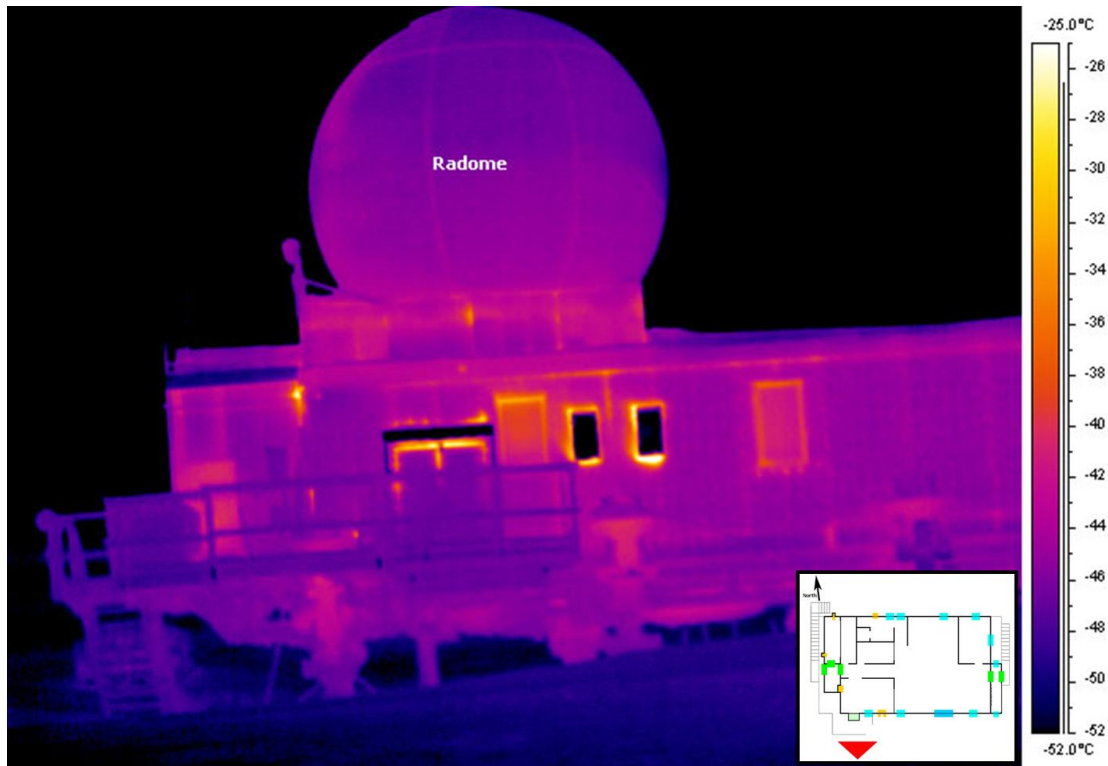
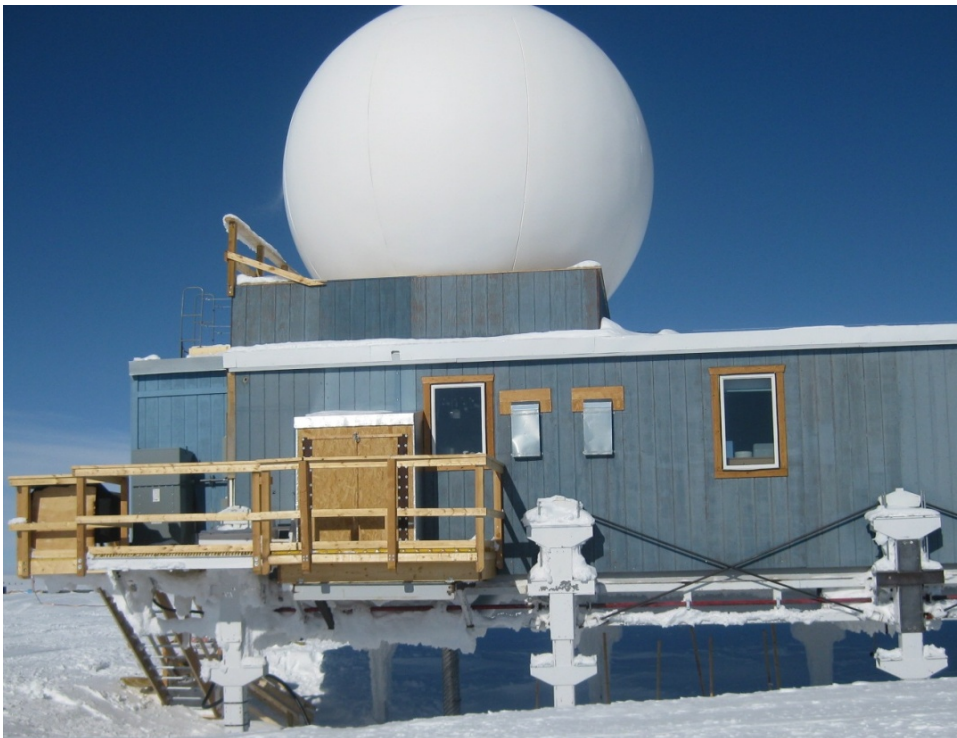
View 11 (Fig. 23) shows the western end of the south side exterior wall, including the radome on the roof. The top portion of the radome base is warmer than the bottom, and there is another warm spot at the roof eave. There is a small heat trace system installed in the radome to keep the instruments warm. The box structure that supports the radome may retain some of this heat. The top of the radome is cold, suggesting that there is not an excessive amount of heat loss. While there is a small heat leak at the base of the radome, it is not a significant amount. On the ceiling inside the Big House are bolts that attach through the roof SIPs that secure the base of the radome. These images indicate some, but not a significant amount of, heat transfer along the bolts. Also shown in this IR image is the propane storage area (center of image, double-door behind deck railing) that shows some heat loss from the heater that maintains a suitable propane temperature. Improving the gasket around the storage doors would reduce this.

Figure 23. View 11 showing location (inset), thermal, and visual image of the of the south exterior wall west end in the vicinity of the kitchen.

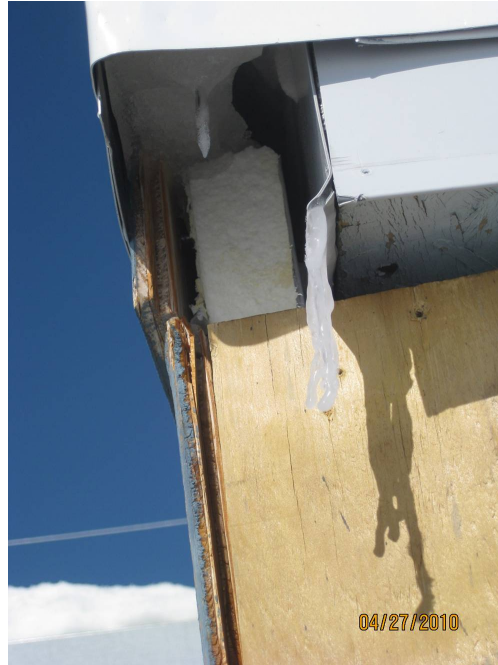
The southwestern corner of the building is shown in **View 12** (Fig. 24) where the west unheated vestibule connects to the main building. The southern portion of the vestibule contains shelving for dry goods and also houses the 600- × 600-mm fresh air intake into the kitchen. The very bright spot at the interface between the main building and the vestibule is a gap indicating excessive heat loss. Further to the right, at the corner of the main building, the bright spot there is from a gap at the eave created when the building was re-sheathed (Fig. 25).

Figure 25. Closeup of the southwestern corner of the original main building showing the gap between the materials of the original exterior and the recent re-sheathing.

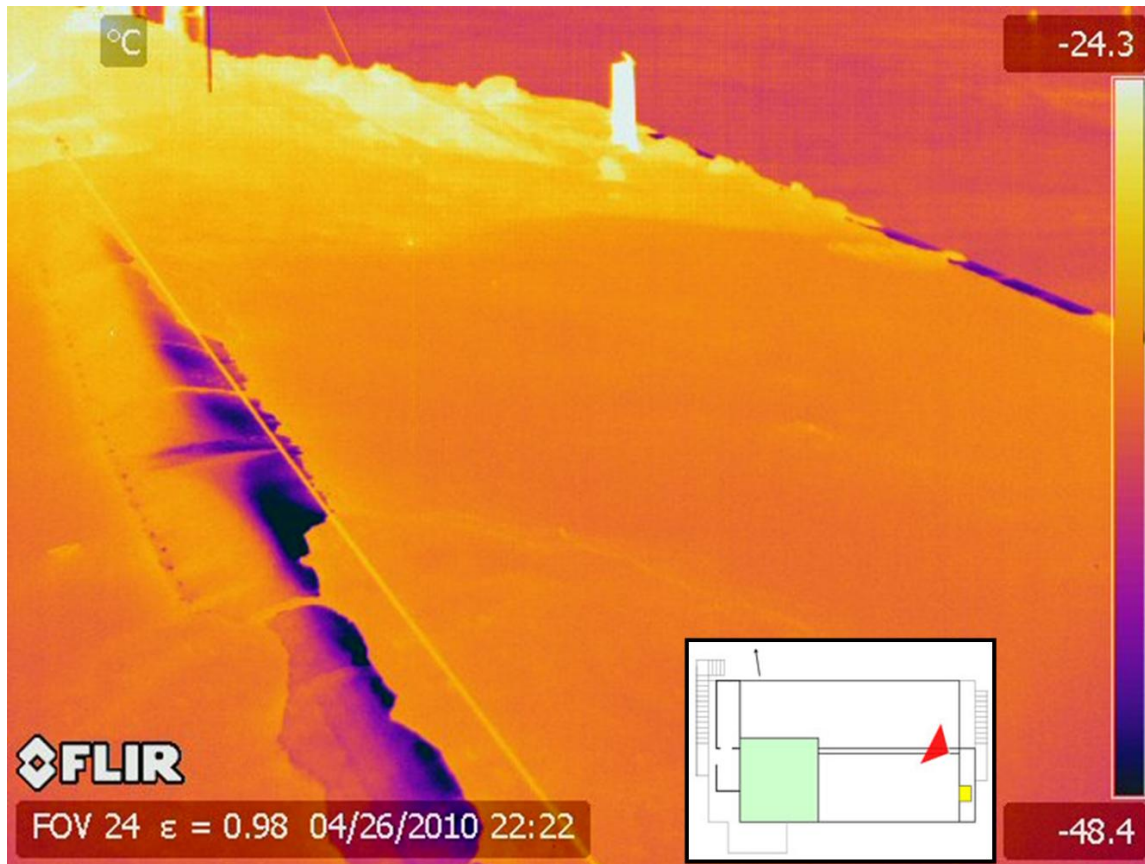
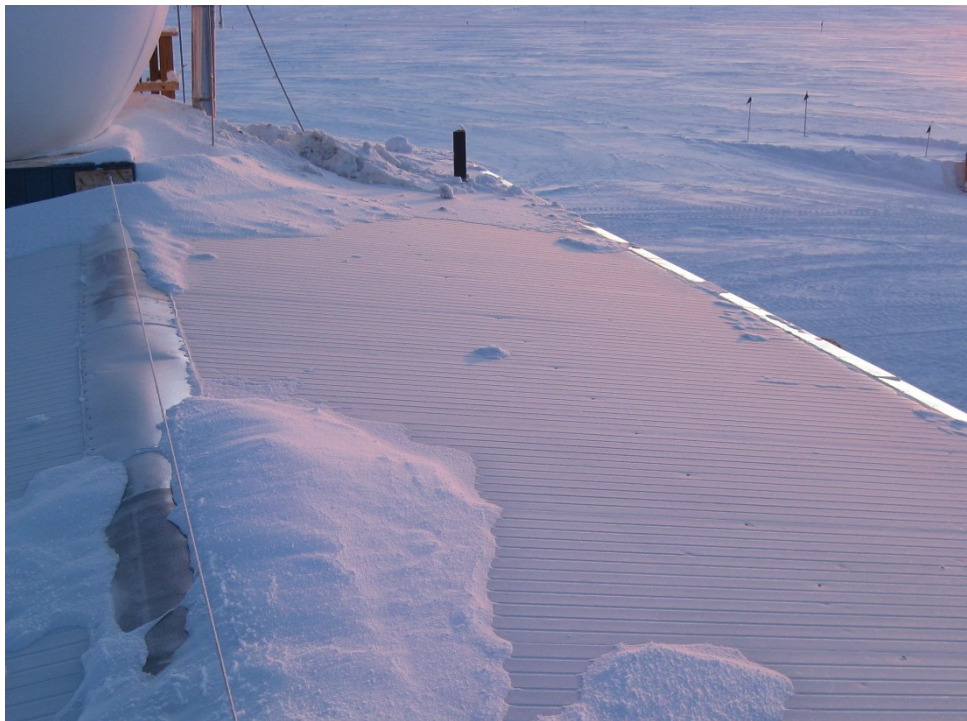
Both IR and visual images looking at the western end of the roof were taken by CPS personnel (for safety reasons) from the eastern end of the building. The images shown for **View 15** in Figures 27 and 28 are the north and south sides, respectively. The bright pipe in the northern view (Fig. 27) is the heated sewer roof vent. The view of the southern side (Fig. 28) includes the base of the radome. Aside from the previously mentioned heat loss from the support base of the radome, there is no significant heat loss from the roof. The dark areas are the reflection of the cold sky on the metal roof.

Figure 27. View 15 showing location (inset), thermal, and visual image of the northern side of the roof.

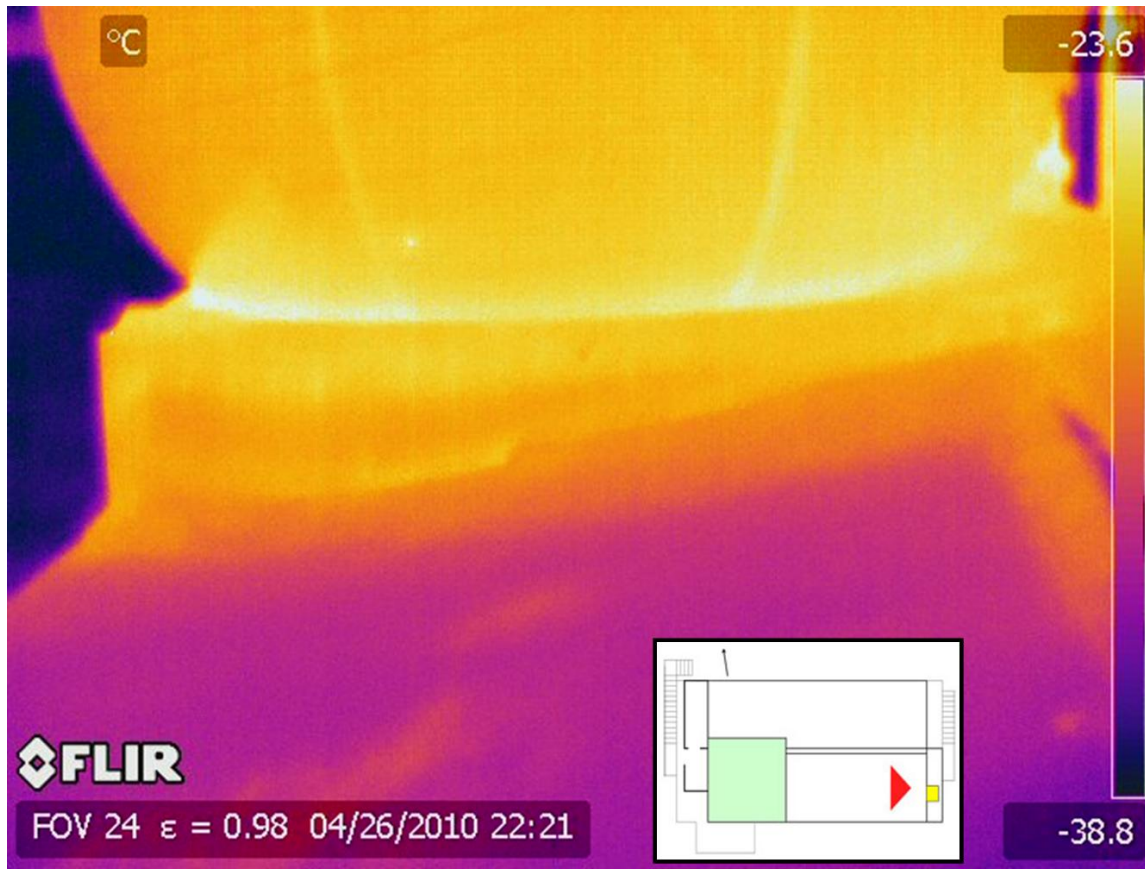
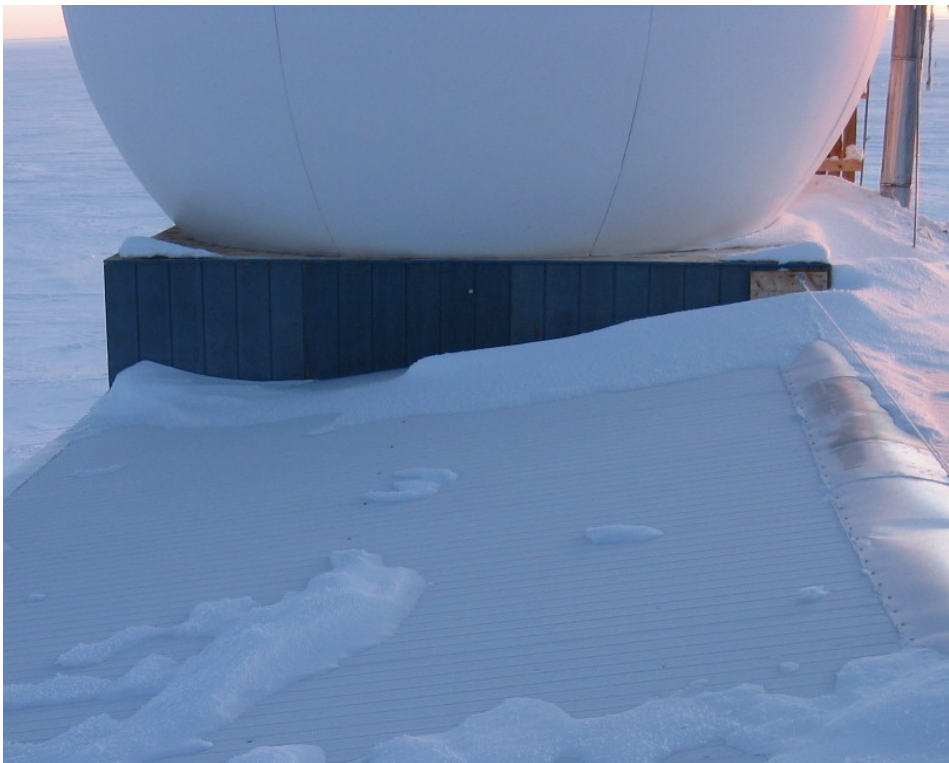
Figure 28. View of the southern side of the roof showing location (inset), thermal, and visual image taken from the same position (View 15).

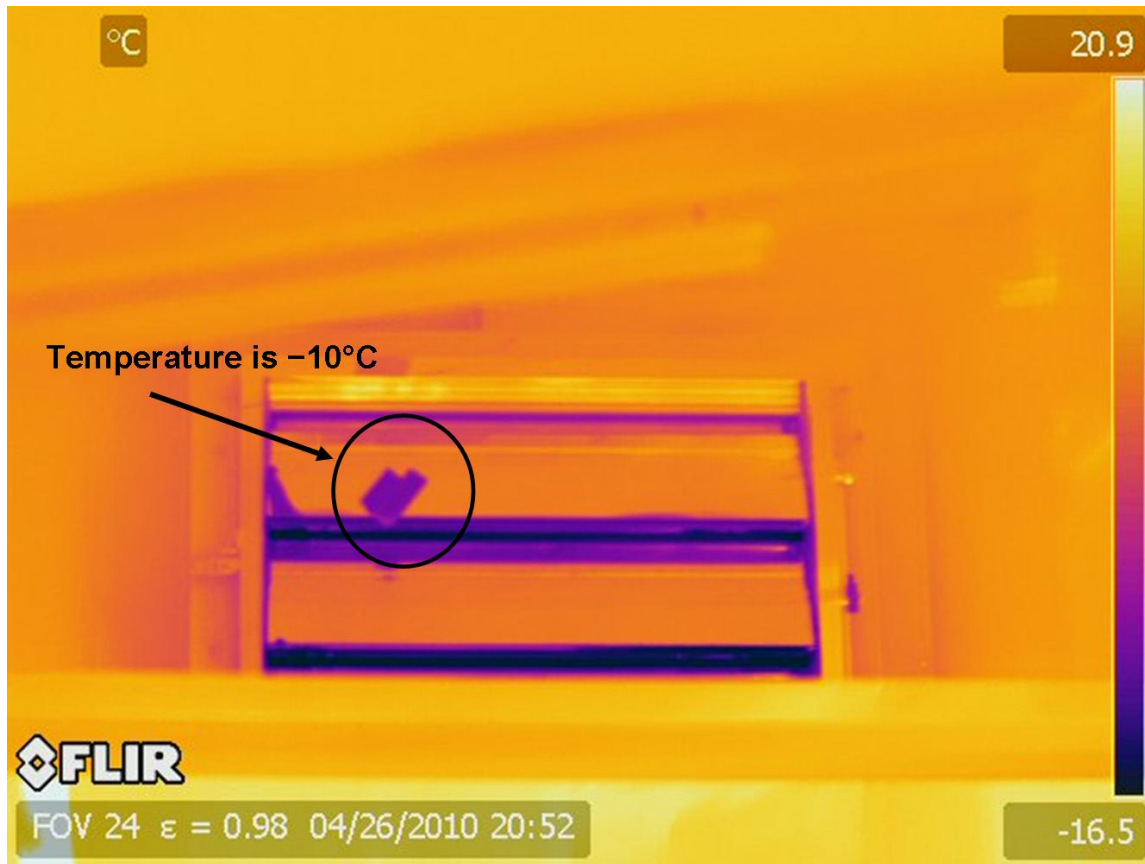
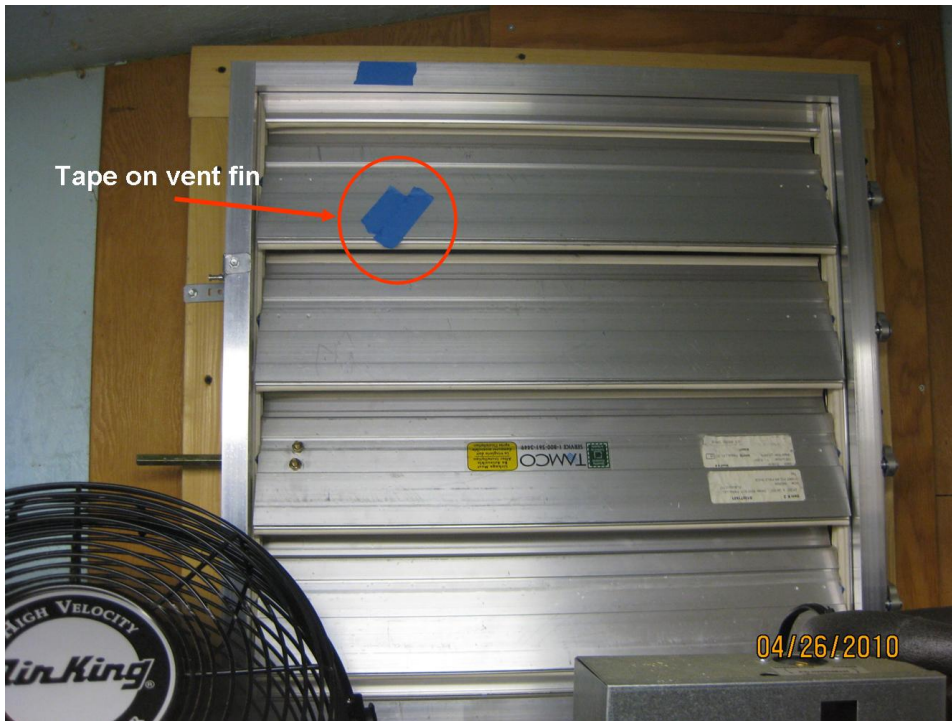
The large fresh air intake vent that brings outside air into the kitchen is a significant source of cold air infiltration (Fig. 33) and also supplies the building with make-up air for any combustion devices (such as the stove and furnace). The opening for the vent is on the underside of the building (Fig. 32). In contrast to the previous IR imagery, the dark colors here mean cold, as the vent fin is in contact with the cold air, and the warmer locations are reflected. The piece of blue tape on the top fin is reading -10°C . Also, in the west vestibule, there is frost buildup on the exterior of the vent under the shelves in the vestibule.

Figure 33. IR and visual imagery of the interior view of the large make up fresh air vent in the kitchen.

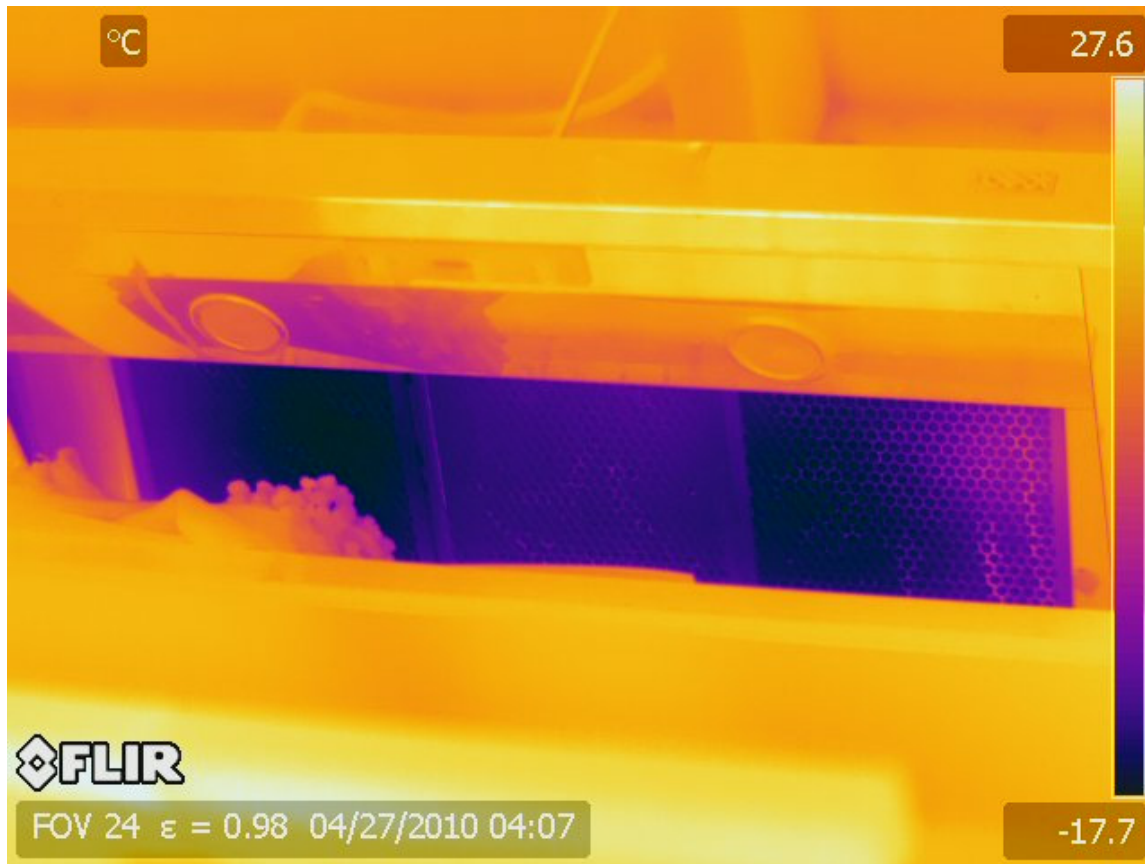
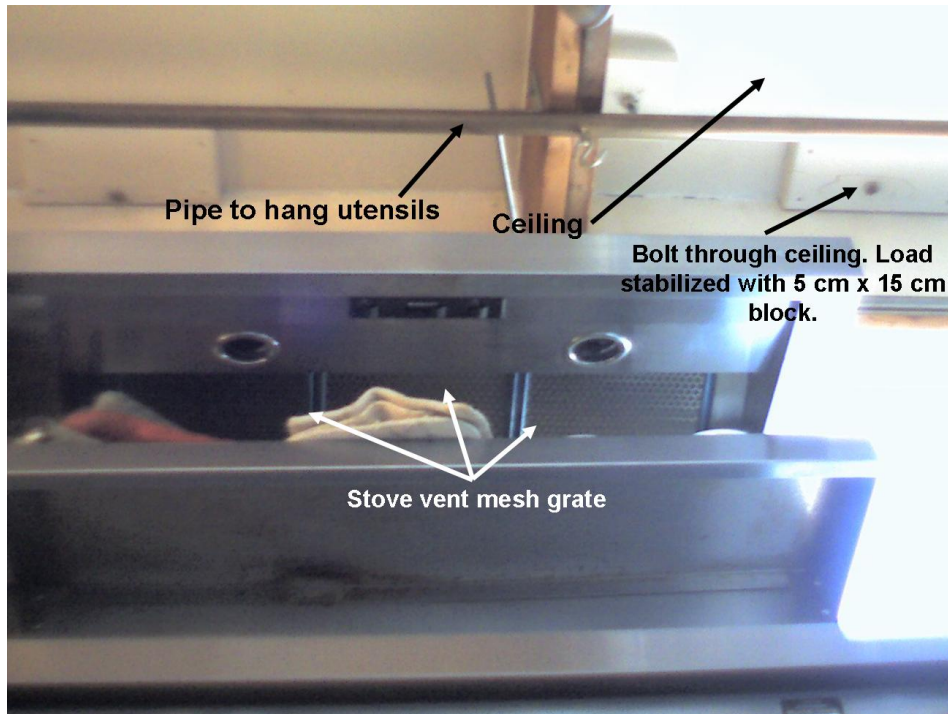
The vents located in the stove hoods are another location where cold exterior air infiltrates into the building, as shown in the IR image in Figure 34. Near this same place, on the wall behind the stove (Fig. 35), there is a cold location between two SIPs below the roof beam. This spot may be the same as the warm location seen on the exterior near the stove vents.

Figure 34. IR and visual imagery of the interior view of the stove vents in the kitchen.

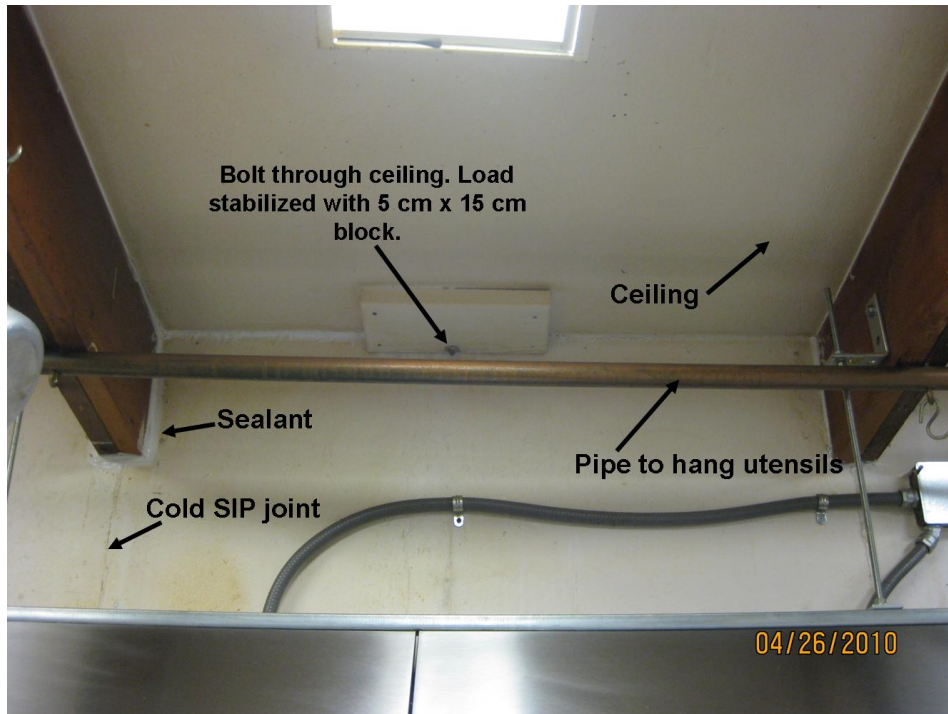
The bolts through the ceiling connecting to the base of the radome (Fig. 35) show locations of cold in the IR imagery. These are thermal bridges, and there are a number of these through the ceiling. They are condensation points for moisture in the air.

Also seen in Figure 35 is the sealant used around roof beams and along the roof-wall interface. This keeps the moisture from migrating through the wall.

Figure 35. IR and visual images of the roof-wall interface behind the stove in the kitchen.

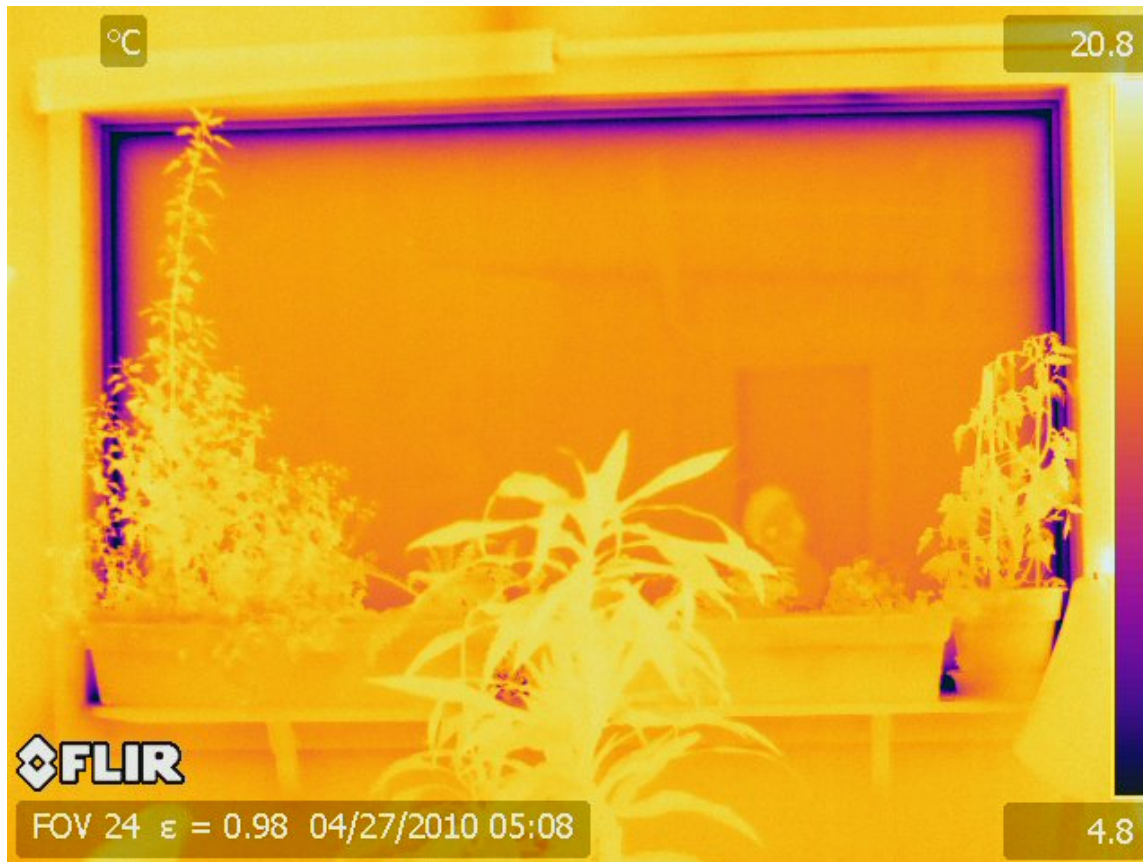
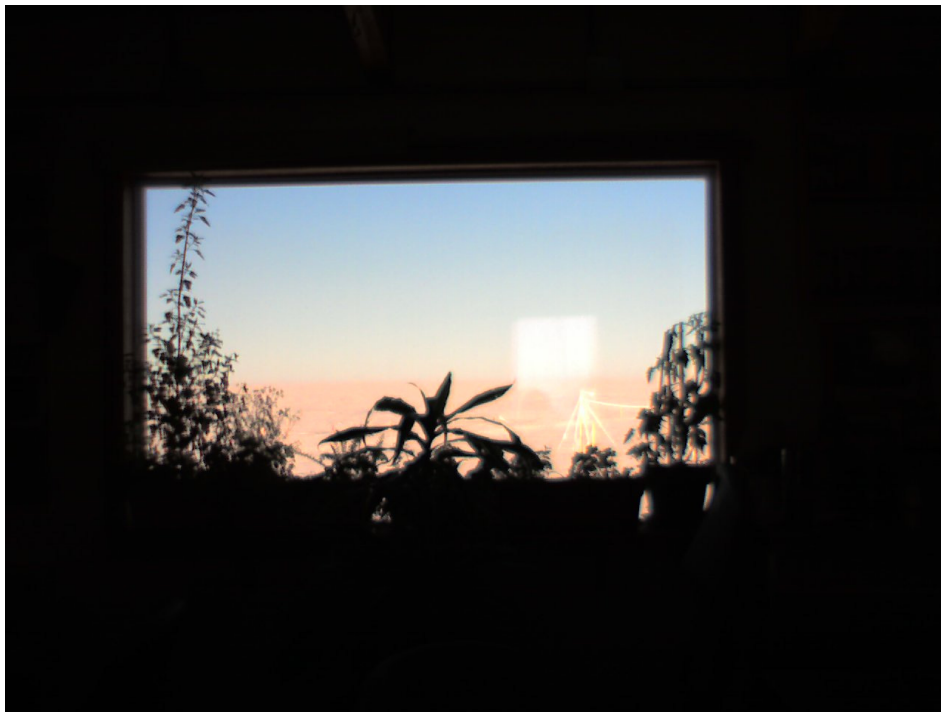
In Figure 37 the IR image of the quad-pane window shows a uniform temperature around the frame of the window. This is consistent with the exterior view and illustrates the difference in energy efficiency between the quad-pane window and the other windows.

Figure 37. IR and visual images of the quad-pane window in the main room.

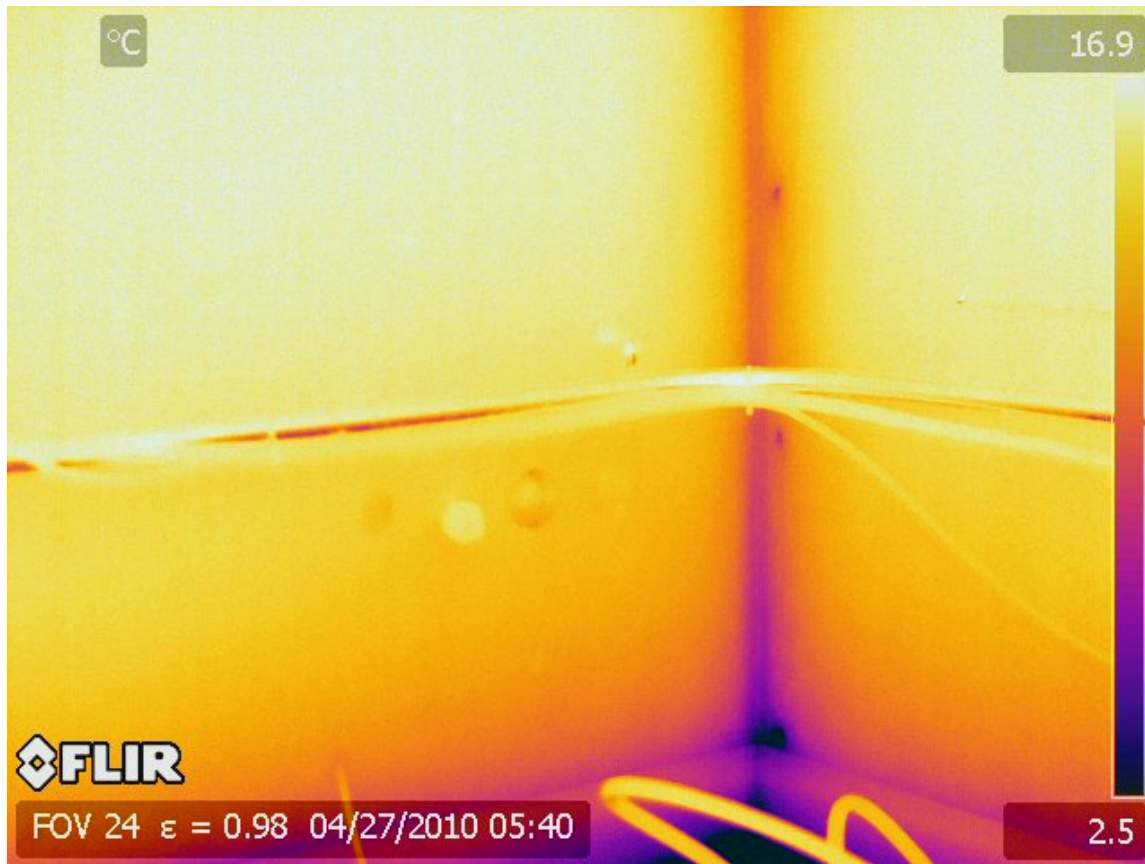
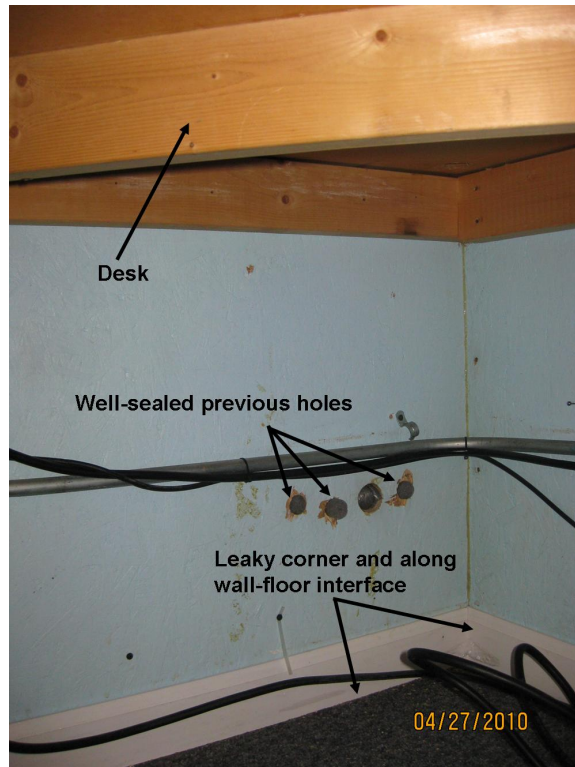
Figure 40. IR and visual images of the north-eastern corner below the desk in the office.

Below the desk (Fig. 40) are leaks at the corner and the wall–floor interface, with similar temperatures as the cold location under the counter in the main room. There are boxes and items stored under the desk that may be insulating this area so that the cold may not be noticeable to people working there. Also under the desk in this same wall were several holes that were well-sealed and did not show up in the IR imagery. It is recommended that previous penetrations to the building envelope that are no longer needed to support instrumentation be removed and completely re-insulated and sealed.

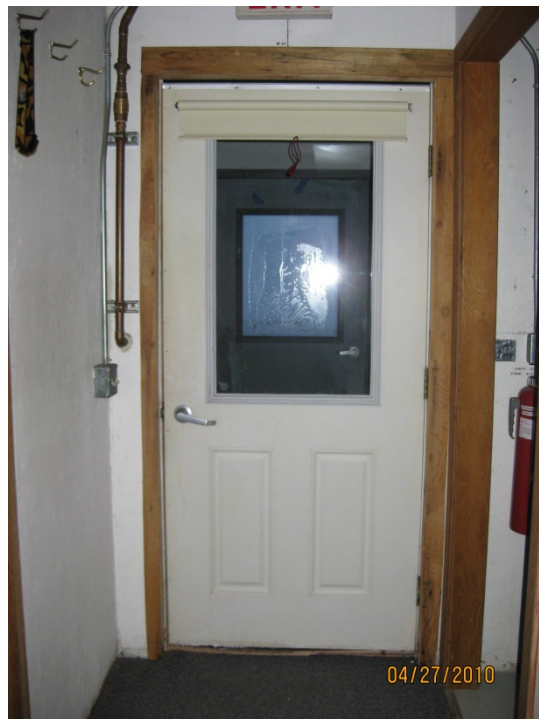
Figure 43. IR and visual images of the main entrance door in the west vestibule.

image in Figure 43 for the entry on the western side shows significant air leakage at the threshold under the door and along the sides. The framing in the wall is visible in the IR image, suggesting that additional insulation or sealing may be needed. This entryway receives heavy traffic as it is used to carry heavy boxes and items to the kitchen for food preparation.

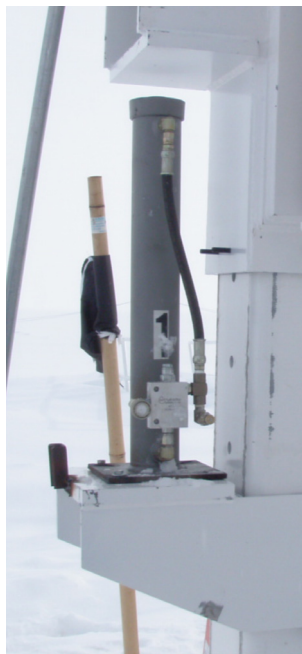
The lifting procedure requires lengthening, when necessary, the steel columns to provide vertical height. The height of the column is typically sufficient for two lifts, and as a result extensions are added every other lift. Hydraulically operated jacks are placed between the center traveler of the column and the lower jack stand (Fig. 44) (CPS draft).

Figure 44. Position of hydraulically operated jack for lift procedure (CPS draft).

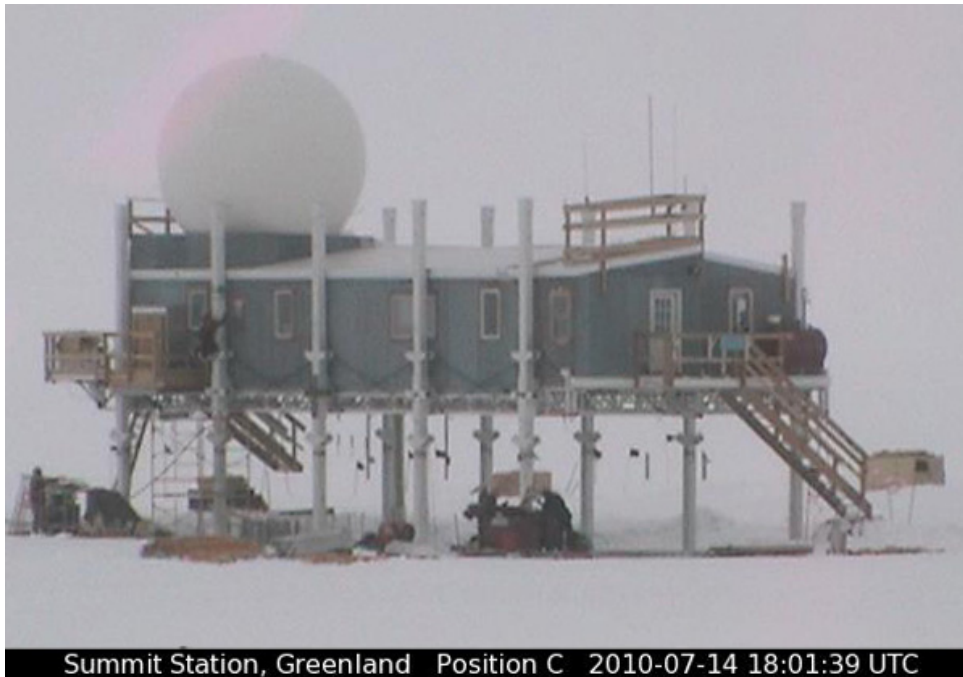
For previous lifts, each column was lifted separately. A new hydraulic pump system was designed and used during the 2010 summer season that allowed the entire structure to be lifted, decreasing the amount of time needed to lift the building. Figure 45 shows the Big House after it was lifted during the summer 2010 season.

Figure 45. Completed lift of the Big House during the 2010 summer season.
