*Monitoring Completed Navigation Projects Program*

## **Lock Wall Expedient Repair Demonstration Monitoring, John T. Myers Locks and Dam, Ohio River**

October 2011

Final report

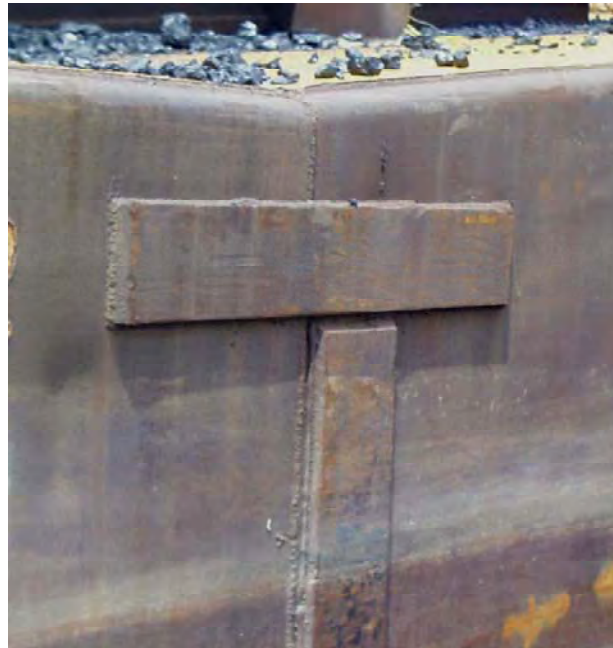
Figure 11. Example of barge protrusions.

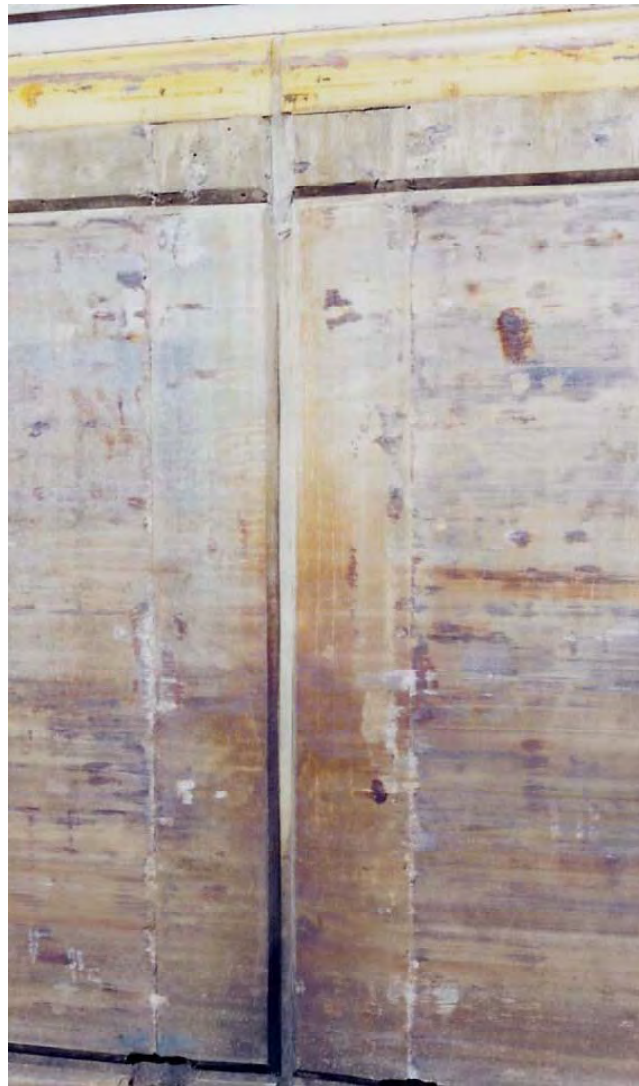
Figure 13. Precast panel joint at Allegheny Lock after four years of service.

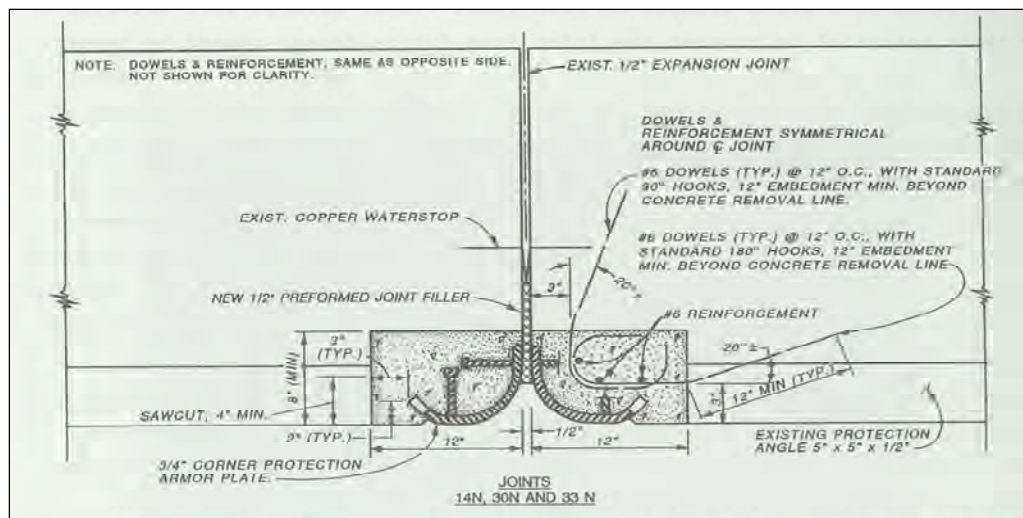
Figure 21. Algiers Lock, curved armor plate.

Curved armor plate was used to provide a recessed corner protection for selected monolith joints at Algiers Lock (Figure 21). Also, an ultra-high molecular-weight polyethylene liner was used in lieu of steel to armor other joints at Algiers Lock (Figure 22). The liner was fixed on one side and free on the other side to accommodate joint expansion and contraction (May and McDonald 1989).

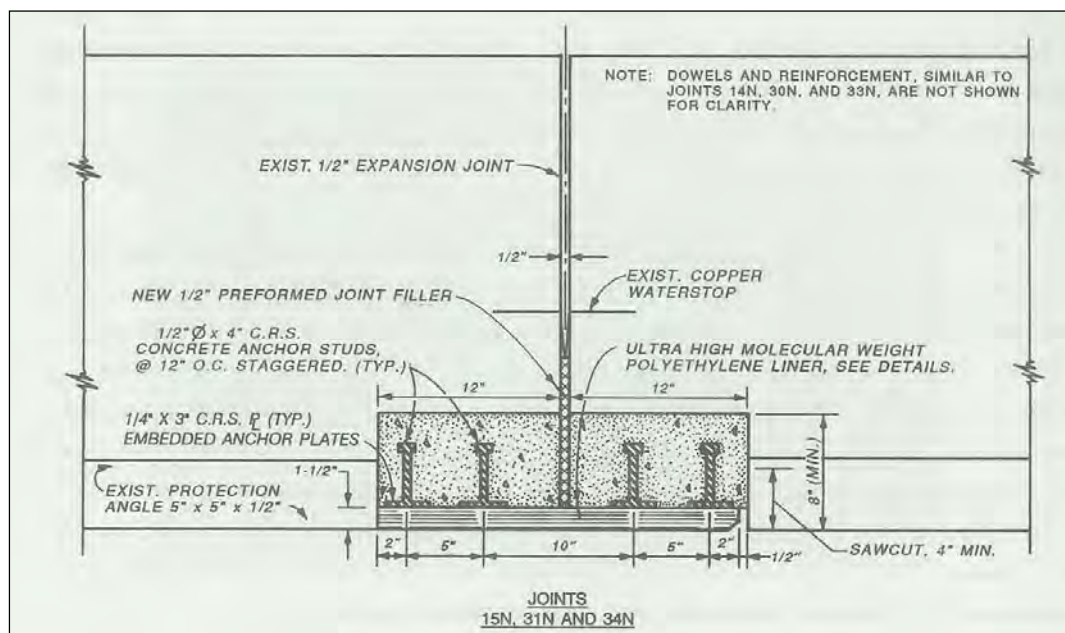
Figure 22. Algiers Lock, polyethylene liner instead of armor plate.

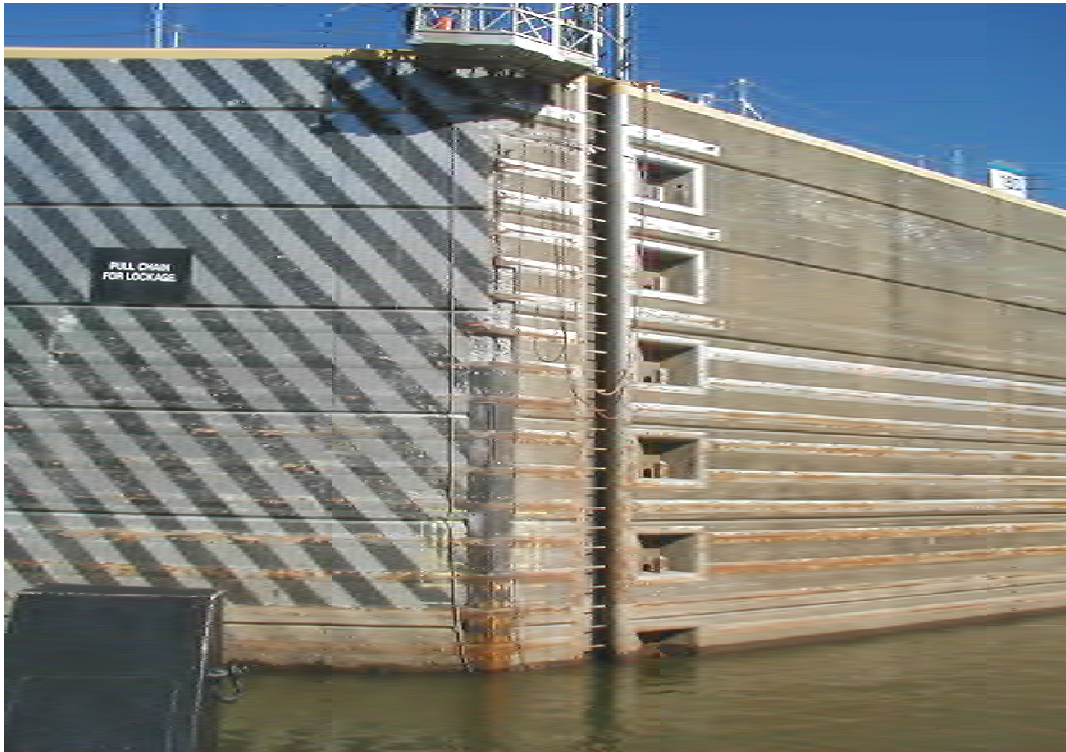
Figure 55. 600-ft chamber lower land-wall approach vertical joint during repair activities.

The top 13.5 ft of monolith L-1 on the downstream side of the vertical joint undergoing repair did not have wall armor rub strips. Hence, the repair steel plate for this area was not 16-in.-high by 12-in.-wide as were those placed below. This section of repair steel plate required dimensions of 13.5-ft-high by 12-in.-wide. The anchor bolts embedded into the concrete monolith were spaced appropriately for this dimension, as were the holes drilled into the plate. Figures 56 and 57 are photos of the vertical joint showing both sides of the finished repair.

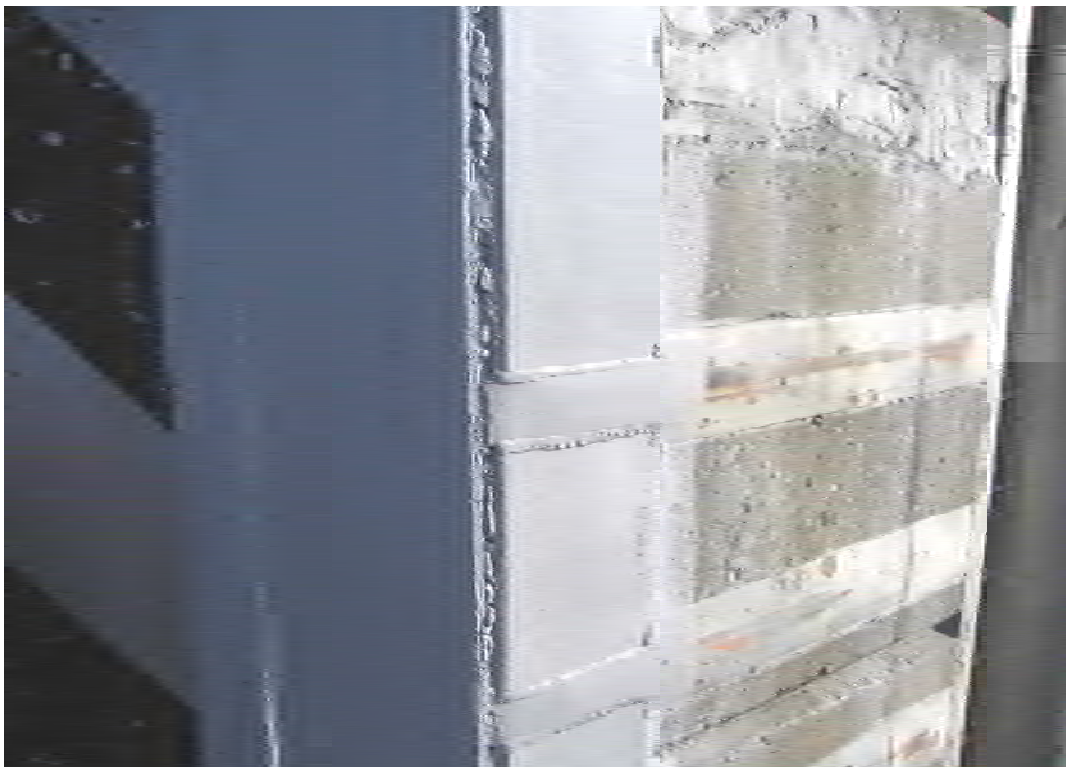
Figure 56. Closeup photo of the 13.5-ft-high by 12-in.-wide top repair steel plate of monolith L-1 on the downstream side of the joint and the 28-in.-high by 12-in.-wide top plate of monolith L-2 on the upstream side of this joint.

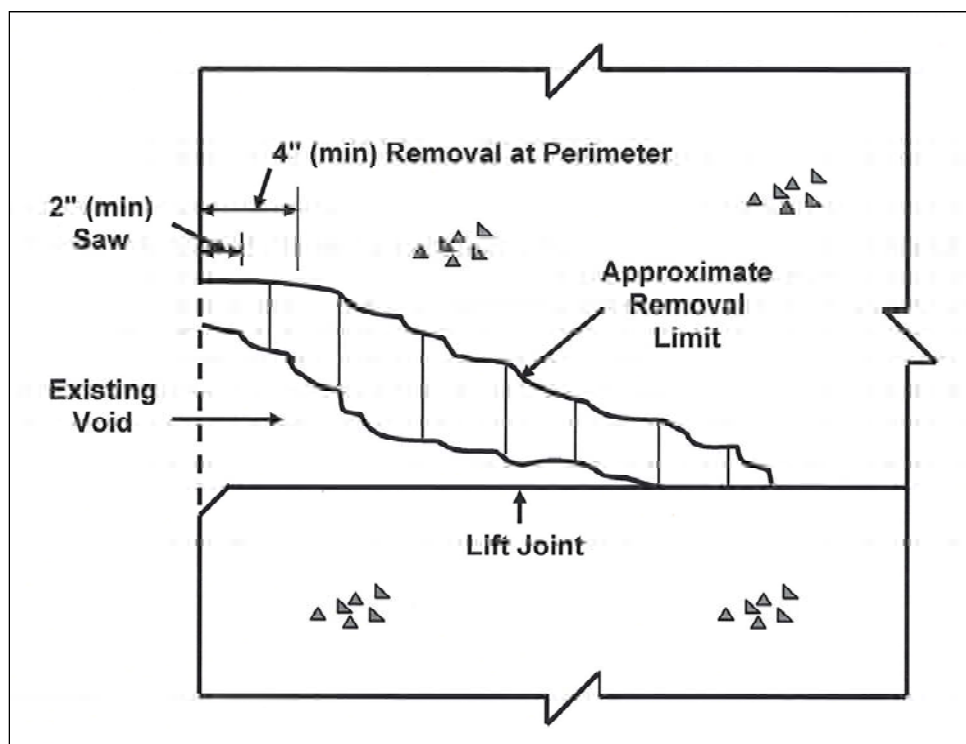
Figure 61. Transverse section through existing void.

Existing concrete within the repair area shall be removed to sound concrete with a 4 in. minimum depth of removal (Figure 61). Continue to remove concrete until aggregate particles are being broken rather than simply removed. Concrete shall be removed to provide a gradual transition from the 4 in. minimum depth to the zone of maximum removal. The upper edge of the concrete surface shall be trimmed to eliminate potential entrapped air pockets that would prevent complete filling of the repair cavity. Proper concrete removal is a primary requirement for the outer two-thirds of the repair cavity. Removing concrete from the back of the confined space is difficult, and removal in this area could be limited to loose material.

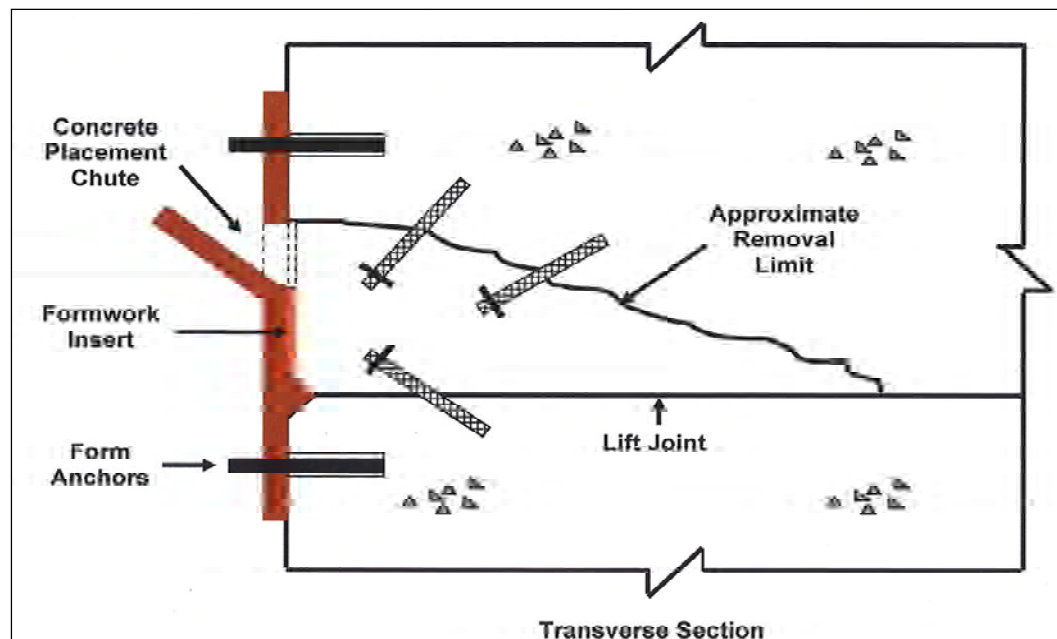
Figure 63. Section through repair cavity showing formwork and placement chute.

Placement openings or chutes are required to place the repair material and allow for insertion of a vibrator for internal consolidation of the repair material (Figure 63). Chutes must be constructed to allow overfilling of the repair cavity prior to consolidation. This is necessary to ensure that the upper edges of the repair cavity are completely filled after consolidation. Forms shall be designed to permit rapid removal without hammering or prying against the repair.

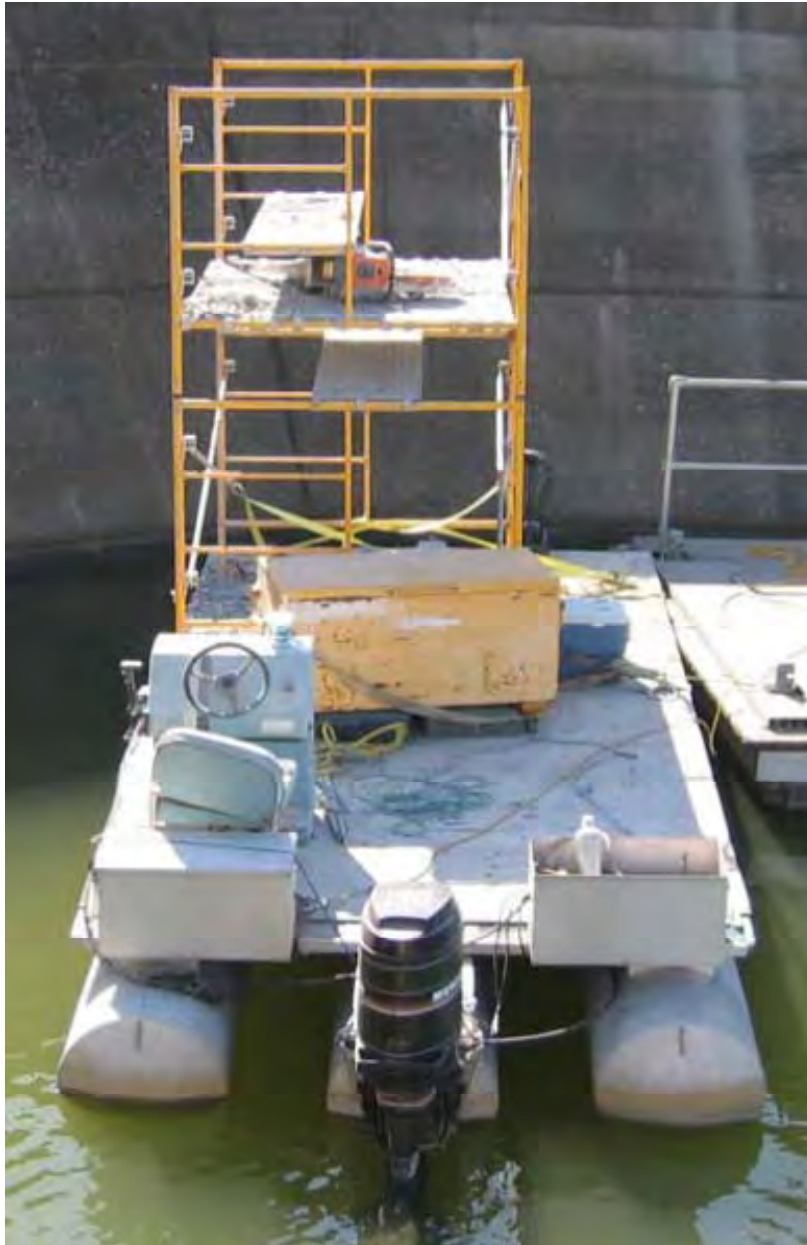
Figure 68. Floating platform for access to repair area.

Two tiers of scaffolding mechanically attached to the deck of a 20-ft-long by 8-ft-wide self-propelled floating work platform were used for access to the repair area (Figure 68). This system allowed contractor employees to easily access the repair area during periods between normal lock chamber operations (Figure 69).

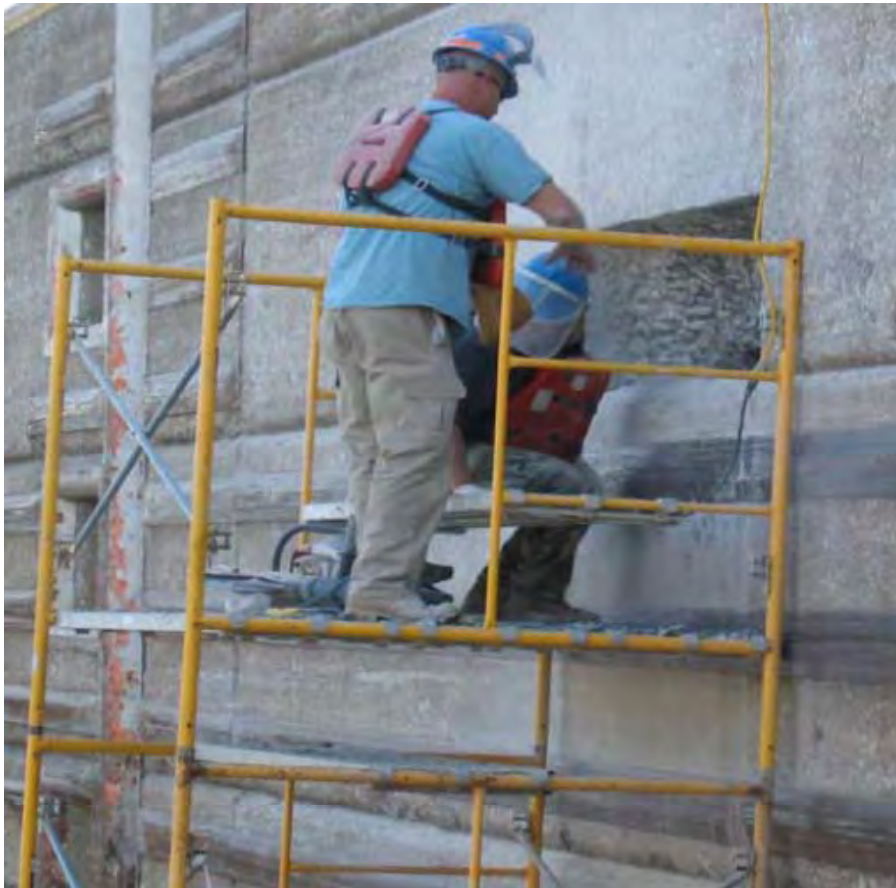
Figure 69. Contractor employees easily accessing work area via floating platform and removing concrete from the repair area.
