COST AND PERFORMANCE REPORT

Ultrasonic Guided Wave Technology for Non-invasive Assessment of Corrosion-induced Damage in Piping for Pollution Prevention in DOD Fuel Storage Facilities

ESTCP Project WP-200819

Version 2

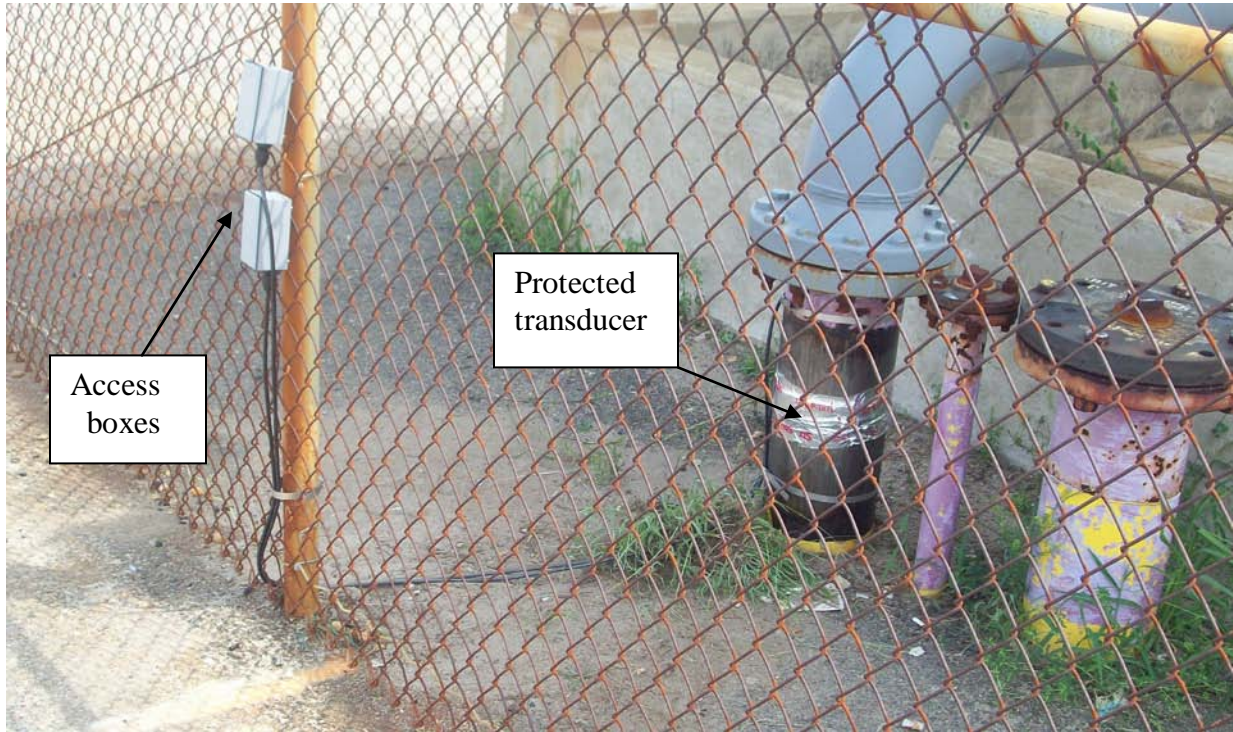
Figure 7. Access boxes for signal monitoring outside of restricted areas around VP5.

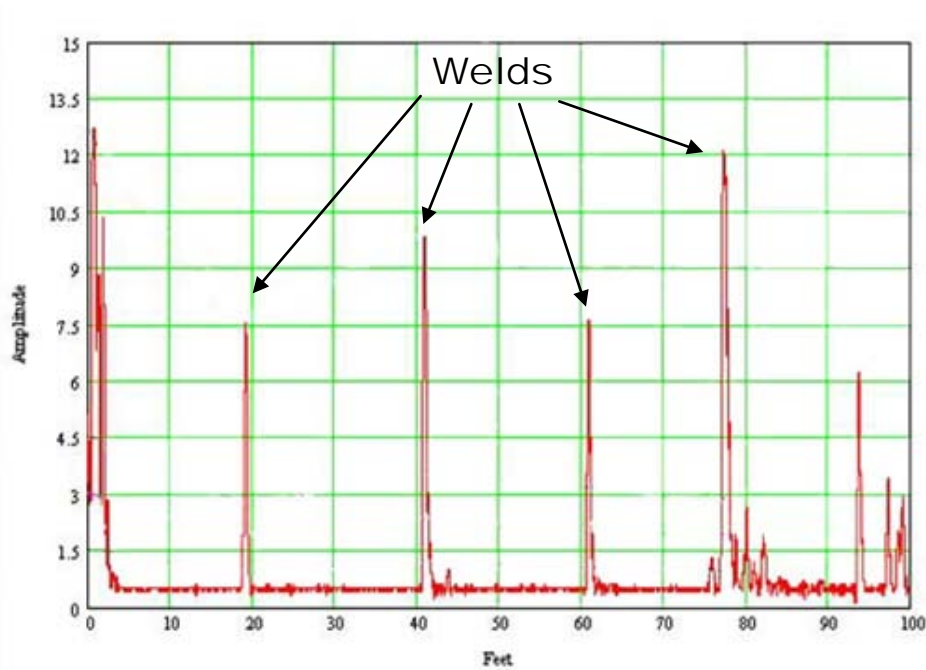
An example of ultrasonic guided wave data showing peak height versus distance along the pipeline (see Figure 4) is shown in Figure 8. Wave propagation speed has been utilized to convert time of flight information to distance information along the pipe. In this figure, the large peaks are reflections from the welds. We note the existence of some small signal peaks with unknown origin before the initiation of corrosion that are not associated with welds. They could

be caused by pipe stands, as-manufactured material anomalies, or other unknown conditions. We will come back to these points later in this report.

Figure 8. Example of plotted ultrasonic guided wave baseline data for the above-ground coating system pipeline at NSWCCD before corrosion was initiated. The plot shows peaks originating from welds, approximately 20 feet apart, as sensed by a transducer mounted in location 2.

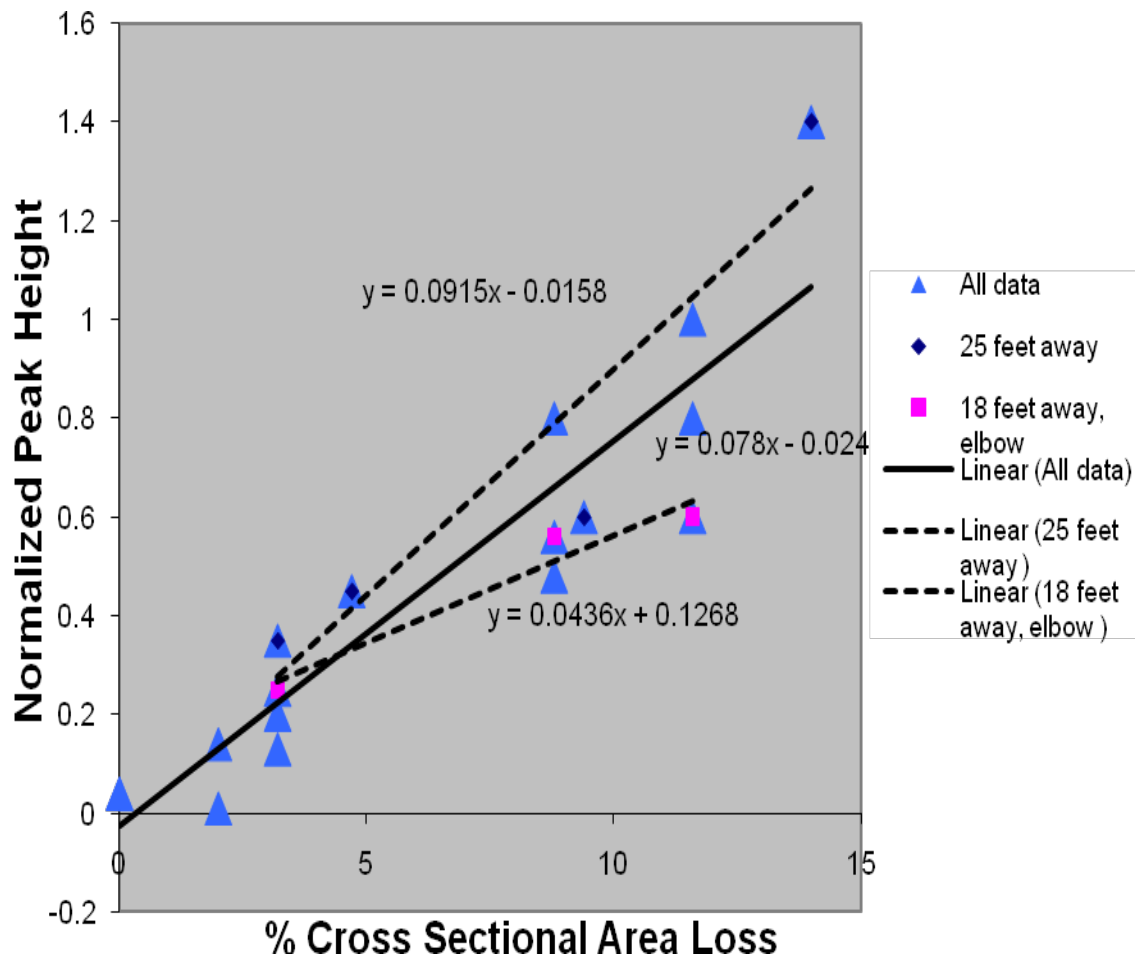
Three trend lines are shown in Figure 10 to summarize the Phase I results. The solid line is based on all the data obtained in Phase I. It represents an averaged trend that provides an empirical “calibration” curve converting relative signal peak height to percentage CSAL for defects. The other two trend lines (dotted) were generated using the two subsets of data including the effects of an elbow (labeled “18 feet away” in the legend) and the ones representing the largest defects (labeled “25 feet away” in the legend). These two dotted trend lines provide the upper and lower bounds for the slope of the average trend line. Defects with 5% and 10% CSAL produced signal peak height of 0.35 and 0.65 volts, respectively, on the average trend line with uncertainties of approximately 25%. These uncertainties are the results of combining all the data obtained from different transducers, located at distances from 12 to 62 feet from the defect, the existence of a variable number of welds and an elbow, as well as defects of different area, volume, and shape.

Figure 10. Trend lines for the increase in signal height as the CSAL increases for data obtained in Phase I.

If we focus our attention on the signals associated with a single transducer, as would be appropriate if we are only interested in measuring the changes of the system from a baseline condition, we realize that the slope of the trend line is mainly controlled by the variations of electronic noise and defect shape change over time. The details of the wave propagation across welds and elbows, as well as, scattering mechanisms affecting the absolute signal peak heights are less important when only signal changes are considered, since the effects of these variables (except for the size of the defect) are constant as a function of time. For the purpose of tracking defect growth, we observed in Figure 10 that the slope of the average trend line departs from those represented by the two extremes by no more or less than a factor of 2. Additional discussions of the Phase I results can be found in the Final Report [3] and a recently published paper [4].
