## **Investigation of Failed Components from a 7-in High Altitude Research Program (HARP) Cannon**

**ARL-TR-5814**

**November 2011**

**Weapons and Materials Research Directorate, ARL**

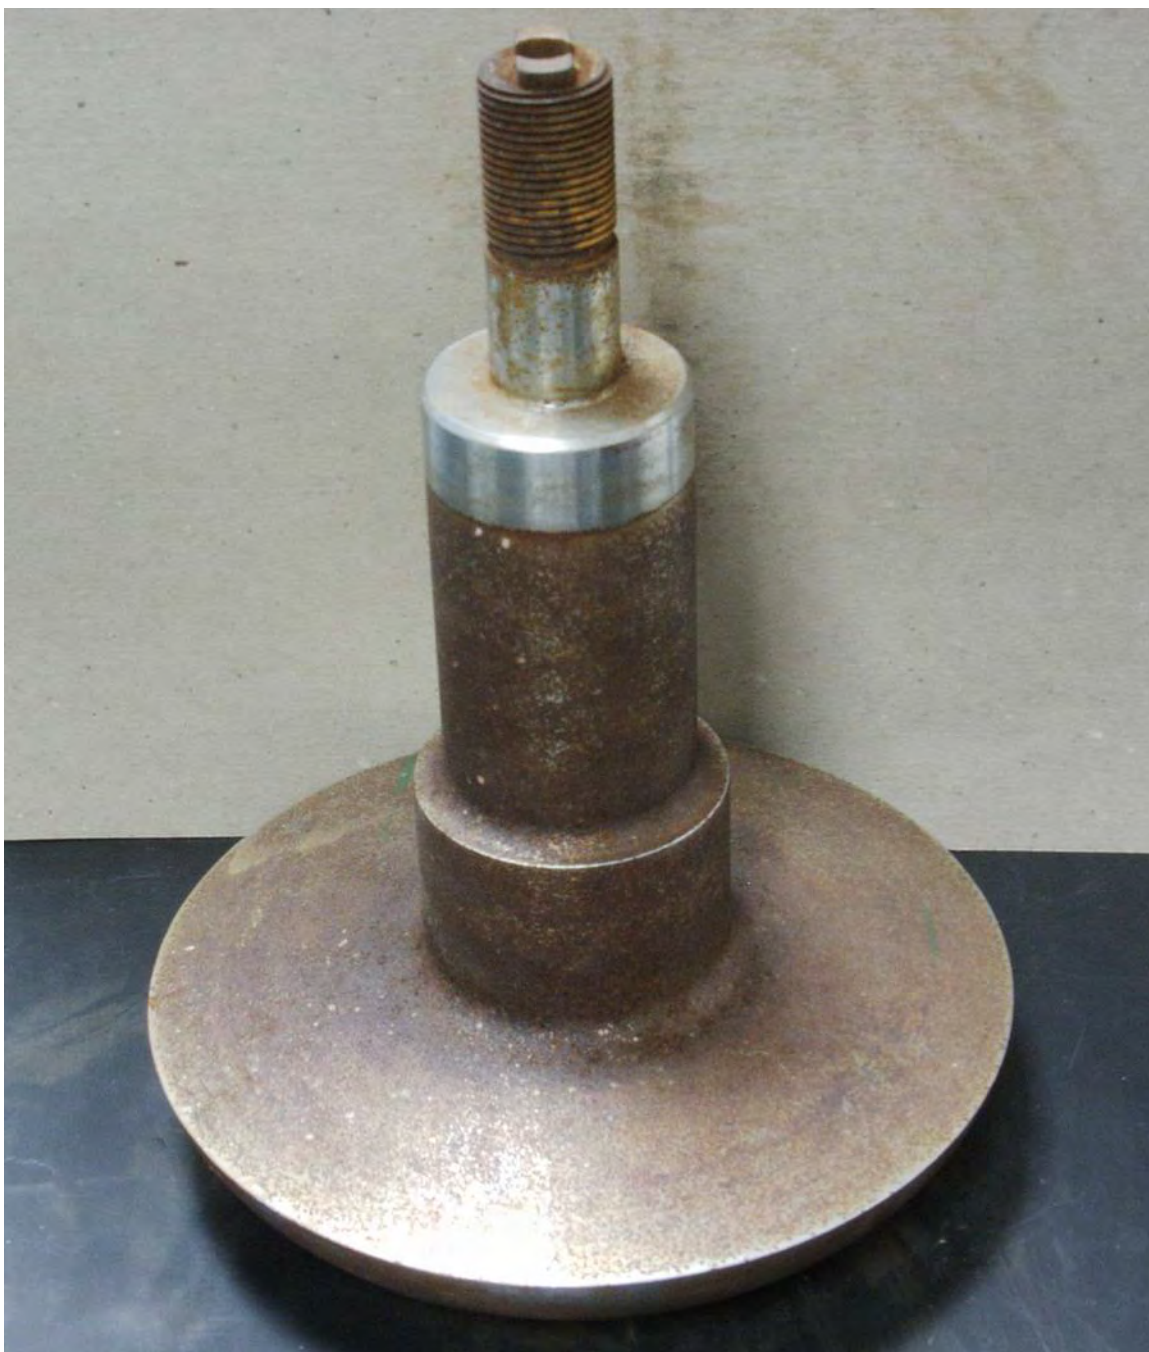
Figure 24. Geometry of an intact spindle, similar to the failed component.

The primary focus of the HARP breech failure was on the spindle, although there were secondary fractures to the assembly. The failed spindle can be observed in figure 1 and compared with the geometry of an intact spindle of similar design in figure 24. The mating fracture half from the failed spindle was never recovered. By contrasting the two figures, it can be discerned that the failure of the spindle occurred very near the end of the turned threads on the spindle.

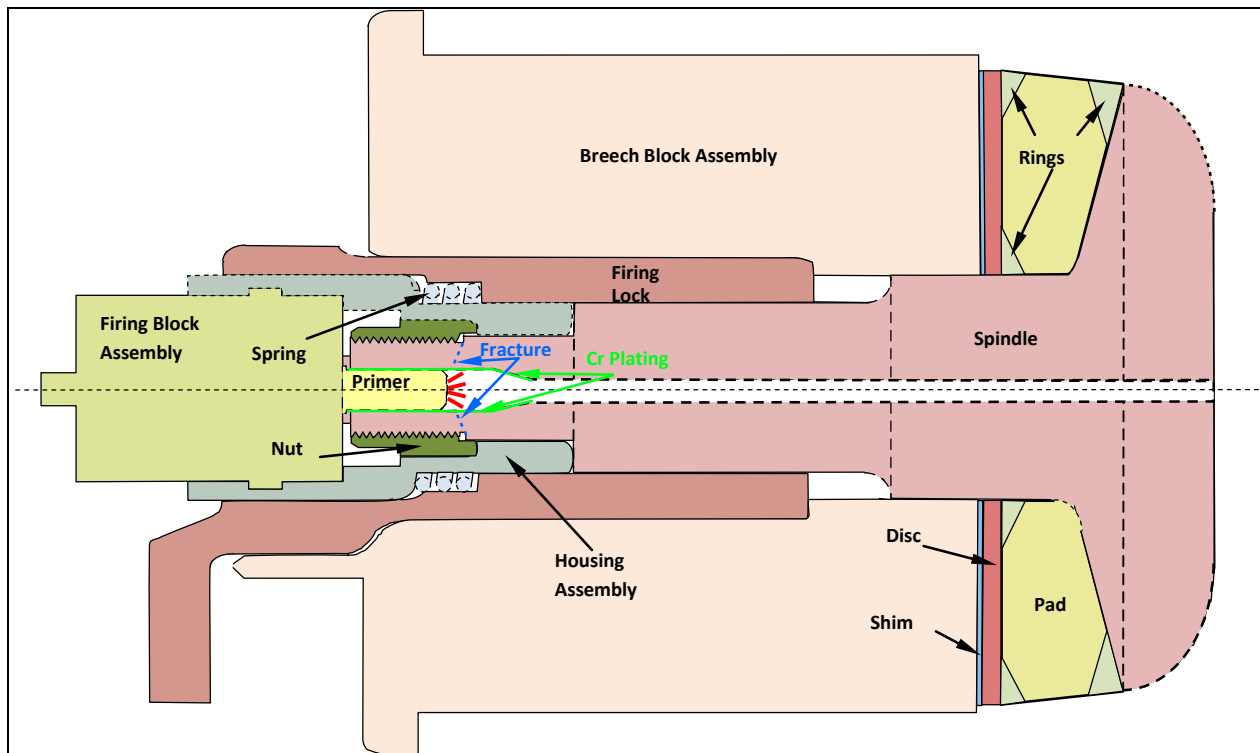
Figure 25. Simplified schematic showing the primer/spindle thread proximity.

Coincidentally, this area is near the exit of the Mk-15 primer cartridge when fitted and locked into the interior bore of the spindle. This relationship can be observed via the simplified schematic in figure 25. From a design perspective, it is likely less than optimum that the exit from the primer charge is located upstream and adjacent to the machined step for the threads. A side-by-side comparison between the failed spindle and an intact example can be viewed in figure 26.
