ESTCP Cost and Performance Report

Ultrasonic Guided Wave Technology for Non-invasive Assessment of Corrosion-induced Damage in Piping for Pollution Prevention in DOD Fuel Storage Facilities

September 2011

Project: WP-200819

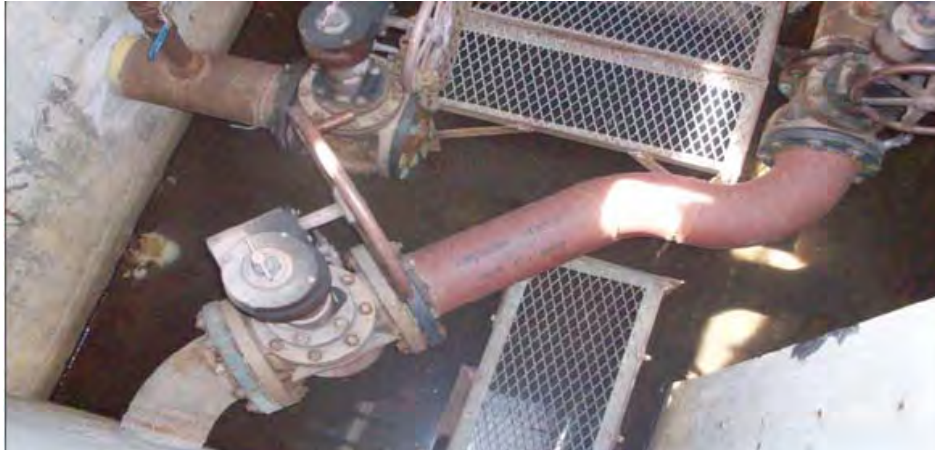
Figure 3. Pipeline accessories inside a valve pit.

JP-5 jet fuel in storage tanks on Craney Island supplies the needs of Navy aircrafts at Naval Station Norfolk via this pipeline that runs through the Elizabeth River before reaching the shores in Norfolk. Sections of the pipeline between VP 5 and VP 7 were deemed unpiggable because of the existence of internal obstructions and reducers and because of cost considerations for a relatively short line. An example of obstructions inside a valve pit is shown in Figure 3.

The second important aspect is that pipe sections typically have bends, elbows, valve attachments, and even flanges within the confined space of 5 to 15 ft inside the pit (see Figures 3 and 6b). These features have the following ramifications. First, guided wave cannot propagate across a flange. Its existence prevents the interrogation of the pipe in the direction away from the pit if a transducer cannot be placed between the flange and the wall in the valve pit. This was the situation in valve pits 21, 22, and 23 and thus limited wave propagation to one direction only away from the pit. Second, the characteristics of the waves in the forward and the reverse directions generated by one transducer would be very different since the complex components inside the pit strongly modified the waveform in the reverse direction. This had the consequence that attempts to compare the forward to the reverse waves to check for consistency in peak identification, as we did in Phase I, was not successful due to the significant distortions in wave propagation in the reverse direction.

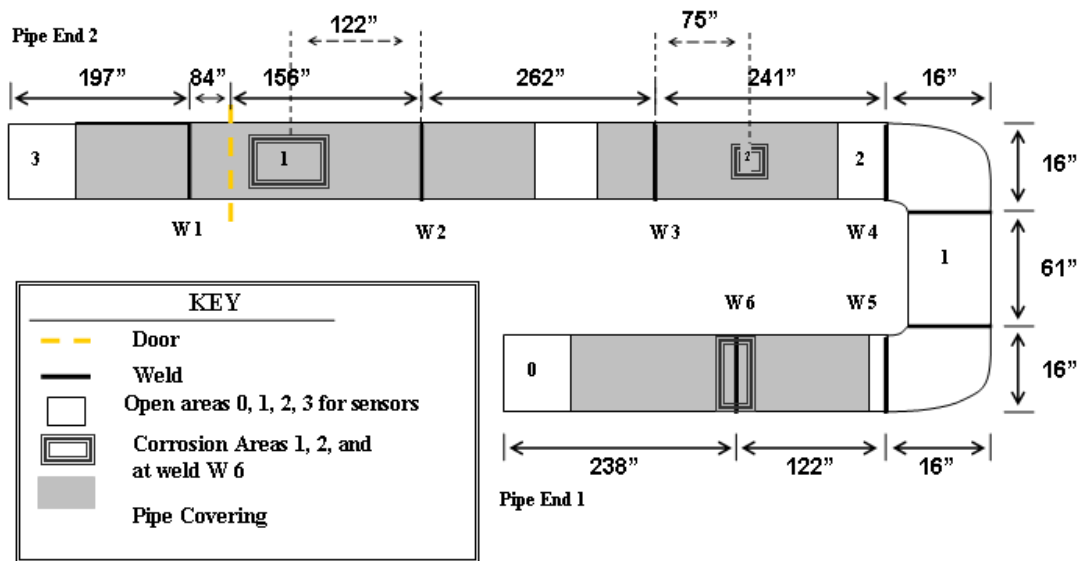
Figure 4. Location of ultrasonic measurement points and corrosion defects in the 8.6-inch diameter pipeline at NSWCCD.

Figure 4 illustrates the locations of the corrosion-induced defects. Two defects (unknown to the inspectors) were placed in the long straight sections of the pipeline. One of the defects not only increased systematically in its depth, but also along the pipe axis and along its circumference as the exposure progressed (Defect 1). The other defect was intended to be a "small" defect (Defect 2) having a fixed lateral dimension of approximately 3×3 inches, but with increasing material loss in the thickness direction. The goal was to achieve a wall thickness loss exceeding 50% in this defect by the end of Phase I.

In Figure 4, regions 0, 1, 2, and 3 show where transducers were mounted. We see that waves excited by Sensor 3 propagating in the negative direction should reach Defects 1 and 2 before reaching an elbow. Waves excited by Sensor 2 propagating in the positive direction should reach Defects 2 and 1 before it reaches the pipe end. Waves excited by Sensor 1 should see Defects 2 and 1 after crossing an elbow in the positive direction and see the Defect W6 in the negative direction after crossing an elbow. Waves excited by Sensor 0 and propagating in the positive direction sees Defect W6 before reaching either elbow and beyond.

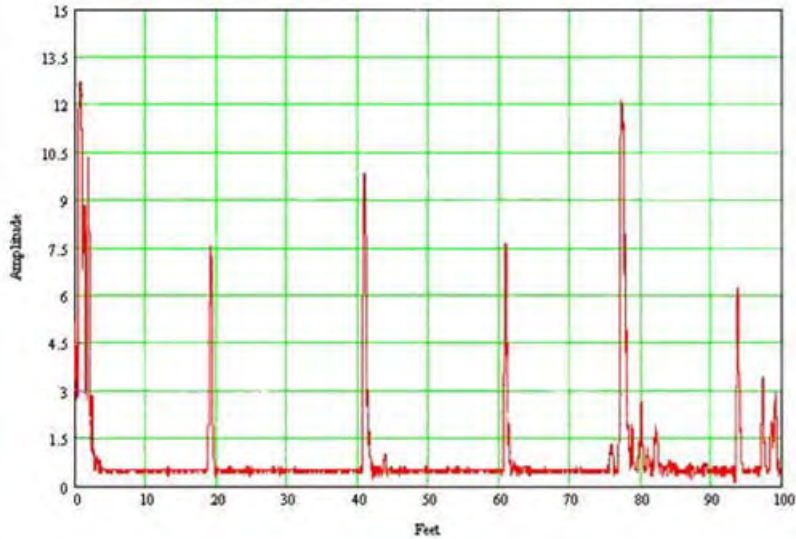
An example of ultrasonic guided wave data showing peak height versus distance along the pipeline (see Figure 4) is shown in Figure 8. Wave propagation speed has been utilized to convert time of flight information to distance information along the pipe. In this figure, the large peaks are reflections from the welds. We note the existence of some small signal peaks with unknown origin before the initiation of corrosion that are not associated with welds. They could be caused by pipe stands, as-manufactured material anomalies, or other unknown conditions. We will come back to these points later in this report.

Figure 8. Example of plotted ultrasonic guided wave baseline data for the aboveground coating system pipeline at NSWCCD before corrosion was initiated.

The plot shows peaks originating from welds, approximately 20 ft apart, as sensed by a transducer mounted in location 2.

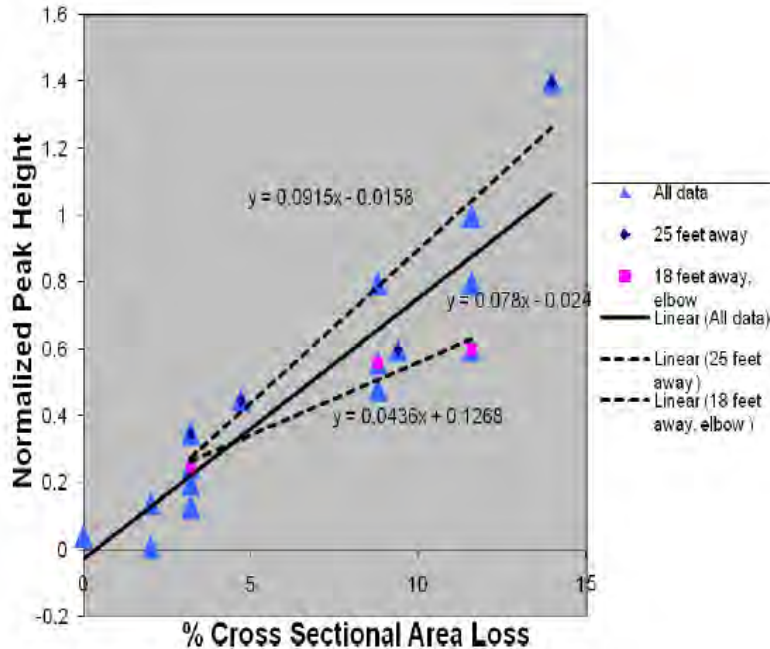
Three trend lines are shown in Figure 10 to summarize the Phase I results. The solid line is based on all the data obtained in Phase I. It represents an averaged trend that provides an empirical “calibration” curve converting relative signal peak height to percentage CSAL for defects. The other two trend lines (dotted) were generated using the two subsets of data including the effects of an elbow (labeled “18 ft away” in the legend) and the ones representing the largest defects (labeled “25 ft away” in the legend). These two dotted trend lines provide the upper and lower bounds for the slope of the average trend line. Defects with 5% and 10% CSAL produced signal peak height of 0.35 and 0.65 volts, respectively, on the average trend line with uncertainties of approximately 25%. These uncertainties are the results of combining all the data obtained from different transducers, located at distances from 12 to 62 ft from the defect, the existence of a variable number of welds and an elbow, as well as defects of different area, volume, and shape.

Figure 10. Trend lines for the increase in signal height as the CSAL increases for data obtained in Phase I.
