ABU GHRAIB DAIRY  
ABU GHRAIB, IRAQ

**SIGIR PA-09-172**  
**JANUARY 14, 2010**

## Abu Ghraib Dairy

### Summary of Report: PA-09-172

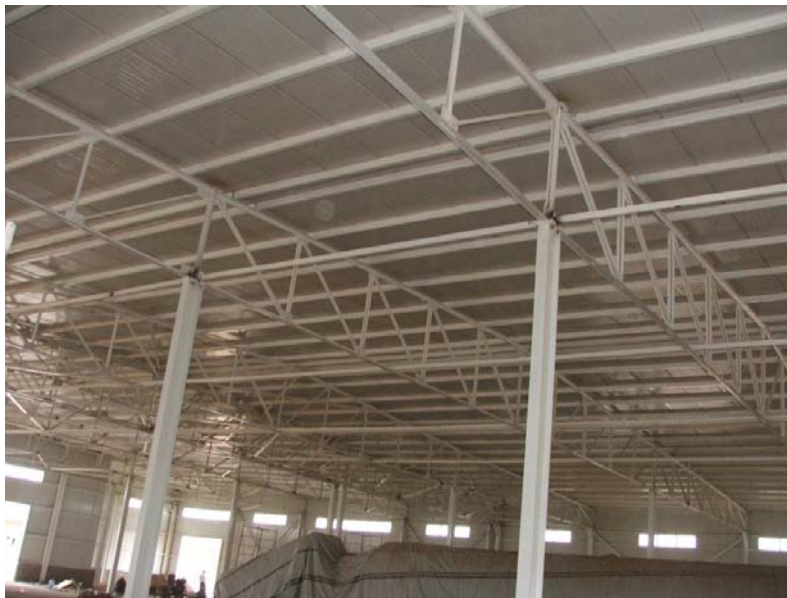
**Site Photo 6. Lateral brace connection at column cap plate**

At the time of the site visit, all structural steel, with the exception of the mezzanine, had been erected. The steel structure for the dairy building consisted of continuous steel trusses supported by steel columns (Site Photo 6). The trusses at the ends of the structure and at either side of the expansion joints were braced with diagonal bracing in the plane of the upper and lower chord. The trusses are also braced transversely in the plane of the lower chord with steel braces running the length of the structure.

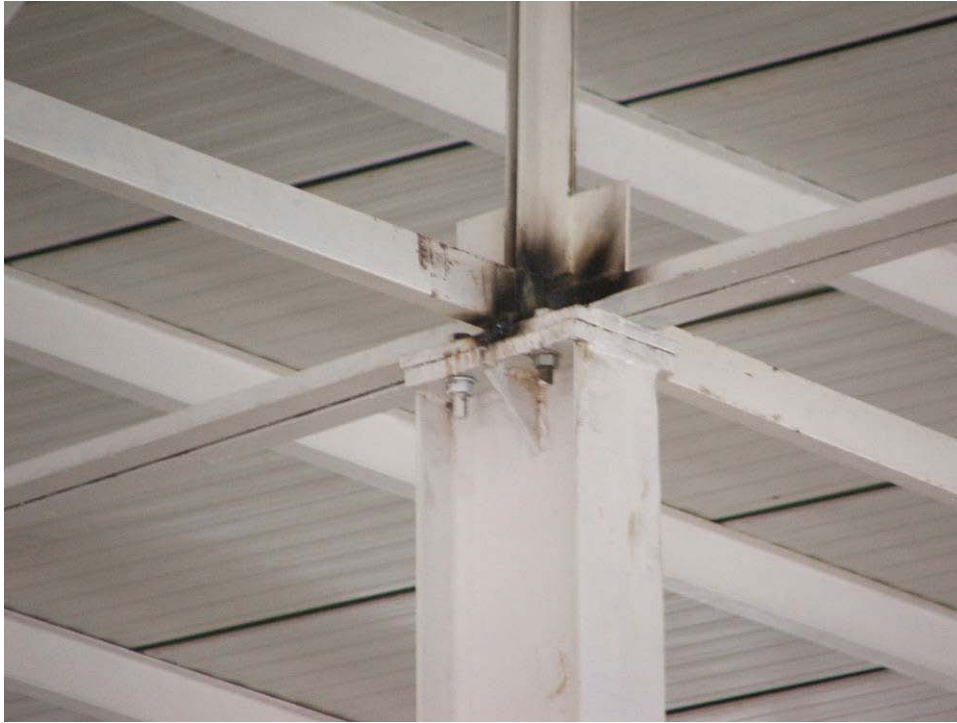
**Site Photo 9. Lateral brace connection at column cap plate**

Lower bracing was welded to the column cap plate (Site Photo 9), which acts to resist lateral sway at the top of the column. Since the truss is continuous, loads from the roof will induce compressive stress in the bottom chord above the column. The compressive stress could produce buckling in the lower chord. The connection between the truss and the column is effectively a hinge point, and the lateral bracing is essential to resist this buckling and prevent movement of the column.

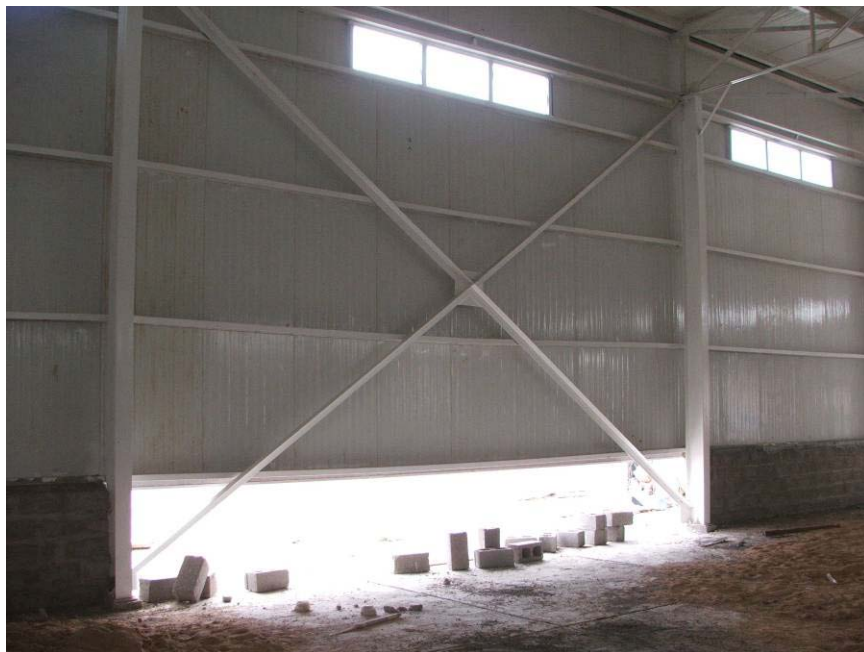
**Site Photo 10. Lateral cross bracing between columns**

Lateral bracing is provided along exterior column lines of the structure. The bracing is provided as vertical steel cross-bracing along the exterior column line perpendicular to the steel trusses (Site Photo 10). As previously noted, the bracing interferes with the

CMU walls due to a contractor construction error. The bracing appeared to be completely installed at the time of the visit.

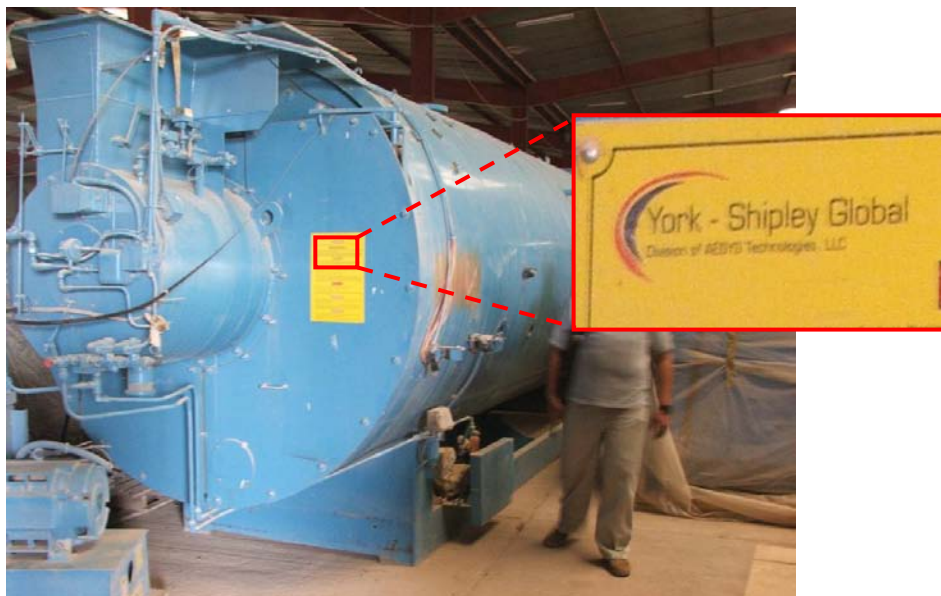
**Site Photo 17. Dairy production equipment**

With the exception of one large piece of equipment already located inside the newly constructed facility, the milk processing and packaging equipment is stored inside a leaking warehouse<sup>23</sup> near the Abu Ghraib Dairy (on the Ministry of Industry and Minerals compound). SIGIR toured the warehouse and found most of the equipment in its original packaging and appeared to be in good condition. One of the pieces of equipment sustained some damage due to either improper storage or handling (Site Photo 16). SIGIR was able to identify several pieces of equipment with visible nameplates (Site Photo 17), and the remainder of the equipment was labeled with shipping labels.

<sup>23</sup> It had recently rained and SIGIR observed a noticeable amount of water on the floor and on the equipment.
