*Monitoring Completed Navigation Projects Program*

## **Kaumalapau Harbor, Hawaii, Breakwater Repair**

May 2012

Final report

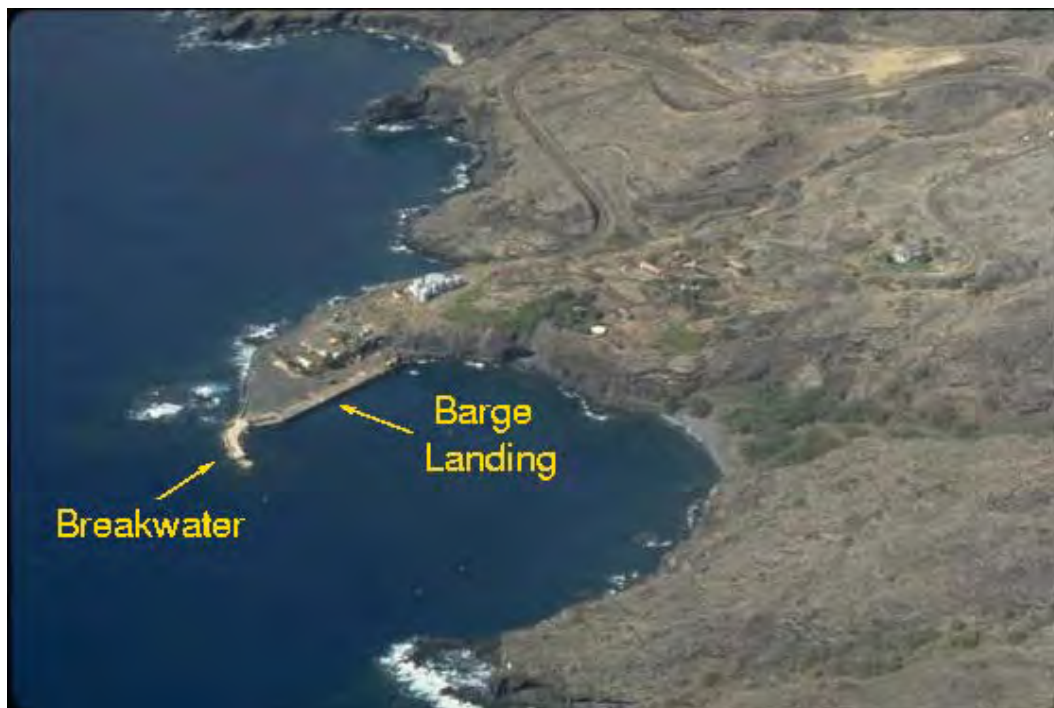
Figure 1.2. Kaumalapau Harbor barge landing and breakwater prior to 2007 repair.

The original breakwater structure may have been an “engineered” design, or it may have simply been a rubble mound constructed of a random mix of available stone. Even if it was an engineered structure, it would not have met the criteria required by modern breakwater design practice, nor would sufficient information regarding oceanographic design conditions have been available to the designer. The breakwater suffered extensive damage over the years, and has been repaired numerous times. A severe “Kona” storm resulting from a low-pressure front southwest of Hawaii damaged the breakwater significantly in January 1980, and Hurricane Iwa caused further damage in 1982.

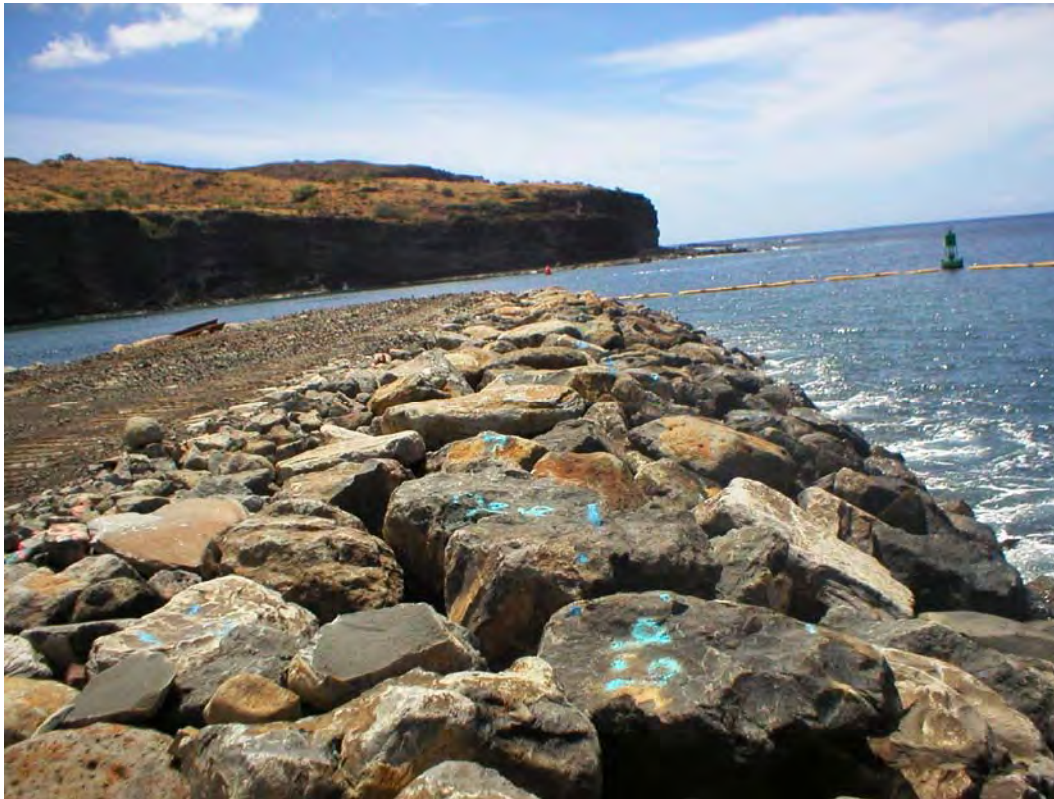
Figure 2.1. Breakwater underlayer prior to placement of Core-Loc armor layer.

The existing rubble mound was excavated and shaped to form the core of the new breakwater. Excavated material was used as core material for the breakwater head, and as stone for a harbor side toe berm. Underlayer stone weighing 2.5 to 4.5 tons was salvaged from the existing structure to the maximum extent possible, and necessary supplemental stone was barged to the project site from the Island of Molokai (Figure 2.1).

The crest cap elevation is +14.5 ft MLLW, and provides for no overtopping during all prevailing wave conditions when the harbor can reasonably be expected to be operating, and only minor overtopping during typically occurring storm wave conditions. Portions of the Core-Loc units randomly extend about 5 to 6 ft above the crest cap. The crest width is 40 ft at the top of the underlayer stone (+9.5 ft MLLW elevation) as shown in Figure 2.1, which permitted use of a ringer crane for construction.

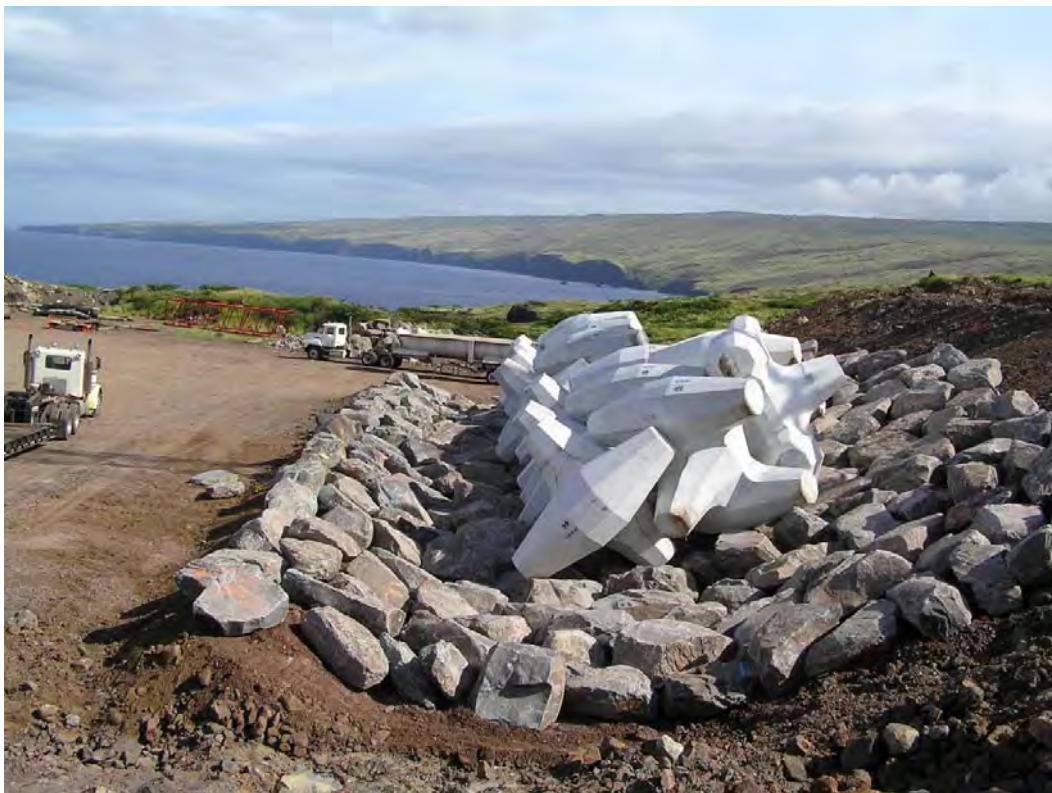
Figure 3.3. Test section constructed on land showing approximation of actual toe trench, and non-random “cannon” orientation (lower row) and “straddled” orientation (upper row) of structure toe Core-Loc armor units.

The specifications for Core-Loc placement also included requirements for building a test section of the Core-Loc placement on land. Constructing with 35-ton armor units is not easy, and errors in prototype construction can be costly and time consuming. Thus, a test section of the Core-Loc placement on land was required prior to starting work on the actual breakwater (Figure 3.3). This gave the contractor a chance to practice slinging units and an understanding of unit attitude variation to facilitate interlocking, and practice adhering to a precise placement plan prior to placing units underwater.

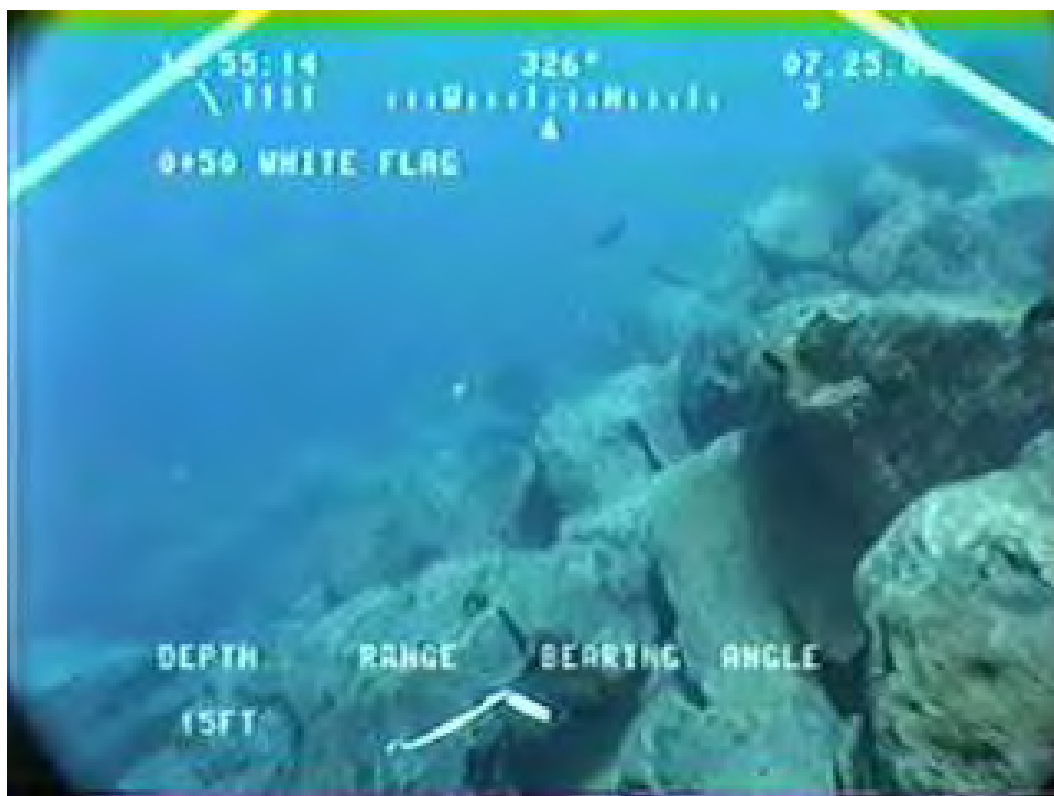
Figure 4.11. Use of ROV for underwater structure inspection of stone underlayer.

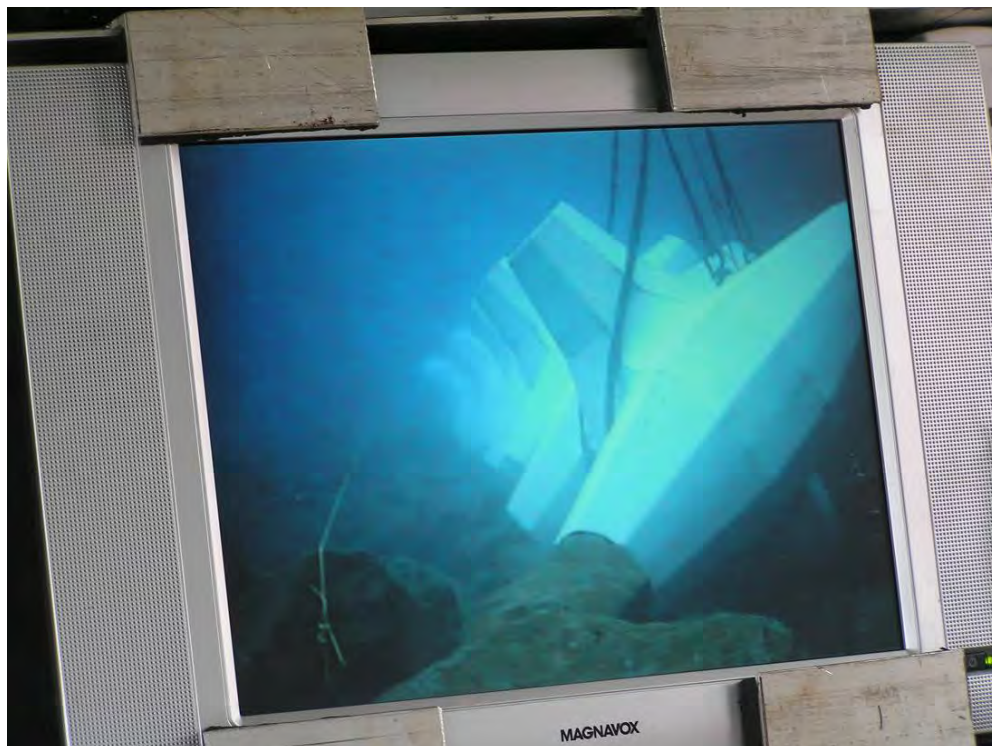
A diver with a helmet-mounted camera was used for final verification of correct Core-Loc placement before it was released from the sling (Figure 4.12). The diver was important particularly for placement of the cannon style toe units and the second row above them. The contractor used diver placement and verification assistance for almost all of the below water Core-Loc placement. The remote cameras worked well, and reduced the reliance on divers as well as providing visual observation as the units were being moved into position when it would have been too dangerous for a diver to be up close. However, the mobility of a diver and the ability to see close up was very important to be sure the unit interlocking was optimized and that the required contact between adjacent units and the underlayer stone was maintained for every unit placed.

Figure 4.12. Operator view of underwater placement of Core-Loc unit from a diver camera.

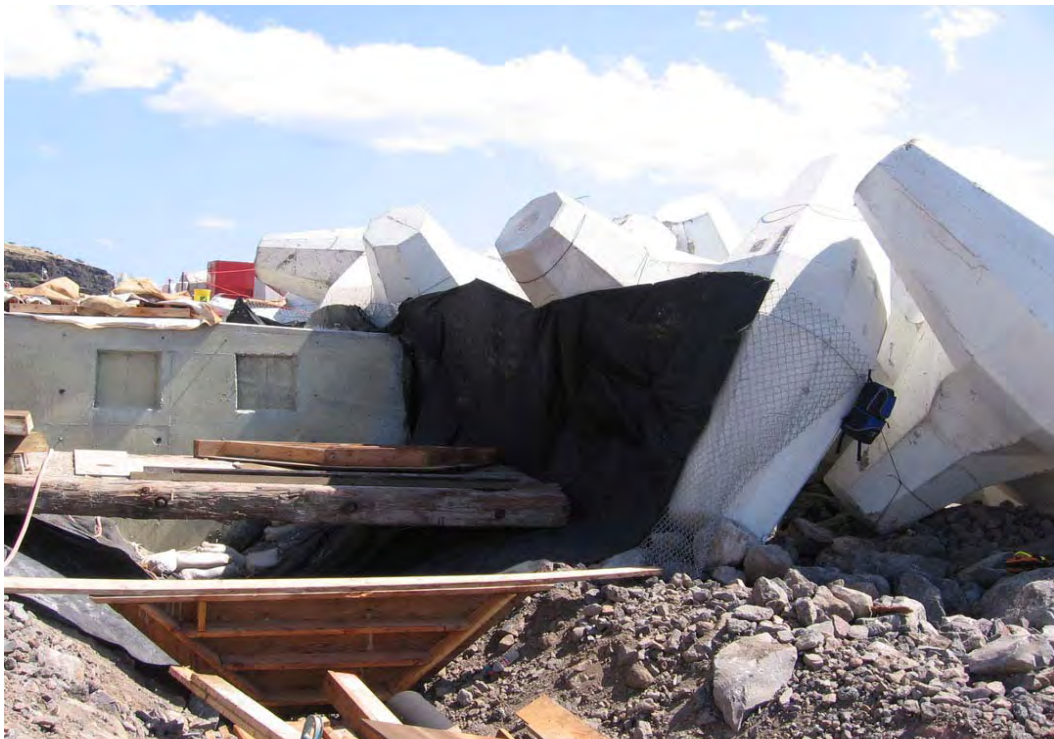
The concrete crest cap was constructed in segments, beginning from the breakwater head and proceeding landward. The segments were to be 10 ft long initially; however, the contractor requested approval to pour them in 15-ft lengths to optimize the use of the batch plant production capability. Figure 4.13 shows a crest cap segment being prepared. Note the shear key female halves cast in the end of the previous segment, and the 3-ft-deep key trench excavated into the crest core material. Heavy wire mesh fencing material lined with geotextile filter fabric was used as the flexible formwork around the Core-Loc crest units, and between the crest units and the cap.

Figure 4.13. Breakwater crest cap segment being prepared, showing 3-ft-deep key trench into core material (Sea Engineering, Inc. and Group 70 International 2008).

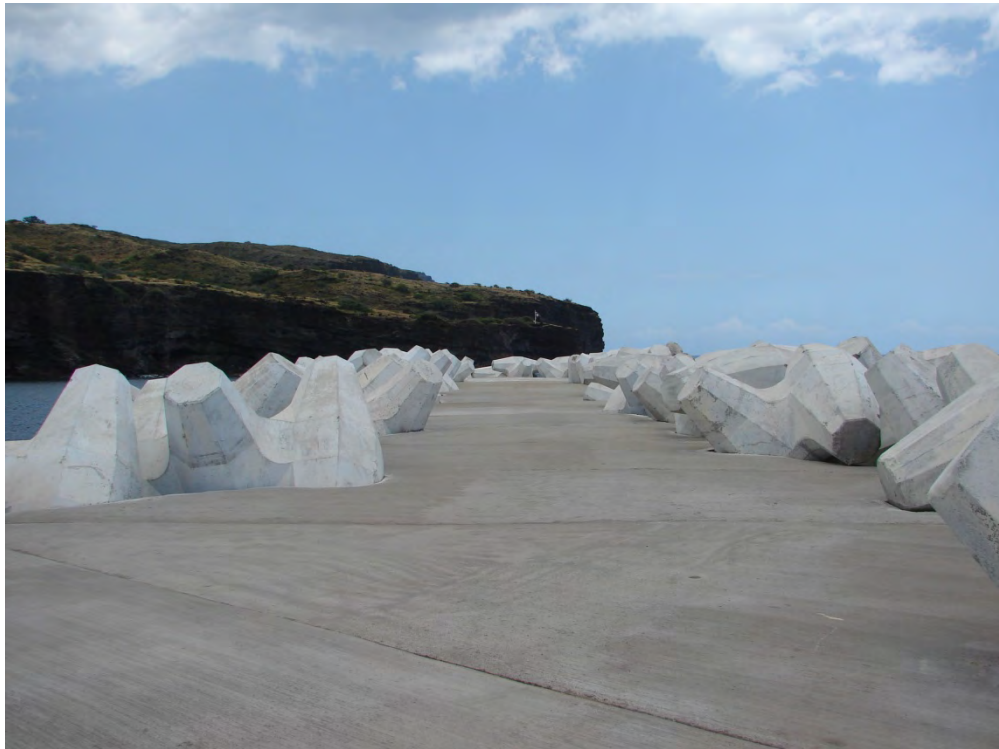
This worked very well as it could be made to conform easily to the varying contours of the Core-Loc units, and it could be made to project into gaps between units. The mesh was held in place by a steel cable system until the concrete cured, and then any mesh and cables projecting above the concrete were cut off. The completed cap is shown in Figure 4.14.

**Figure 4.14. Completed breakwater crest cap.**

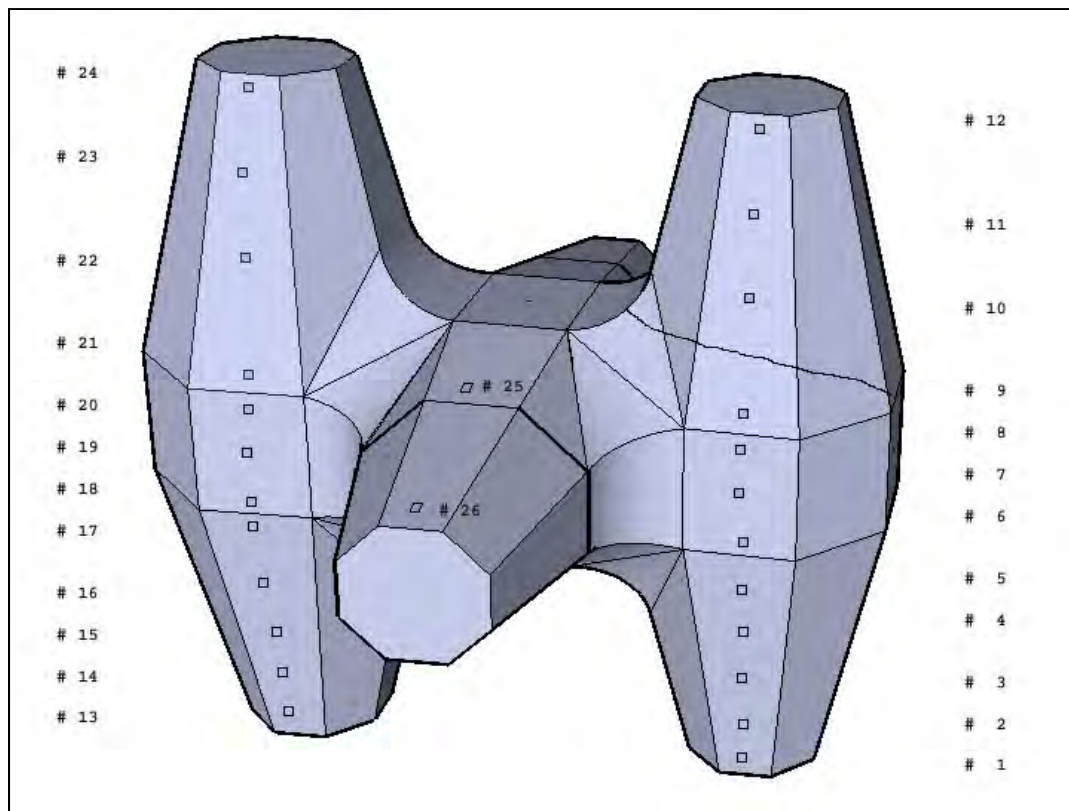
Figure 5.2. Location of pulse velocity readings (O'Neil and Haskins 2008).

The pulse-velocity measurements collected from core samples were within acceptable ranges according to uncorrelated estimation guidelines. Due to the complex geometry of the Core-Loc units, times-of-arrival could not be converted to velocities; however, a relative comparison of percent differences of arrival times (using structural symmetry) indicated that the material properties were consistent throughout the structure.

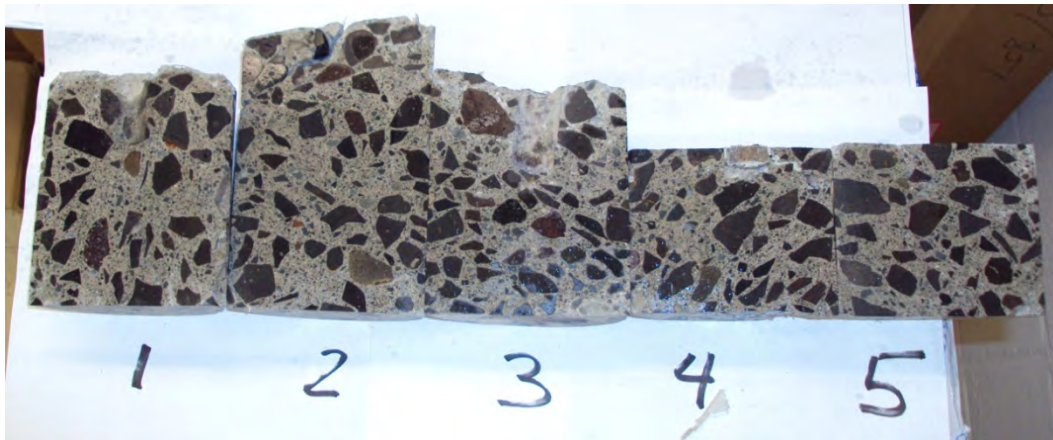
No concrete segregation, as observed in the Tercia (Azores, Portugal) Core-Loc units, appeared to occur within this specimen according to the in-situ collected data as well as the core specimen data. Visual observation of cut cross-sections from the 4-inch-diameter (in.-diam) collected cores also confirmed consistency from the top to bottom in terms of aggregate distribution (Figure 5.3).

Figure 5.3. Photograph of saw-cut sections of Kaumalapau Core-Loc 4-in.-diam core samples (O'Neil and Haskins 2008).

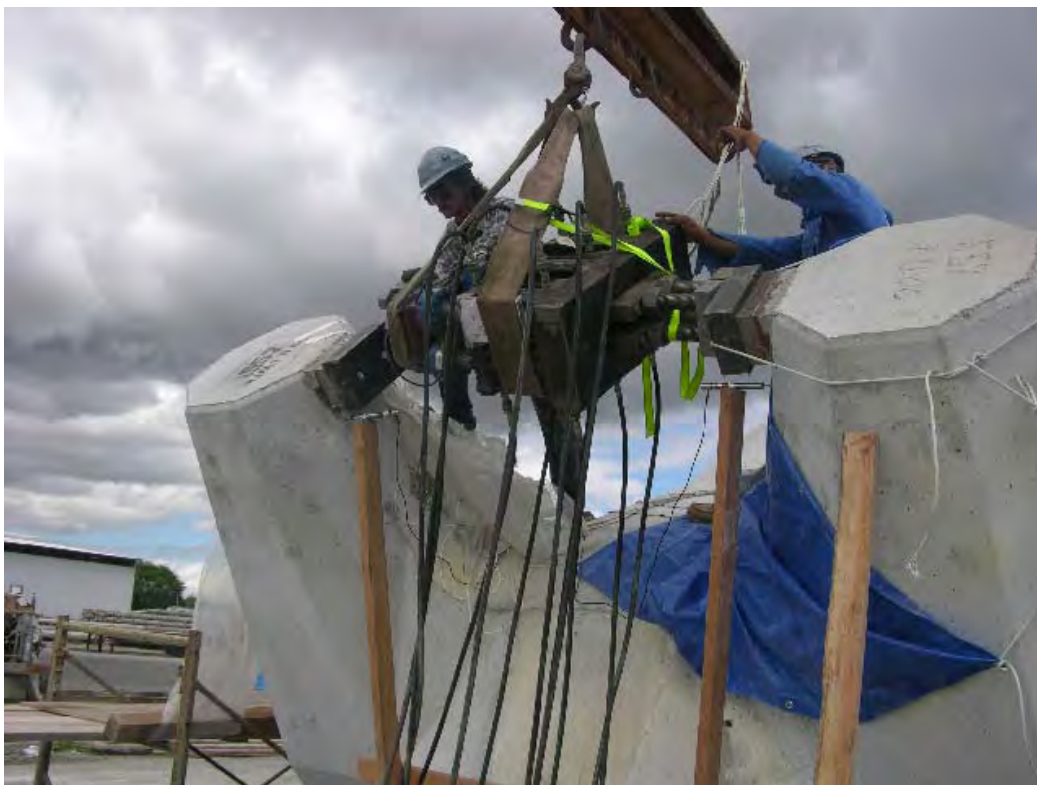
The primary purpose of the destructive test was to establish a load that would fail one leg of a Core-Loc. The hydraulic ram was arranged to push from between the two legs and break one of the legs with tension on the inside of the leg and compression on the outside. Figure 5.7 shows the loading assembly being placed between the Core-Loc legs.

Figure 5.7. Hydraulic ram placed between the Core-Loc legs (O'Neil and Haskins 2008).

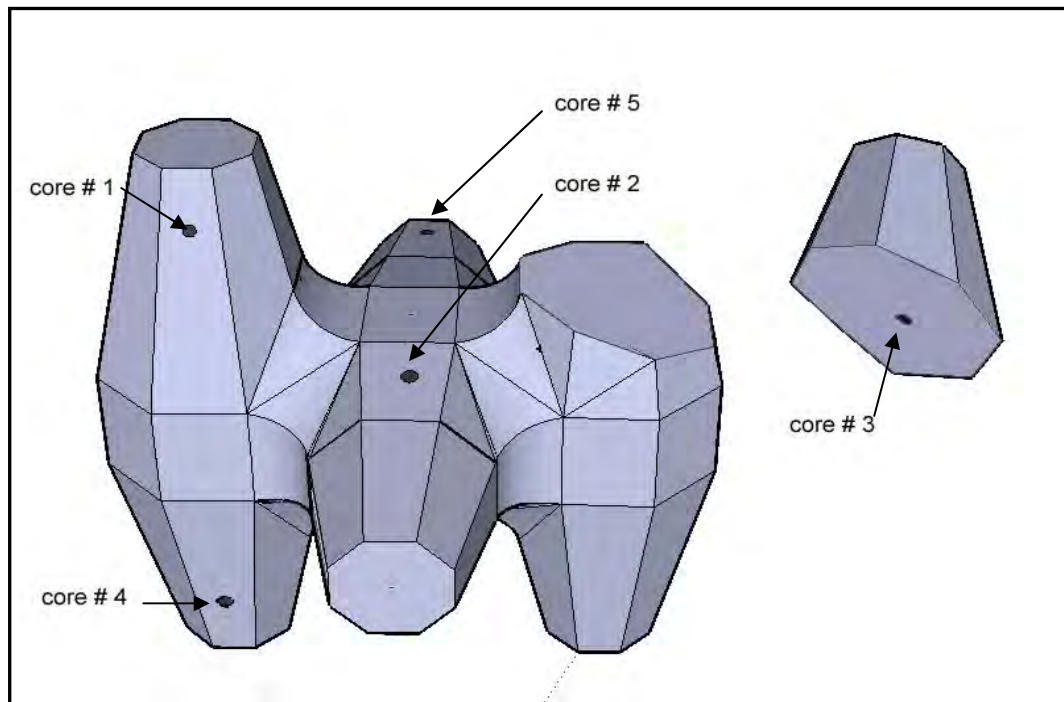
After failure of the armor unit, 4-in.-diam core samples were taken from the locations shown in Figure 5.9. The sample cores were returned to the ERDC laboratory and were tested for density, and subjected to ultrasonic pulse-velocity measurements to calculate the Modulus of Elasticity and Poisson's ratio. The cores also were prepared for determining the structural properties of compressive and splitting tensile strength.

Figure 5.9. Location of core samples transported to ERDC (O'Neil and Haskins 2008).

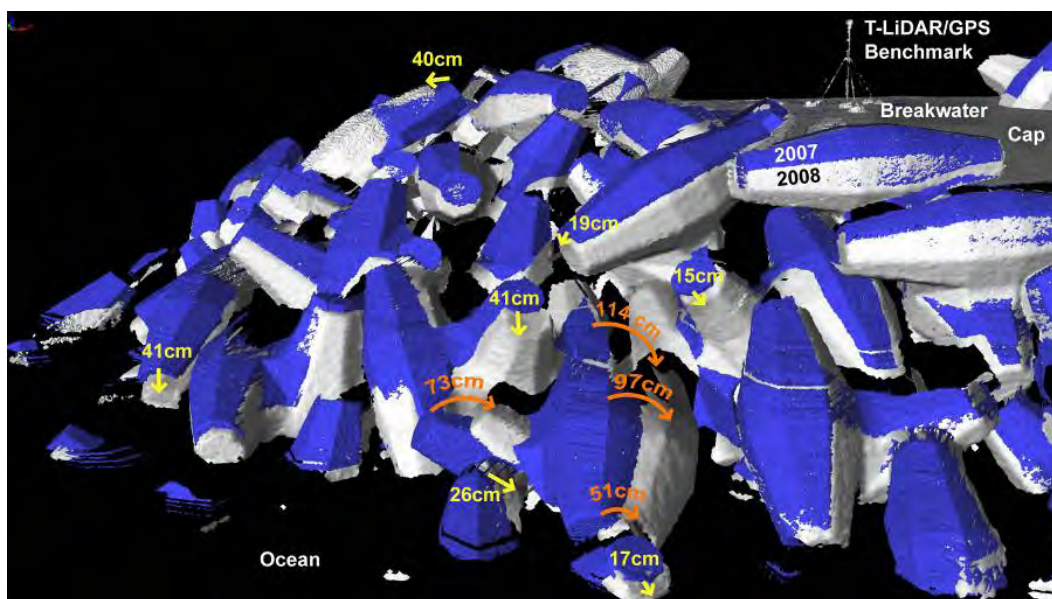
Comparison of these ultra-dense georeferenced positional data (in point cloud form) has enabled the detection of armor unit movement (measured as maximum displacement at any point on an individual unit) as small as  $5$  cm, and in excess of one meter, as shown by the comparison of 2007 and 2008 point cloud images in Figure 8.5. This figure is an overlay of two point cloud datasets (2007 data in blue, and 2008 data in white), viewed on the ocean side of the breakwater head. The measured maximum displacement of several units, including one armor unit with a maximum landward rotation of  $114$  cm ( $44.9$  in.), is represented by arrow-arcs in orange for rotational displacement and straight line arrows in yellow for translational displacement.

Figure 8.5. Point cloud data showing measured armor unit displacement from 2007 to 2008.

units has been both rotational and translational, but has been primarily toward the structure (rather than being pulled away or “off” the breakwater) and/or lower in elevation (indicated by displacement arrows shown in Figure 8.5). This appears to indicate that the units are indeed settling and “nesting” into a tighter matrix, rather than being loosened or pulled apart. Secondly, the movement has typically been observed to occur in groups of several adjacent armor units, as shown in locations A (ocean side head), B (ocean side dogleg), and D (harbor side root) of the 2007-2008 change detection map in Figures 8.6 and 8.7. This illustrates the interdependence of each armor unit on those surrounding it and in direct contact with it, whether above, below, or alongside.

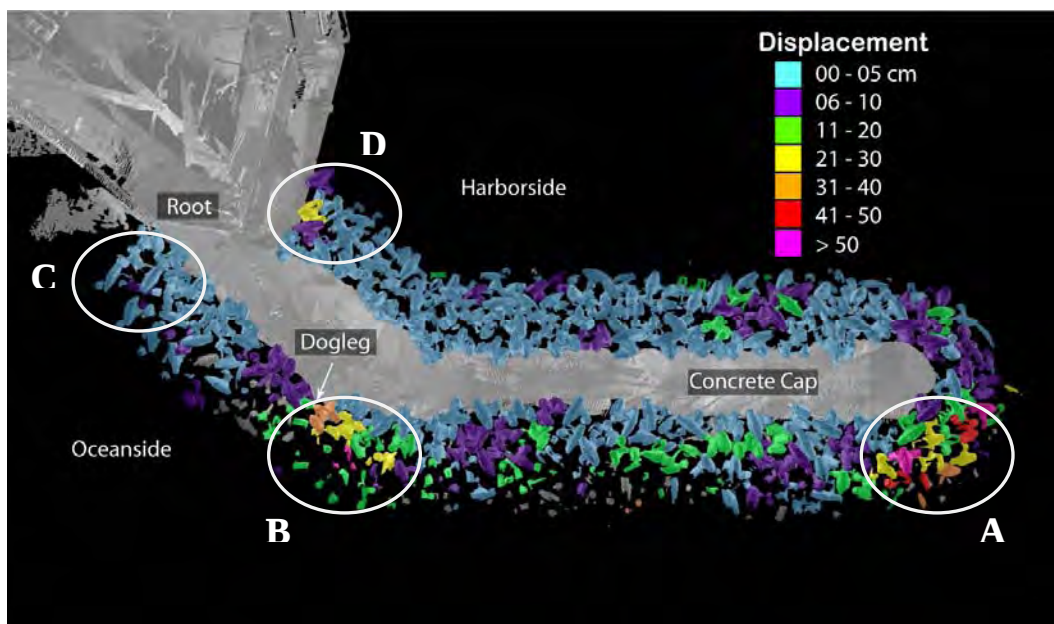
Figure 8.6. Plan view of 2007-2008 T-LiDAR change detection map: A. Ocean side head, B. Ocean side dogleg, C. Ocean side root, D. Harbor side root.

In addition, the change measurements over the 2007 - 2008 time period indicate that the largest movements of individual armor units, on the order of 20 cm to over 1 m (0.7 to 3.3 ft), occur at one of two locations: the ocean side head or ocean side dogleg of the structure (Figure 8.6 and 8.7 at locations A and B). This is also illustrated by the plan view of the change detection map at the breakwater head in Figure 8.8, which shows a dramatic difference in the magnitude of displacement between the harbor side and ocean side of the structure head. This distinction is evidenced by the range of colorization on the left side of the figure in comparison with that on the right side of the figure. The armor unit identified previously in Figure 8.5 that rotated landward a distance of 114 cm (44.9 in.) is called out in this figure. Photos taken at the completion of construction show

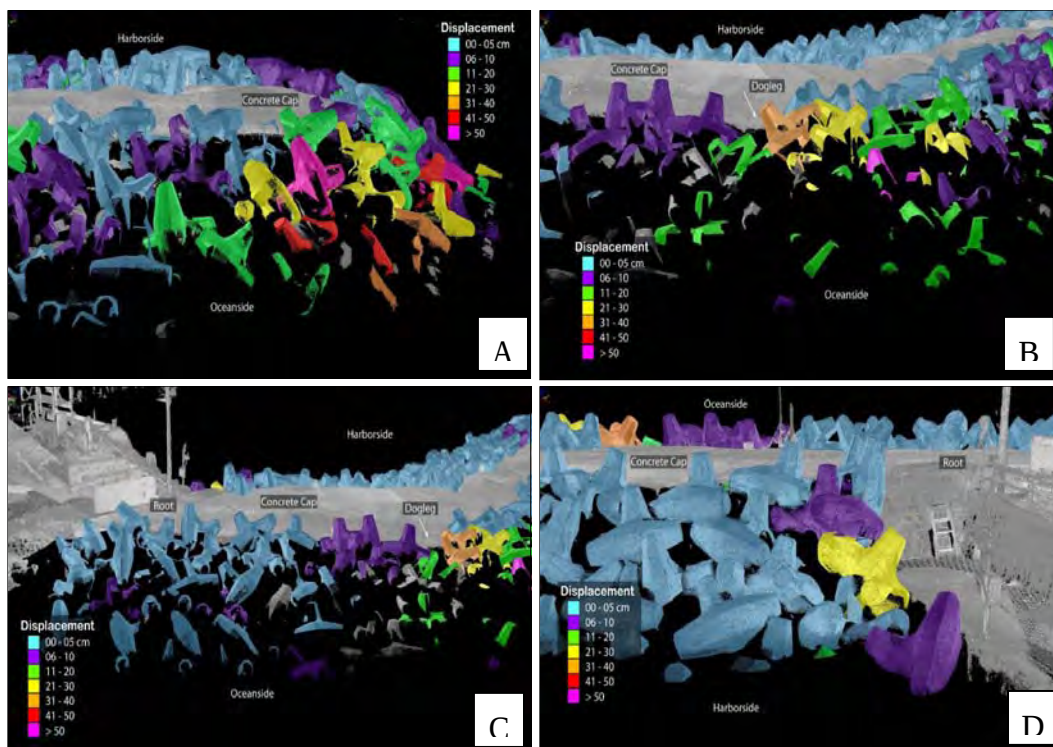
Figure 8.7. Oblique angle views of 2007-2008 T-LiDAR change detection map: A. Ocean side head, B. Ocean side dogleg, C. Ocean side Root, D. Harbor side root.

Next, and likely one of the most significant results from this data collection, is the variation in both the quantity and magnitude of armor unit movement evident when comparing the change detection map from the first year following construction (Figure 8.7) to the map for the two following years

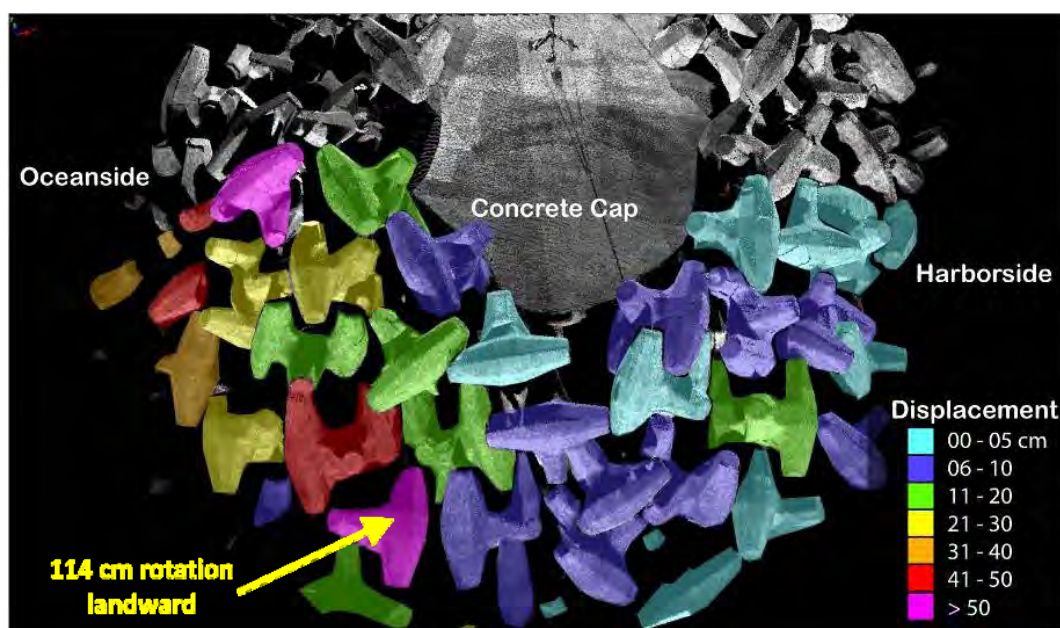
Figure 8.8. Plan view of 2007-2008 T-LIDAR change detection map at breakwater head.

that the armor units in this area were placed such that a void existed between this rotated unit and the unit just landward of it. Movement of 11 to 50 cm (4.3 to 19.7 in.) in the nearby armor units is also evident in Figure 8.8. Since the T-LiDAR laser does not penetrate the water, it is not possible to quantitatively determine whether the motion observed at this location is regionally independent, or was caused by movement below the waterline. However, again referring back to Figure 8.5, portions of two Core-Loc units protruding above the waterline directly below these units moved about 17 cm (6.7 in.) and 26 cm (10.2 in.), respectively. Therefore, it is likely that the larger scale motion observed at the head of the breakwater may relate to nesting of armor units below the water surface.

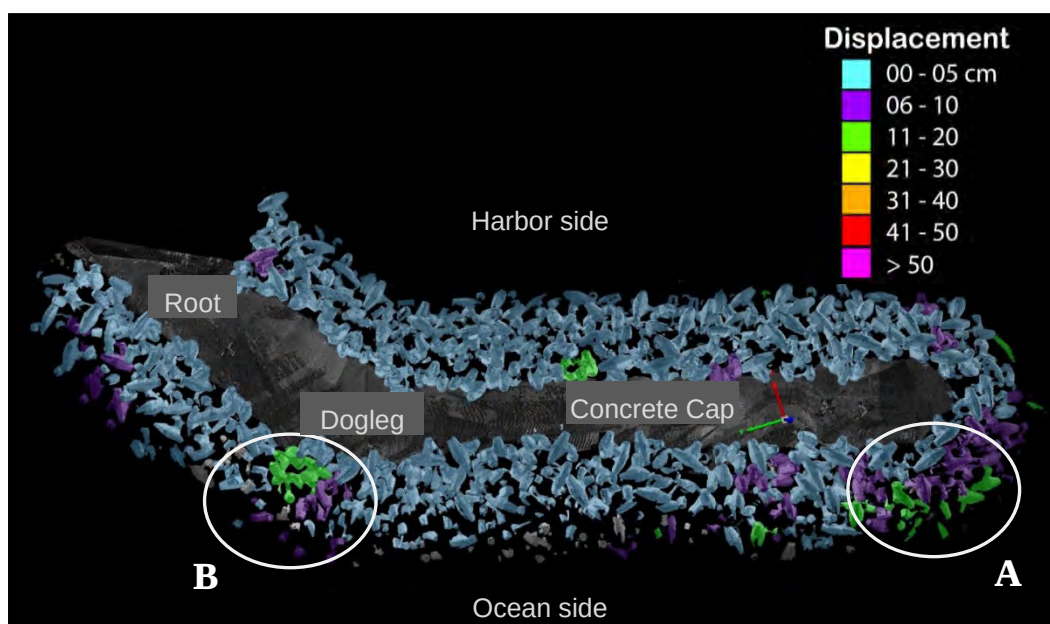
This concentration of armor unit displacement at the ocean side head and dogleg is also evident, though less dramatically so, in change detection maps for the 2008 - 2010 time period (Figure 8.9, locations A and B) as well as in the combined measurements over the entire three-year survey period (shown in Figure 8.10, locations A and B). This phenomenon may be explained by one or more of the following factors:

Figure 8.9. Plan view of 2008-2010 T-LiDAR change detection map: A. Ocean side head, B. Ocean side dogleg.

(Figure 8.9). Side-by-side evaluation of colorized change detection maps for these two time periods clearly shows that the majority of notable armor unit movement (defined here as movement greater than 10 cm (3.9 in.) for an individual unit) occurred within the first year post-construction, with comparatively much less discernable change in armor unit positions occurring between the second and third T-LiDAR surveys in 2008 and

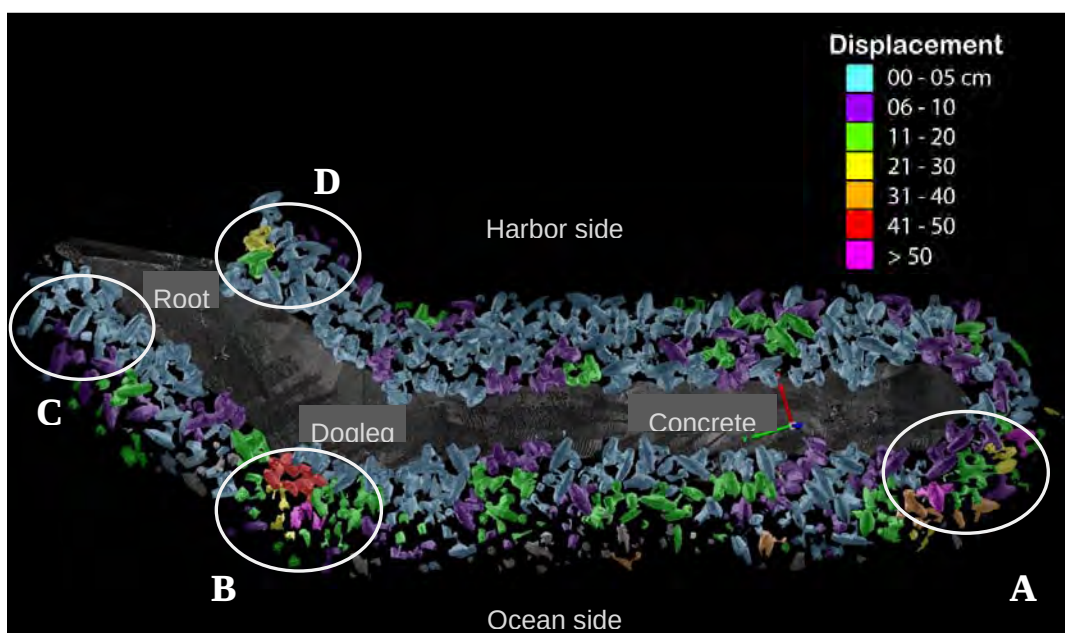
Figure 8.10. Plan view of 2007-2010 T-LiDAR change detection map: A. Ocean side Head, B. Ocean side Dogleg, C. Ocean side Root, D. Harbor side Root

The harbor side of the structure at the root, adjacent to the barge pier (Figure 8.10, Location D), became an area of concern during construction when a modification was made by using a partial armor unit (breakage occurred during placement at the head, so the unit was removed) to abut the existing bulkhead wall, due to the fact that a complete armor unit would not fit into this area. The displacement measured in this unit between the 2007 and 2008 surveys (Figure 8.6) was in the range of 21 to 30 cm (8.3 to 11.8 in.), and in two adjacent armor units, displacement was measured in the range of 6 to 10 cm (2.4 to 3.9 in.). However, the displacement measured between the 2008 and 2010 surveys (Figure 8.9) shows that the partial armor unit has not experienced additional movement, and only one of the adjacent units experienced detectable movement, less than 10 cm (3.9 in.).

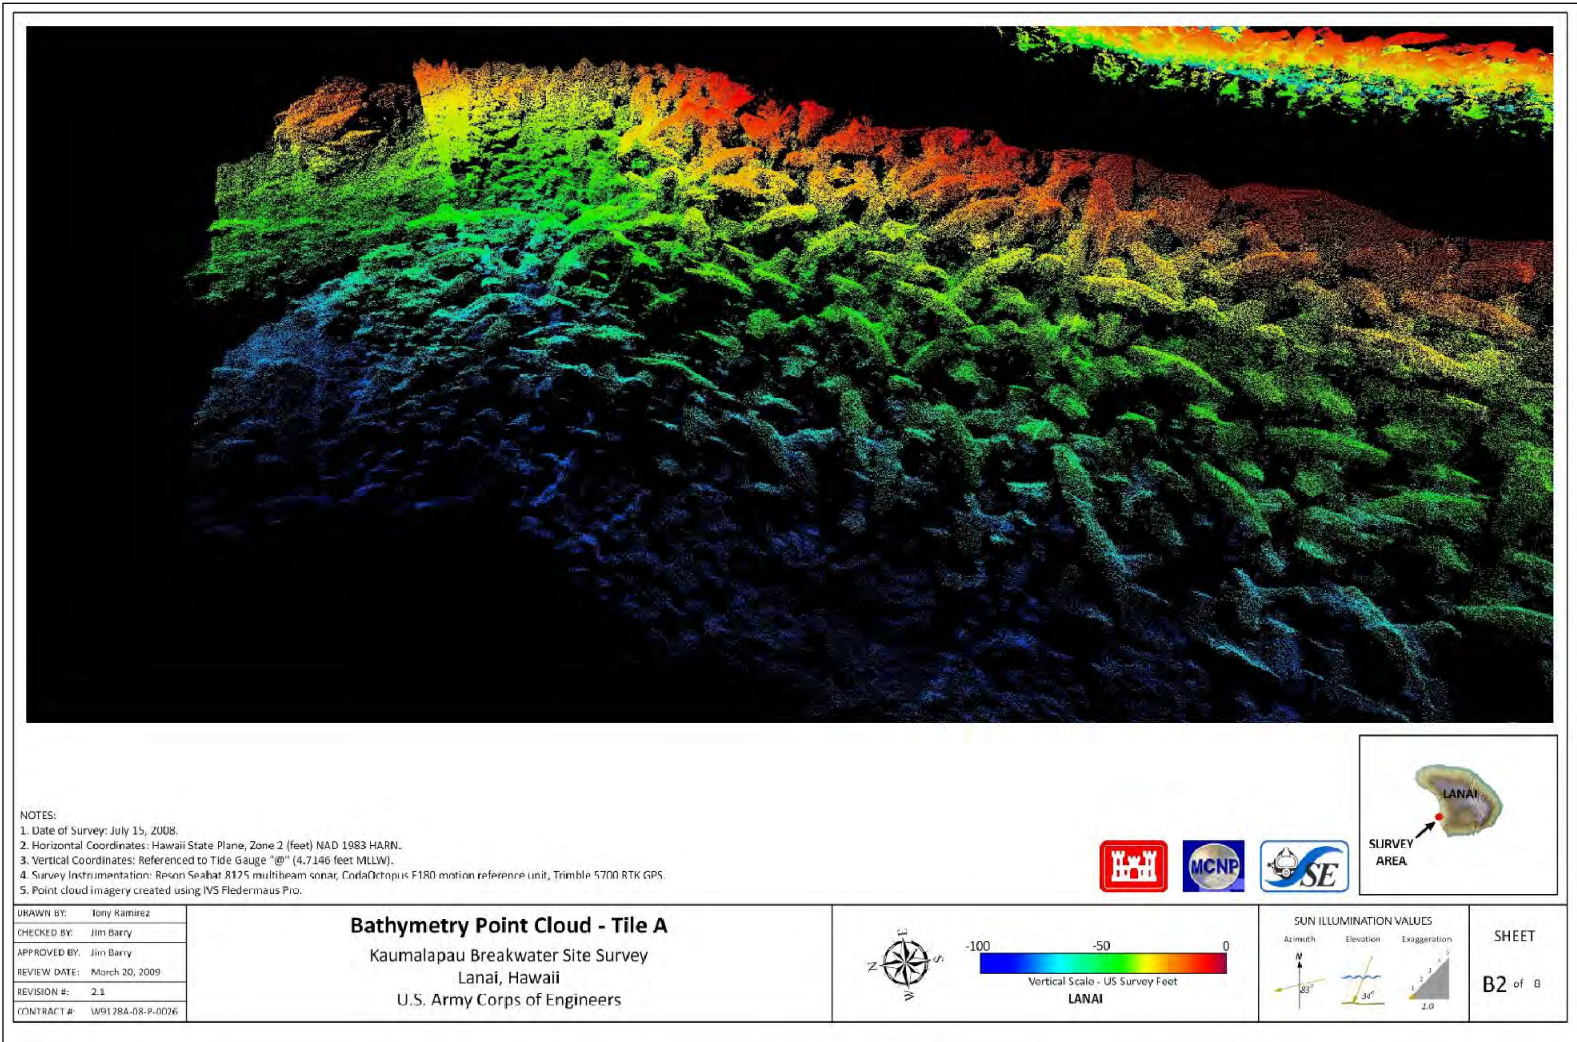
Figure 9.9. Bathymetry point cloud, Section A, Kaumalapau Harbor breakwater (Sea Engineering, Inc. 2009).

Visual analysis of the point cloud images enables the identification of several features of the underwater portion of the structure. Figure 9.9 (Tile A) shows a defined demarcation at the top center of the figure where the ocean side root of the structure ties in to the existing rock outcrop, indicated by an abrupt change in the color scale of the point cloud near the water surface from red to yellow to green. It is also relatively easy to distinguish the difference between the angular Core-Loc units and the armor stones (or other more naturally shaped features such as the rocky seafloor). Figure 9.10 (Tile B) is an almost complete view of the ocean side of the structure from the root to the dogleg. This figure clearly shows the side slope of the structure composed of Core-Loc, and the stone toe buttress (in dark blue). Along the right side of the figure, several of the first row of Core-Locs (placed in the cannon orientation) are easily visible, as well as the interlocking row of Core-Locs placed directly above them also in a specific (but different) orientation. The remainder of the Core-Locs, resting higher on the side slope, clearly are in a more random orientation, as designed.

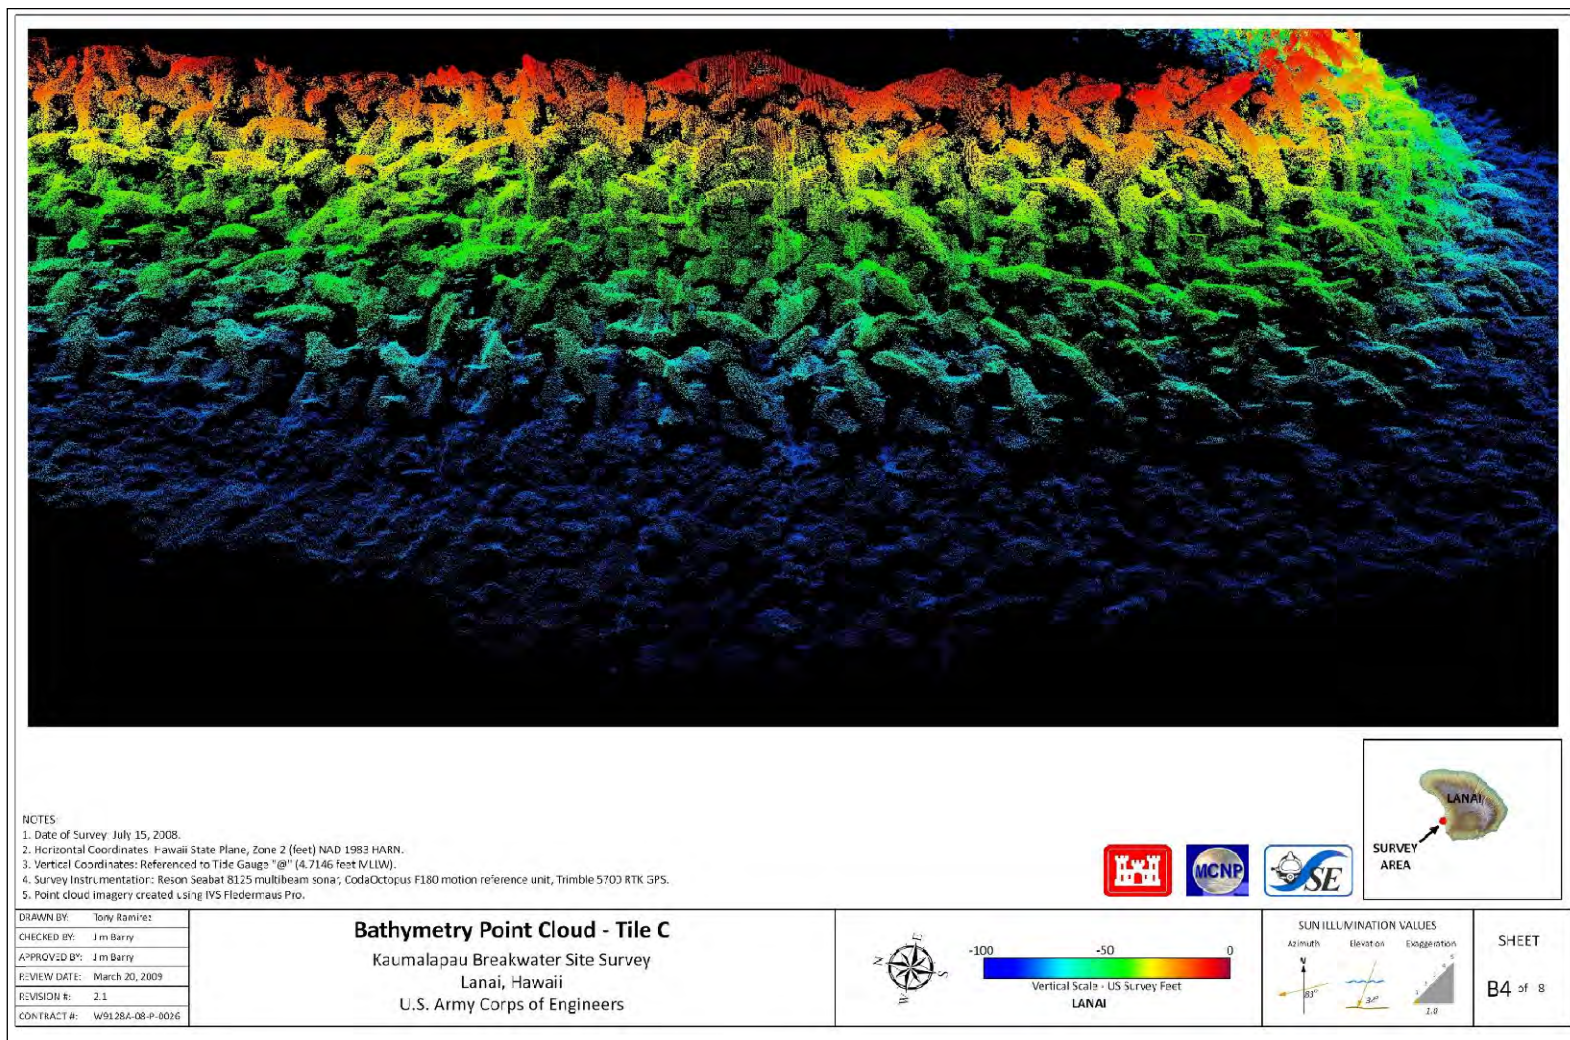
Figure 9.11. Bathymetry point cloud, Section C, Kaumalapau Harbor breakwater (Sea Engineering, Inc. 2009).

Figures 9.11 (Tile C) and 9.12 (Tile D) show similar representations of the point cloud data from the ocean side dogleg to the ocean side head, and the entire structure head, respectively. Both figures indicate that the structure toe appears to follow a consistent contour along the rock foundation, with no visible deviations or non-interlocked Core-Loc units. Figure 9.13 (Tile E) shows the harbor side head of the structure, as well as the transition to the harbor side toe berm (right half of figure). Examination of the point cloud of the toe berm indicates that there is likely a large gradation in stone size in this area, however, this is consistent with construction specifications allowing for the use of existing stone at the project site to be recovered and reshaped for use in the toe berm (refer to Chapter 2 of this document).

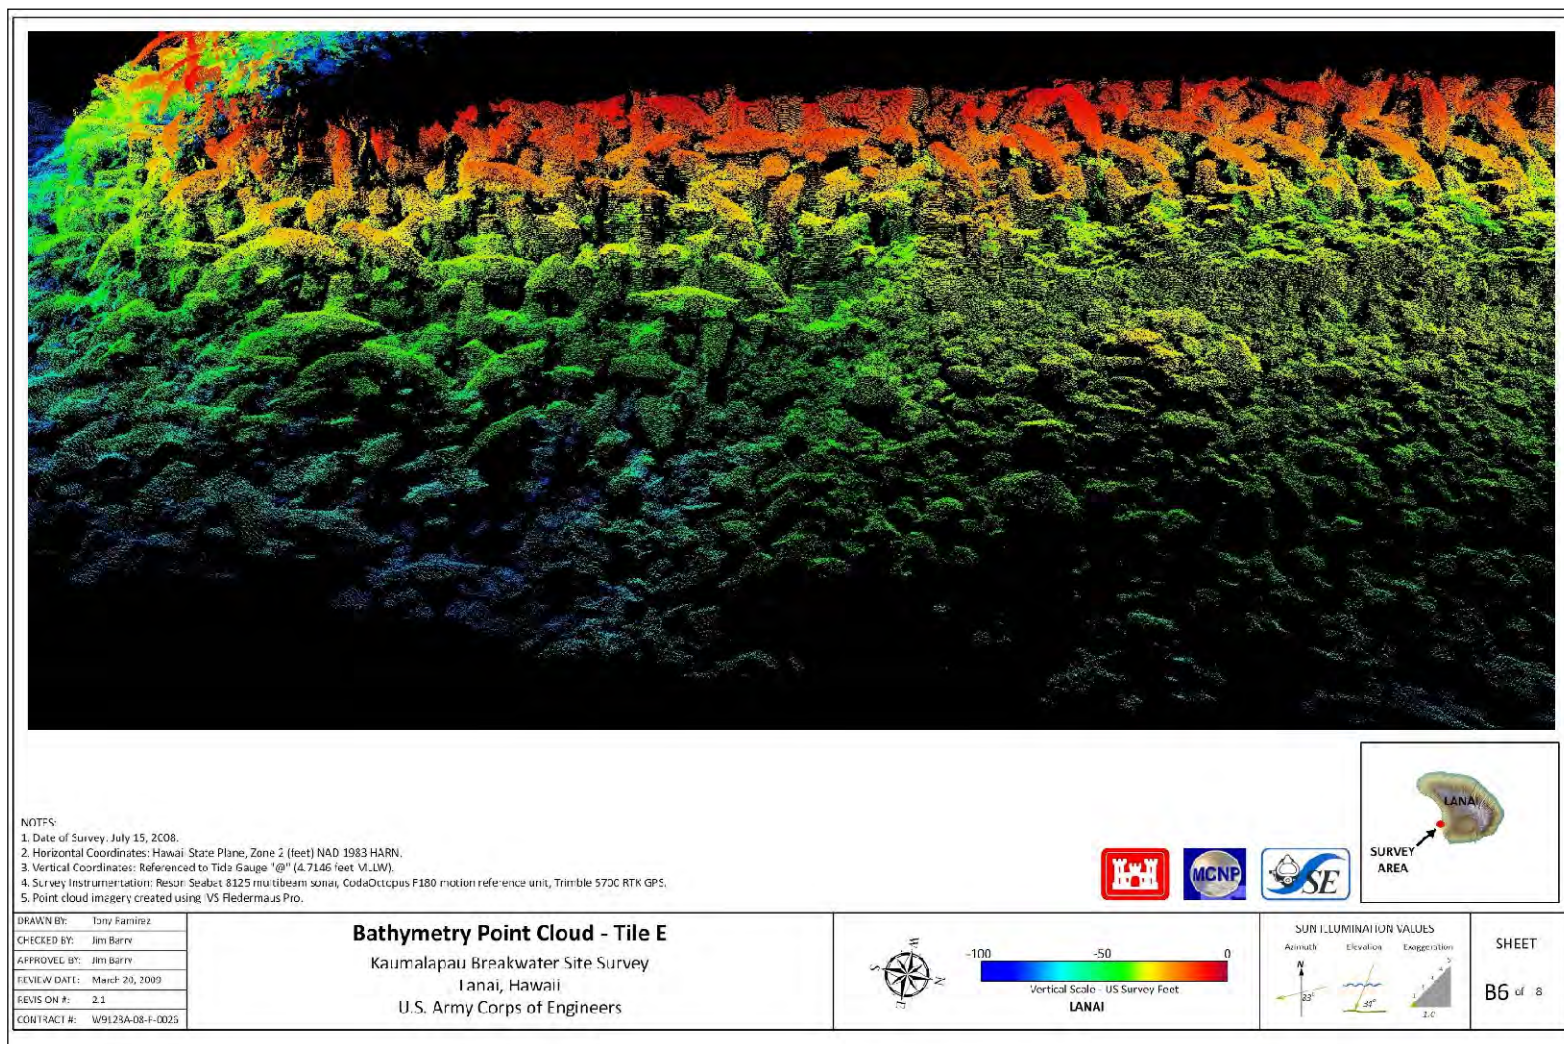
Figure 9.13. Bathymetry point cloud, Section E, Kaumalapau Harbor breakwater (after Sea Engineering, Inc. 2009).

Also visible in Figures 9.13 and 9.14 (Tiles E and F) is what appears to be a steepened slope within the harbor side toe berm (approximately half way down the right side of the image in Figure 9.13 and half way down the majority of the image in Figure 9.14). Reference back to the contour plot of the multibeam survey (Figure 9.3) suggests that this may be due to the change from the relatively flat slope of the wide toe berm at approximately 15 ft below MLLW, to a more steep side slope between the 20-ft and 40-ft contour. It is also possible that the angle of the image may be causing an exaggerated view of this side slope, however, this location should be monitored for changes and/or stability in any future underwater surveys or inspections. Finally, Figure 9.15 (Tile G) shows the location where the harbor side root ties into the existing barge pier, as well as the underwater portion of the sheet pile bulkhead of the barge pier.
