*Monitoring Completed Navigation Projects Program*

## **Kaumalapau Harbor, Hawaii, Breakwater Repair**

May 2012

Final report

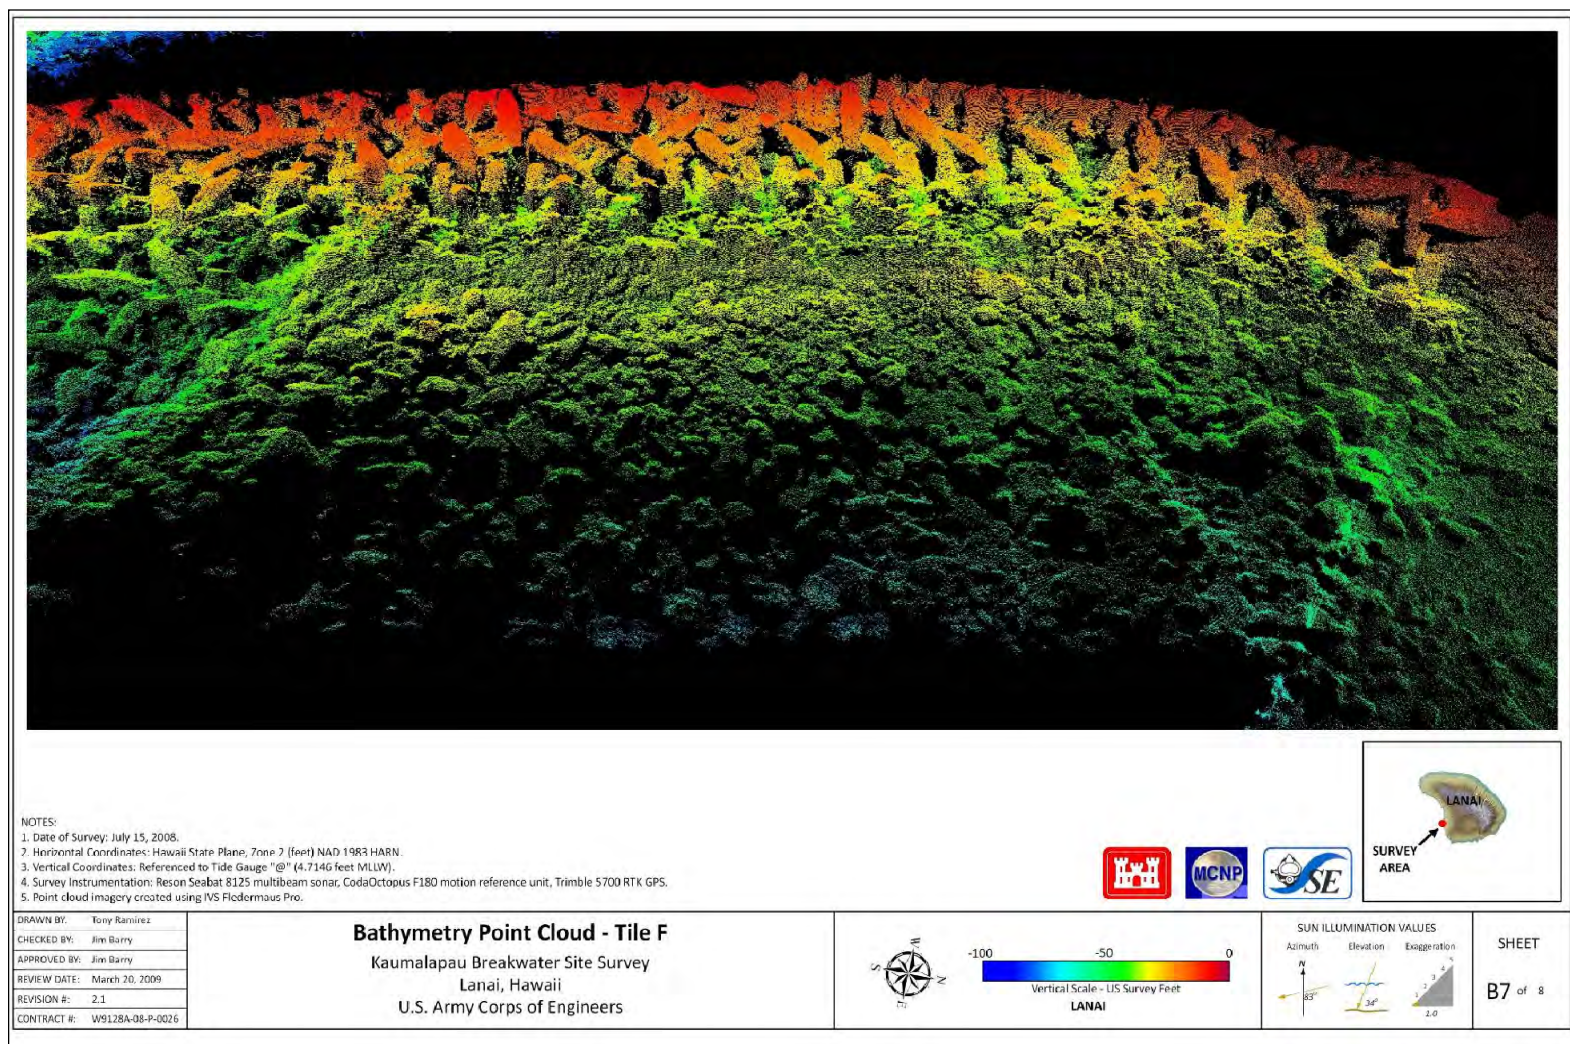
Figure 9.14. Bathymetry point cloud, Section F, Kaunalapau Harbor breakwater (Sea Engineering, Inc. 2009).

Also visible in Figures 9.13 and 9.14 (Tiles E and F) is what appears to be a steepened slope within the harbor side toe berm (approximately half way down the right side of the image in Figure 9.13 and half way down the majority of the image in Figure 9.14). Reference back to the contour plot of the multibeam survey (Figure 9.3) suggests that this may be due to the change from the relatively flat slope of the wide toe berm at approximately 15 ft below MLLW, to a more steep side slope between the 20-ft and 40-ft contour. It is also possible that the angle of the image may be causing an exaggerated view of this side slope, however, this location should be monitored for changes and/or stability in any future underwater surveys or inspections. Finally, Figure 9.15 (Tile G) shows the location where the harbor side root ties into the existing barge pier, as well as the underwater portion of the sheet pile bulkhead of the barge pier.

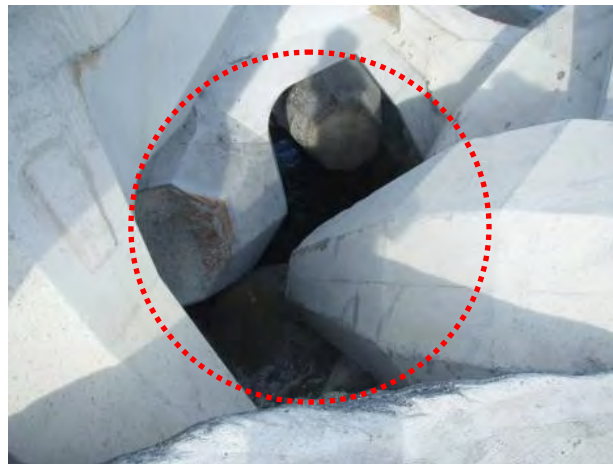
Voids between armor units were observed in several locations, including Station -1+00 along the root of the structure on the ocean side (shown in Figure 10.2) and on the harbor side trunk at Station 1+58 (shown in Figure 10.3). In many cases, these voids exposed underlayer stones, which is undesirable because the stones may be exposed to greater wave attack and possibly become mobilized during very large wave events. If the void between armor units is larger than the armor stone diameter, the mobilized armor stone could potentially be pulled out of the structure through the void.

Figure 10.2. Void in armor layer on ocean side root at Station -1+00 with armor stone and water surface visible through void. (2007 photo)

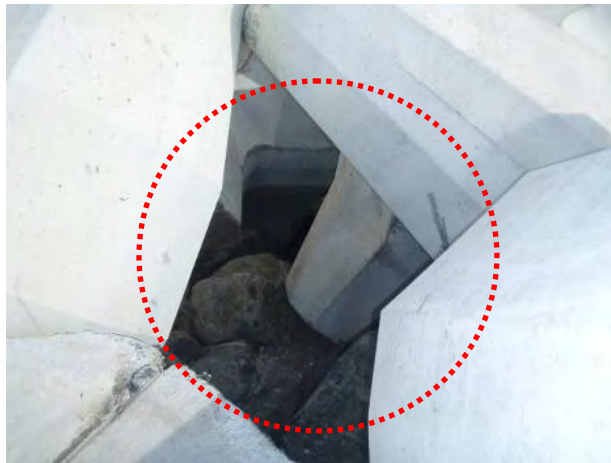
Figure 10.3. Void in armor layer on harbor side trunk at Station 1+59 with armor stone exposed. (2007 photo)

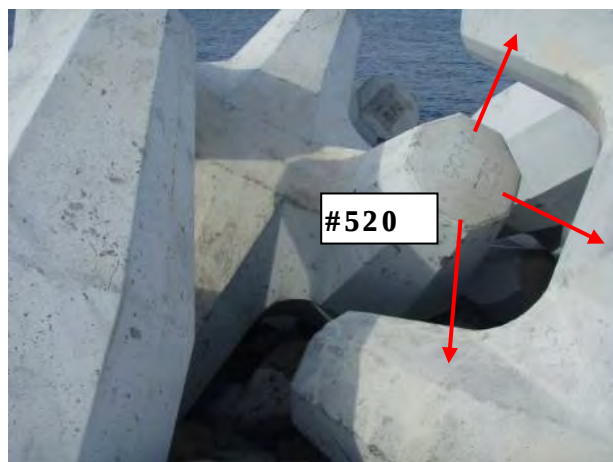
Figure 10.5. Poor contact between unit #520 and adjacent armor units at Station 1+36 on ocean side trunk (2007 photo). Unit #520 has moved 5.9 in. (15 cm) toward head from 2007-2010 (T-LiDAR).

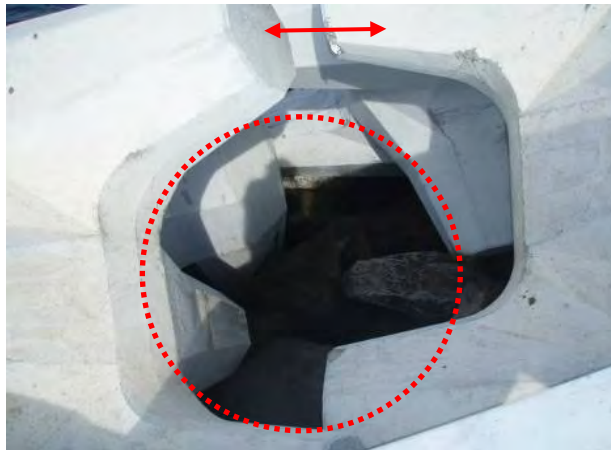
Figure 10.6. Limited contact between armor units placed end-to-end on ocean side trunk near crest at Station 1+82. Void with underlayer exposed. (2007 photo)

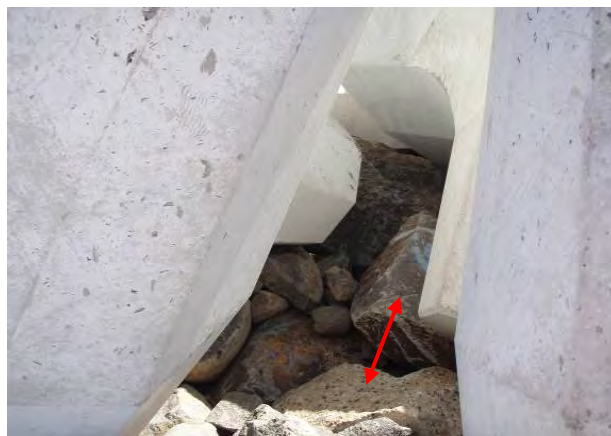
Figure 10.7. Limited contact between armor unit leg and underlayer stone on harbor side trunk at Station 1+26. Void in armor layer with underlayer exposed. (2010 photo)

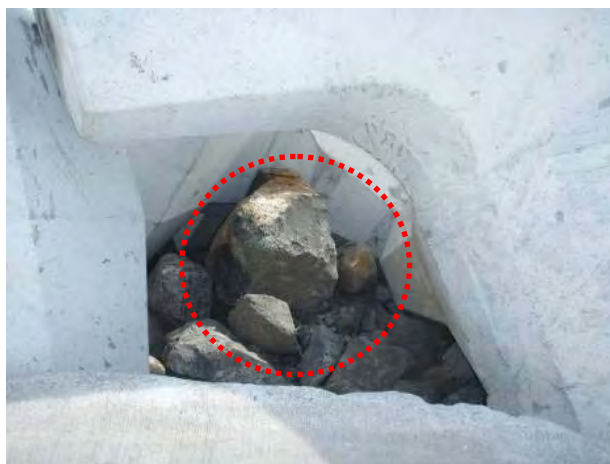
Figure 10.10. Undersize underlayer stone on harbor side trunk at Station 1+51, estimated to be ~0.8- to 2.5-ft diam. (2007 photo)

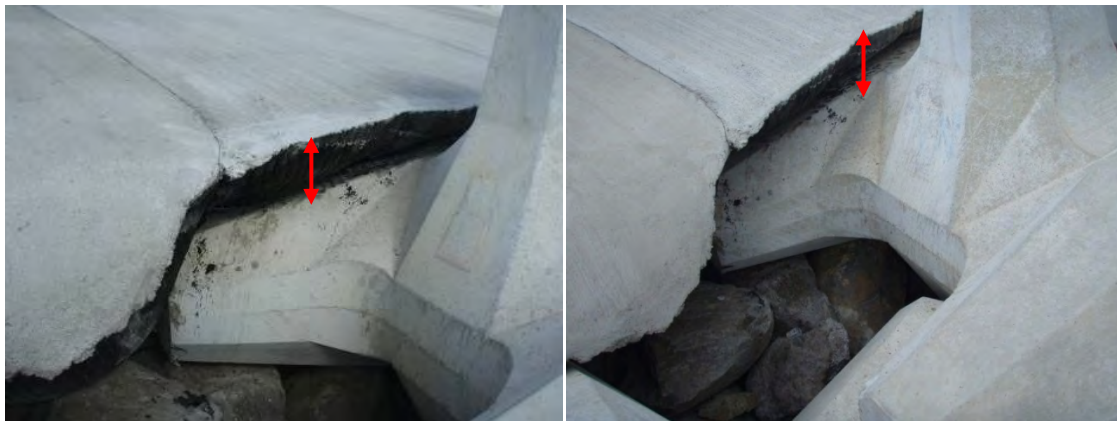
Inspections also noted areas along the breakwater where the side of concrete cap was exposed (i.e., not protected by armor units). Some areas were also noted where the edge of the concrete cap was thin in comparison to the rest of the cap. These areas could be of potential concern due to their greater exposure to wave impact and potential for damage. Photos of these areas are shown in Figure 10.10 through 10.11.

Figure 10.12. Concrete cap is thin and overhangs armor unit along ocean side trunk at Station -0+36. Apparent movement of armor unit between 2007 (left) and 2009 (right).

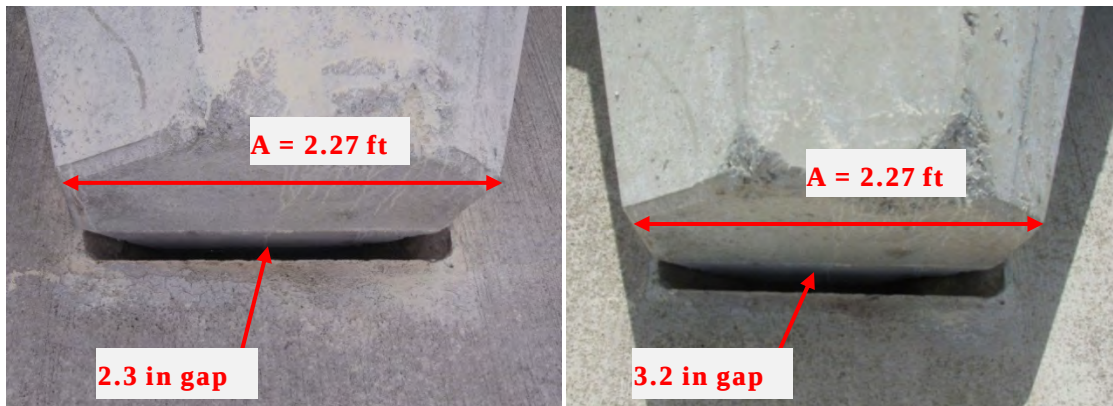
Figure 10.14. Gap created between armor unit and concrete cap on ocean side trunk at Station 0+55. Measured gap was 2.3 in. in 2008 (left) and 3.2 in. in 2009 (right).

from the concrete cap. Since the cap was poured following the placement of the armor layer (using a wire mesh overlaid with geotextile fabric to contain the concrete around the edges of the cap as it flowed into place), it was initially in contact with the armor units at the crest of the structure. Since completion of construction, the gravitational settlement of the armor units at the crest has caused them to pull away from the edge of the concrete cap. The gaps created by this occurrence are relatively small, usually on the order of 6 in. or less. At this scale, the separation of the armor units from the cap is not likely to affect the function or stability of either; however it is important to monitor these areas to keep track of the scale of movement over time. If the gap between the armor units and the cap becomes very large, the cap could become more exposed to damage from wave action. Photos of gaps observed are shown in Figures 10.14 and 10.15.

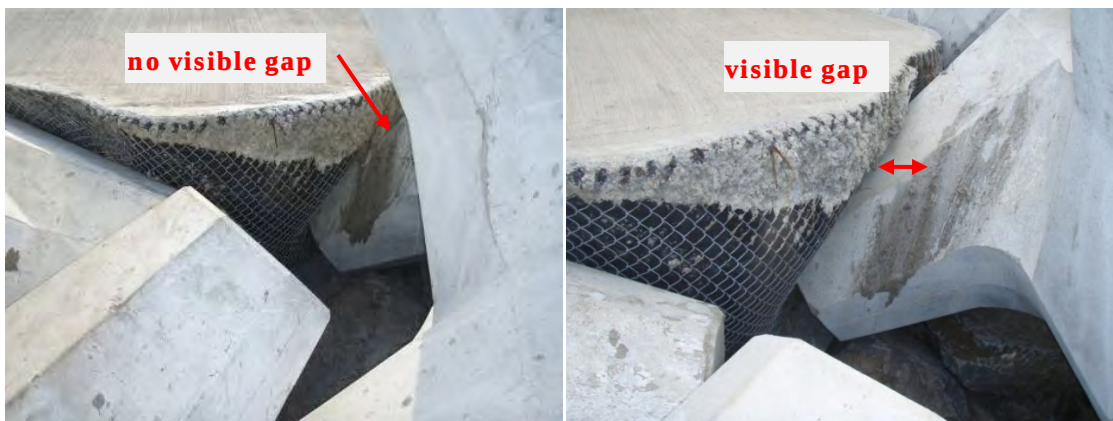
Figure 10.15. Exposed edge of concrete cap with apparent pulling away of armor unit between 2007 (left) and 2009 (right) on ocean side trunk at Station -0+14.

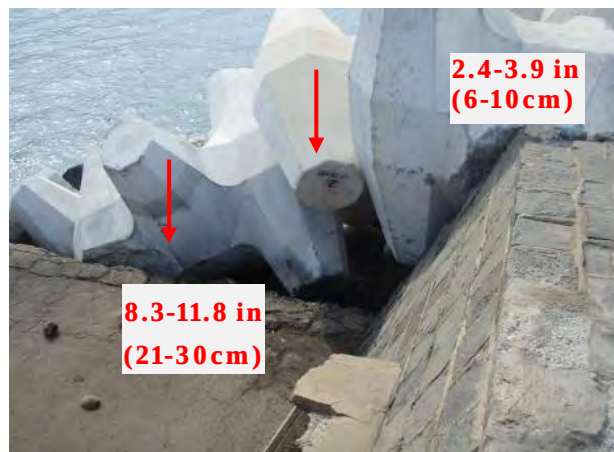
As previously noted, six armor units that were broken (either the nose or a leg detached) during construction were set aside and later used to aid in construction of the tieback along the harbor side root of the structure. It was determined that, because this area was expected to have the least amount of wave impact, use of the partial armor units in this location would not adversely affect the stability of the armor layer. In addition, placing the partial units in this area solved a logistical issue – the fully-intact armor units would not fit securely against the existing wall and face of the barge pier, and the partial units were arranged to do so. This area was monitored closely during inspection to determine whether the partial units had settled, and whether any settlement had affected the adjacent armor units or the integrity of the harbor side tieback. The results of inspection (shown in Figures 10.16 through 10.19), as well as the results of T-LiDAR surveys presented in Chapter 8, indicate that there has been movement of the units in this location, on the order of 4.3 to 11.8 in. (11 to 30 cm) between 2007 and 2010.

Figure 10.16. 2007 photo of harbor side tieback at Station -0+75. T-LiDAR measured settlement between 2007-2008 indicated for two armor units.

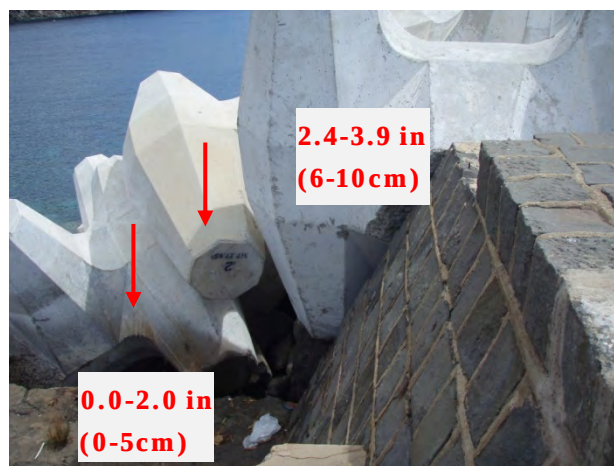
Figure 10.18. 2009 photo of harbor side tieback at Station -0+75. T-LiDAR measured settlement between 2008 -2010 indicated for two armor units.

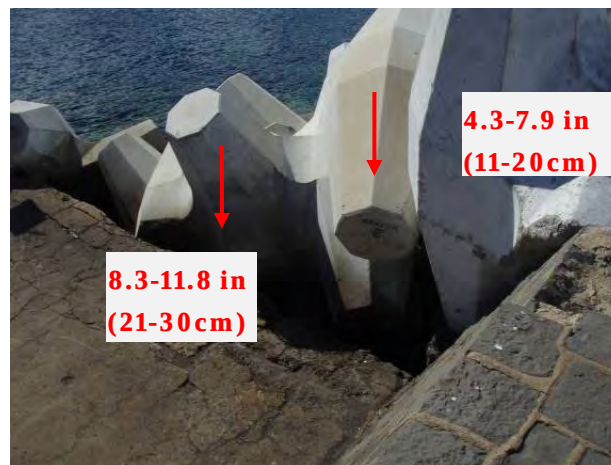
Figure 10.19. 2010 photo of harbor side tieback at Station -0+75. T-LiDAR measured settlement between 2007-2010 indicated for two armor units.

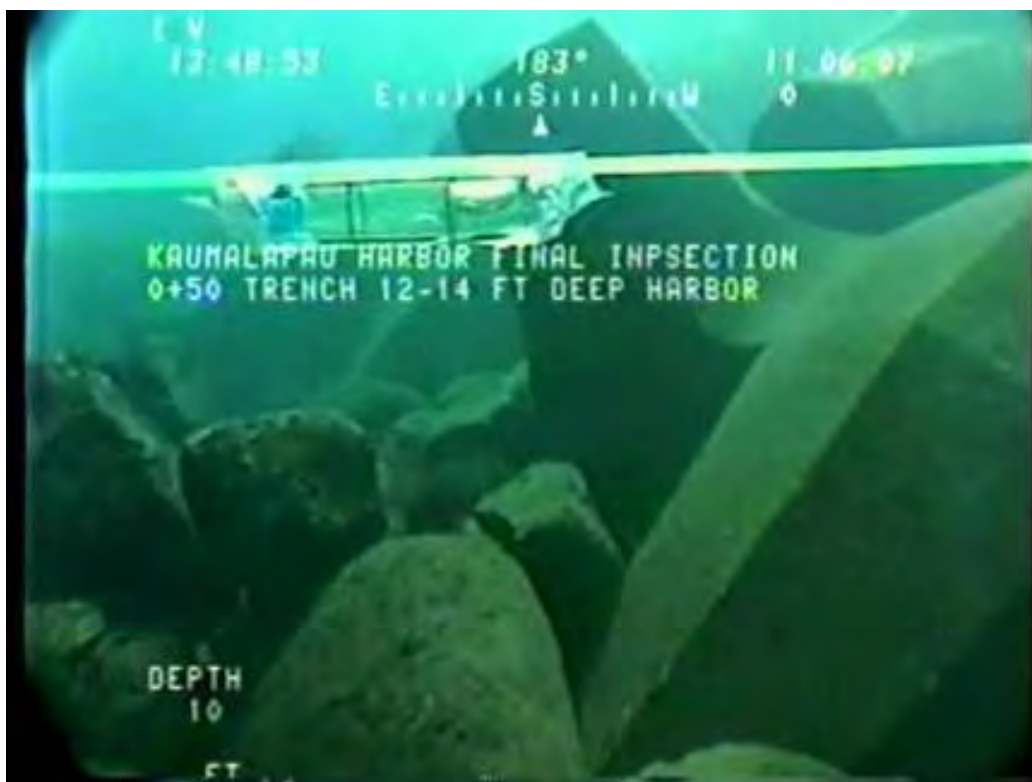
Figure 10.23. Harbor side trunk at approximate Station 0+50. Toe armor units in “cannon” orientation at 12- to 14-ft depth and varied size of toe berm armor stone.

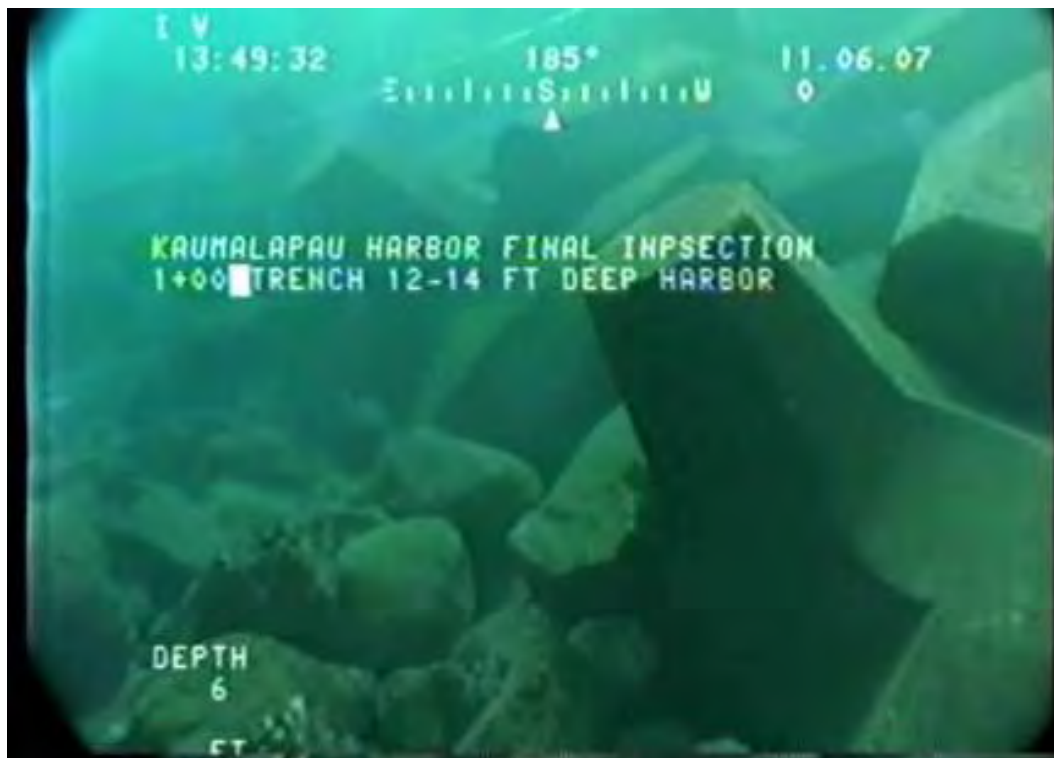
Figure 10.24. Harbor side trunk at approximate Station 1+00. Multiple toe armor units in “cannon” position but in slightly varying orientation and variable size stone toe berm.

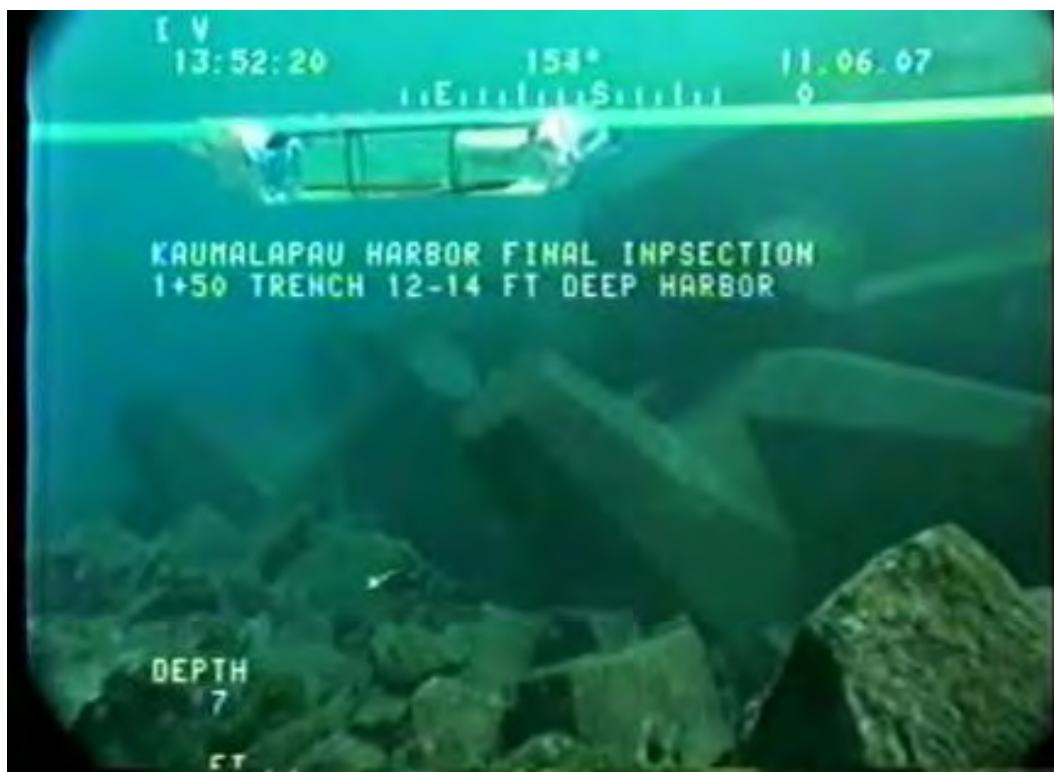
Figure 10.25. Harbor side trunk at approximately Station 1+50. Second row of tow armor units and stone toe berm with variable rock sizes are visible. Toe units are well seated into toe berm.

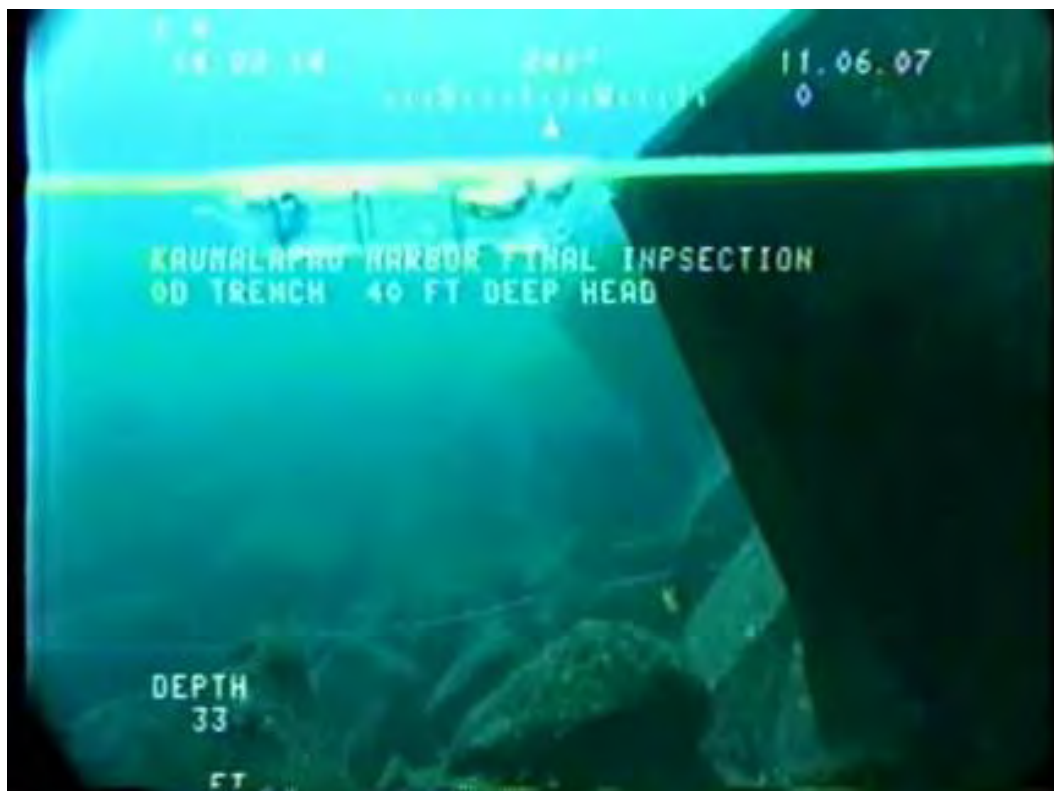
Figure 10.27. Breakwater head. Two well-entrenched toe units visible in “cannon” orientation.

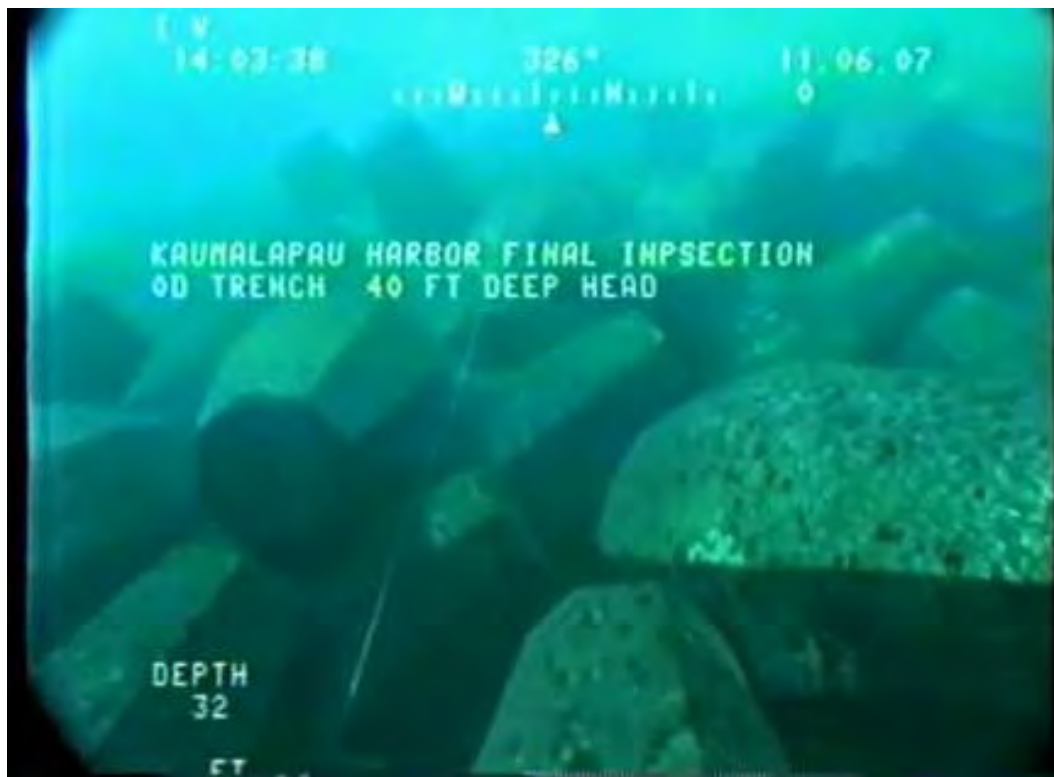
Figure 10.28. Ocean side of breakwater head. Side slope of breakwater shown with armor units well interlocked.

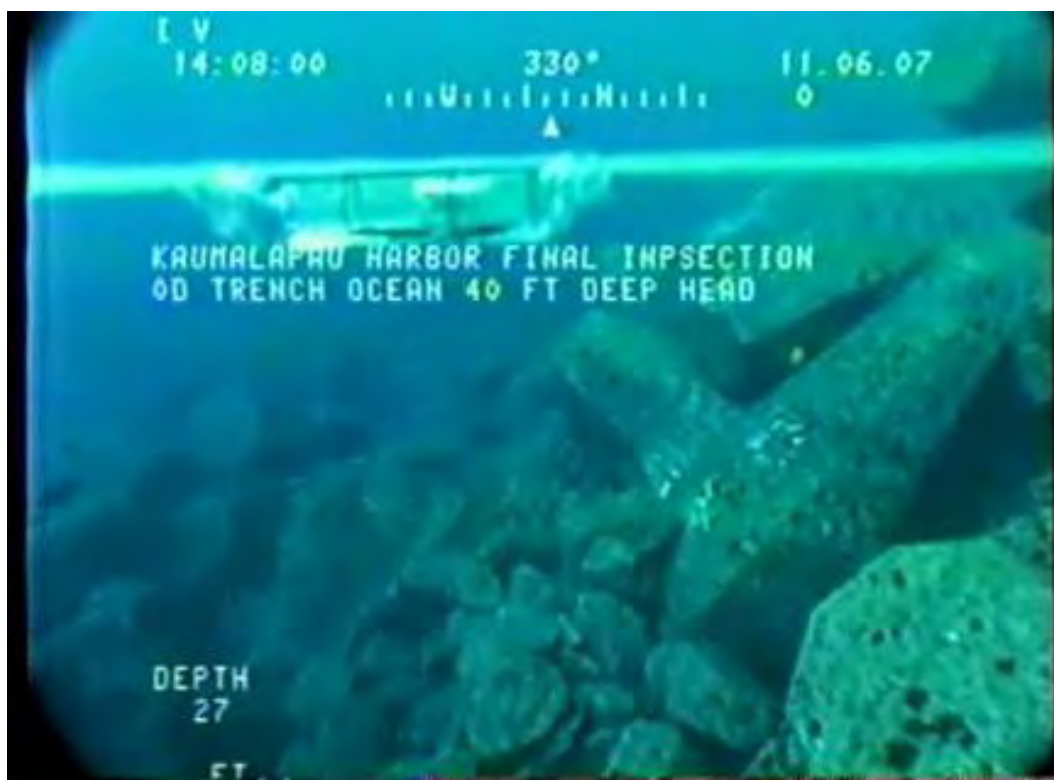
Figure 10.29. Ocean side head at approximately Station 2+20. Toe units in "cannon" orientation and ocean side toe trench/stone buttress with varied sized of stone are visible.

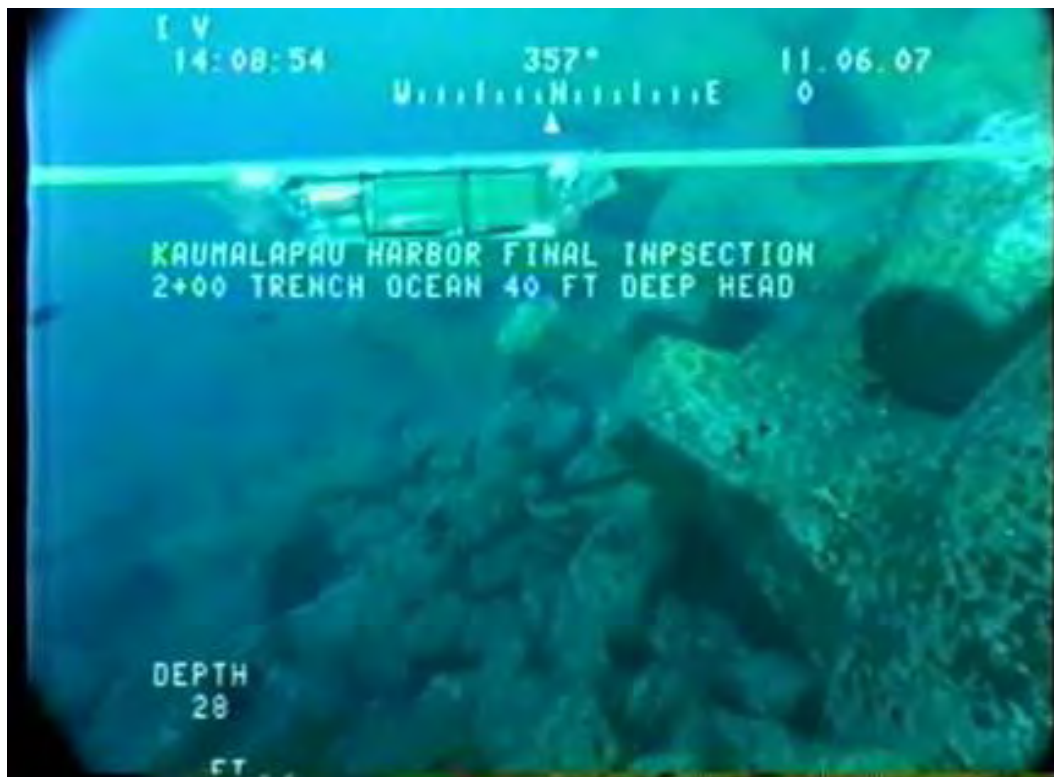
Figure 10.30. Ocean side trunk at approximately Station 2+00. Toe armor units and second row of armor units visible. Slope of toe trench/stone buttress appears somewhat steep.

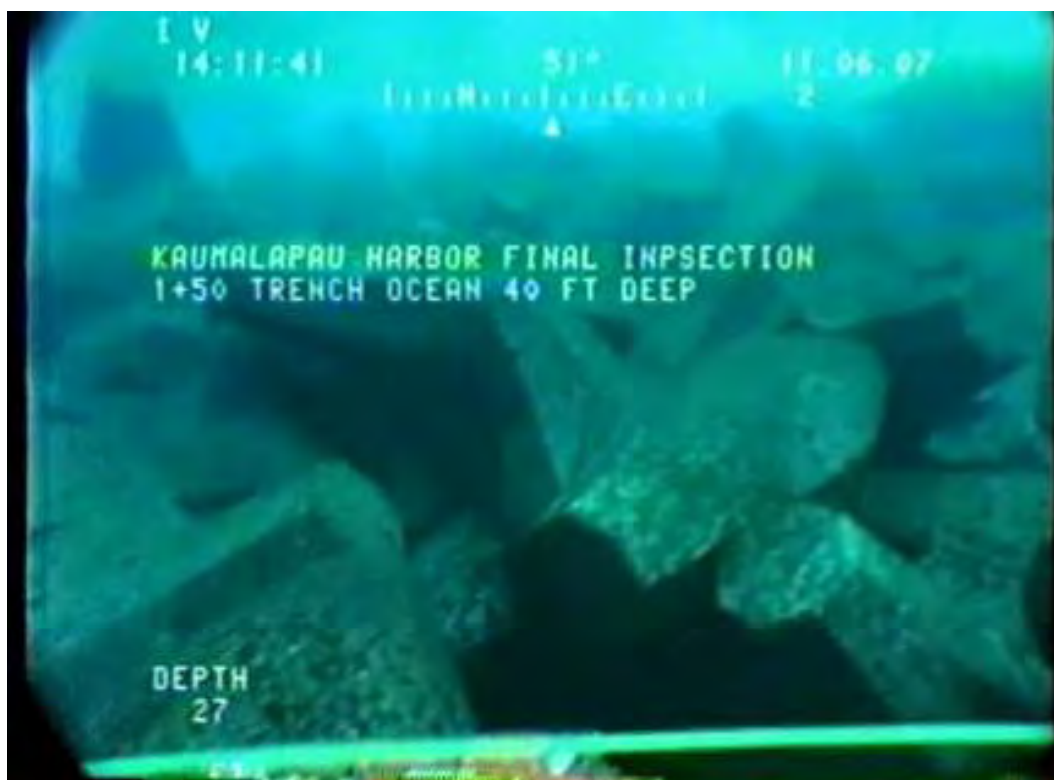
Figure 10.31. Ocean side trunk at approximately Station 1+50. Armor units appear well interlocked along breakwater side slope.

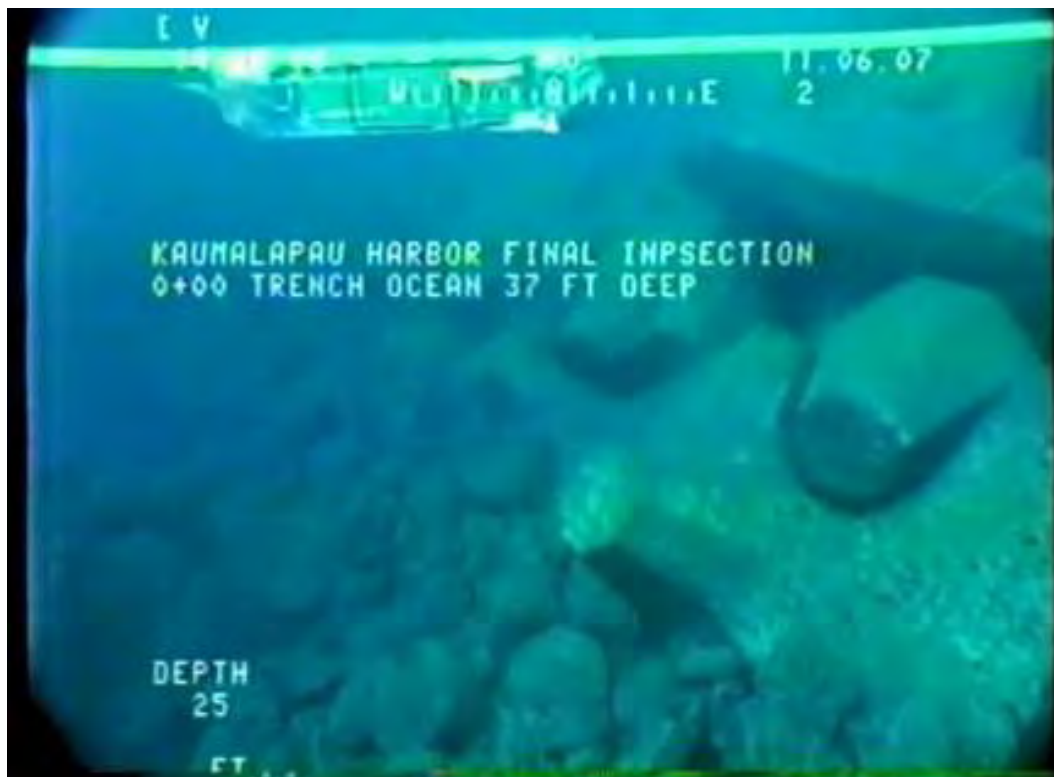
Figure 10.34. Ocean side trunk at approximately Station 0+00. Several toe units and interlocked units in the row above are visible at approximately 25-ft depth.

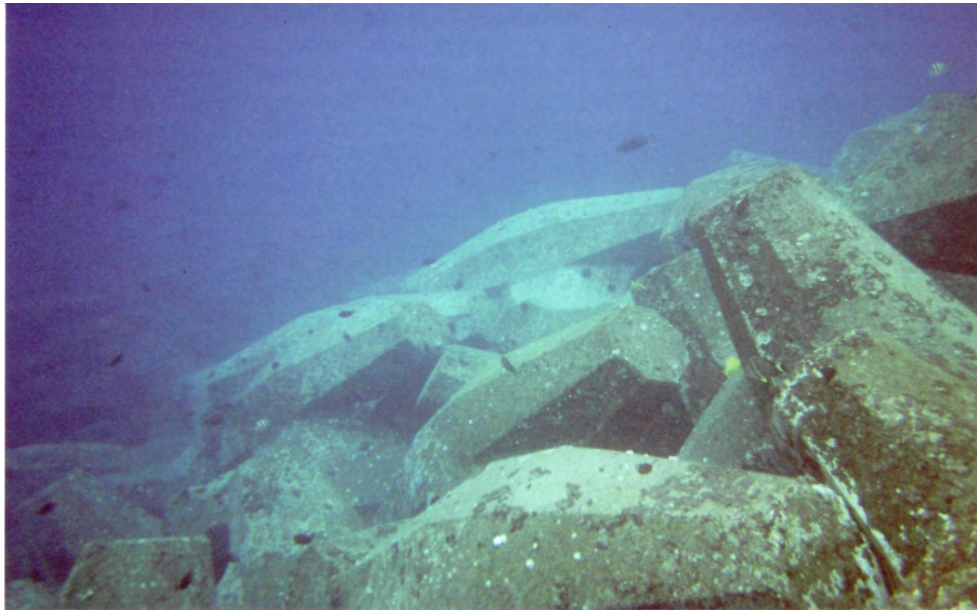
Figure 10.36. Photo of underwater structure side slope. (Photo by Orville T. Magoon, August 2009).

The following Figures 10.36 through 10.39 are photos of the underwater portion of the structure from August 2009, obtained by a private individual. The photos, in addition to the photographer's observations, indicated that there were no visible broken armor units, and that the armor layer still appeared to be well interlocked at that time. No location information is available for these photos.
