# Fatigue Crack Initiation from Pitting Introduced during the Anodising Process

*Cathy Smith*

**Air Vehicles Division**  
Defence Science and Technology Organisation

DSTO-TR-2729

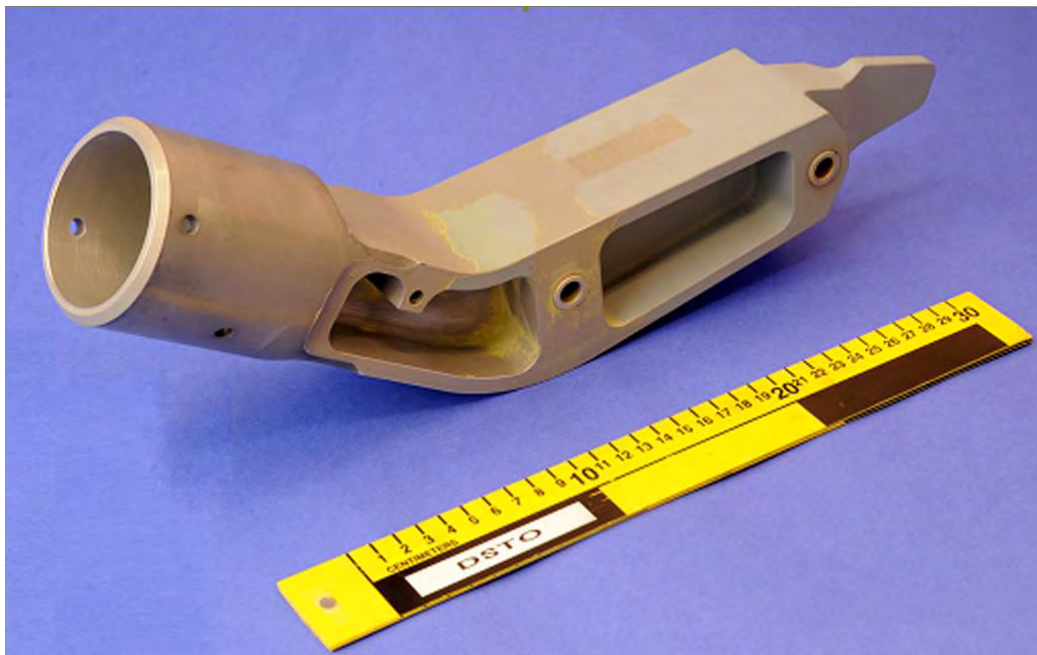
During routine inspection, pitting was observed on a new rescue hoist arm for an ADF rotary wing aircraft [11]. An in-service rescue hoist arm, from the same manufacturing batch, was also inspected and found to have similar pitting. The rescue hoist arm, shown in Figure 20, was manufactured from aluminium alloy 7075-T73 with a chromic acid anodising surface treatment.

Figure 20. Photograph of the rescue hoist arm as received. The rescue hoist arm consisted of a tubular end section and a H-profile body.

Examination of the two rescue hoist arms revealed the presence of fine etch pits on all surfaces. The pits were typically 50 – 100  $\mu\text{m}$  in diameter, see Figure 21. In addition to the fine etch pitting, a distribution of larger corrosion pits was observed on the outer surfaces of the rescue hoist arms, see Figure 22. The locations of the corrosion pits were generally consistent between the two rescue hoist arms, see Figure 23. The corrosion pits were up to 5 mm in length, with some containing dark coloured deposits and others being filled with paint or containing paint particles that were consistent in size and shape with the paint observed within the etch pits, see Figure 24.
