### Low Dissolved Oxygen Levels in Summer Powerplant Discharges from Fort Randall Dam, South Dakota

**Report Number: CENWO-ED-HA/SSR/Fort Randall Tailwaters/2010**

**October 2010**

**Prepared by:  
Water Control and Water Quality Section  
Hydrologic Engineering Branch  
Engineering Division  
Omaha District  
U.S. Army Corps of Engineers**

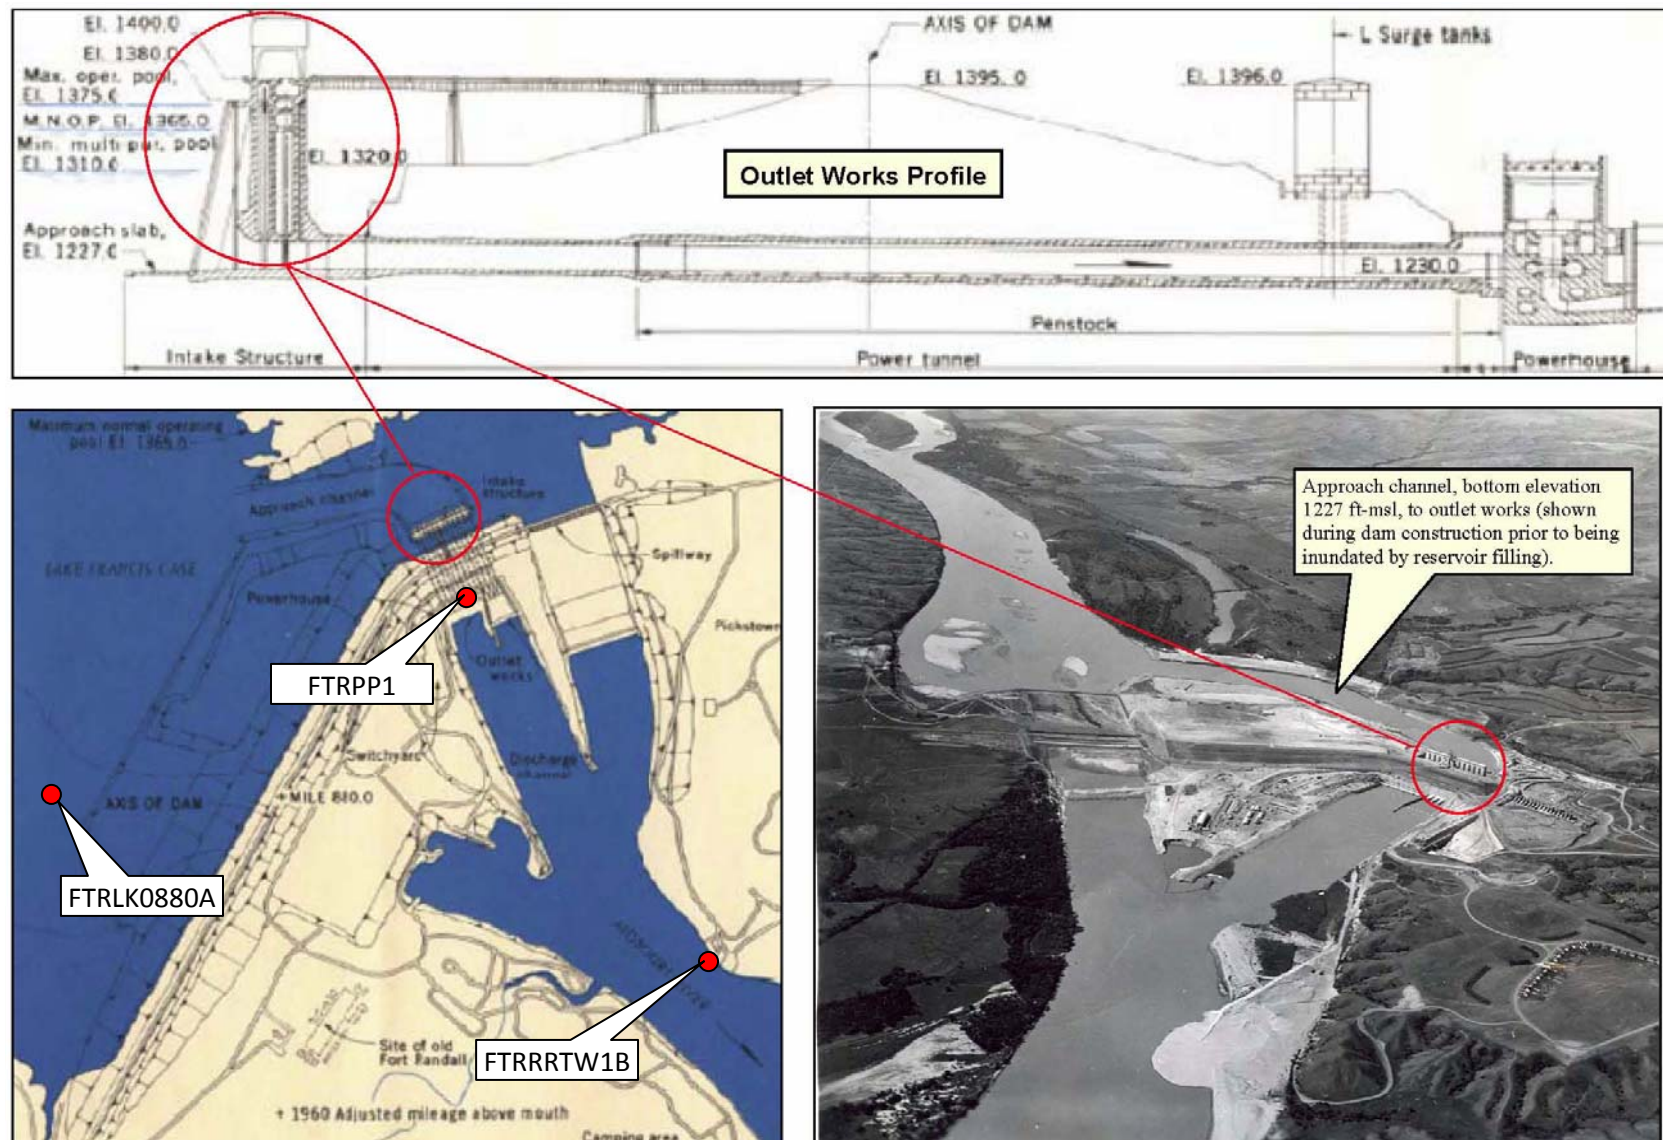
A water quality monitoring station is located in the Fort Randall powerplant (Figure 1). Water is withdrawn from the “raw water” supply line and routed through a flow chamber where a water quality monitor is located that logs hourly water temperature and dissolved oxygen levels. The monitored “raw water” is believed to represent water quality conditions in Lake Francis Case at the dam intake structure and in the water discharged to the Missouri River tailwaters. During the 6-year period 2004 through 2007 and 2009, 2,982 hourly measurements of dissolved oxygen were recorded in the powerplant in August (no measurements were recorded in 2008 due to monitoring equipment failure). Of these measurements, 546 (18%) were less than South Dakota’s 5 mg/l minimum dissolved oxygen water quality standards’ criterion for the protection of Warmwater Permanent Fish Life Propagation. The lowest dissolved oxygen measurements were associated with low- or no-flow discharge conditions. The no-flow conditions may be measurements of “static water” in the penstocks that is not being continuously discharged. This water is believed to have been drawn into the penstocks along the reservoir bottom as power generation was ramped down. The lowest dissolved oxygen concentration recorded was 2.0 mg/l on August 25 and 26, 2007. The low dissolved oxygen levels are attributed to hypoxic conditions in the hypolimnion of Lake Francis Case and the bottom withdrawal of water from the reservoir. A potential concern is whether the low dissolved oxygen levels monitored in the powerplant are reflective of dissolved oxygen levels occurring in the Missouri River tailwaters immediately downstream of the Fort Randall Dam.

**Figure 1.** Schematic drawing and photo of outlet works at Fort Randall Dam. Water quality monitoring sites shown in lower left diagram.

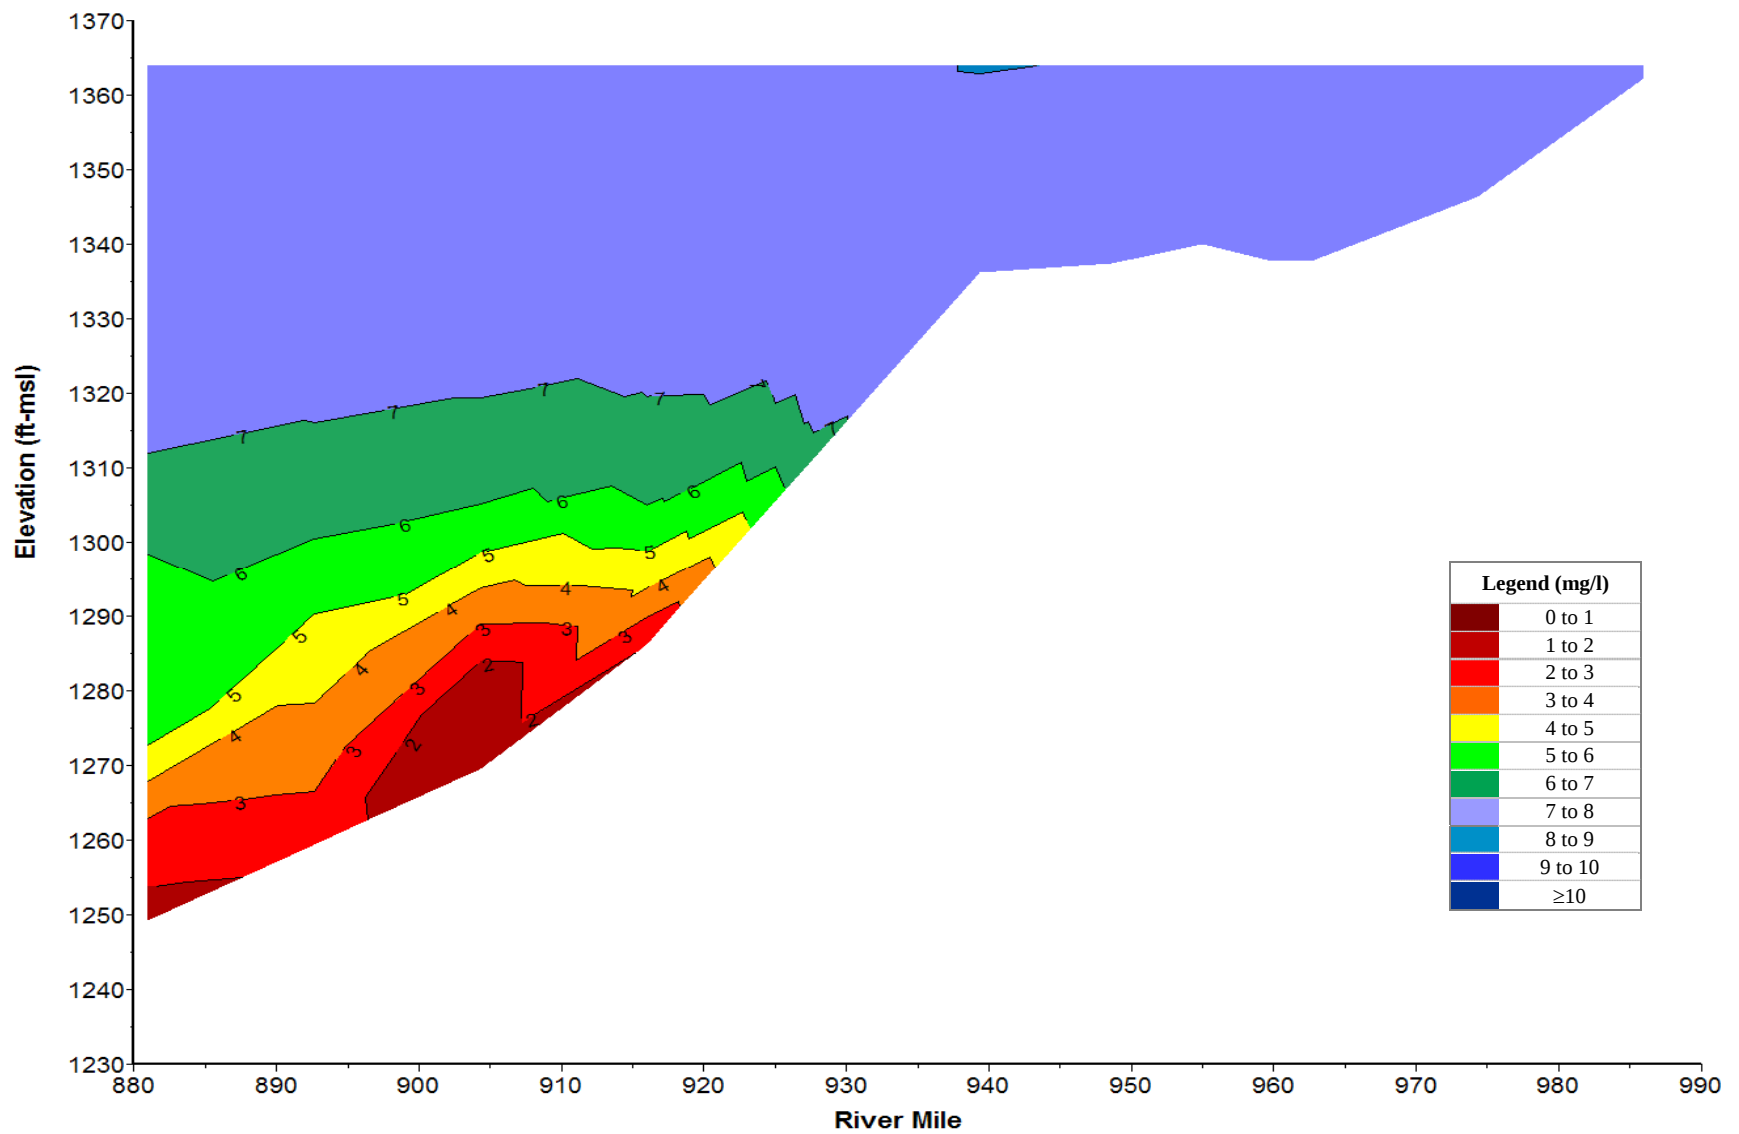
During the summer of 2010, dissolved oxygen conditions in Lake Francis Case varied longitudinally from the dam to the reservoir’s upstream reaches and vertically from the reservoir surface to the bottom. An area of low dissolved oxygen (i.e., <5 mg/l) was first monitored in July and occurred along the reservoir bottom from the dam upstream to RM925 (Figure 10). A similar area of low dissolved oxygen was again monitored in August, with the most hypoxic water located along the reservoir bottom near the dam (Figure 12). The area of low dissolved oxygen had dissipated when monitored in mid-September, ostensibly with the occurrence of “fall turnover.” The lowest dissolved oxygen concentration measured near the reservoir bottom on June 17, July 15, and August 12, were, respectively, 5.5, 1.6, and 0.4 mg/l.

**Figure 10.** Longitudinal dissolved oxygen contour plot of Lake Francis Case based on depth-profile dissolved oxygen levels measured at RM880, RM911, RM 940, and RM968 on July 15, 2010.

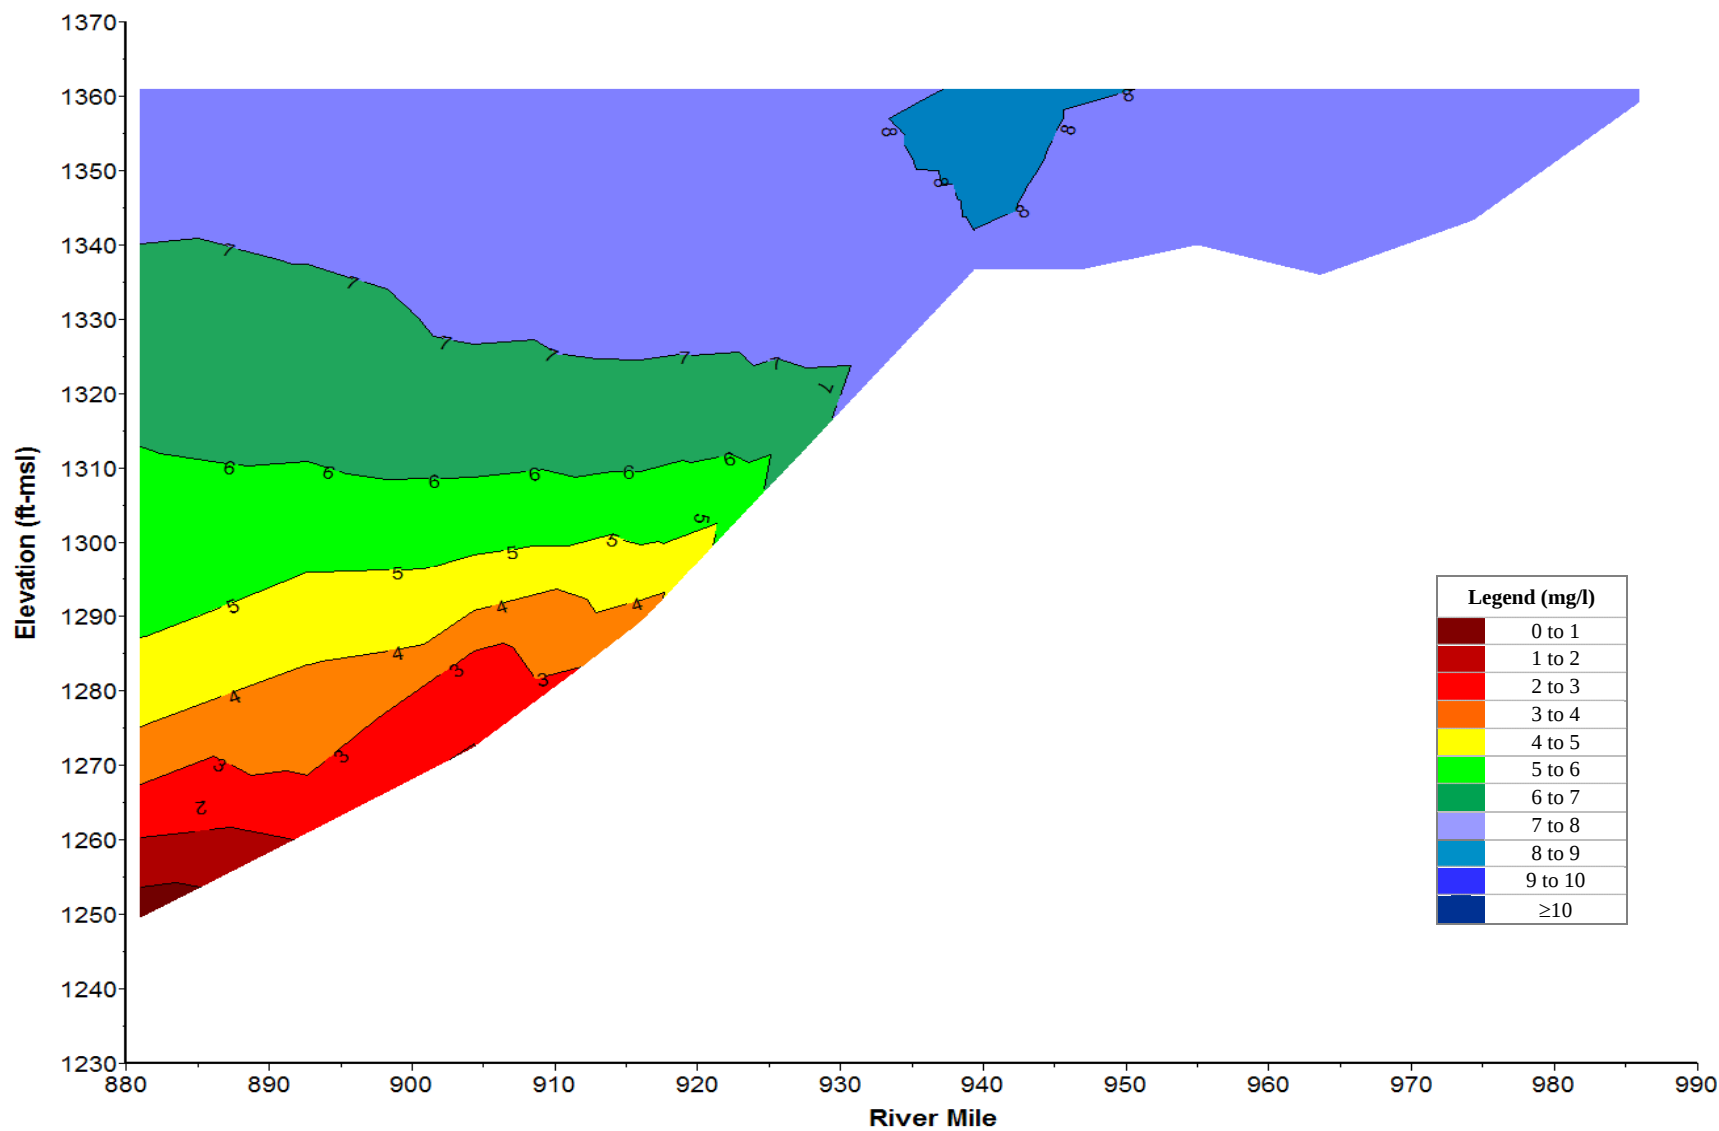
**Figure 12.** Longitudinal dissolved oxygen contour plot of Lake Francis Case based on depth-profile dissolved oxygen levels measured at RM880, RM911, RM 940, and RM968 on August 12, 2010.

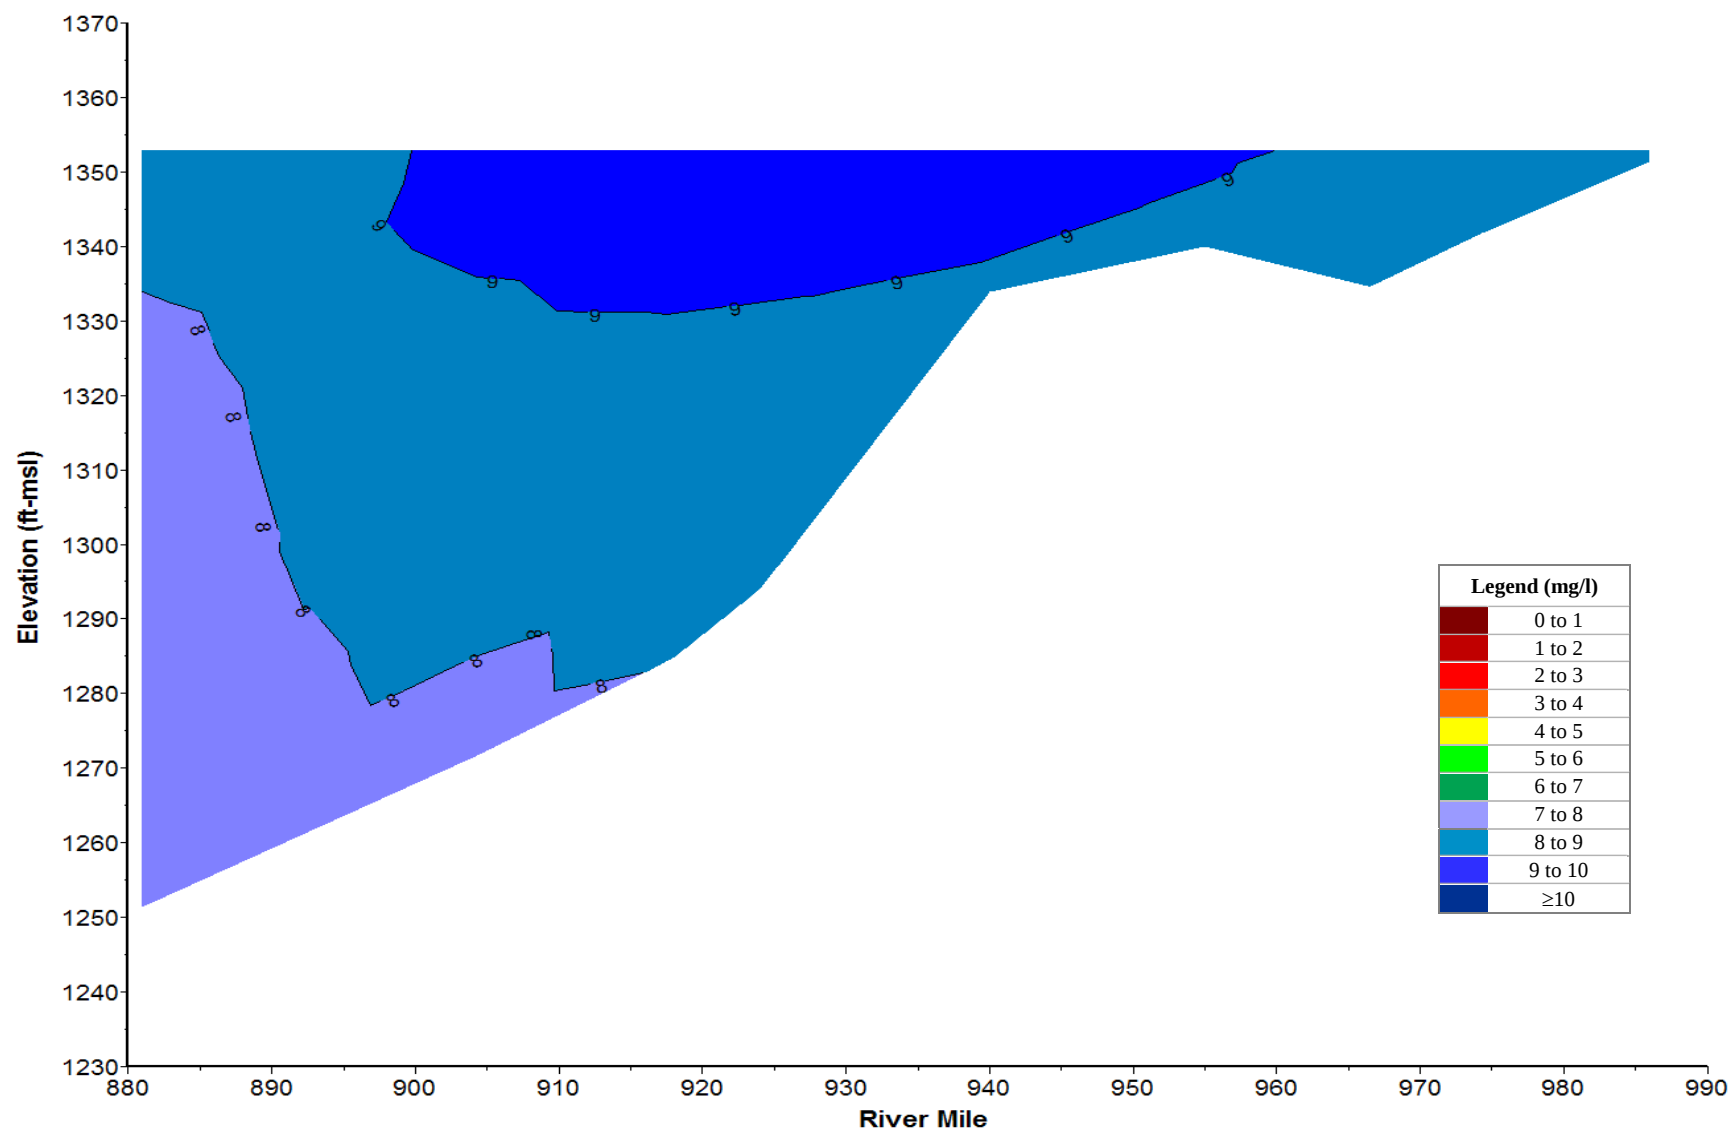
**Figure 14.** Longitudinal dissolved oxygen contour plot of Lake Francis Case based on depth-profile dissolved oxygen levels measured at RM880, RM911, and RM968 on September 16, 2010.

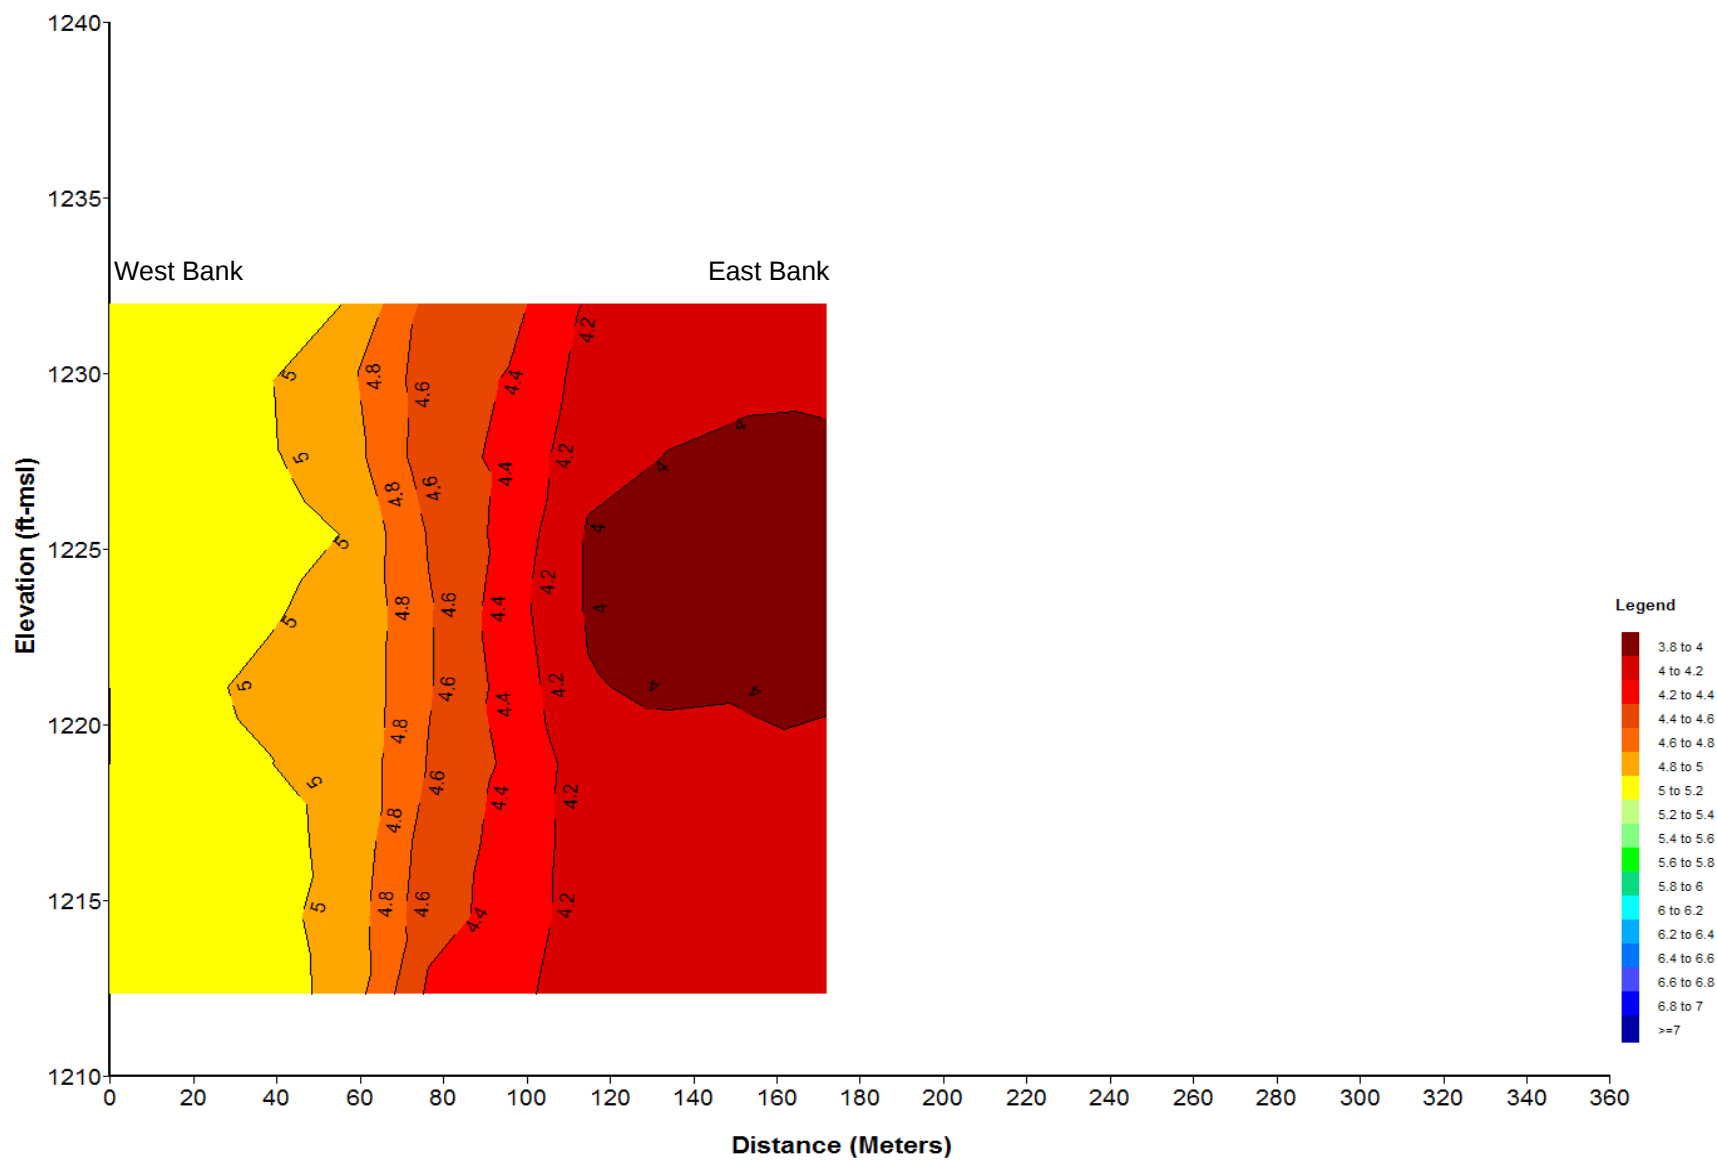
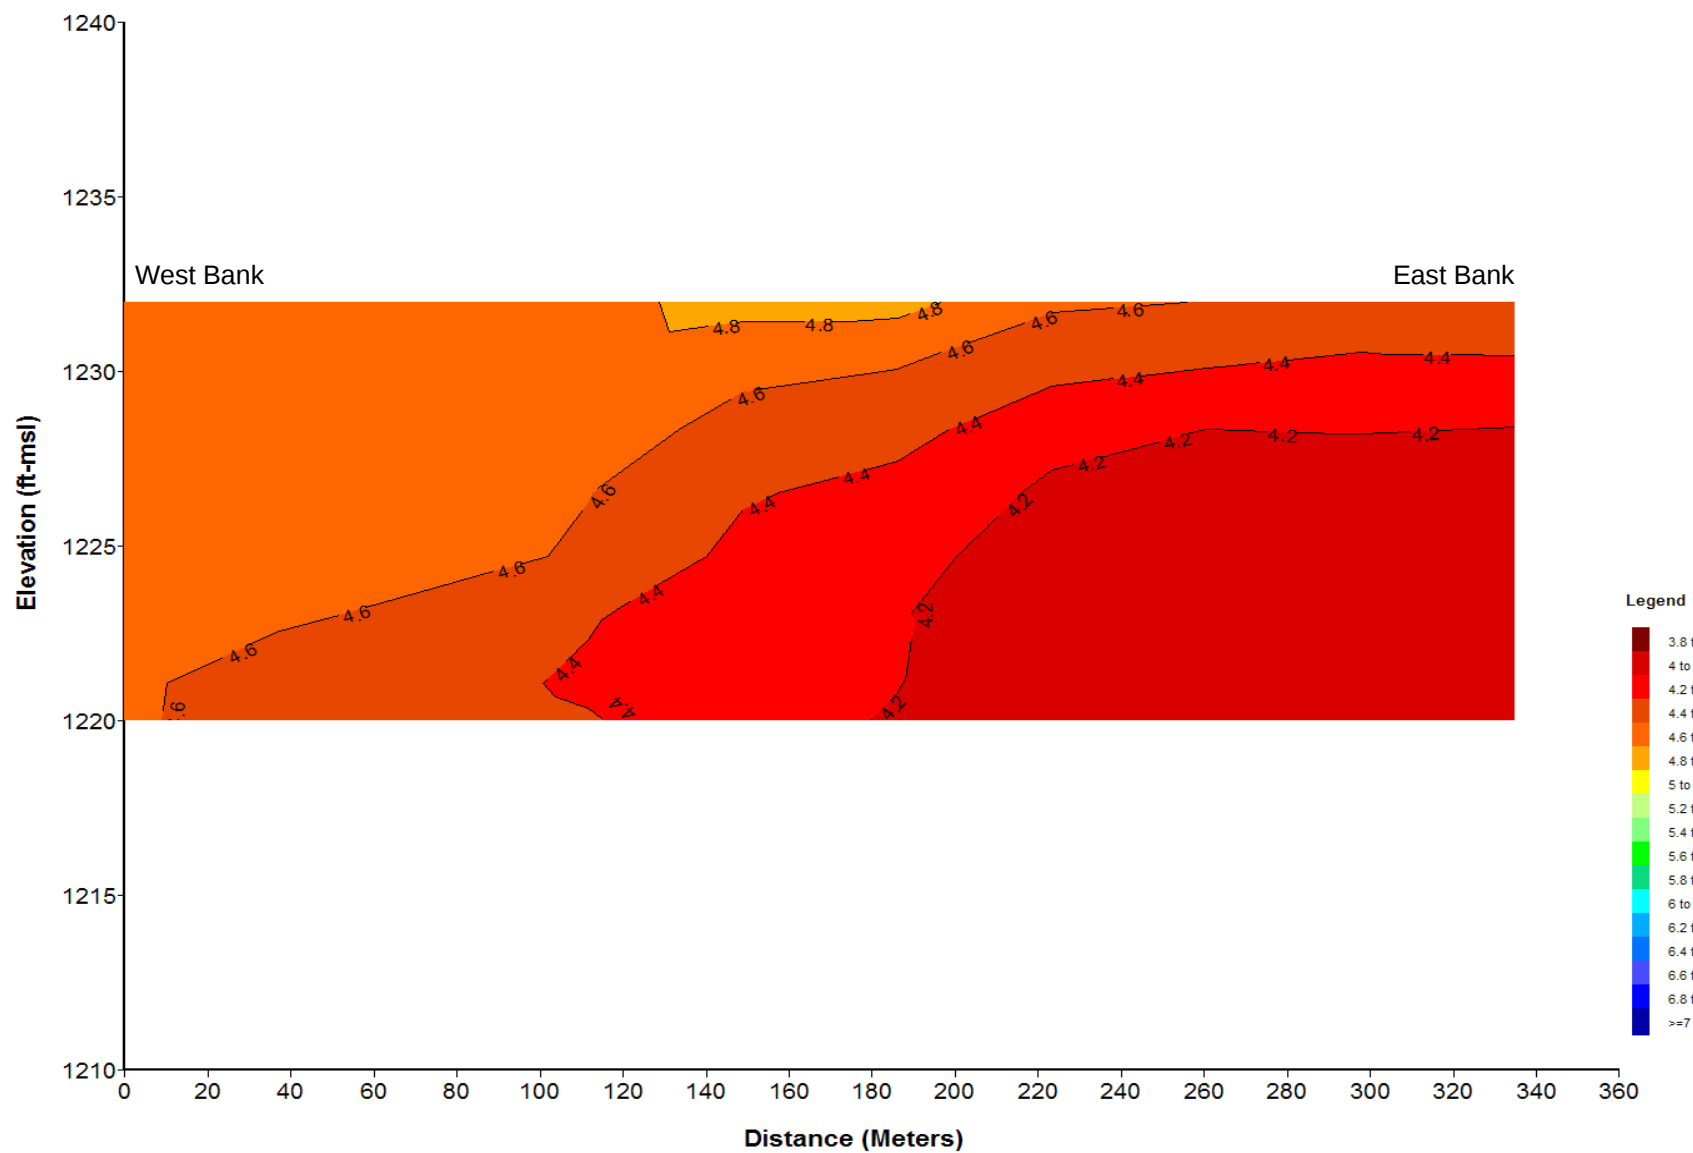
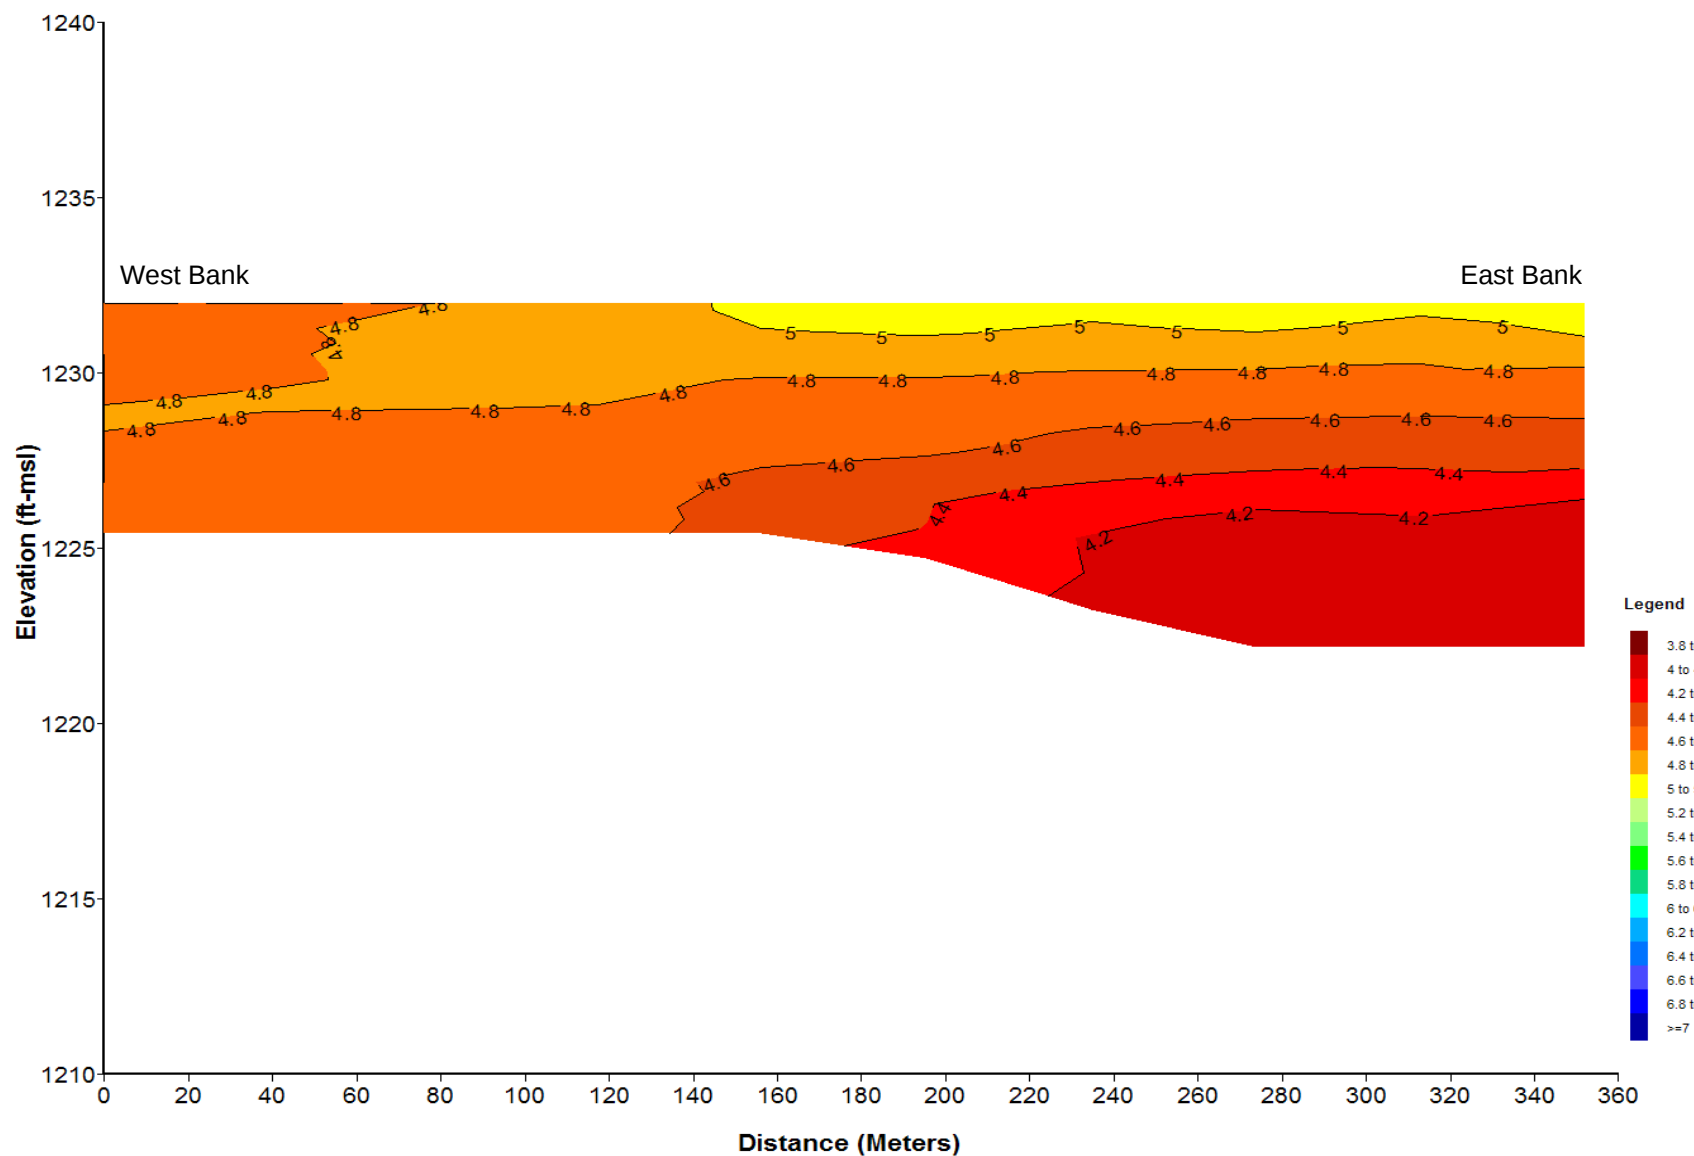
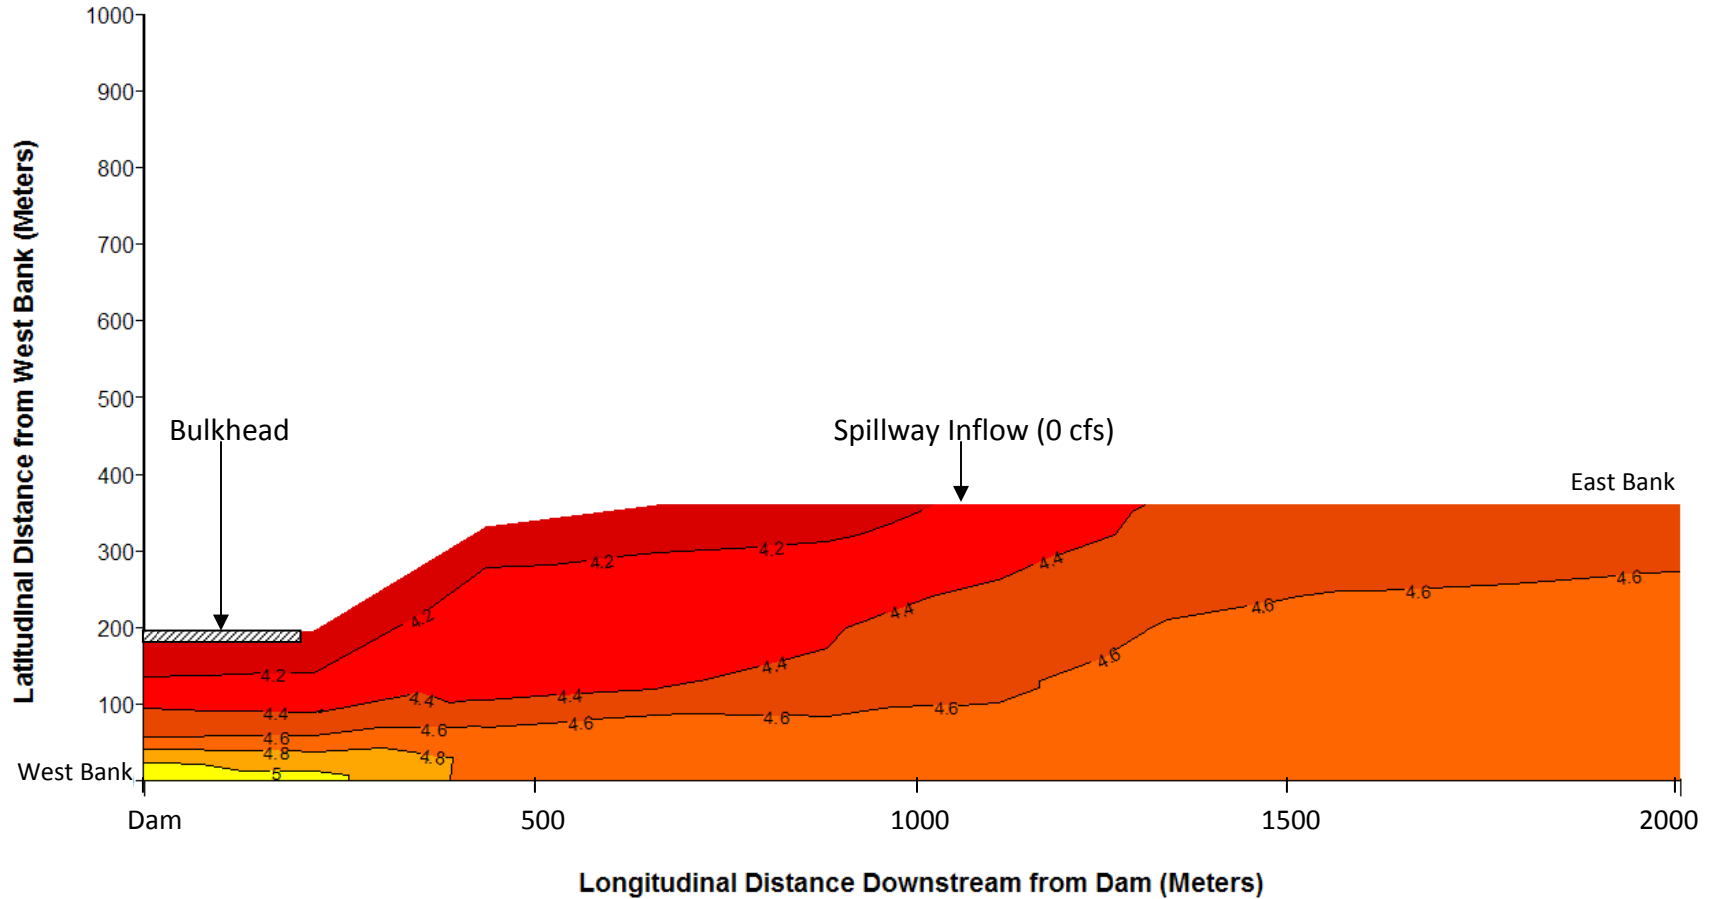
Figures 19, 20, and 21, respectively, display transect contour plots that were constructed to depict the dissolved oxygen concentrations measured across the Fort Randall Dam tailwaters at the near-dam (FTRTW3), spillway confluence (FTRTW2), and downstream (FTRTW1) sites on 27-July-2010. Figure 22 displays an aerial contour plot of the water-column average dissolved oxygen concentrations in the tailwaters based on the 1-meter incremental depth-profile measurements.

Water quality monitoring of the Fort Randall Dam tailwaters over the period 27-July-2010 through 26-August-2010 indicates that dissolved oxygen levels generally improved from the first time they were monitored on July 27. On July 27, dissolved oxygen levels throughout the tailwaters were below South Dakota’s dissolved oxygen water quality standard of 5 mg/l (Figures 19, 20, 21, and 22). Subsequent tailwaters monitoring on August 3, 5, 10, 12, 17, and 19 generally indicated dissolved oxygen levels above the 5 mg/l water quality standard along the west bank, and below the 5 mg/l standard along the east bank when no water was being spilled (Figures 23 - 46). The spillway enters the tailwater area about 1,000 meters downstream

The dissolved oxygen levels monitored in the Fort Randall tailwaters indicate that dissolved oxygen levels are higher along the west bank than along the east bank (Figures 19 - 54). The difference between the dissolved oxygen levels monitored along the east and west banks is up to 2 mg/l. The following is provided as a possible explanation for the differences in dissolved oxygen levels along the east and west banks:

**Figure 19.** Contour plot depicting dissolved oxygen concentrations measured across the near-dam transect (FTRTW3) on July 27, 2010.

**Figure 20.** Contour plot depicting dissolved oxygen concentrations measured across the spillway transect (FTRTW2) on July 27, 2010.

**Figure 21.** Contour plot depicting dissolved oxygen concentrations measured across the downstream transect (FTRTW1) on July 27, 2010.

**Figure 22.** Contour plot of average water-column dissolved oxygen concentrations for the Fort Randall Dam tailwaters on July 27, 2010. Water-column average based on 1-meter depth-profile dissolved oxygen measurements taken at the near-dam, spillway confluence, and downstream transects. Plot is an aerial view from above with the dam to the left, flow going to the right, west bank on the bottom, and the east bank on the top (see Figure 18 for an aerial photo of the area).
