### Low Dissolved Oxygen Levels in Summer Powerplant Discharges from Fort Randall Dam, South Dakota

**Report Number: CENWO-ED-HA/SSR/Fort Randall Tailwaters/2010**

**October 2010**

**Prepared by:  
Water Control and Water Quality Section  
Hydrologic Engineering Branch  
Engineering Division  
Omaha District  
U.S. Army Corps of Engineers**

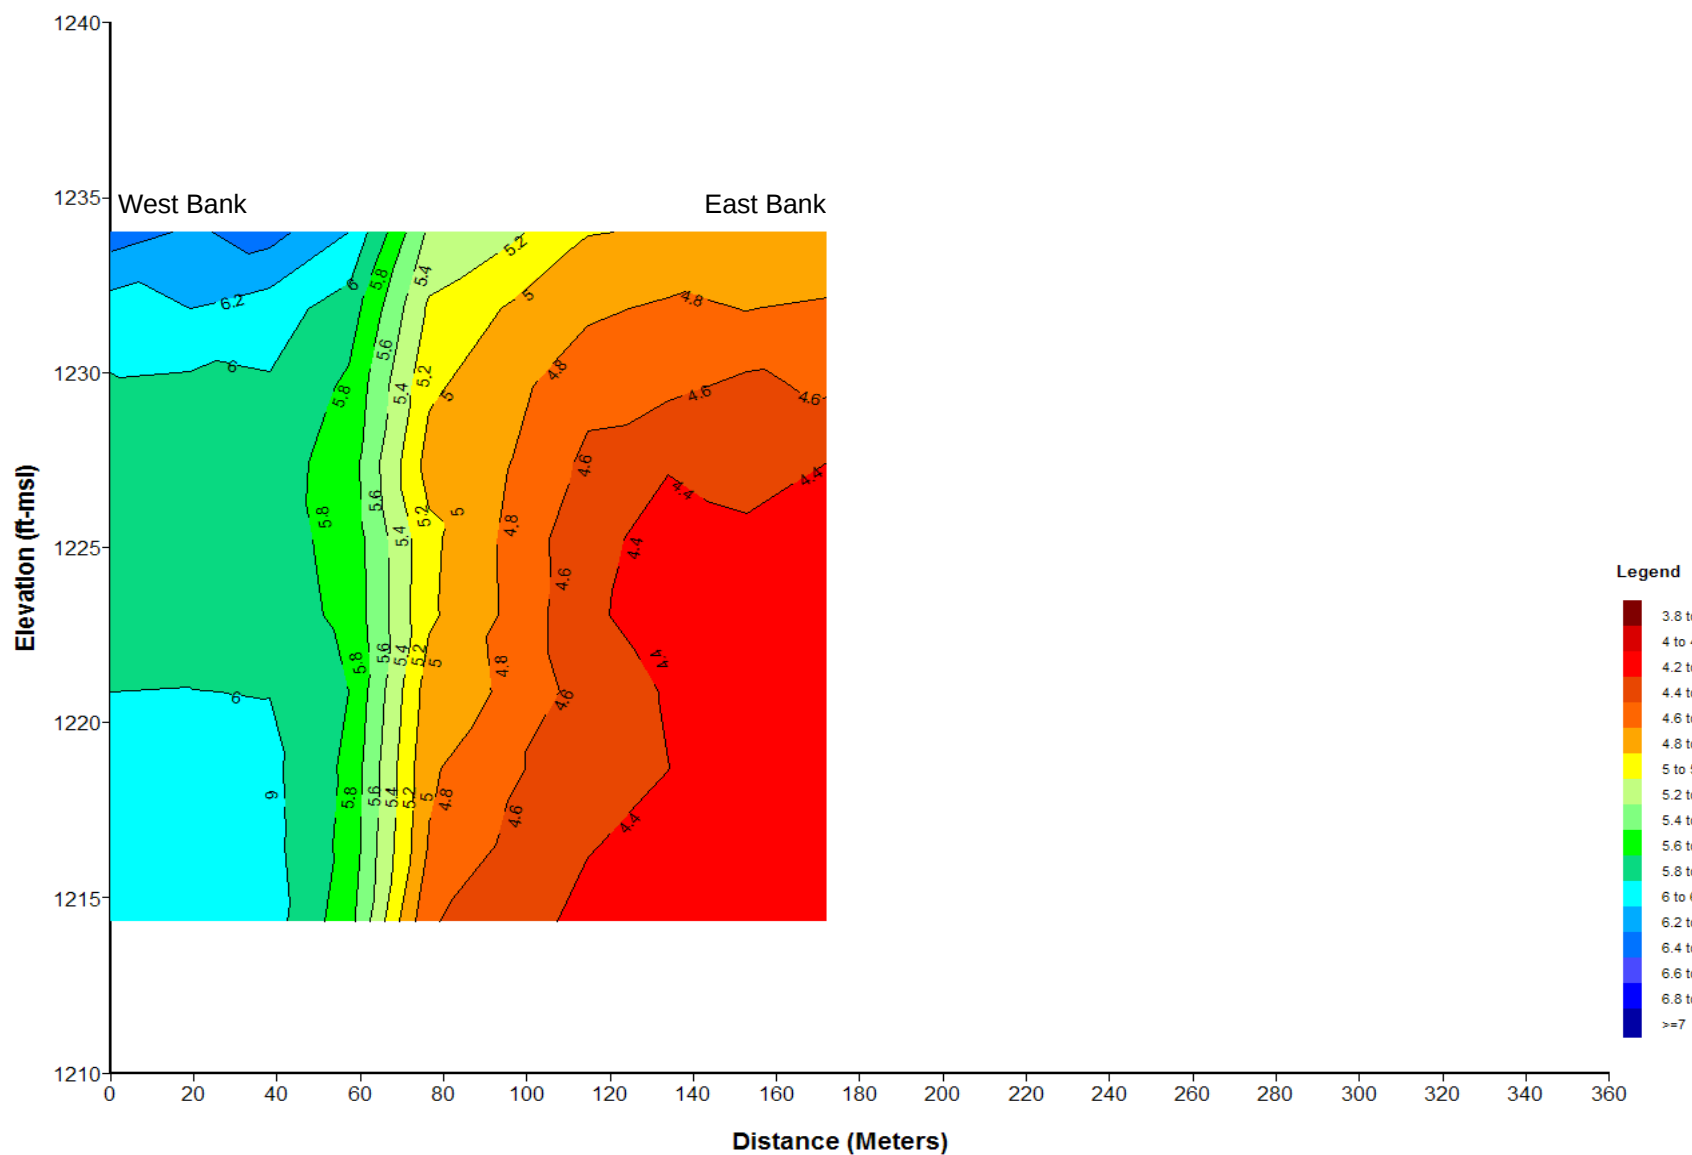
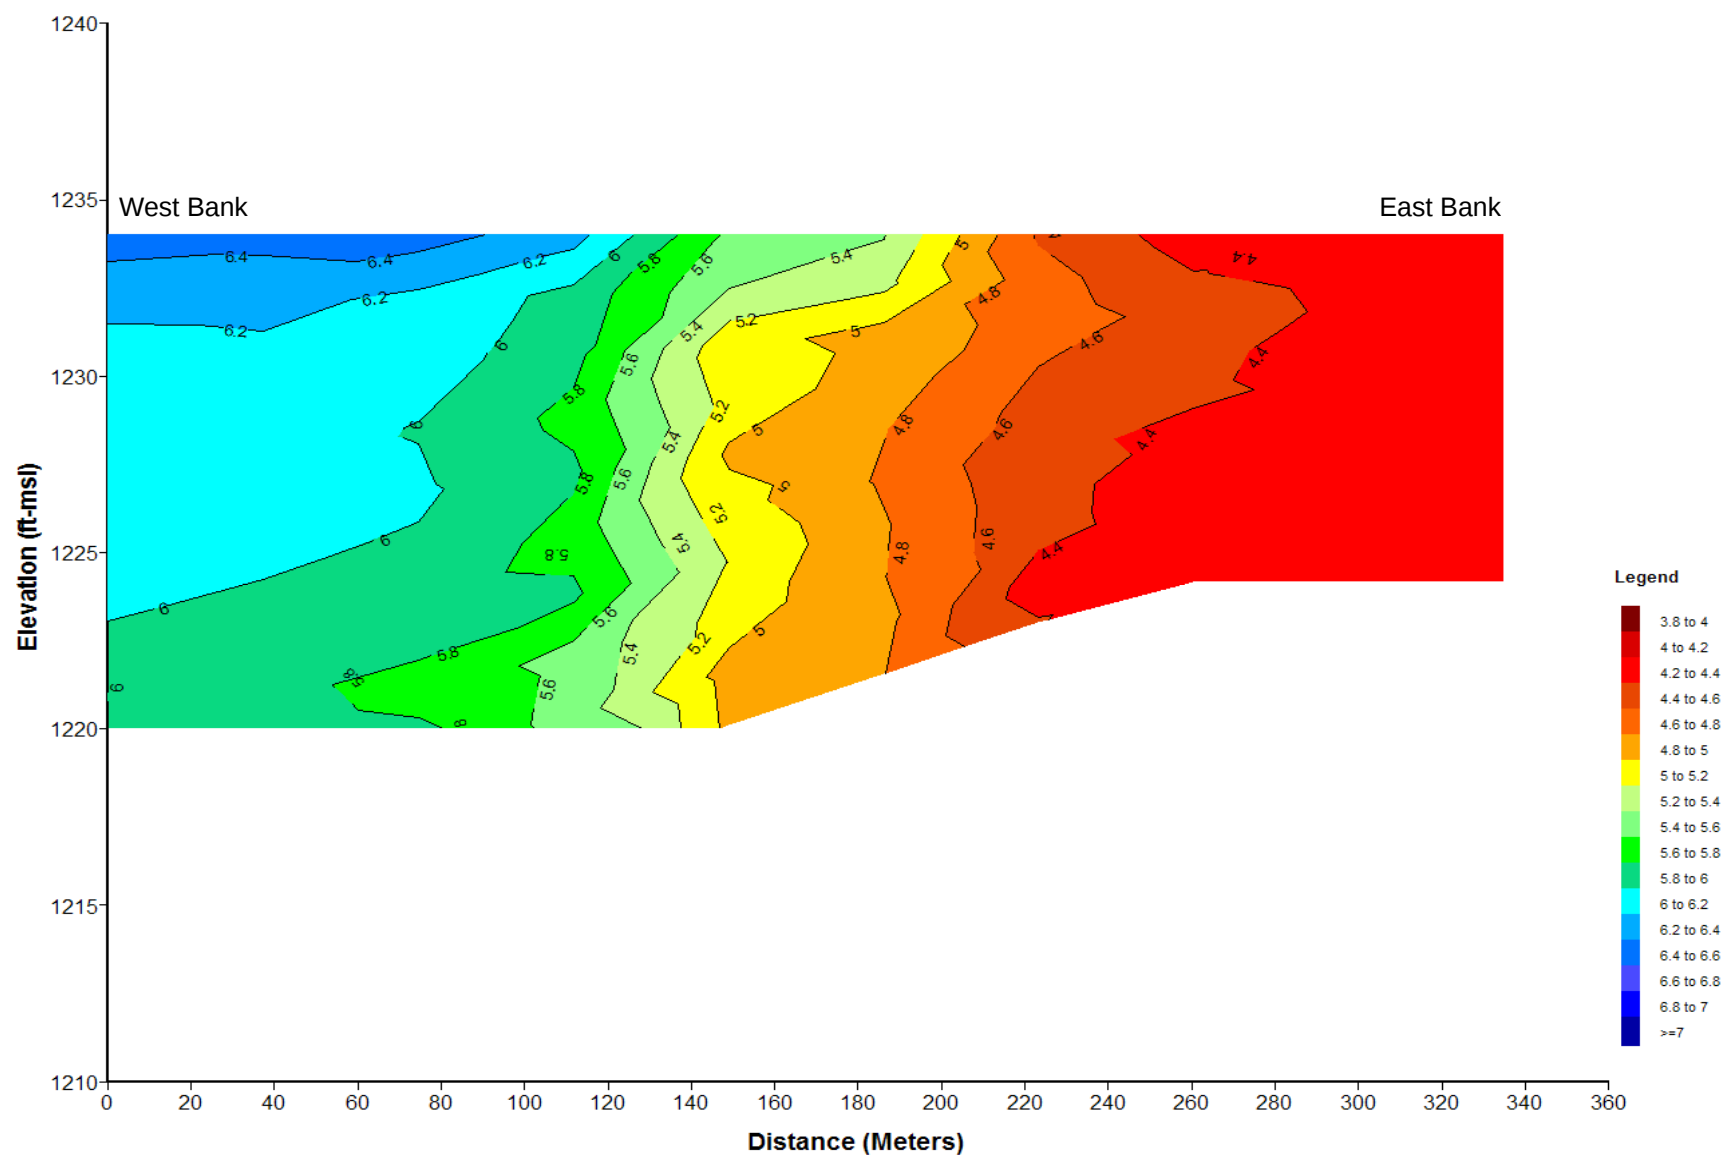
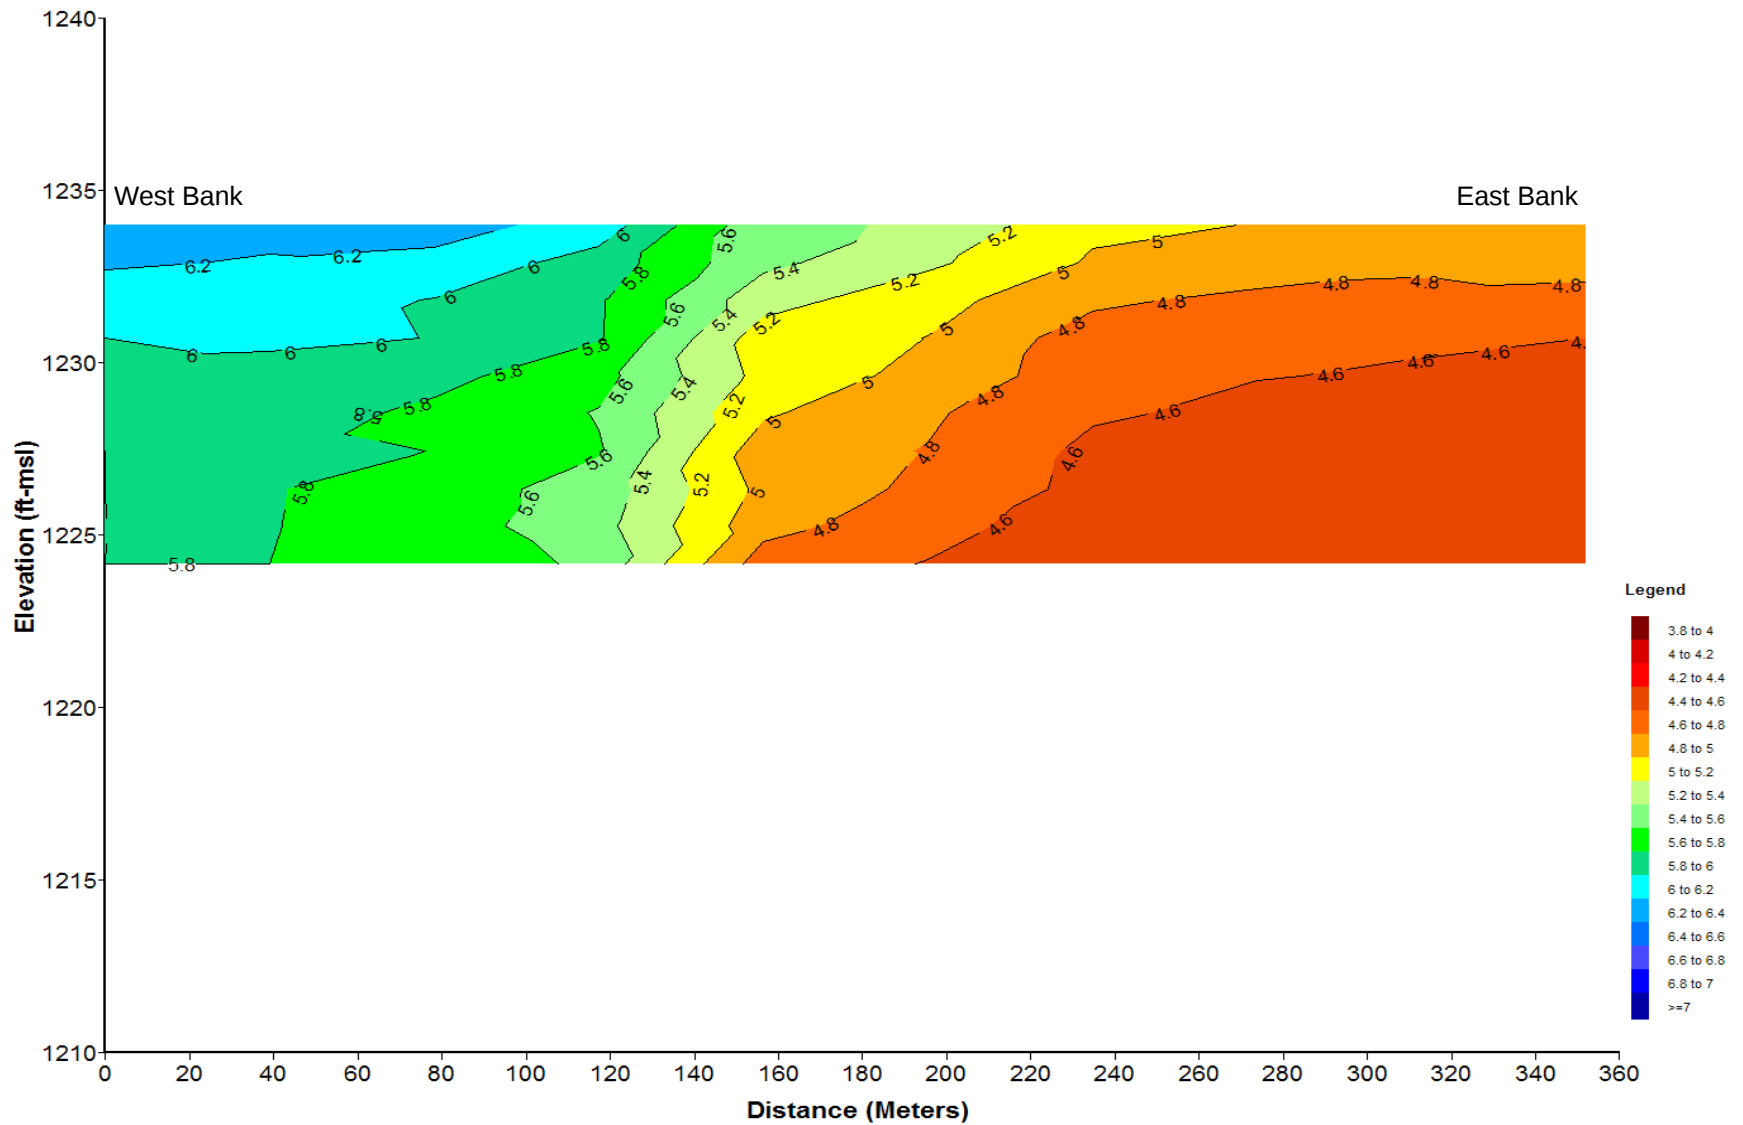
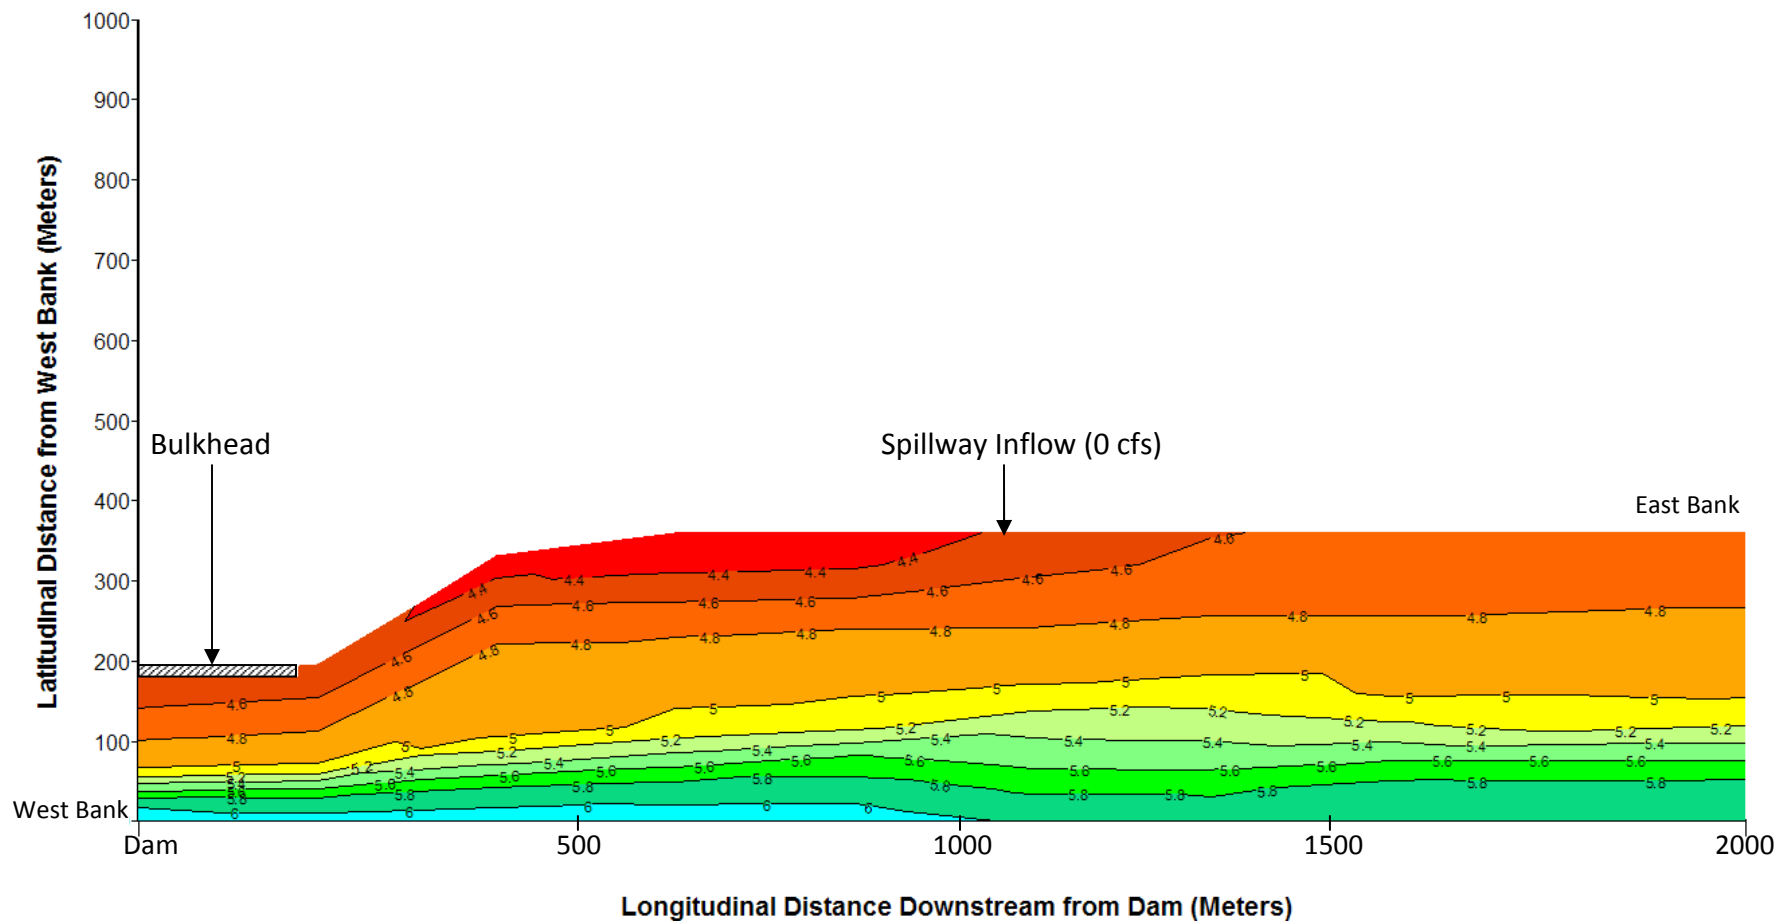
Figures 23, 24, and 25, respectively, display transect contour plots that were constructed to depict the dissolved oxygen concentrations measured across the Fort Randall Dam tailwaters at the near-dam (FTRTW3), spillway confluence (FTRTW2), and downstream (FTRTW1) sites on 3-August-2010. Figure 26 displays an aerial contour plot of the water-column average dissolved oxygen concentrations in the tailwaters based on the 1-meter incremental depth-profile measurements.

Water quality monitoring of the Fort Randall Dam tailwaters over the period 27-July-2010 through 26-August-2010 indicates that dissolved oxygen levels generally improved from the first time they were monitored on July 27. On July 27, dissolved oxygen levels throughout the tailwaters were below South Dakota’s dissolved oxygen water quality standard of 5 mg/l (Figures 19, 20, 21, and 22). Subsequent tailwaters monitoring on August 3, 5, 10, 12, 17, and 19 generally indicated dissolved oxygen levels above the 5 mg/l water quality standard along the west bank, and below the 5 mg/l standard along the east bank when no water was being spilled (Figures 23 - 46). The spillway enters the tailwater area about 1,000 meters downstream

**Figure 23.** Contour plot depicting dissolved oxygen concentrations measured across the near-dam transect (FTRTW3) on August 3, 2010.

**Figure 24** Contour plot depicting dissolved oxygen concentrations measured across the spillway transect (FTRTW2) on August 3, 2010.

**Figure 25.** Contour plot depicting dissolved oxygen concentrations measured across the downstream transect (FTRTW1) on August 3, 2010.

**Figure 26.** Contour plot of average water-column dissolved oxygen concentrations for the Fort Randall Dam tailwaters on August 3, 2010. Water-column average based on 1-meter depth-profile dissolved oxygen measurements taken at the near-dam, spillway confluence, and downstream transects. Plot is an aerial view from above with the dam to the left, flow going to the right, west bank on the bottom, and the east bank on the top (see Figure 18 for an aerial photo of the area).

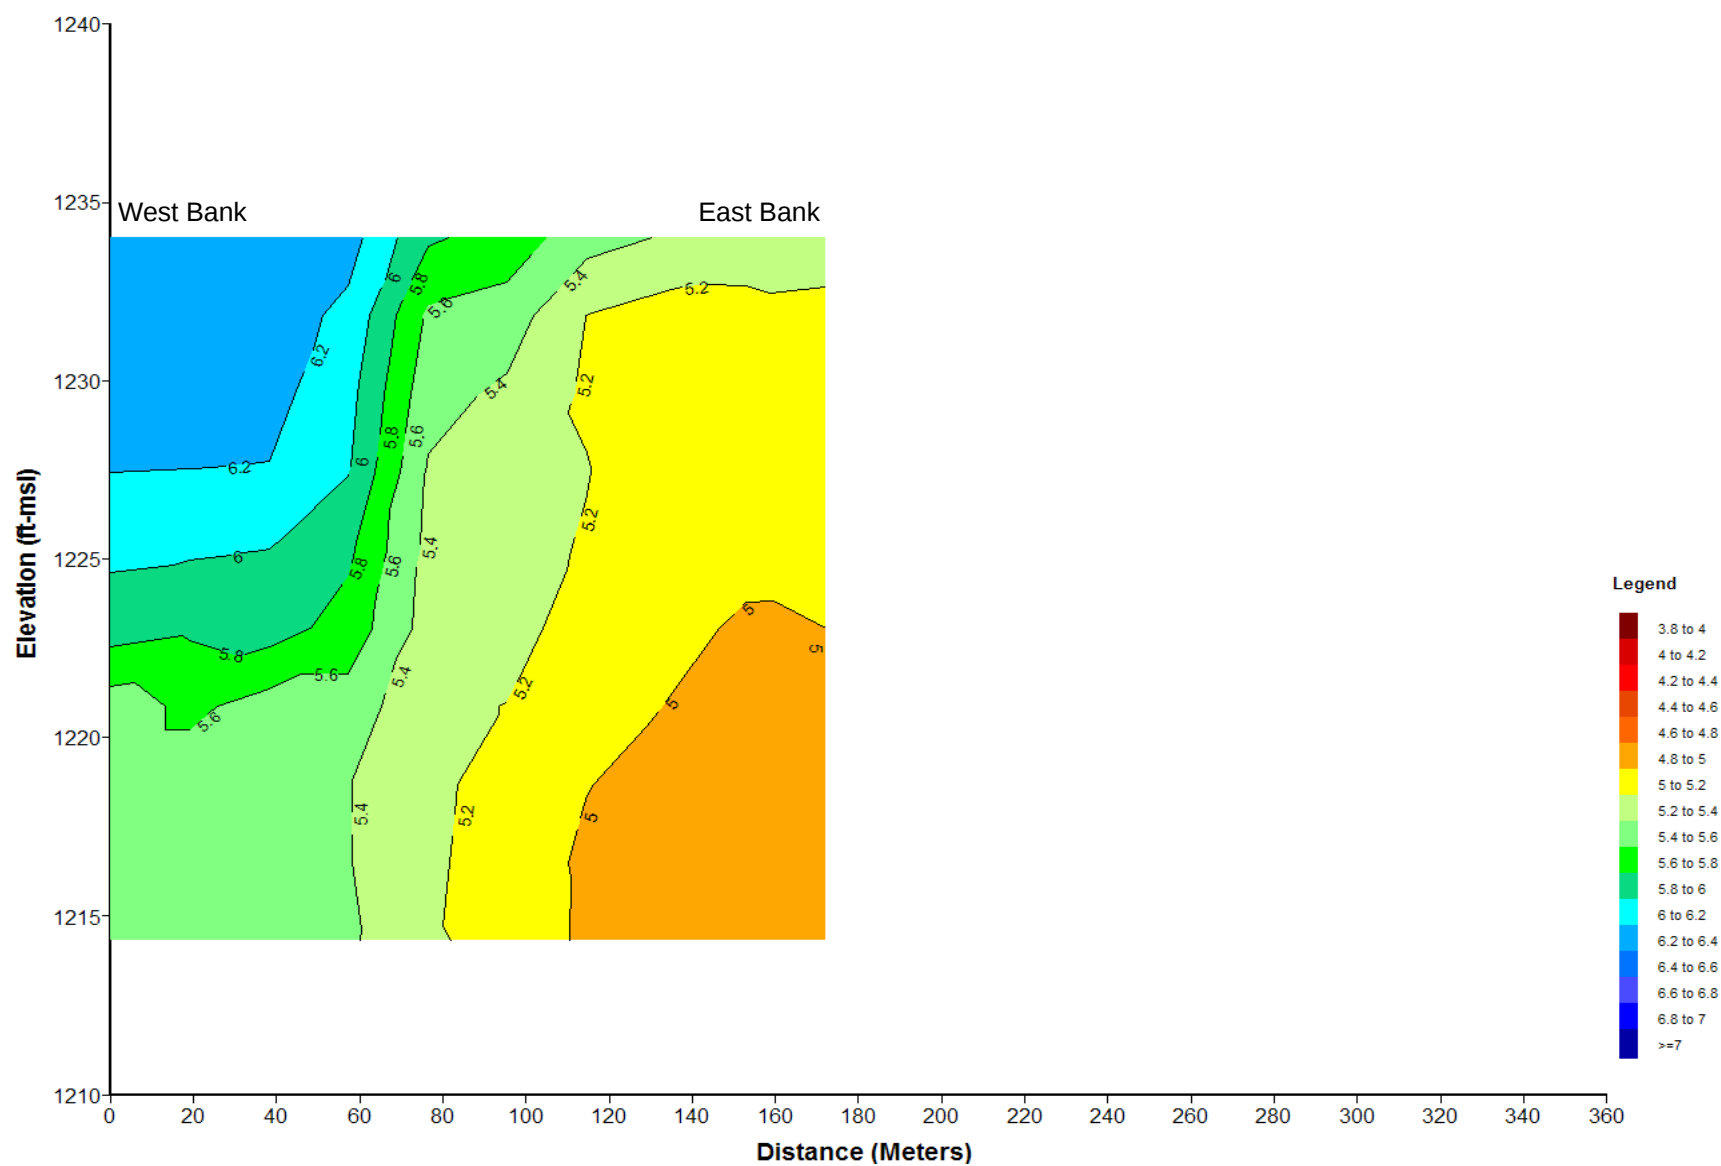
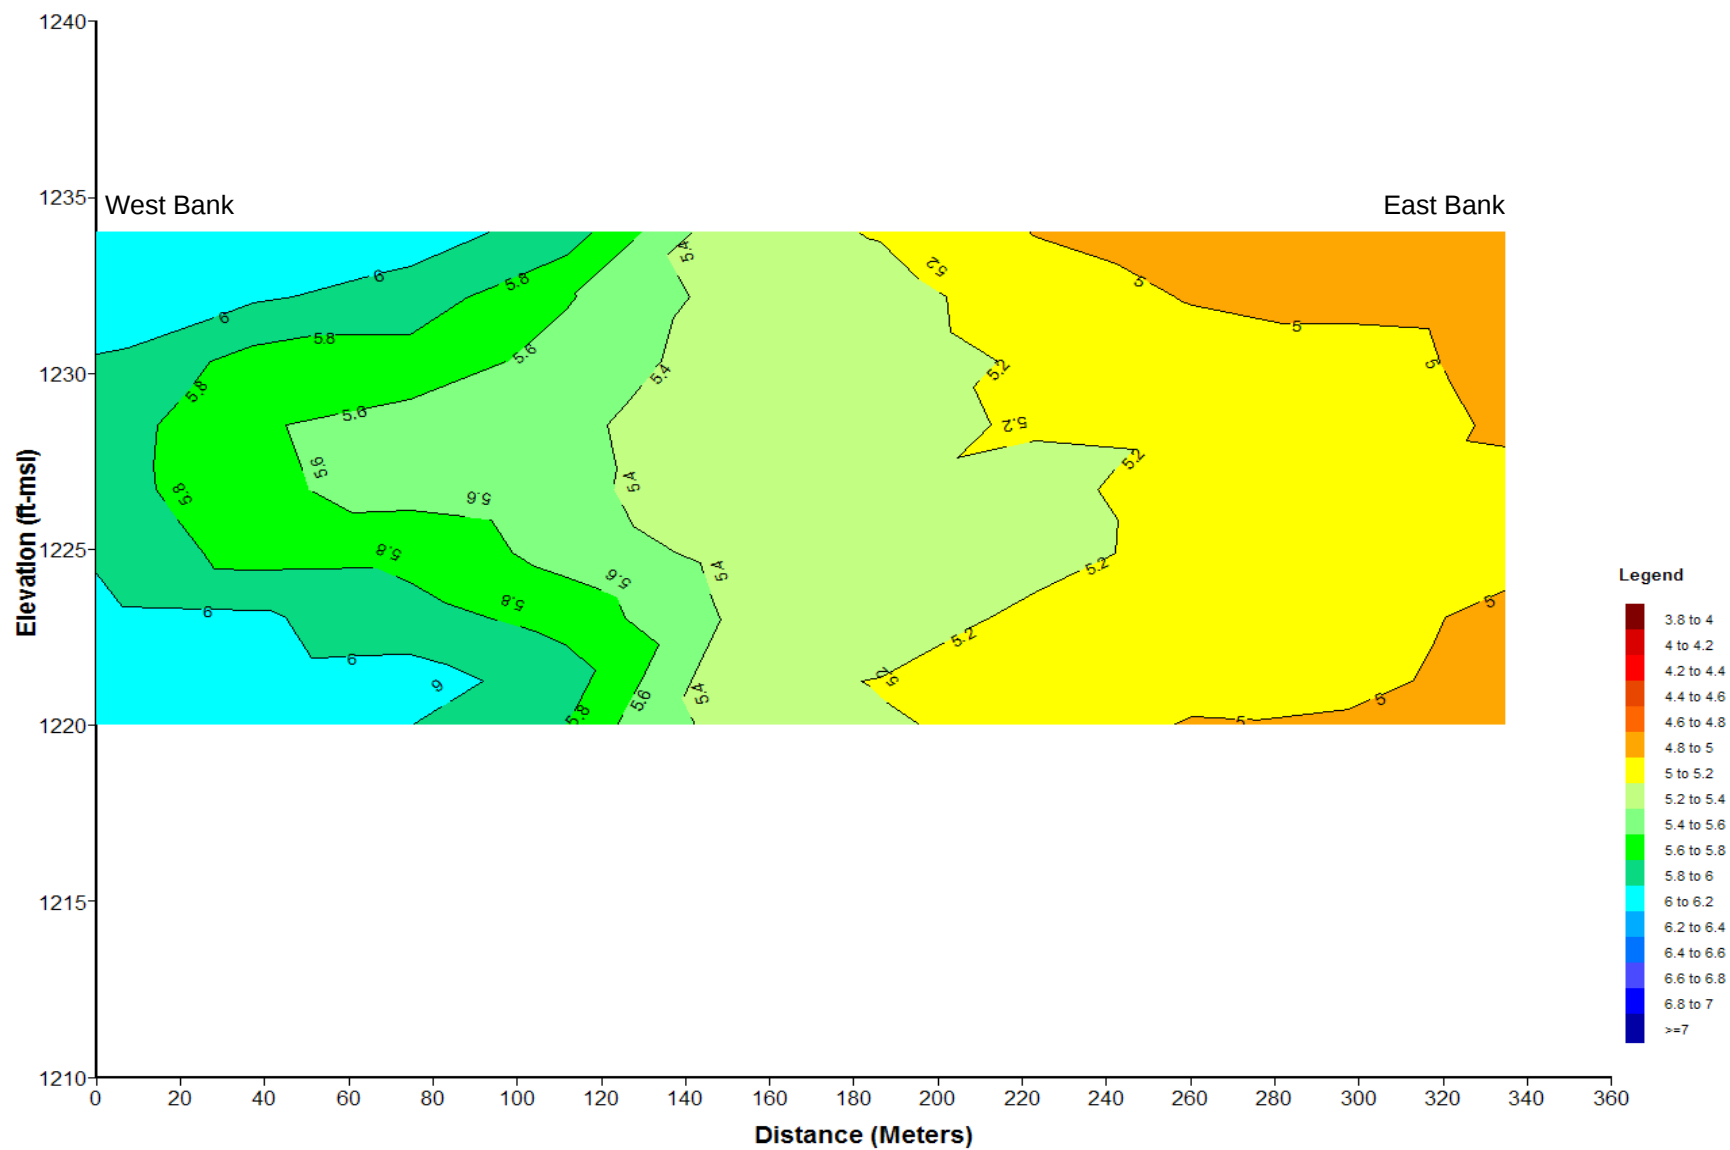
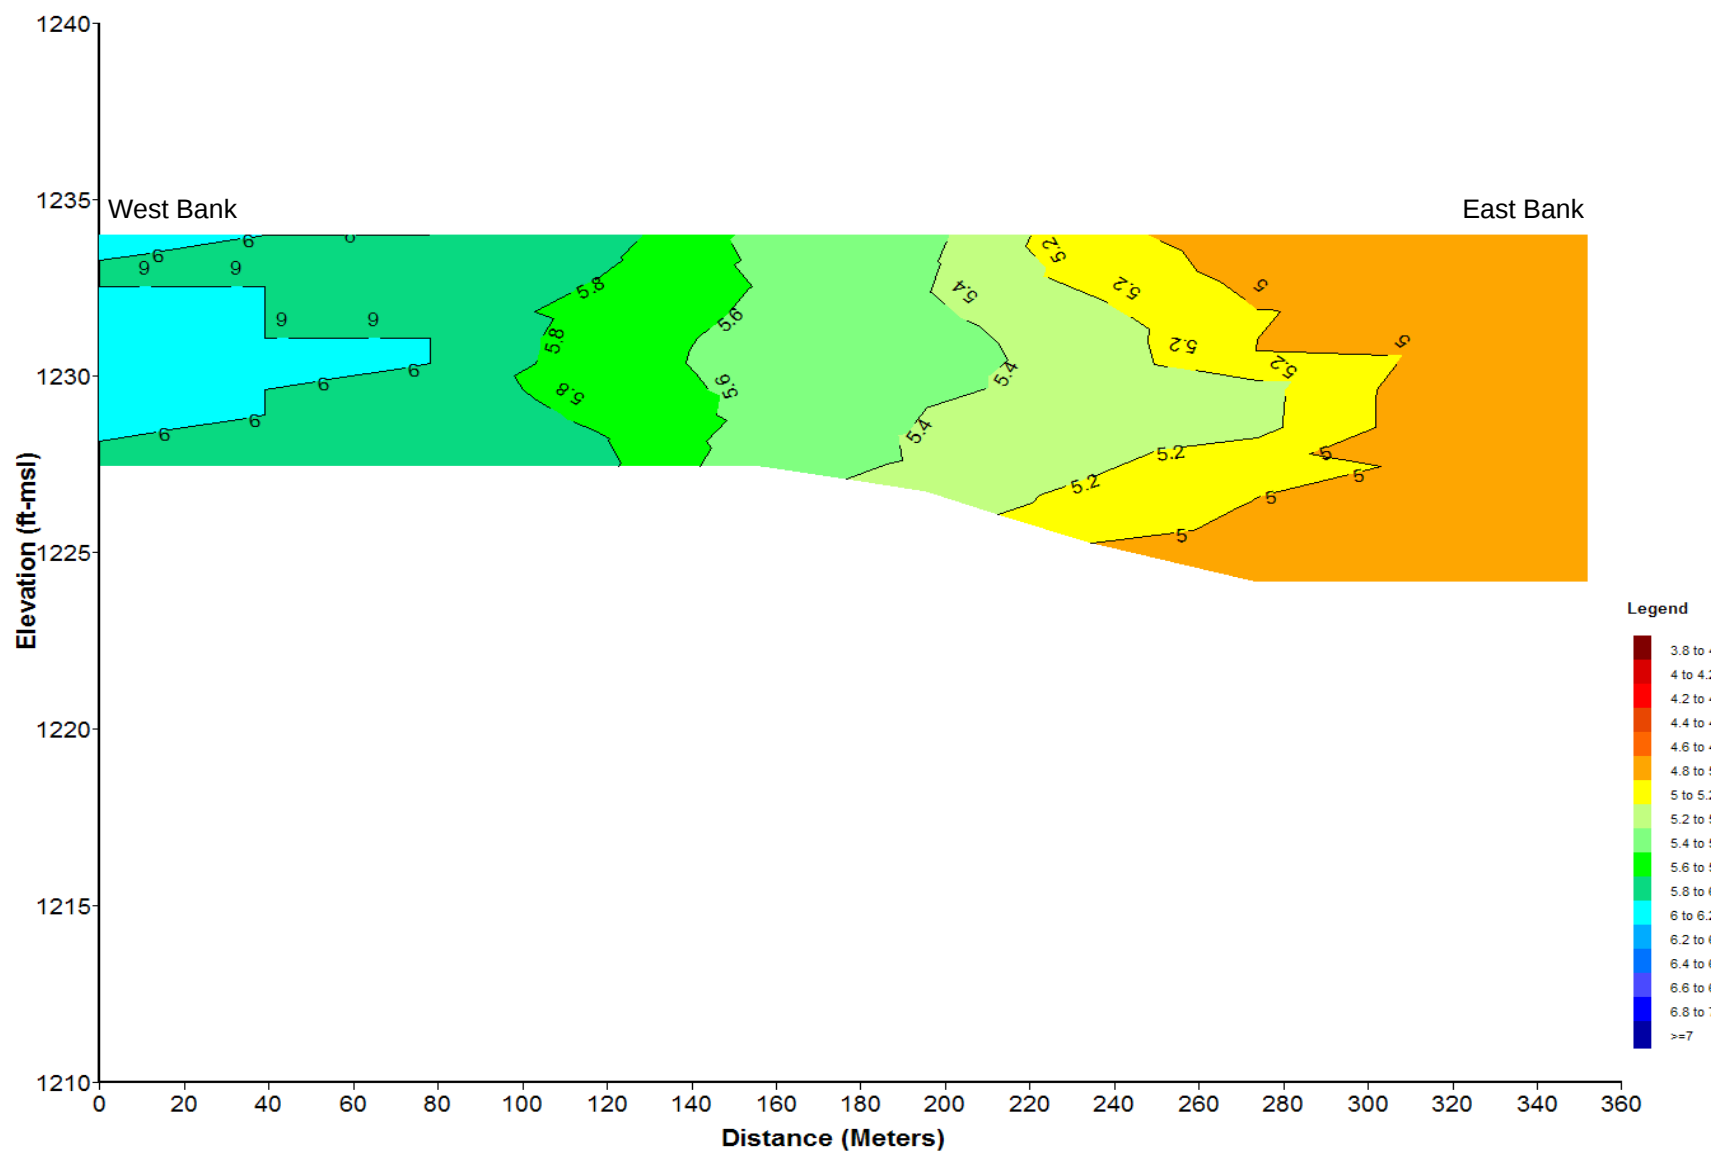
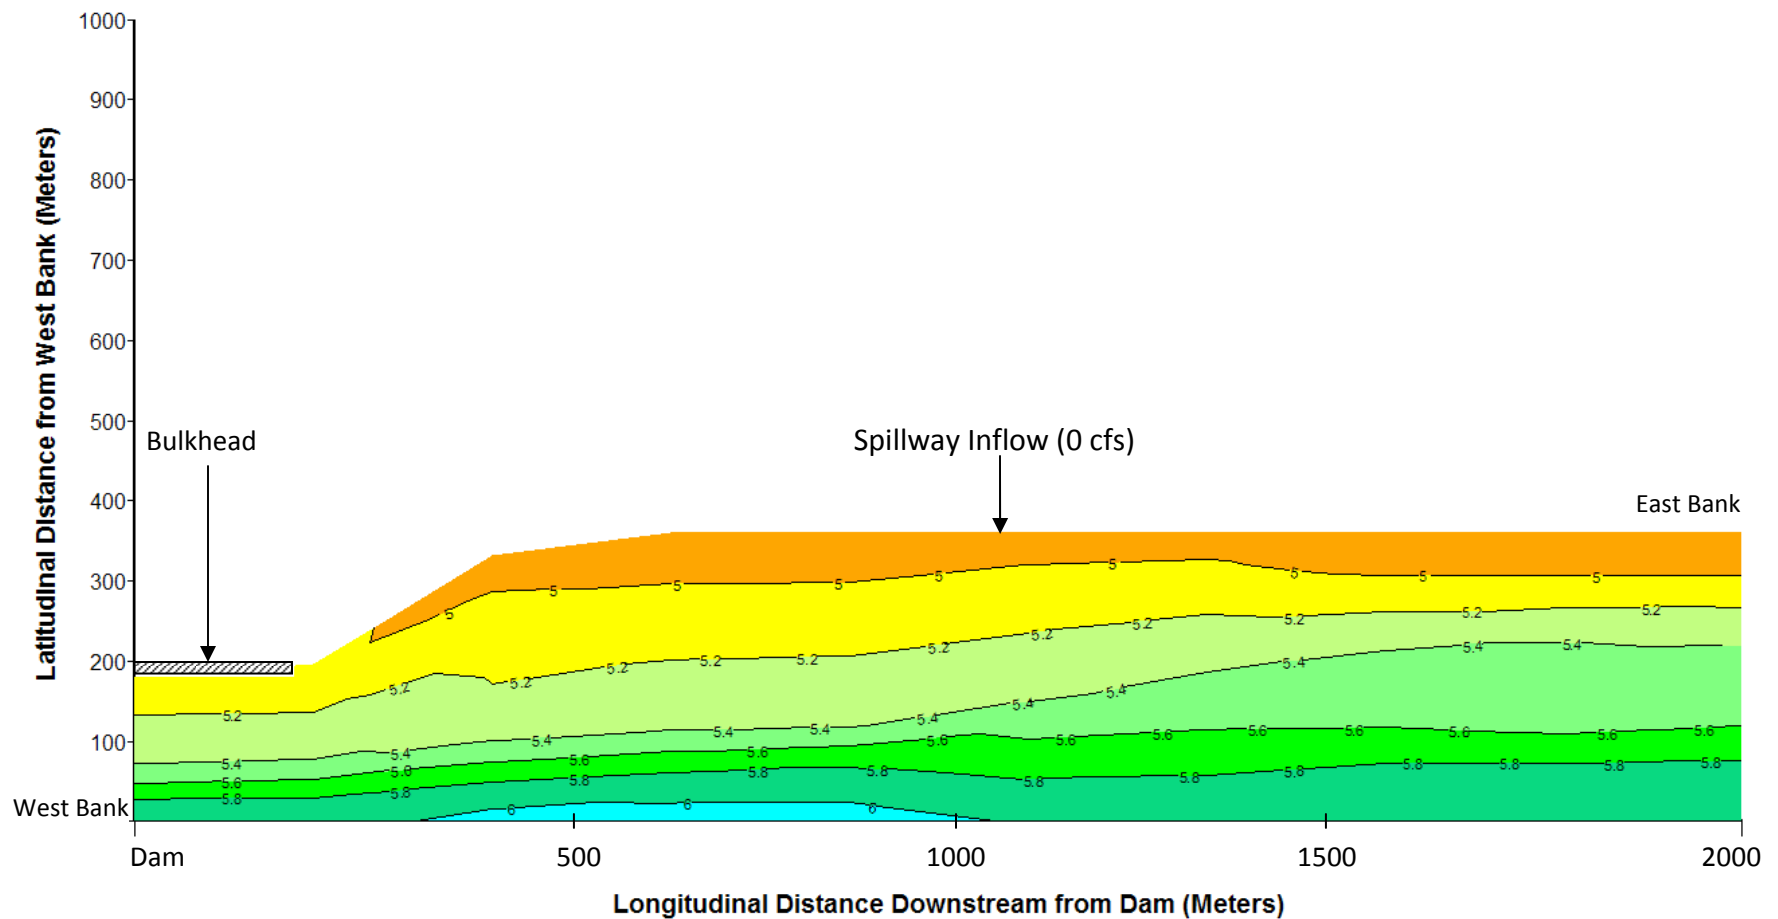
**Figure 27.** Contour plot depicting dissolved oxygen concentrations measured across the near-dam transect (FTRTW3) on August 5, 2010.

**Figure 28.** Contour plot depicting dissolved oxygen concentrations measured across the spillway transect (FTRTW2) on August 5, 2010.

**Figure 29.** Contour plot depicting dissolved oxygen concentrations measured across the downstream transect (FTRTW1) on August 5, 2010.

**Figure 30.** Contour plot of average water-column dissolved oxygen concentrations for the Fort Randall Dam tailwaters on August 5, 2010. Water-column average based on 1-meter depth-profile dissolved oxygen measurements taken at the near-dam, spillway confluence, and downstream transects. Plot is an aerial view from above with the dam to the left, flow going to the right, west bank on the bottom, and the east bank on the top (see Figure 18 for an aerial photo of the area).

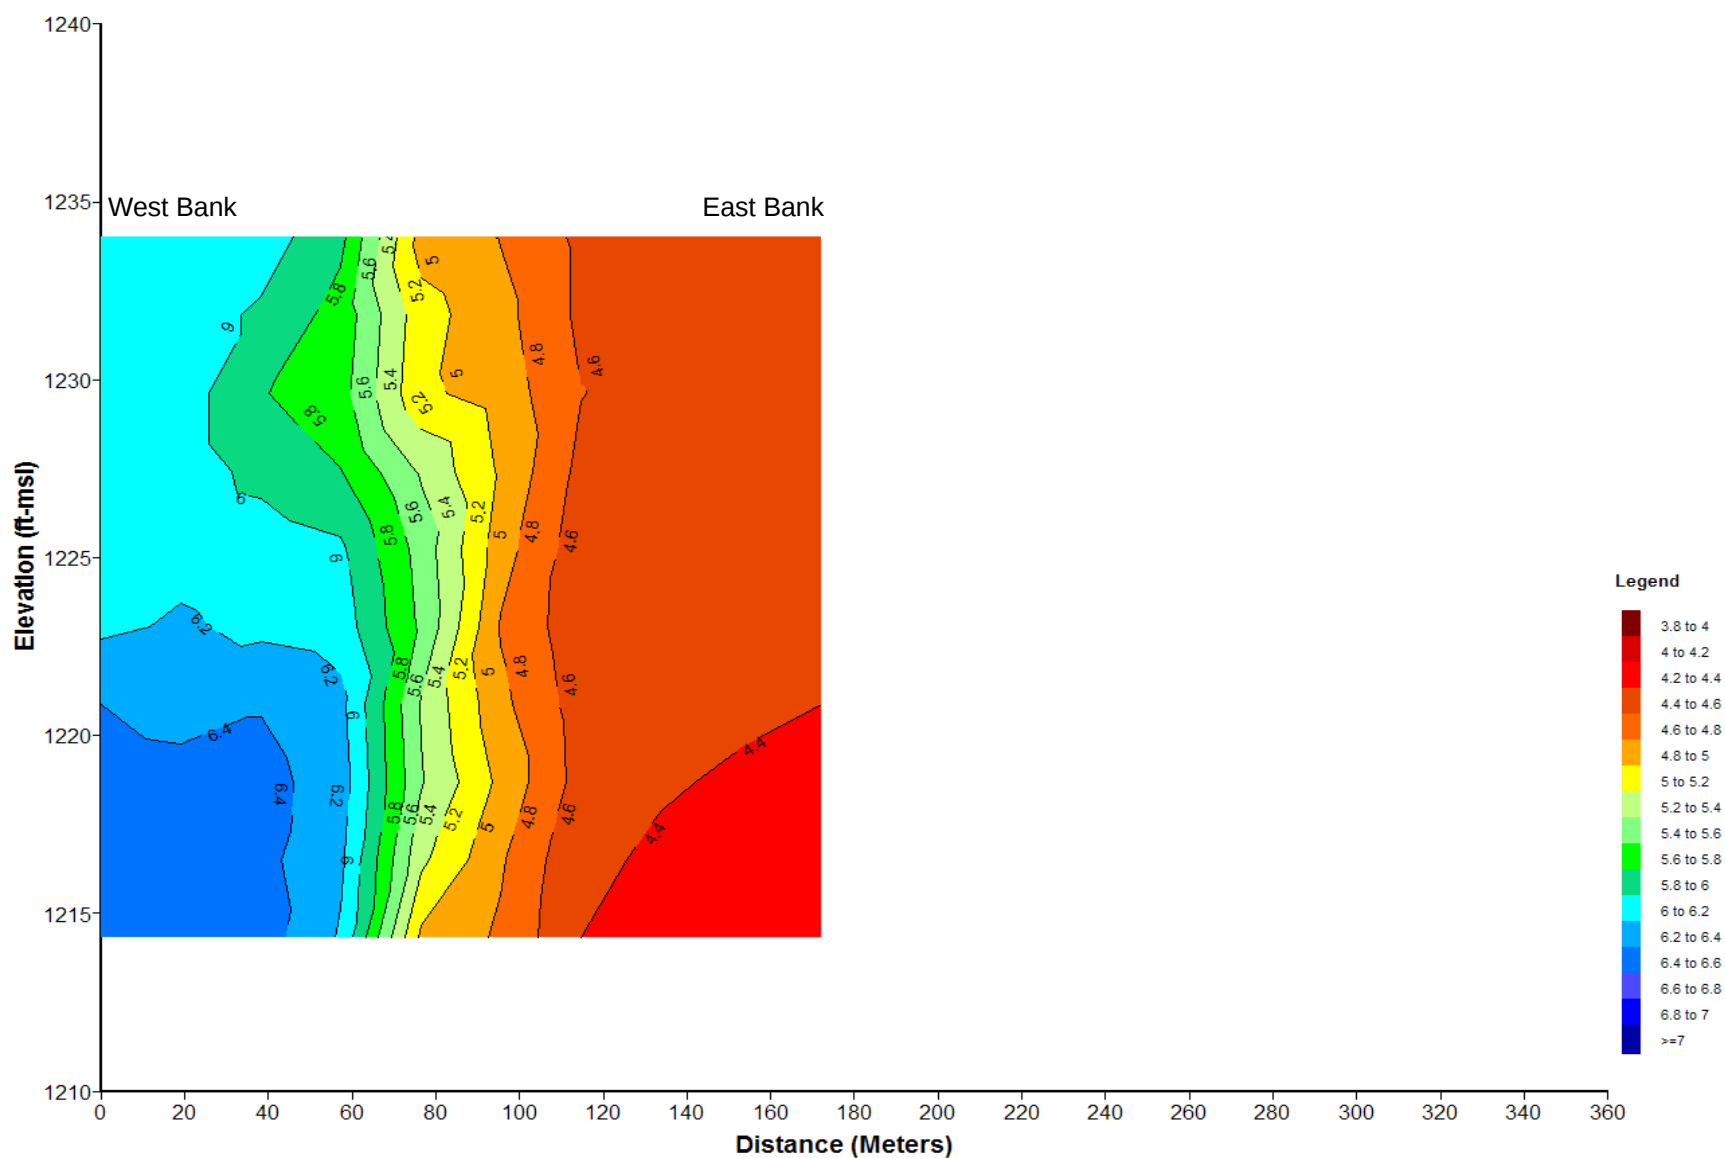
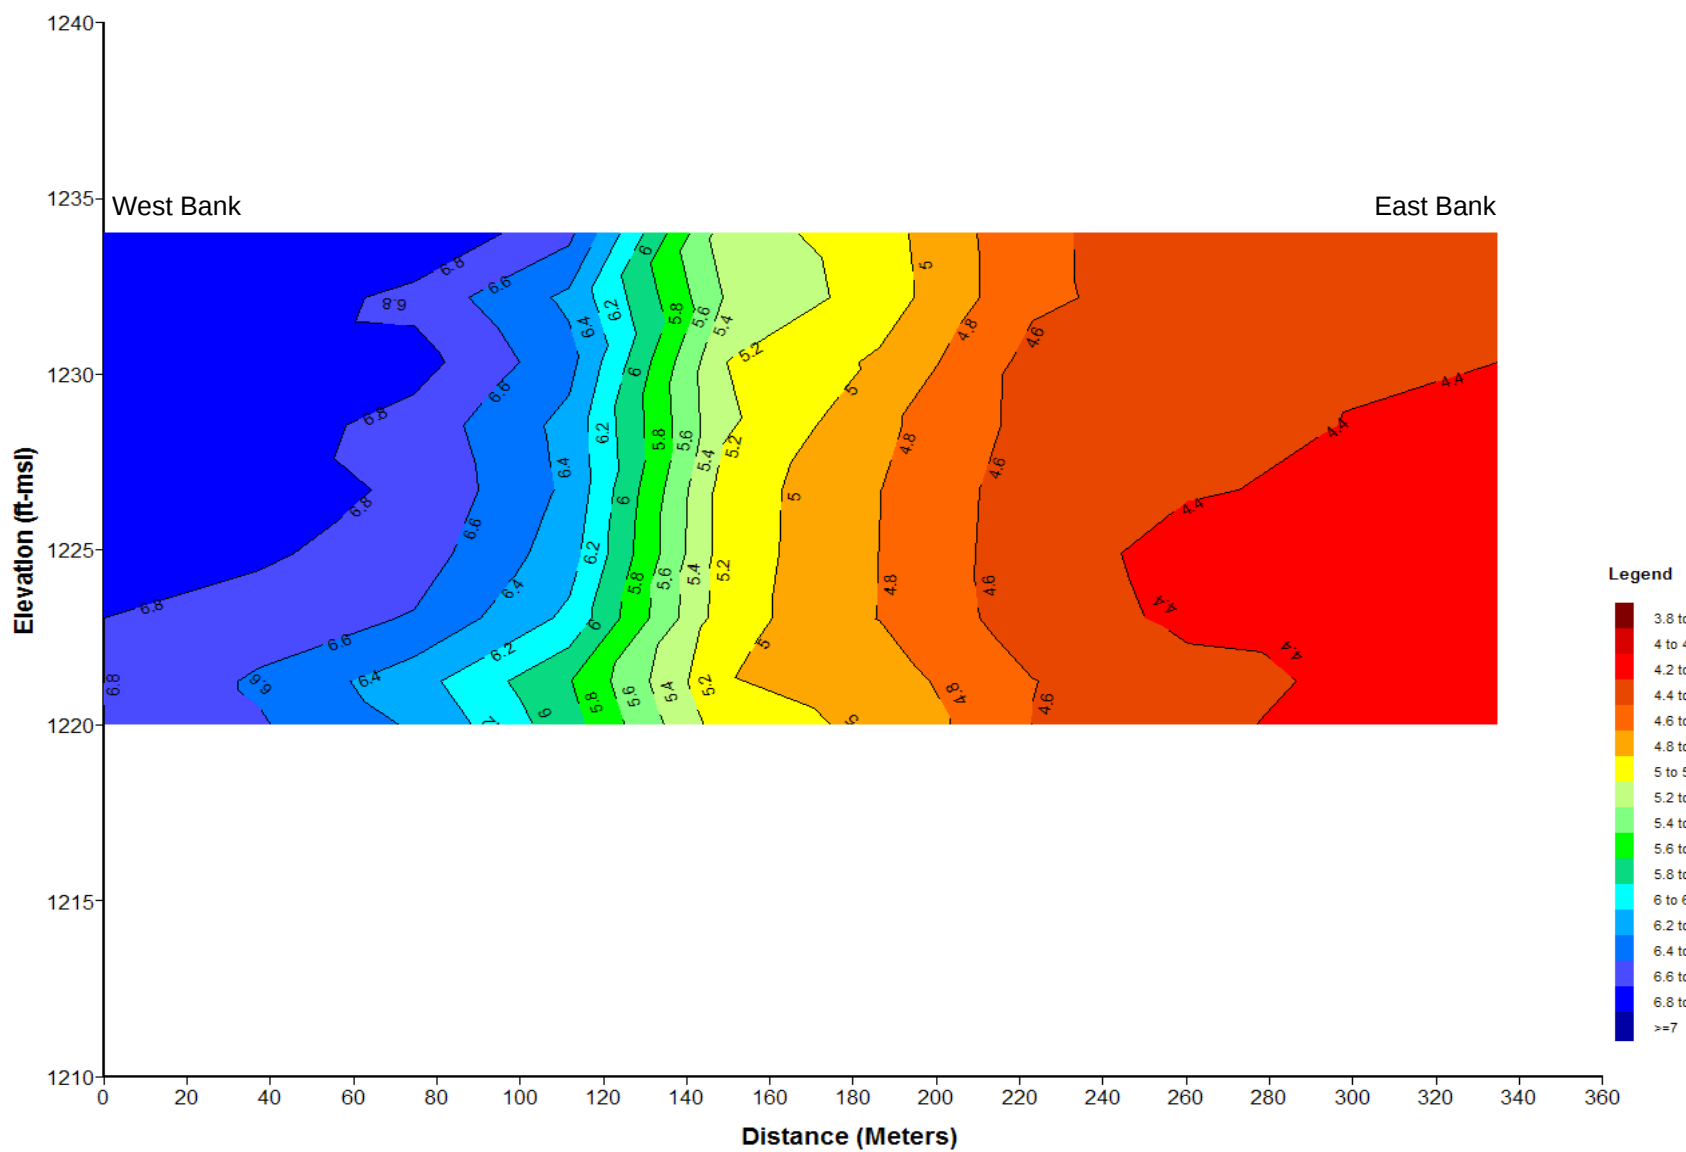
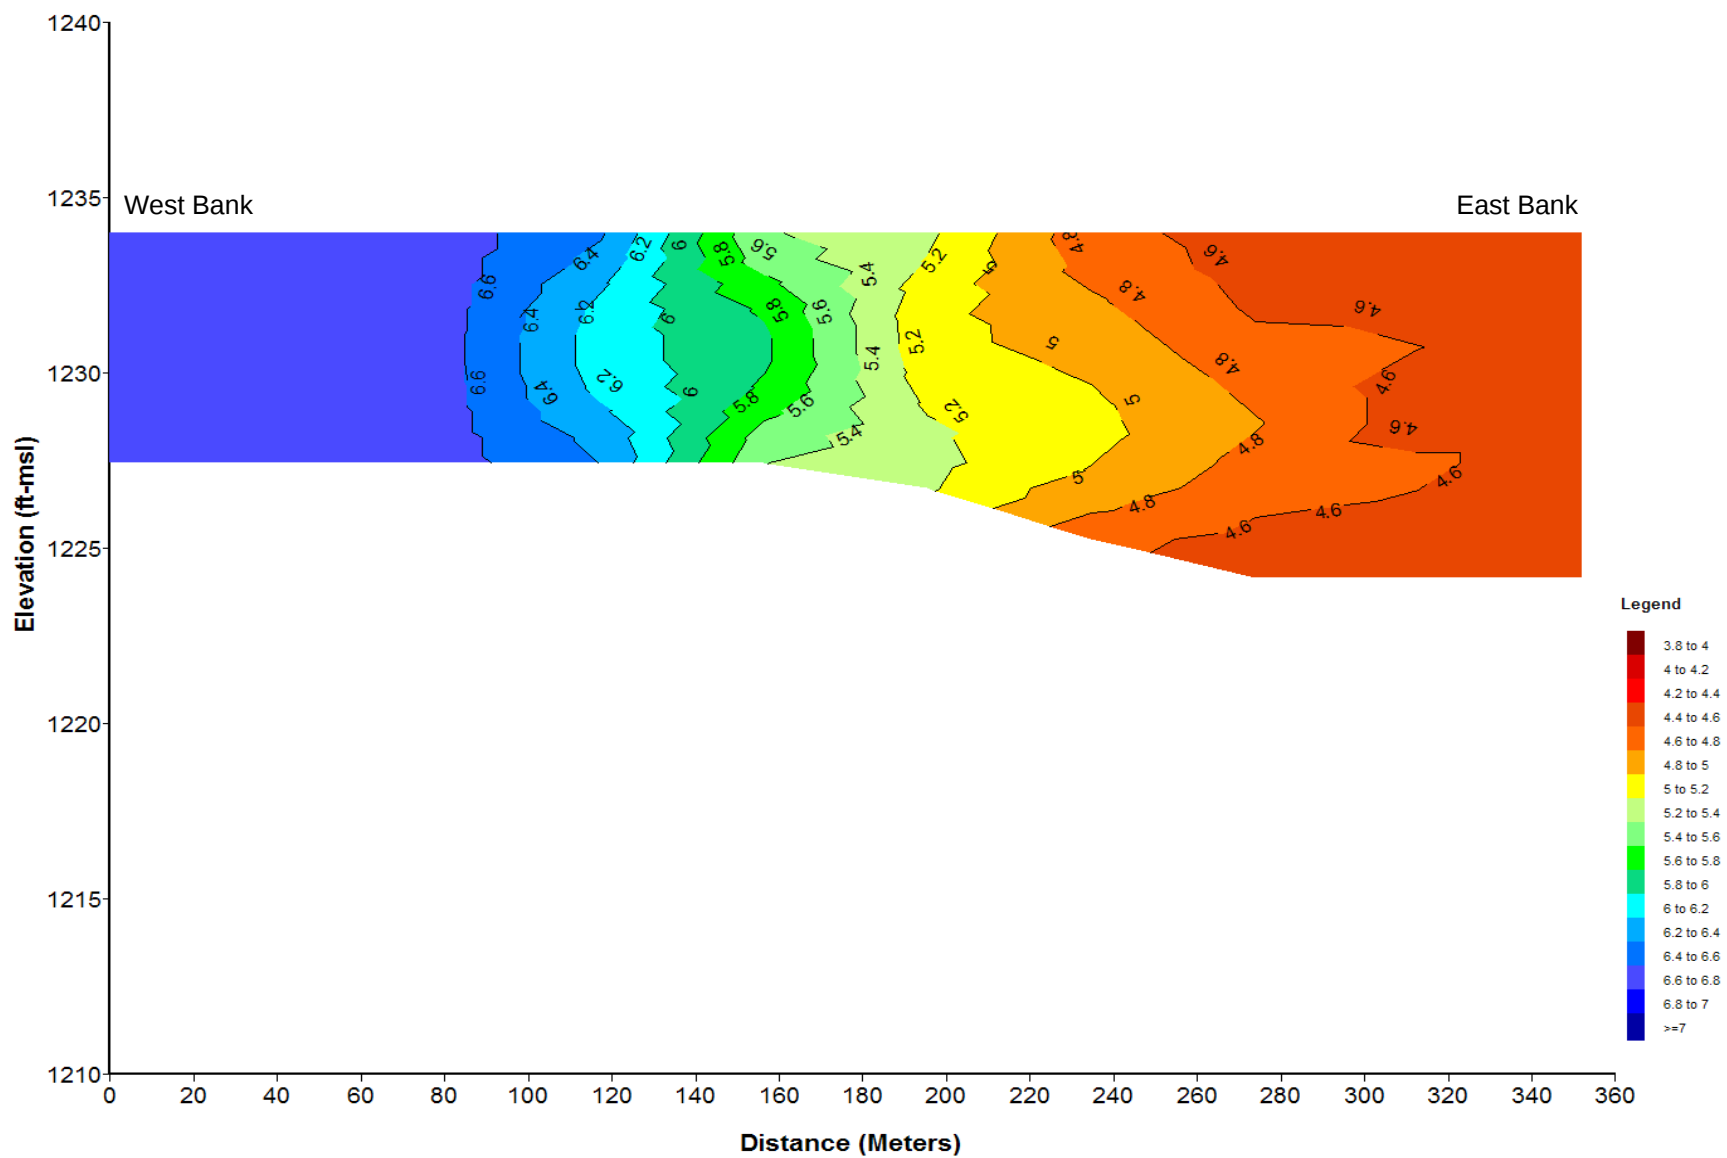
Figures 31, 32, and 33, respectively, display transect contour plots that were constructed to depict the dissolved oxygen concentrations measured across the Fort Randall Dam tailwaters at the near-dam (FTRTW3), spillway confluence (FTRTW2), and downstream (FTRTW1) sites on 10-August-2010. Figure 34 displays an aerial contour plot of the water-column average dissolved oxygen concentrations in the tailwaters based on the 1-meter incremental depth-profile measurements.

**Figure 31.** Contour plot depicting dissolved oxygen concentrations measured across the near-dam transect (FTRTW3) on August 10, 2010.

**Figure 32.** Contour plot depicting dissolved oxygen concentrations measured across the spillway transect (FTRTW2) on August 10, 2010.

**Figure 33.** Contour plot depicting dissolved oxygen concentrations measured across the downstream transect (FTRTW1) on August 10, 2010.

**Figure 34.** Contour plot of average water-column dissolved oxygen concentrations for the Fort Randall Dam tailwaters on August 10, 2010. Water-column average based on 1-meter depth-profile dissolved oxygen measurements taken at the near-dam, spillway confluence, and downstream transects. Plot is an aerial view from above with the dam to the left, flow going to the right, west bank on the bottom, and the east bank on the top (see Figure 18 for an aerial photo of the area).
