### Low Dissolved Oxygen Levels in Summer Powerplant Discharges from Fort Randall Dam, South Dakota

**Report Number: CENWO-ED-HA/SSR/Fort Randall Tailwaters/2010**

**October 2010**

**Prepared by:  
Water Control and Water Quality Section  
Hydrologic Engineering Branch  
Engineering Division  
Omaha District  
U.S. Army Corps of Engineers**

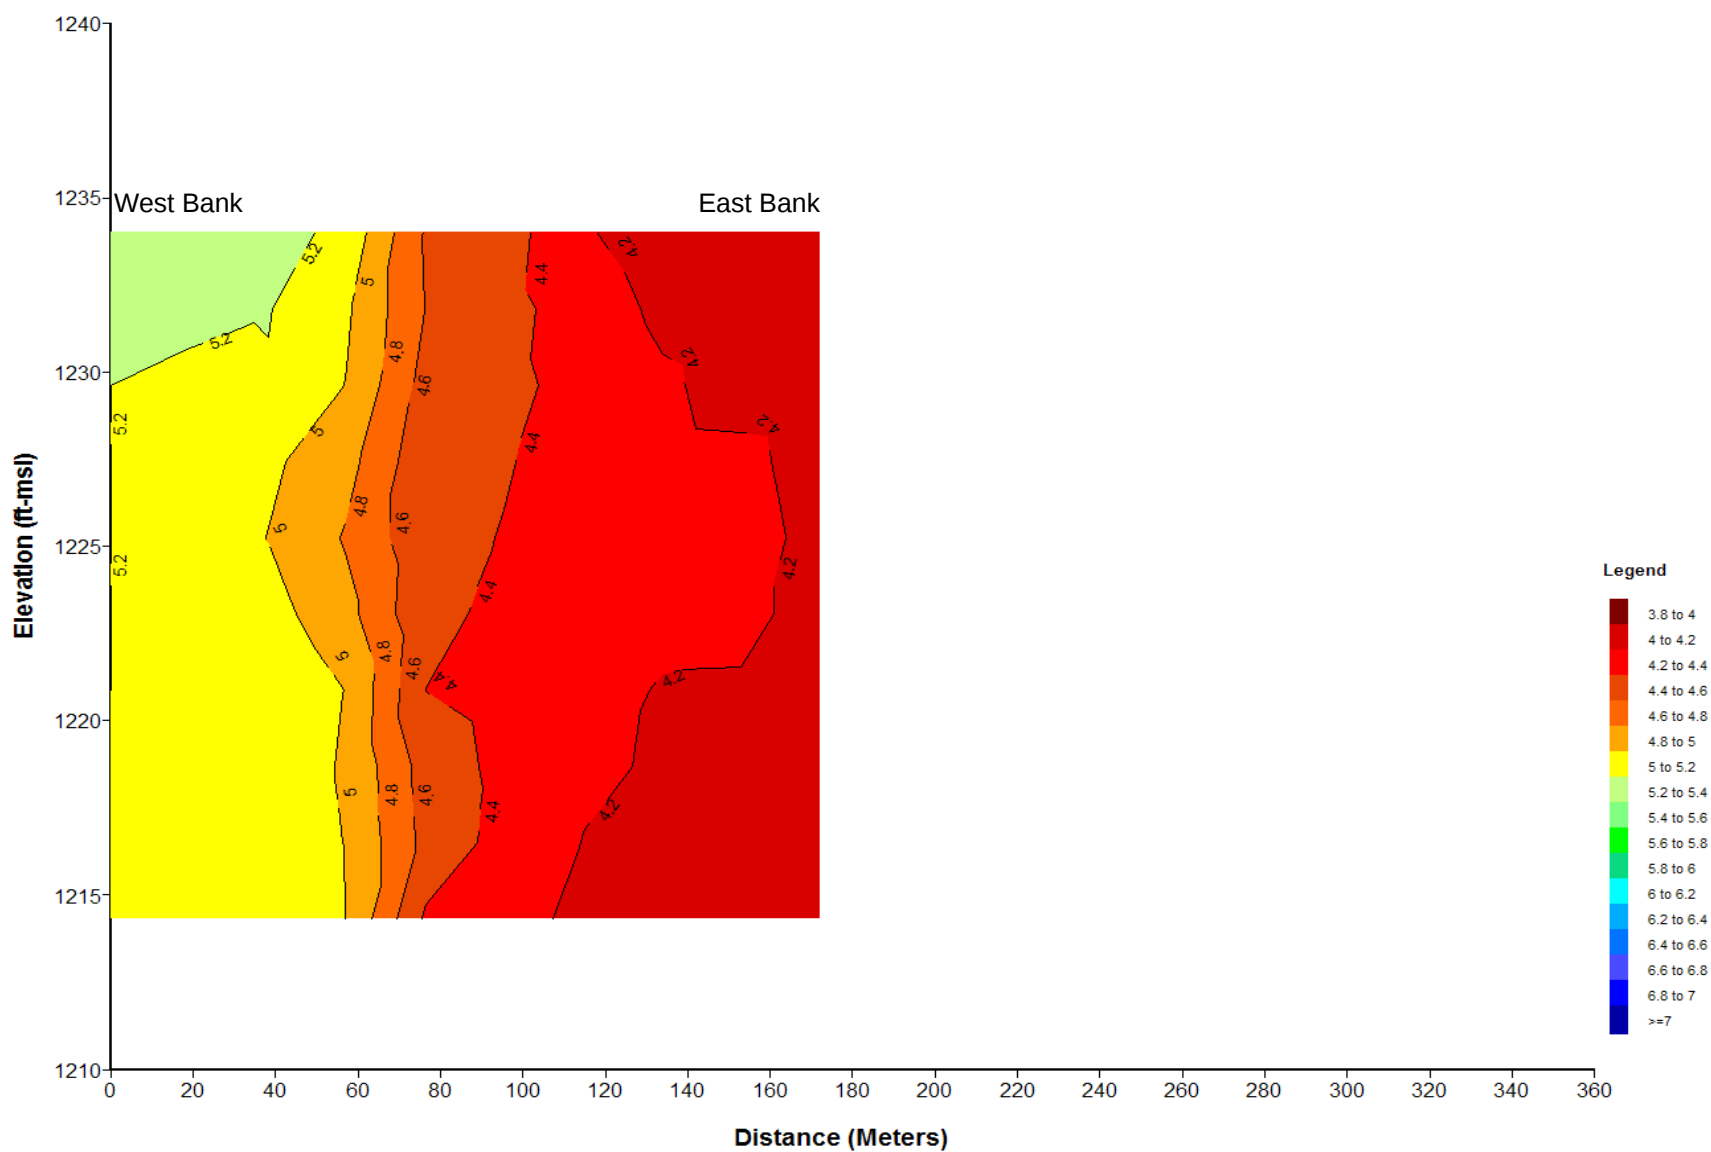
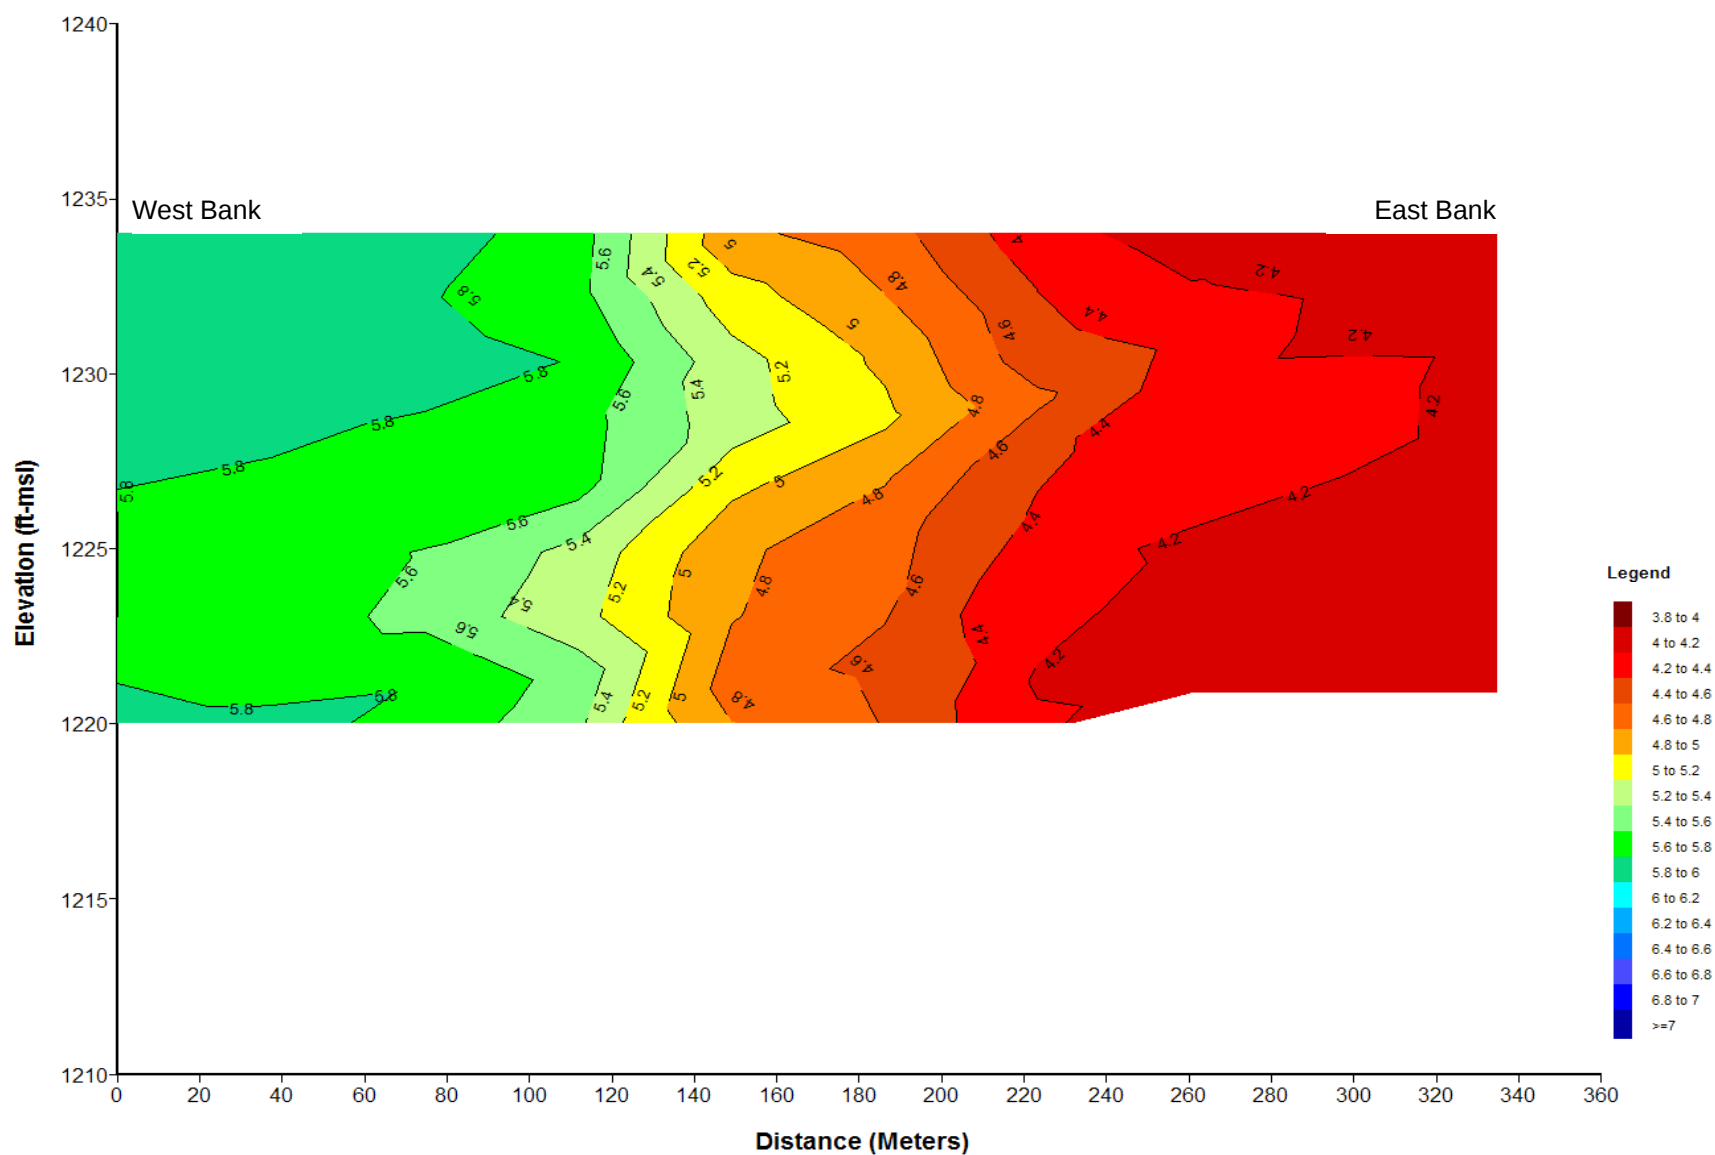
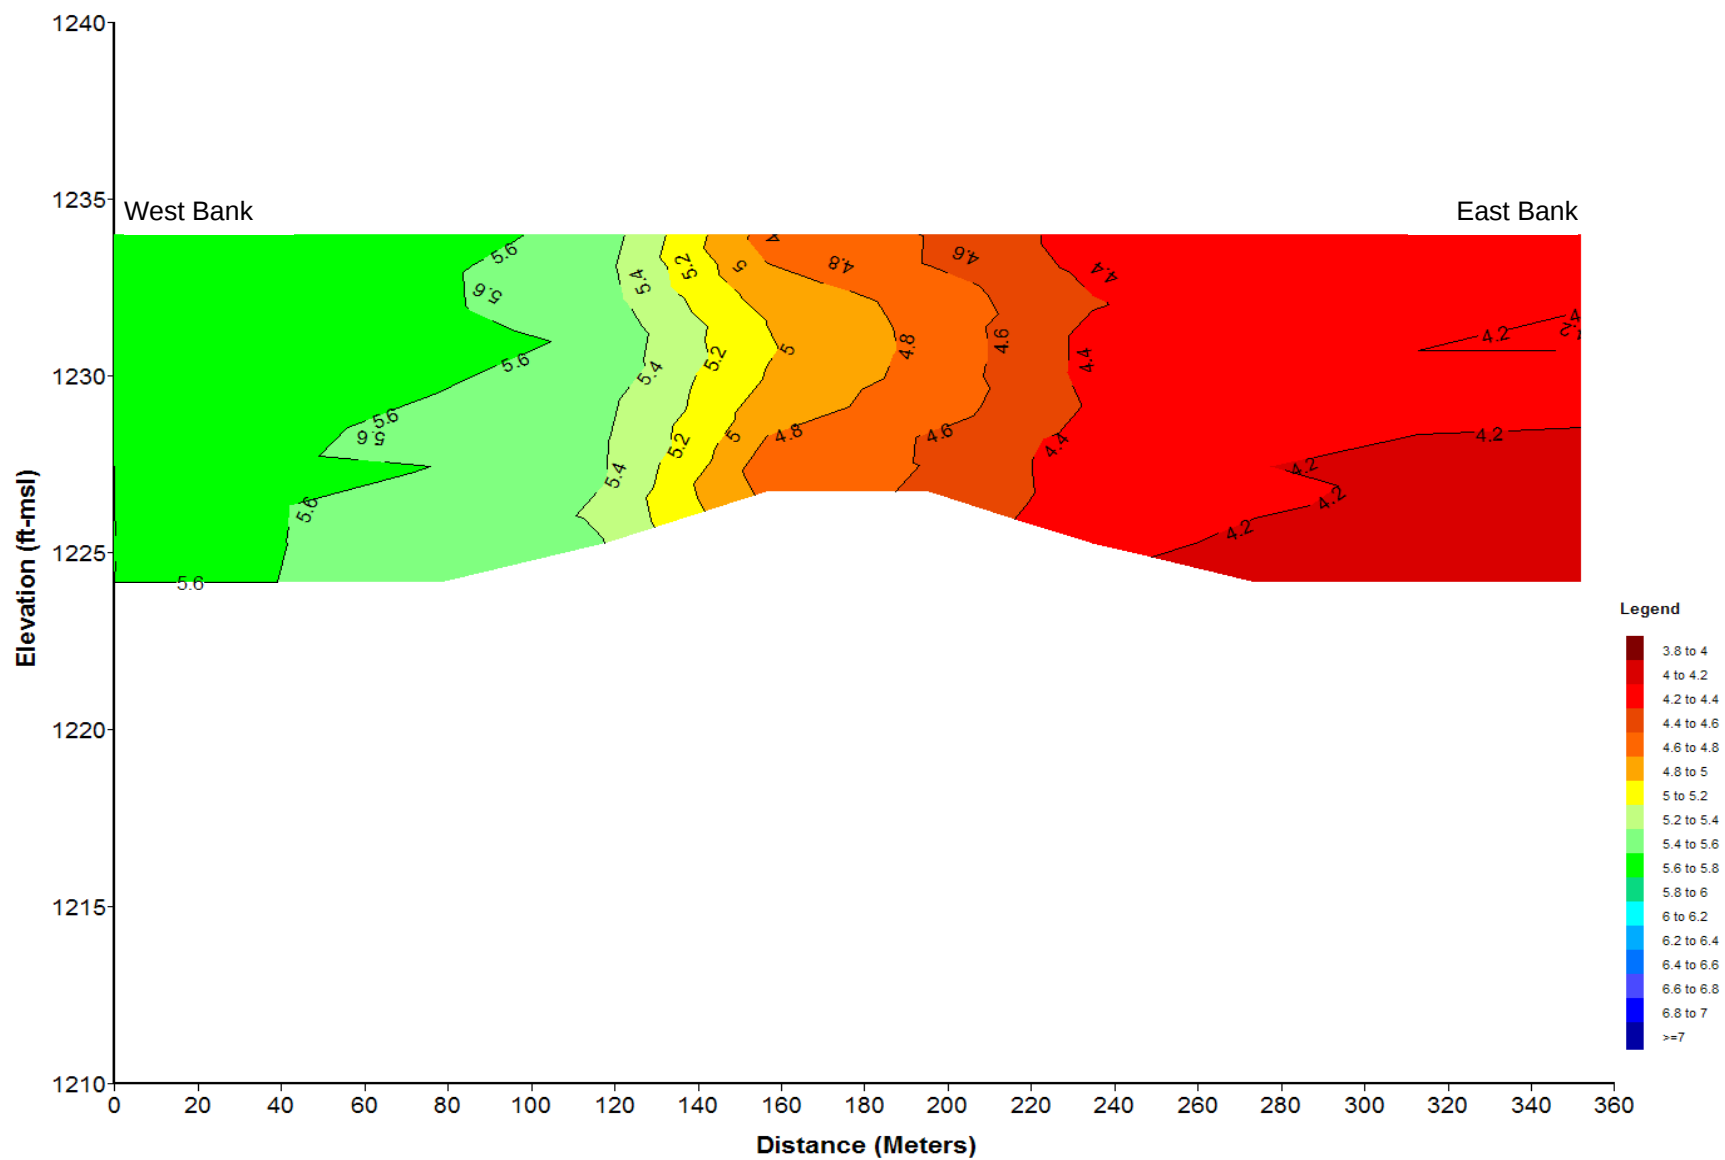
Figures 35, 36, and 37, respectively, display transect contour plots that were constructed to depict the dissolved oxygen concentrations measured across the Fort Randall Dam tailwaters at the near-dam (FTRTW3), spillway confluence (FTRTW2), and downstream (FTRTW1) sites on 12-August-2010. Figure 38 displays an aerial contour plot of the water-column average dissolved oxygen concentrations in the tailwaters based on the 1-meter incremental depth-profile measurements.

**Figure 35.** Contour plot depicting dissolved oxygen concentrations measured across the near-dam transect (FTRTW3) on August 12, 2010.

**Figure 36.** Contour plot depicting dissolved oxygen concentrations measured across the spillway transect (FTRTW2) on August 12, 2010.

**Figure 37.** Contour plot depicting dissolved oxygen concentrations measured across the downstream transect (FTRTW1) on August 12, 2010.

**Figure 38.** Contour plot of average water-column dissolved oxygen concentrations for the Fort Randall Dam tailwaters on August 12, 2010. Water-column average based on 1-meter depth-profile dissolved oxygen measurements taken at the near-dam, spillway confluence, and downstream transects. Plot is an aerial view from above with the dam to the left, flow going to the right, west bank on the bottom, and the east bank on the top (see Figure 18 for an aerial photo of the area).

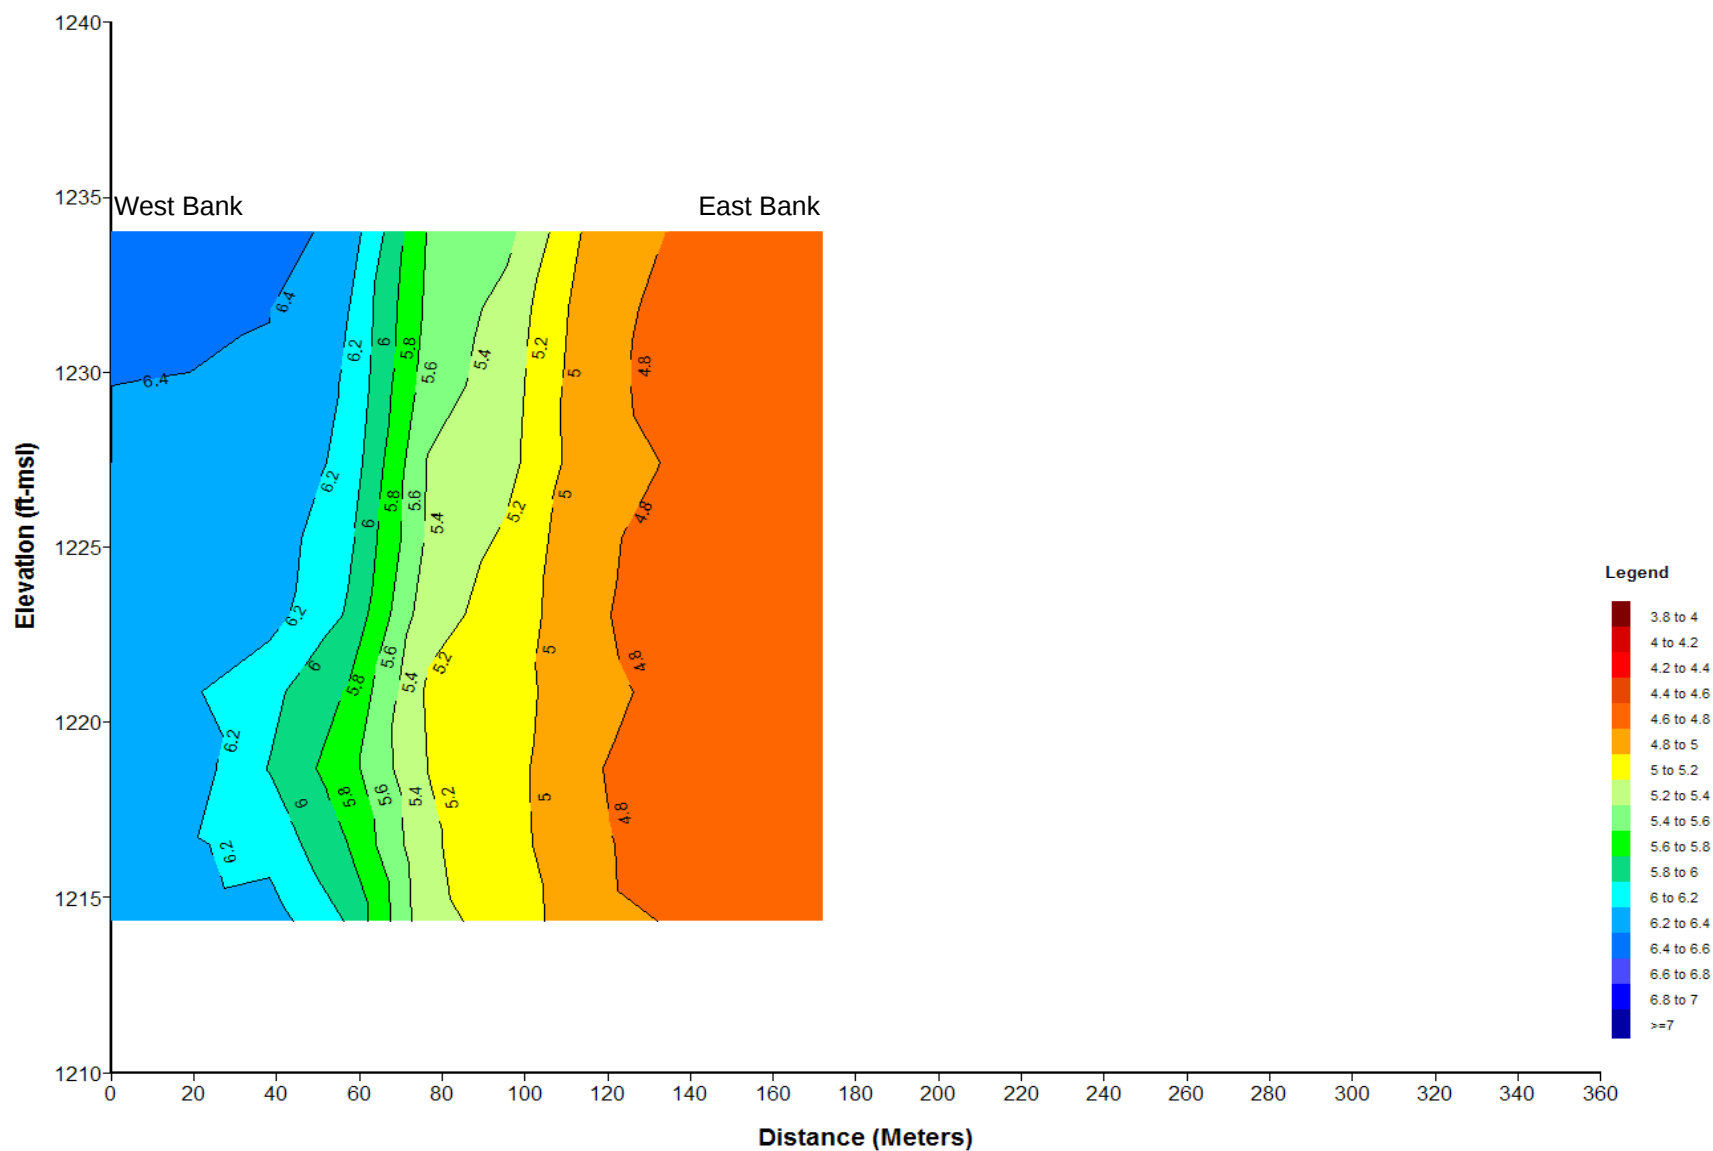
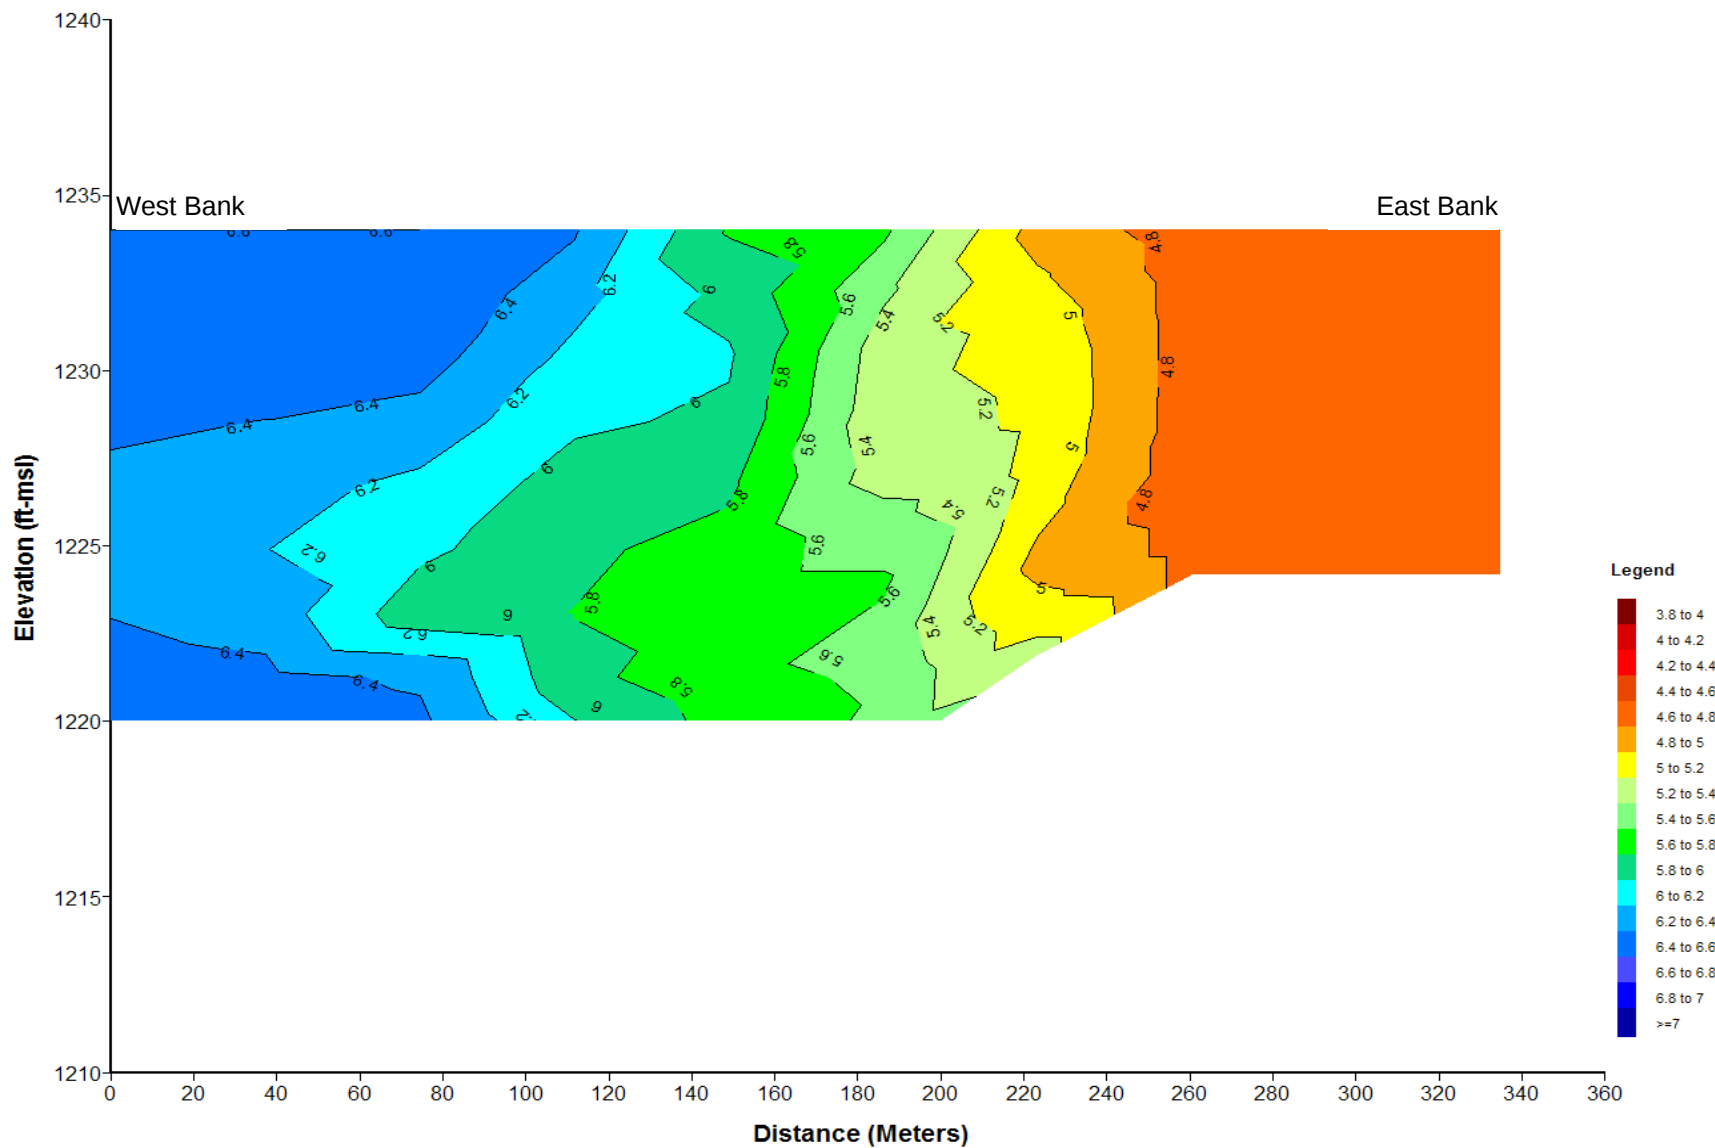
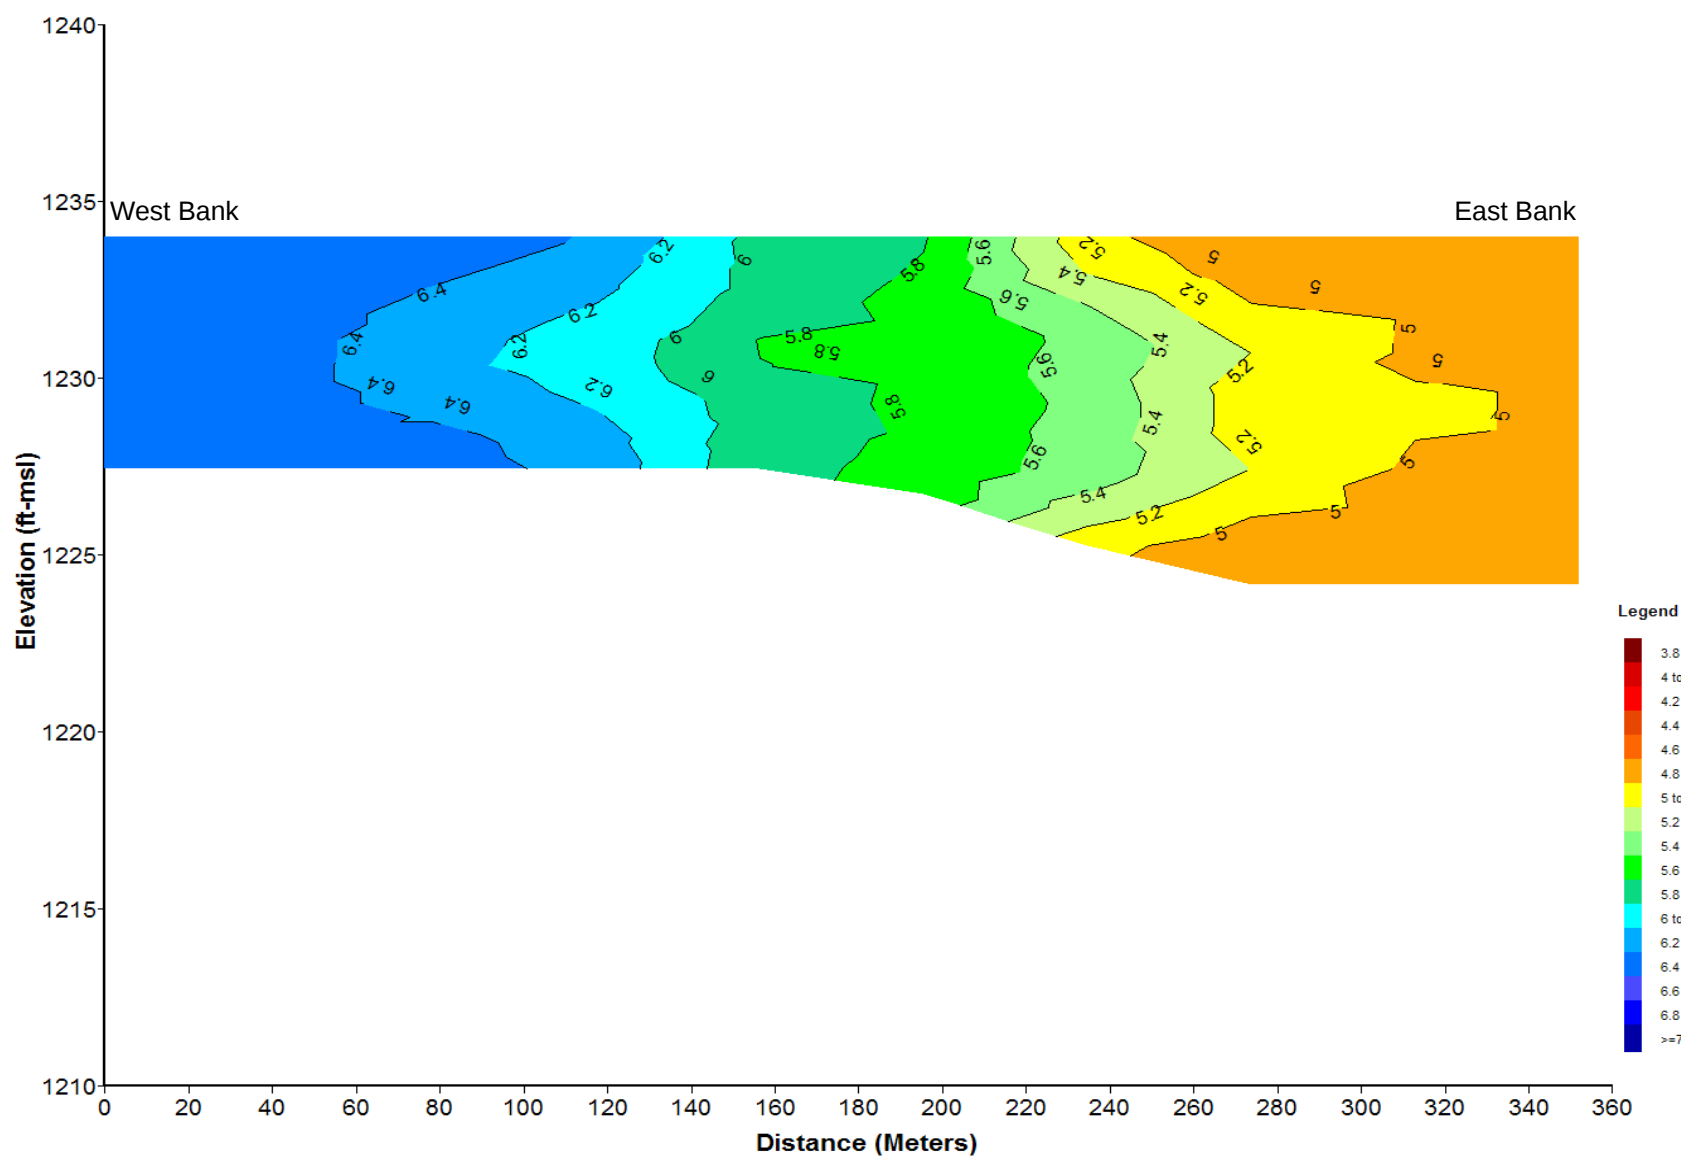
**Figure 39.** Contour plot depicting dissolved oxygen concentrations measured across the near-dam transect (FTRTW3) on August 17, 2010.

**Figure 40.** Contour plot depicting dissolved oxygen concentrations measured across the spillway transect (FTRTW2) on August 17, 2010.

**Figure 41.** Contour plot depicting dissolved oxygen concentrations measured across the downstream transect (FTRTW1) on August 17, 2010.

**Figure 42.** Contour plot of average water-column dissolved oxygen concentrations for the Fort Randall Dam tailwaters on August 17, 2010. Water-column average based on 1-meter depth-profile dissolved oxygen measurements taken at the near-dam, spillway confluence, and downstream transects. Plot is an aerial view from above with the dam to the left, flow going to the right, west bank on the bottom, and the east bank on the top (see Figure 18 for an aerial photo of the area).

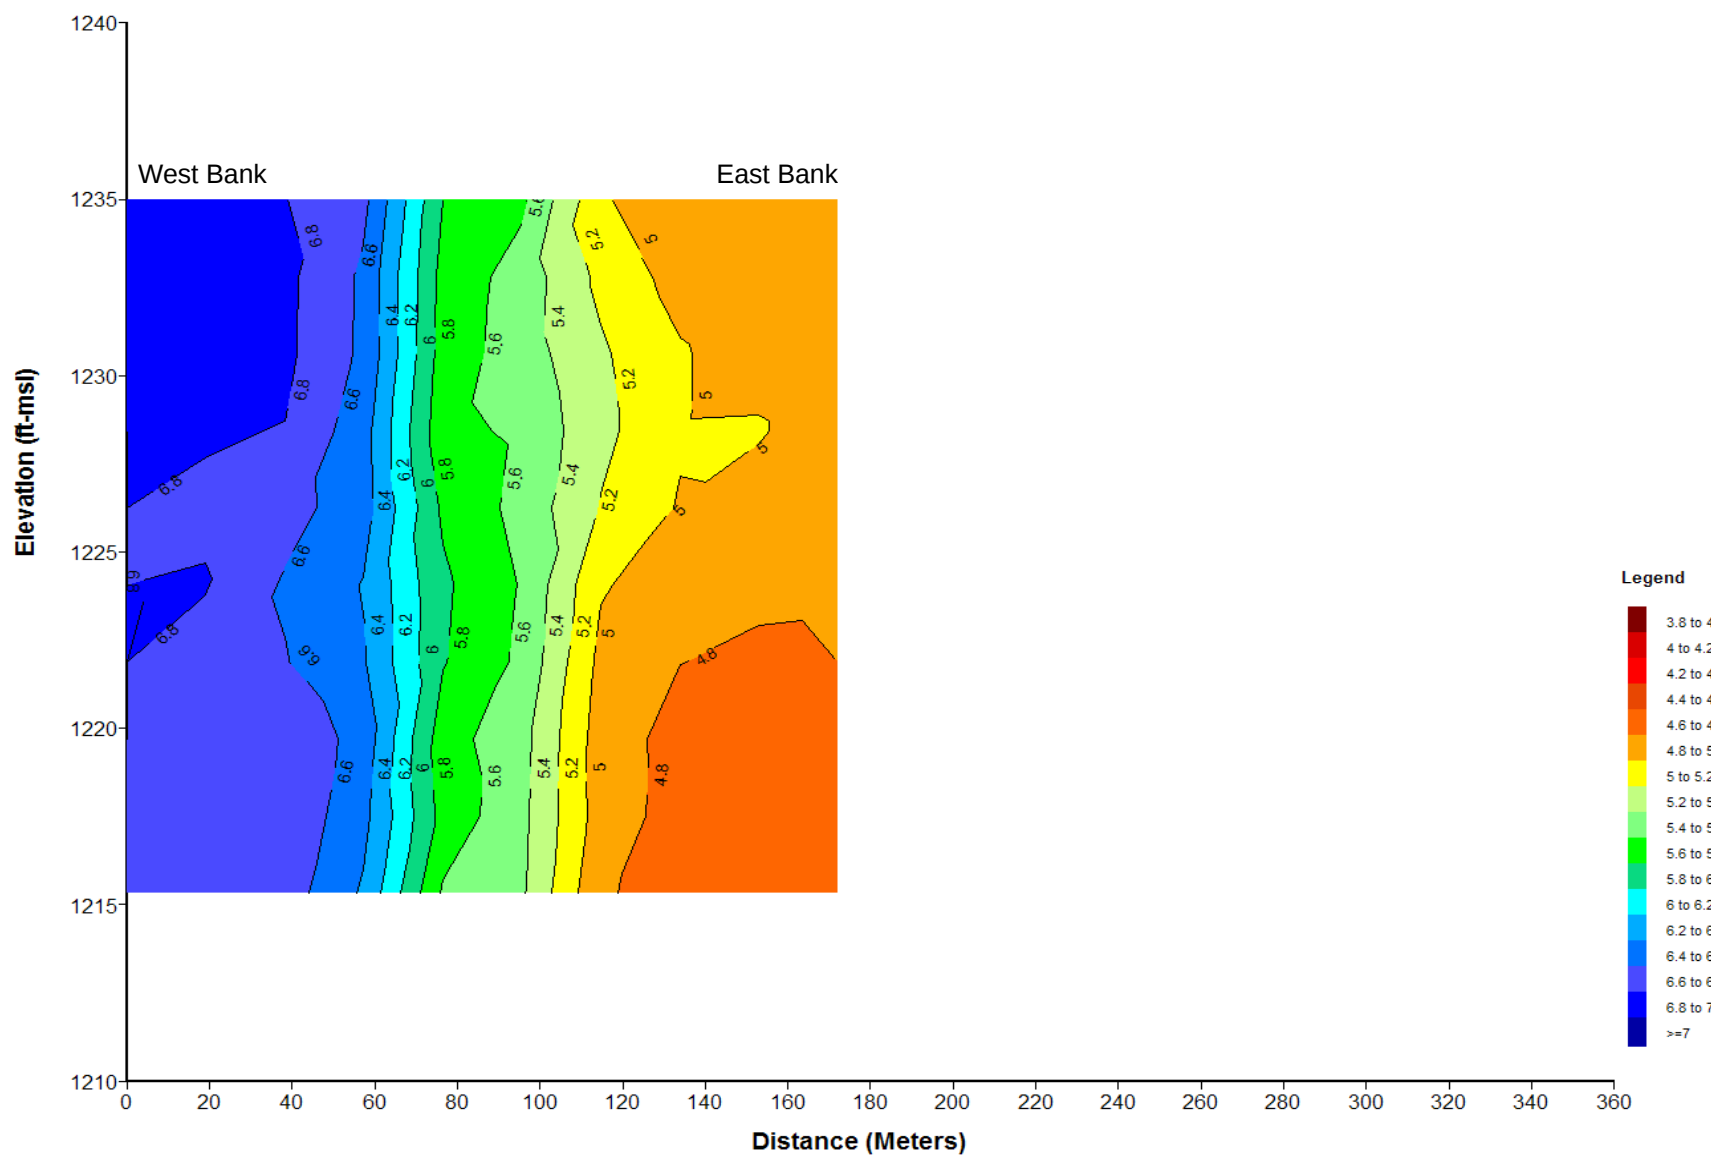
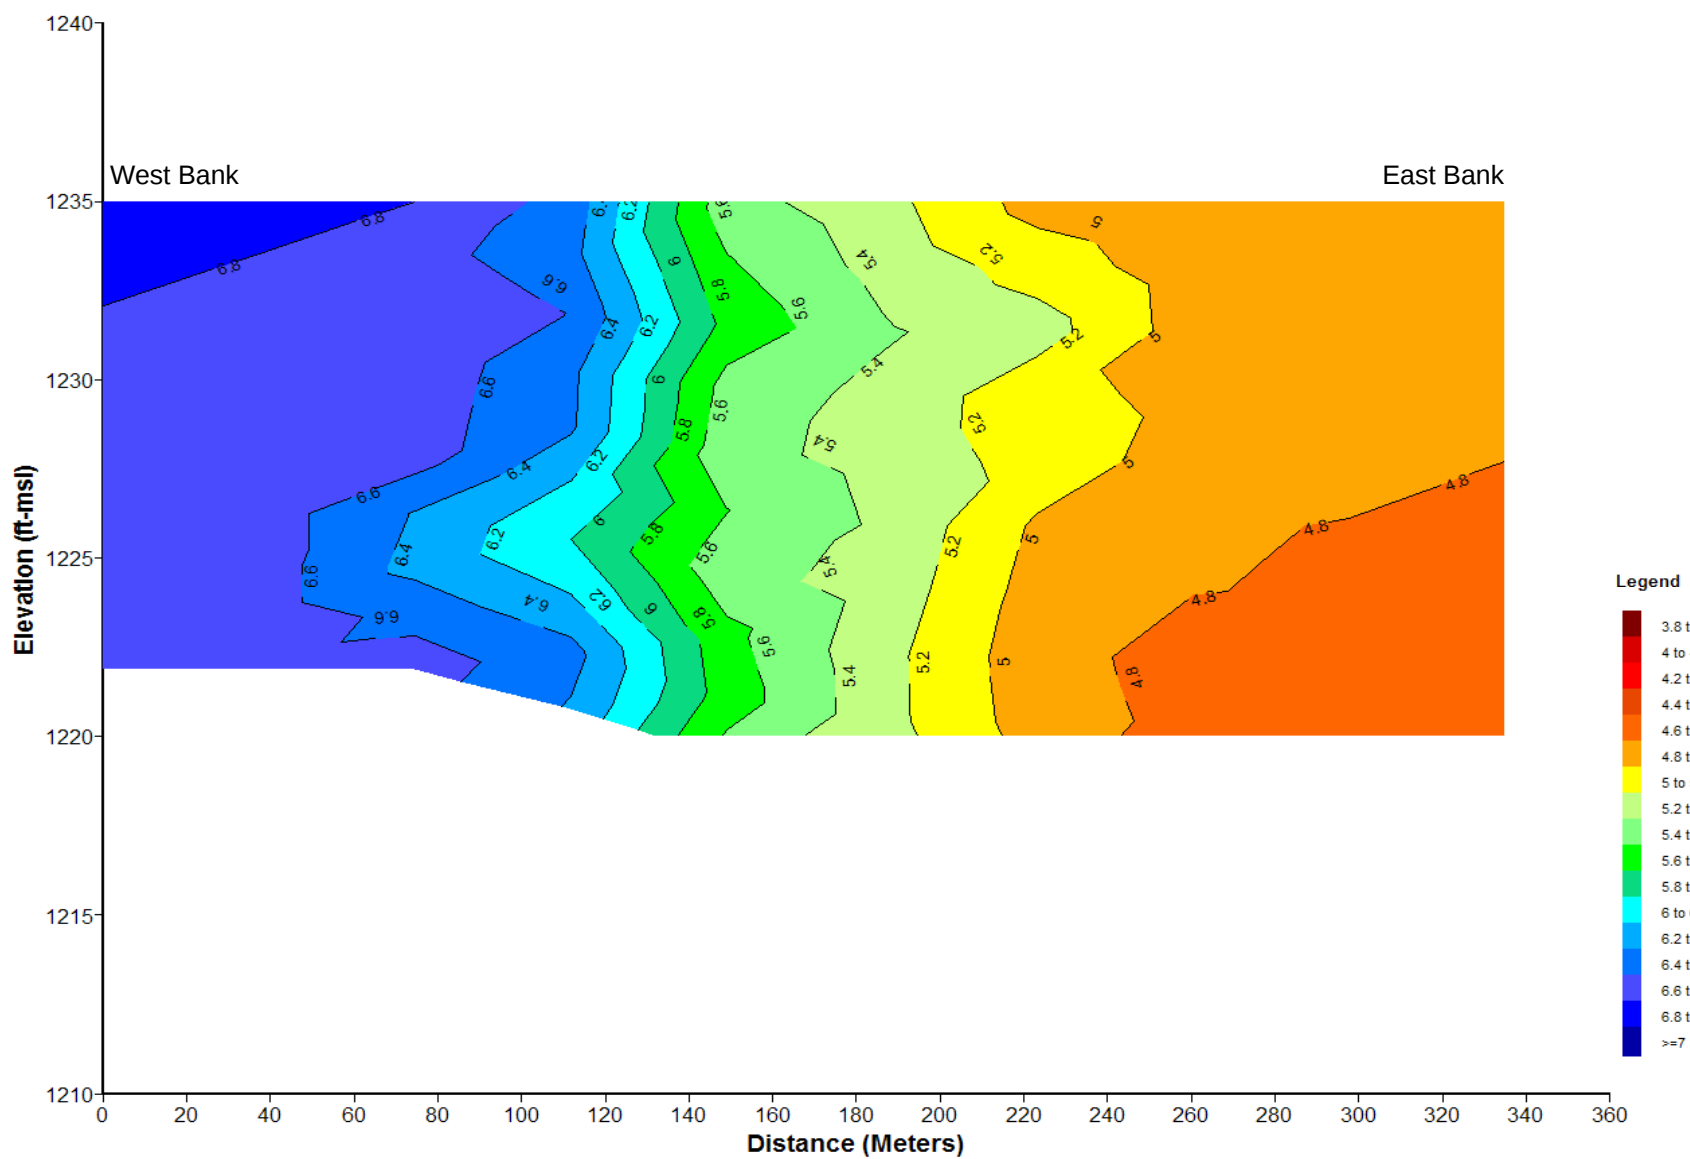
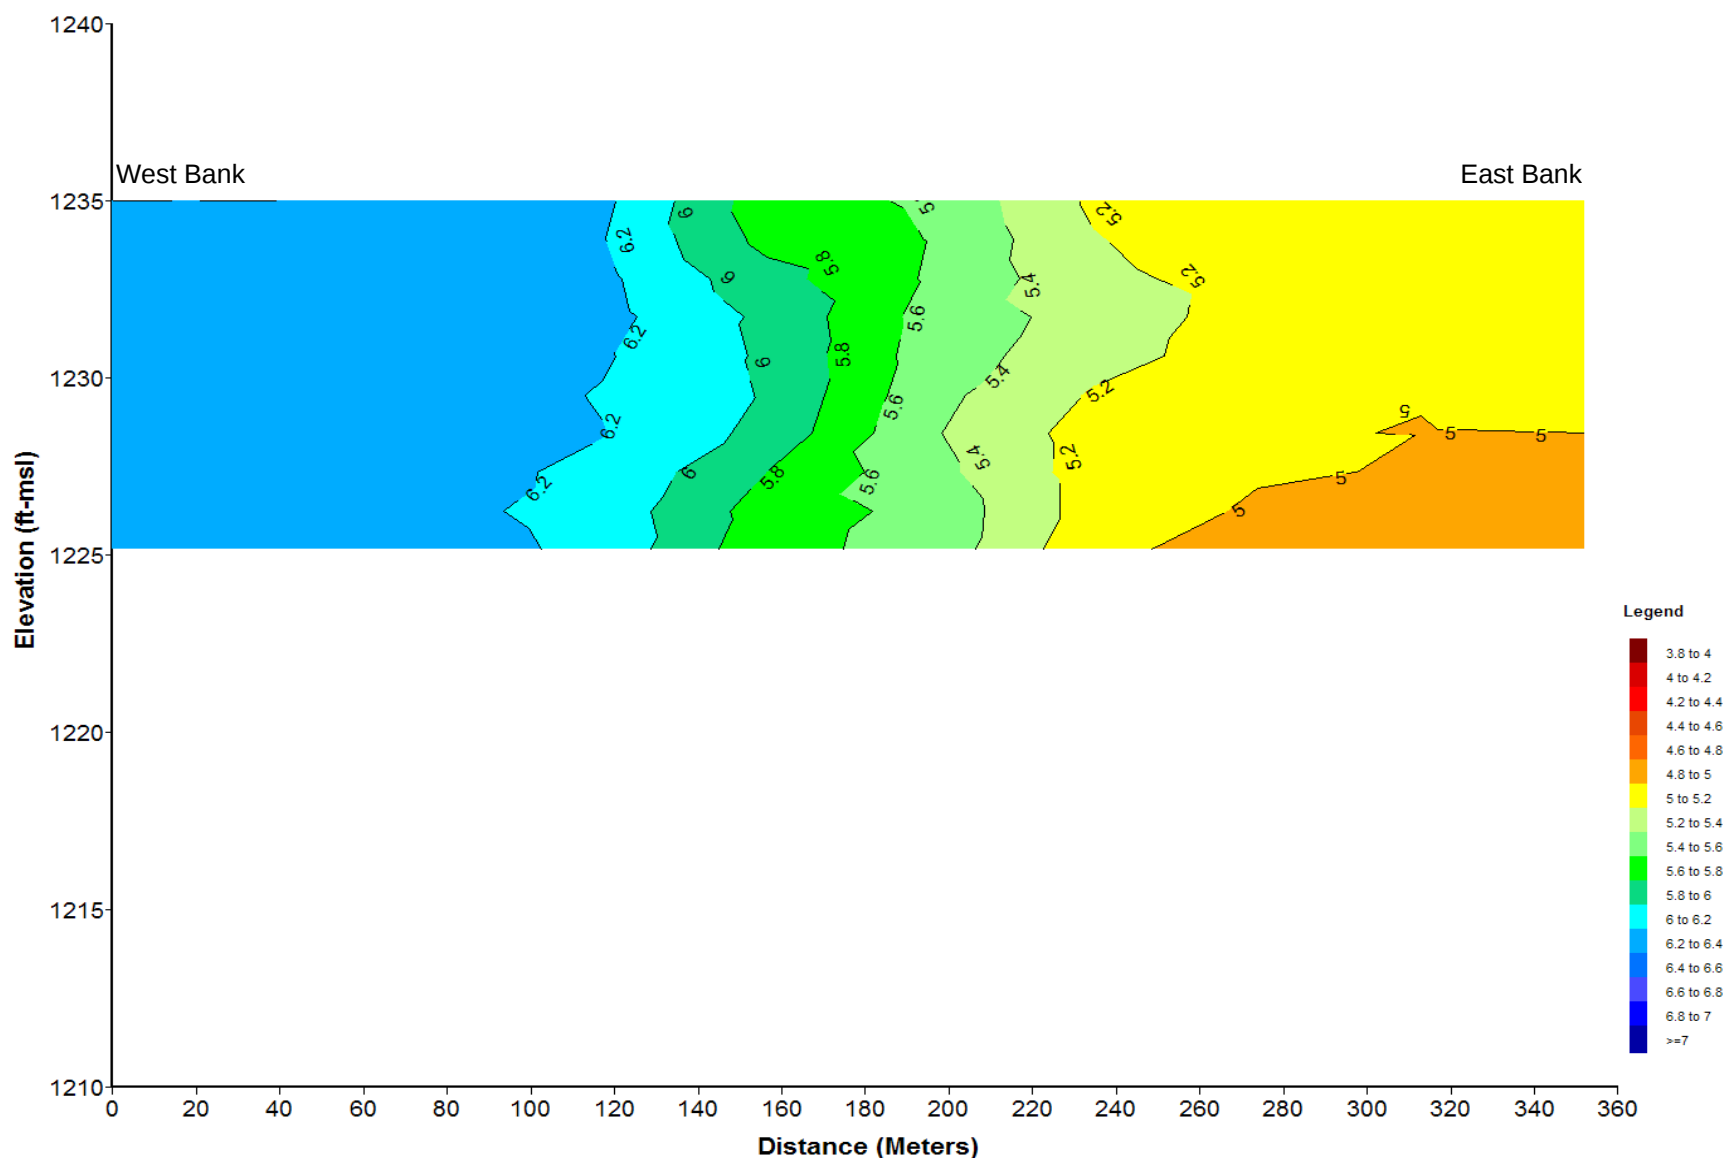
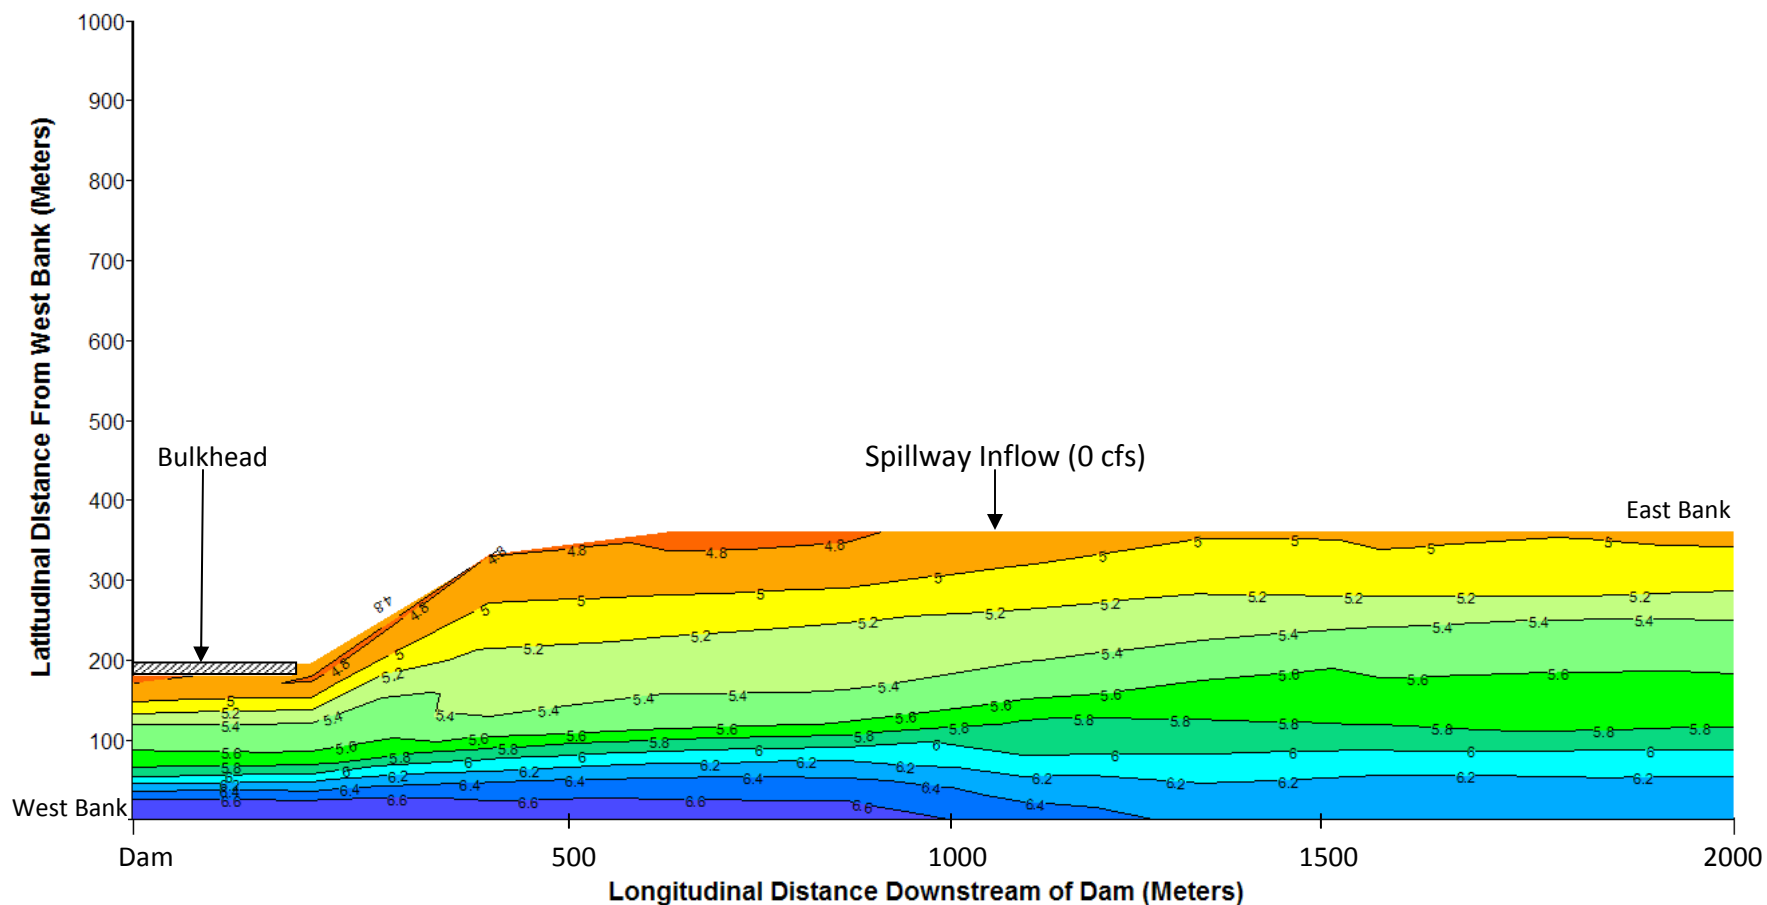
**Figure 43.** Contour plot depicting dissolved oxygen concentrations measured across the near-dam transect (FTRTW3) on August 19, 2010.

**Figure 44.** Contour plot depicting dissolved oxygen concentrations measured across the spillway transect (FTRTW2) on August 19, 2010.

**Figure 45.** Contour plot depicting dissolved oxygen concentrations measured across the downstream transect (FTRTW1) on August 19, 2010.

**Figure 46.** Contour plot of average water-column dissolved oxygen concentrations for the Fort Randall Dam tailwaters on August 19, 2010. Water-column average based on 1-meter depth-profile dissolved oxygen measurements taken at the near-dam, spillway confluence, and downstream transects. Plot is an aerial view from above with the dam to the left, flow going to the right, west bank on the bottom, and the east bank on the top (see Figure 18 for an aerial photo of the area).
