### Low Dissolved Oxygen Levels in Summer Powerplant Discharges from Fort Randall Dam, South Dakota

**Report Number: CENWO-ED-HA/SSR/Fort Randall Tailwaters/2010**

**October 2010**

**Prepared by:  
Water Control and Water Quality Section  
Hydrologic Engineering Branch  
Engineering Division  
Omaha District  
U.S. Army Corps of Engineers**

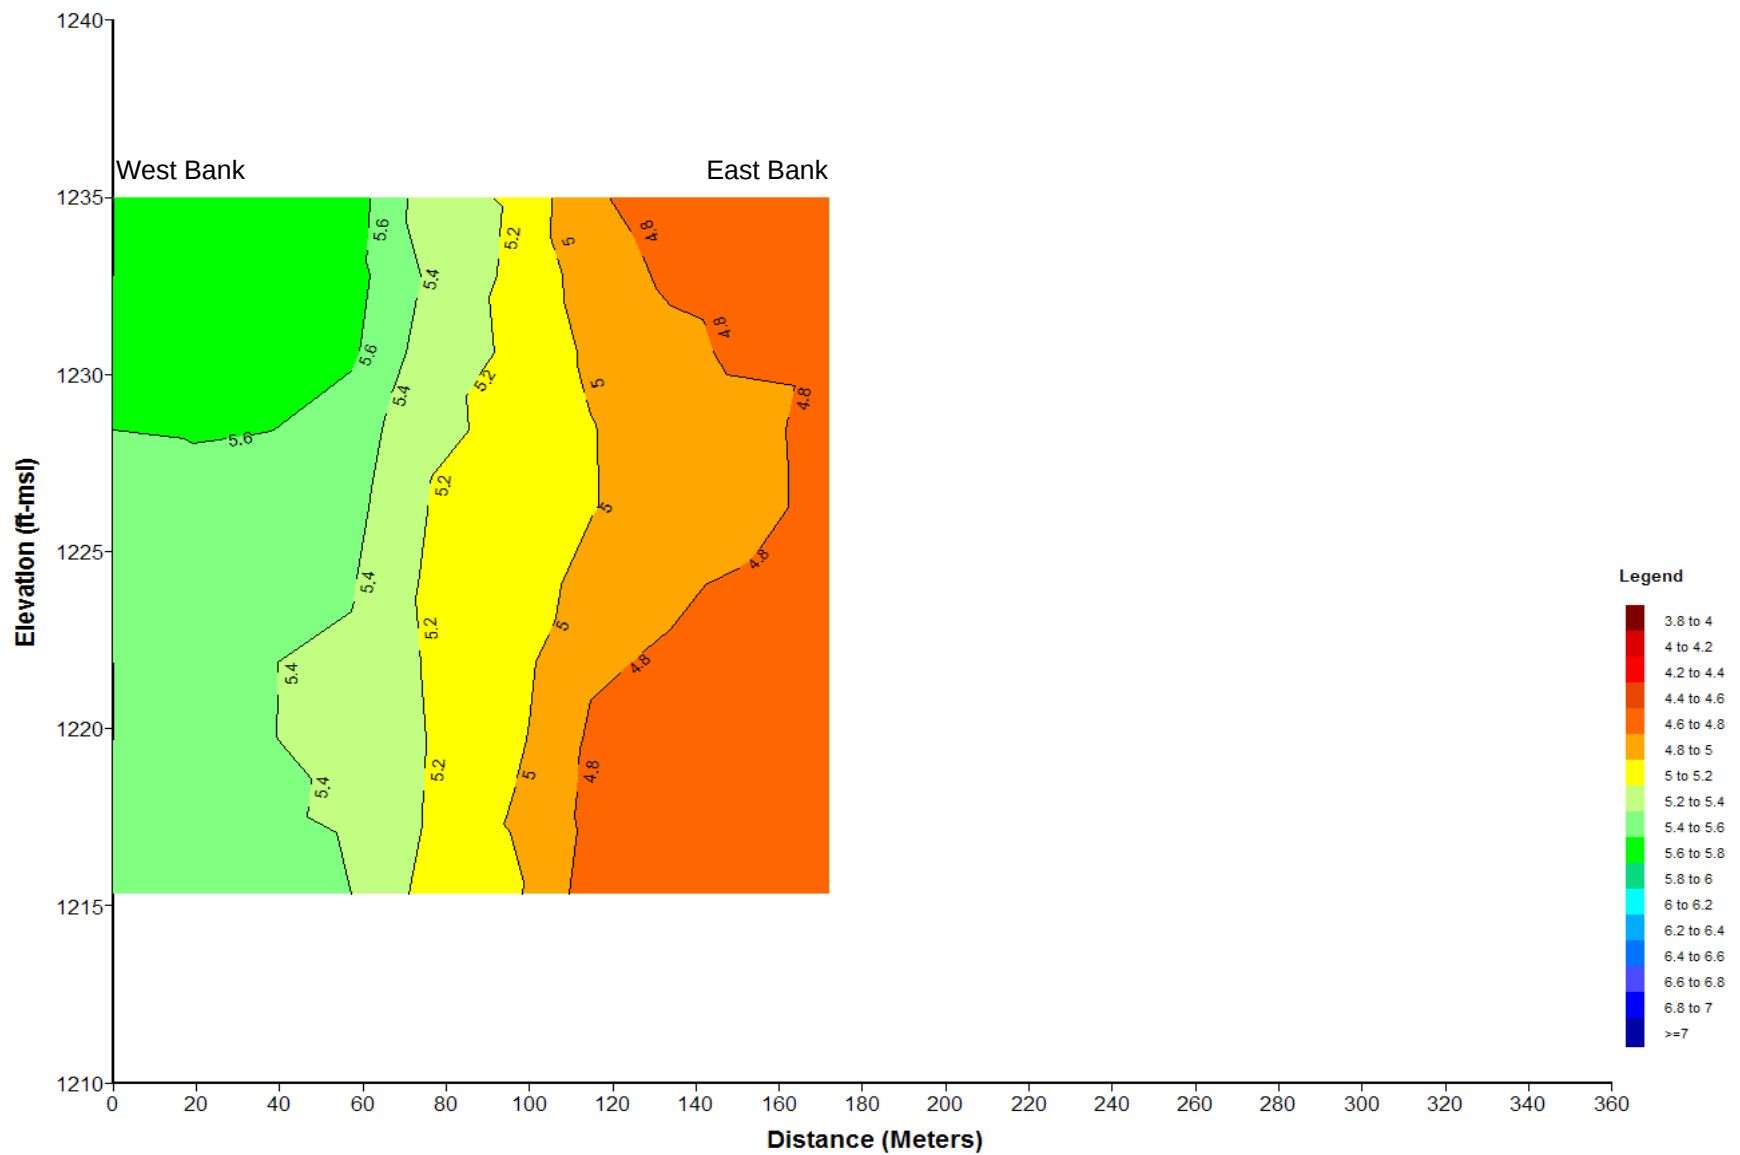
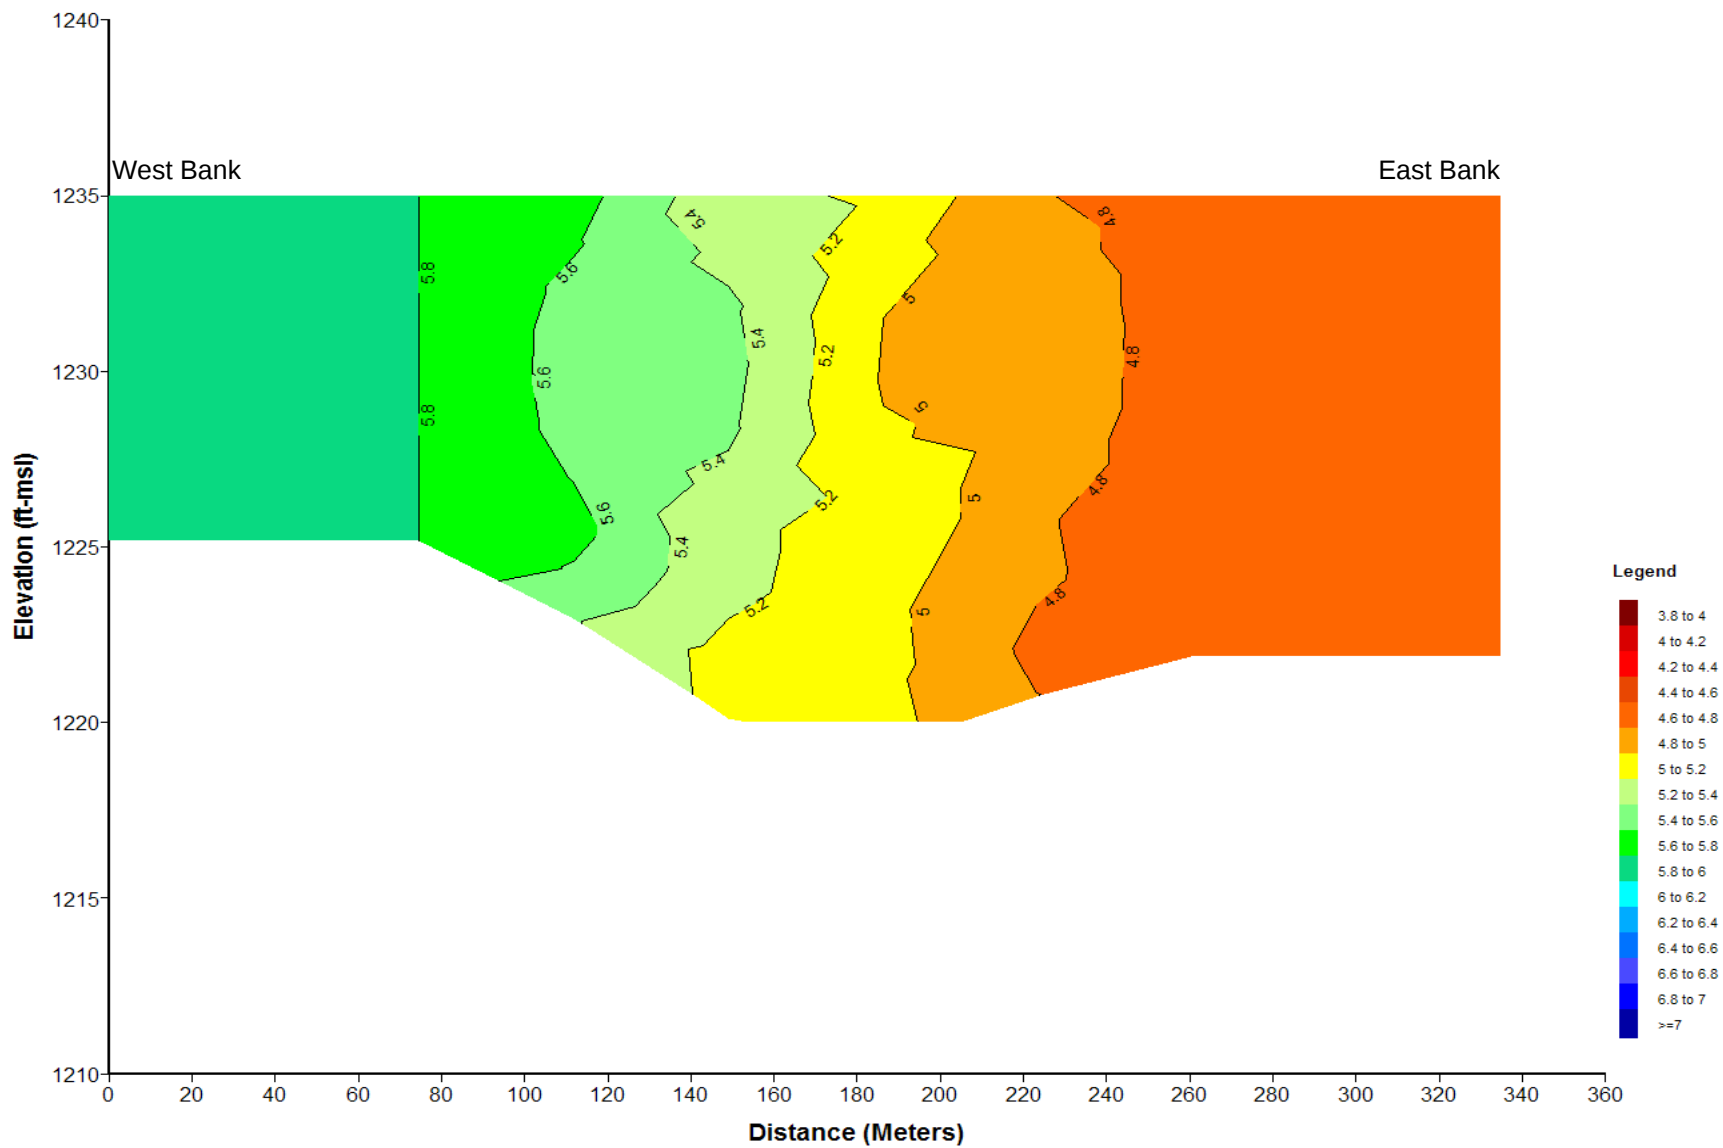
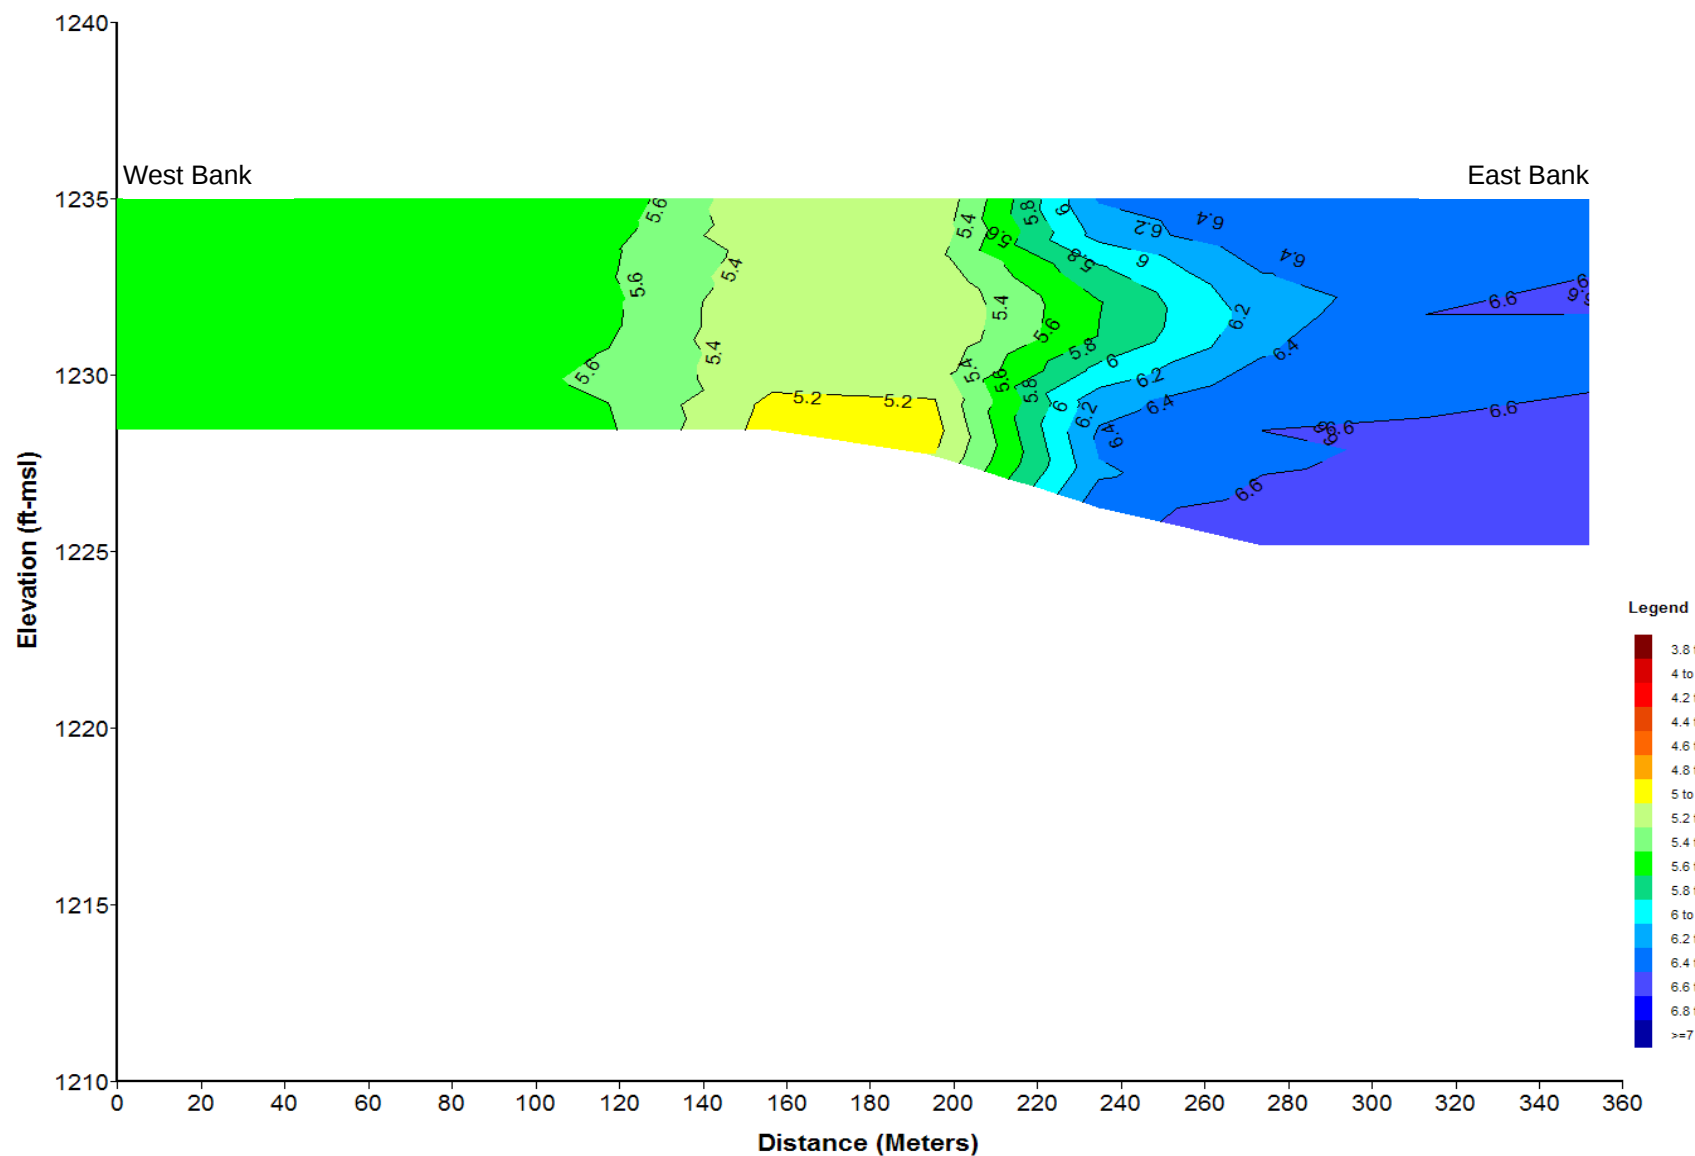
Figures 47, 48, and 49, respectively, display transect contour plots that were constructed to depict the dissolved oxygen concentrations measured across the Fort Randall Dam tailwaters at the near-dam (FTRTW3), spillway confluence (FTRTW2), and downstream (FTRTW1) sites on 24-August-2010. Figure 50 displays an aerial contour plot of the water-column average dissolved oxygen concentrations in the tailwaters based on the 1-meter incremental depth-profile measurements.

of the dam, and the downstream monitored transect was located downstream of the spillway inflow (Figure 18). Monitoring on August 24 and 26 indicated that spilling water re-oxygenated the Fort Randall tailwaters along the east bank downstream of the spillway inflow (Figures 47 - 54). Also, higher dam discharges generally resulted in higher dissolved oxygen levels in the tailwaters – especially earlier in the monitored period.

**Figure 47.** Contour plot depicting dissolved oxygen concentrations measured across the near-dam transect (FTRTW3) on August 24, 2010.

**Figure 48.** Contour plot depicting dissolved oxygen concentrations measured across the spillway transect (FTRTW2) on August 24, 2010.

**Figure 49.** Contour plot depicting dissolved oxygen concentrations measured across the downstream transect (FTRTW1) on August 24, 2010.

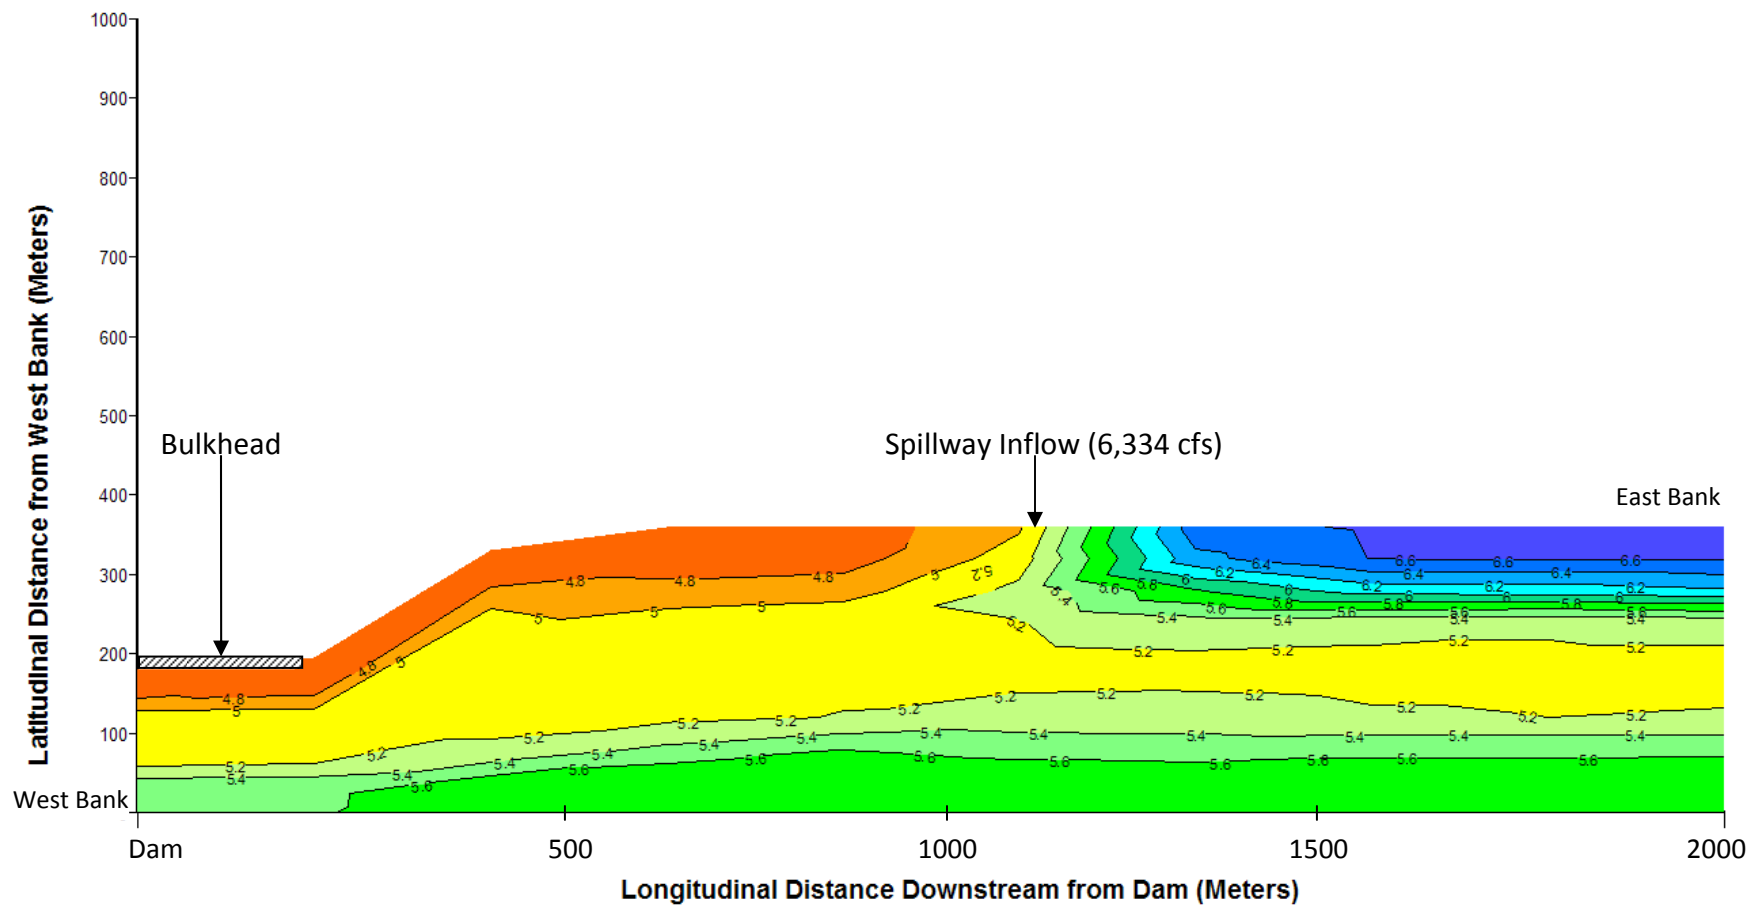
**Figure 50.** Contour plot of average water-column dissolved oxygen concentrations for the Fort Randall Dam tailwaters on August 24, 2010. Water-column average based on 1-meter depth-profile dissolved oxygen measurements taken at the near-dam, spillway confluence, and downstream transects. Plot is an aerial view from above with the dam to the left, flow going to the right, west bank on the bottom, and the east bank on the top (see Figure 18 for an aerial photo of the area).

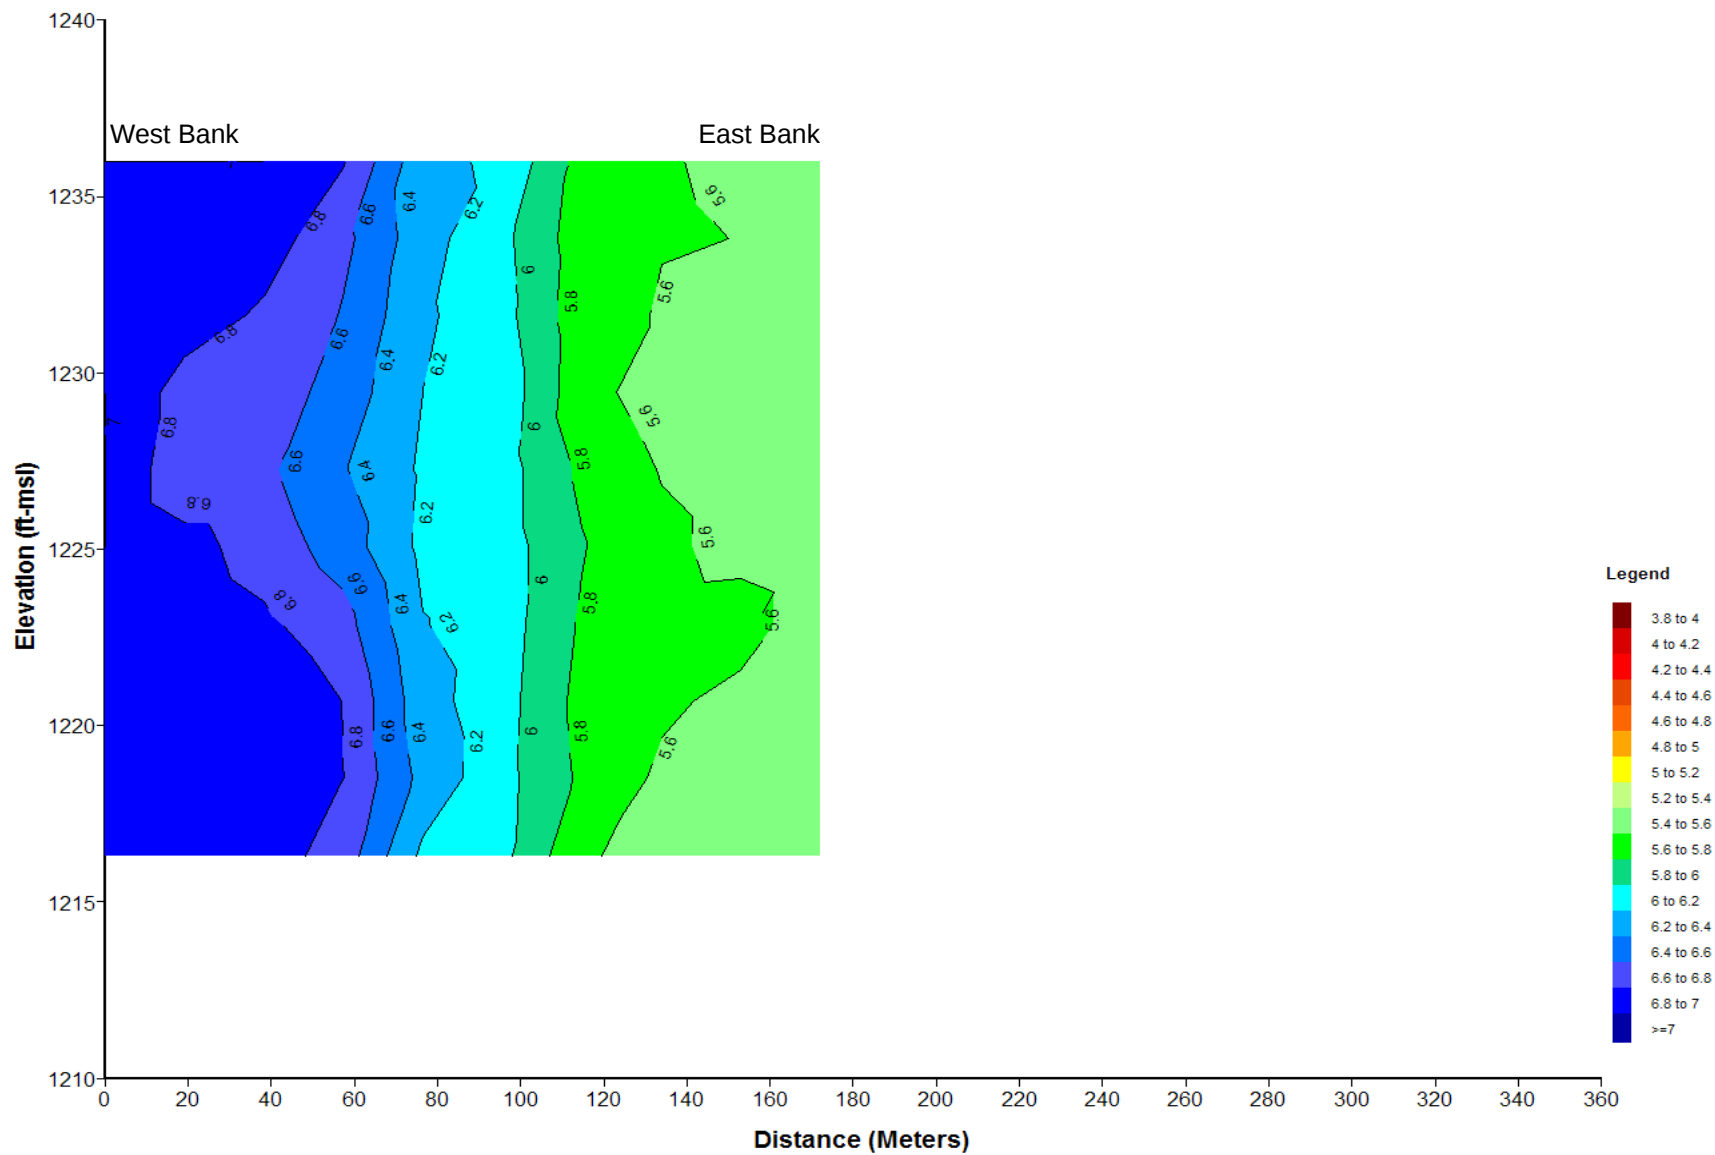
Figures 51, 52, and 53, respectively, display transect contour plots that were constructed to depict the dissolved oxygen concentrations measured across the Fort Randall Dam tailwaters at the near-dam (FTRTW3), spillway confluence (FTRTW2), and downstream (FTRTW1) sites on 26-August-2010. Figure 54 displays an aerial contour plot of the water-column average dissolved oxygen concentrations in the tailwaters based on the 1-meter incremental depth-profile measurements.

**Figure 51.** Contour plot depicting dissolved oxygen concentrations measured across the near-dam transect (FTRTW3) on August 26, 2010.

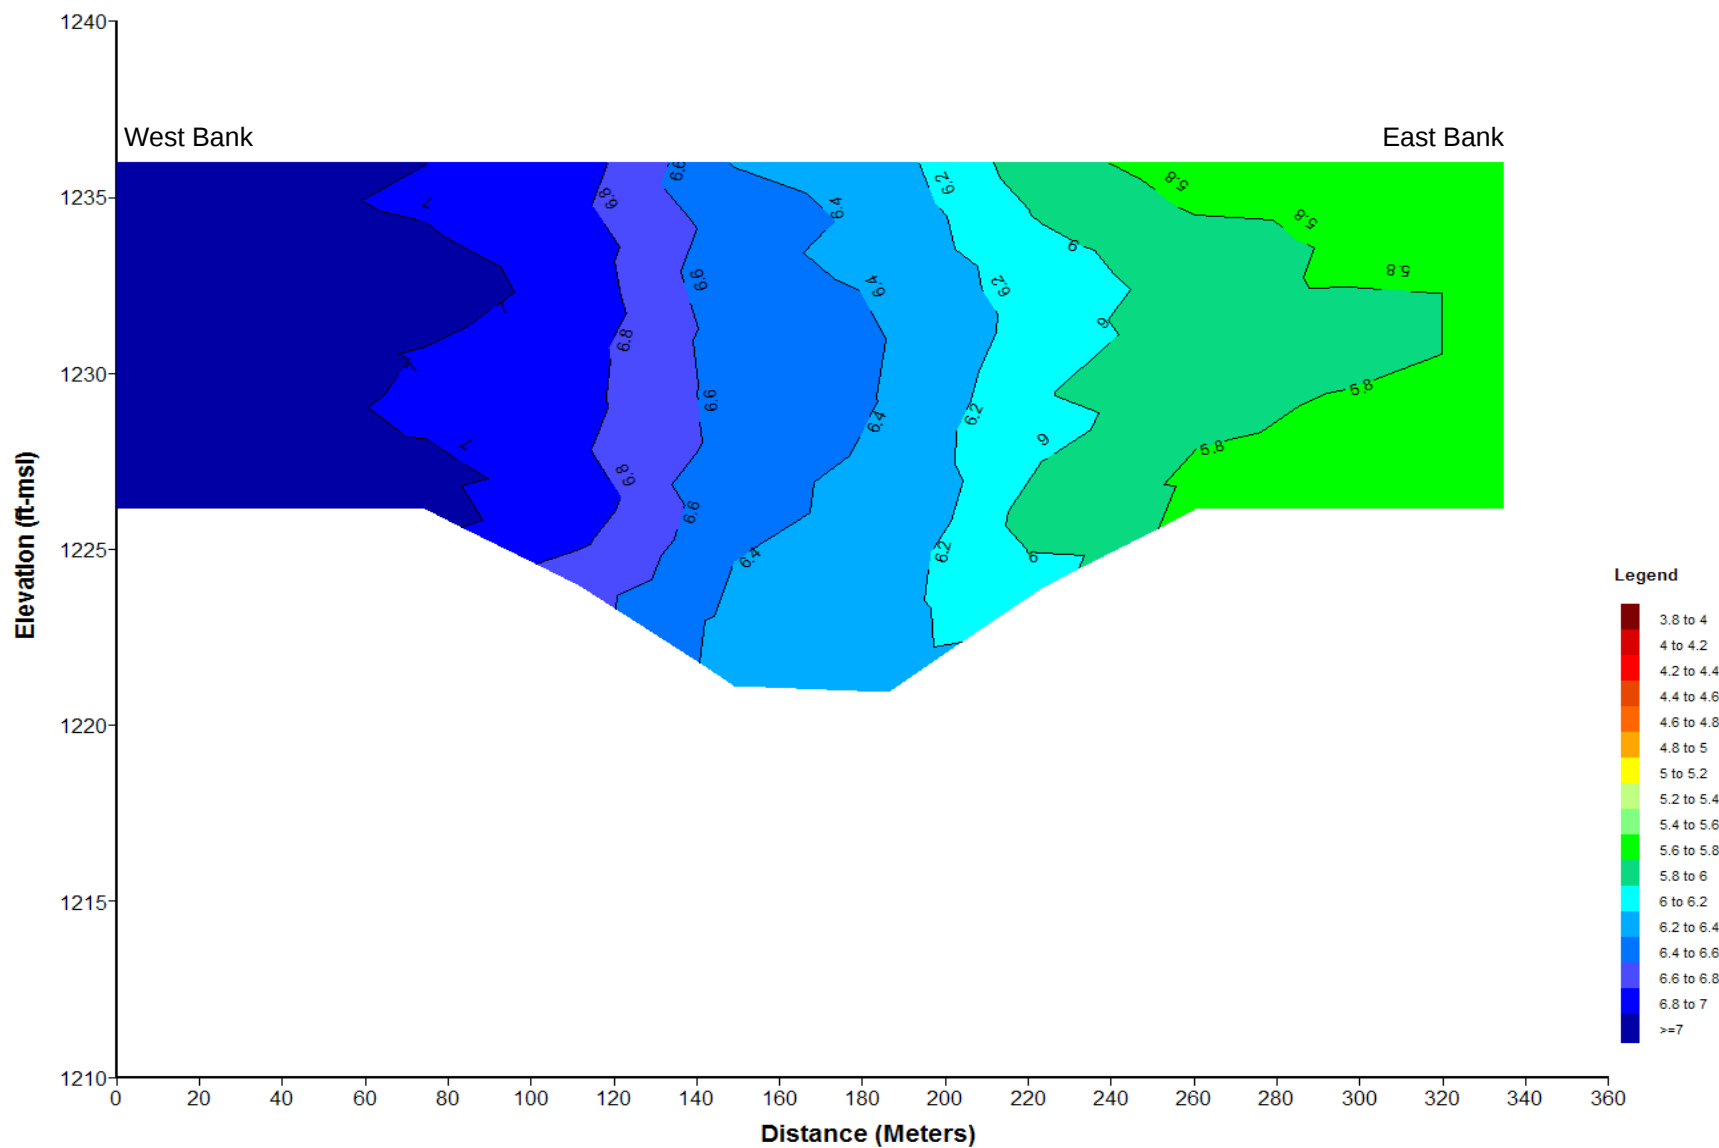
**Figure 52.** Contour plot depicting dissolved oxygen concentrations measured across the spillway transect (FTRTW2) on August 26, 2010.

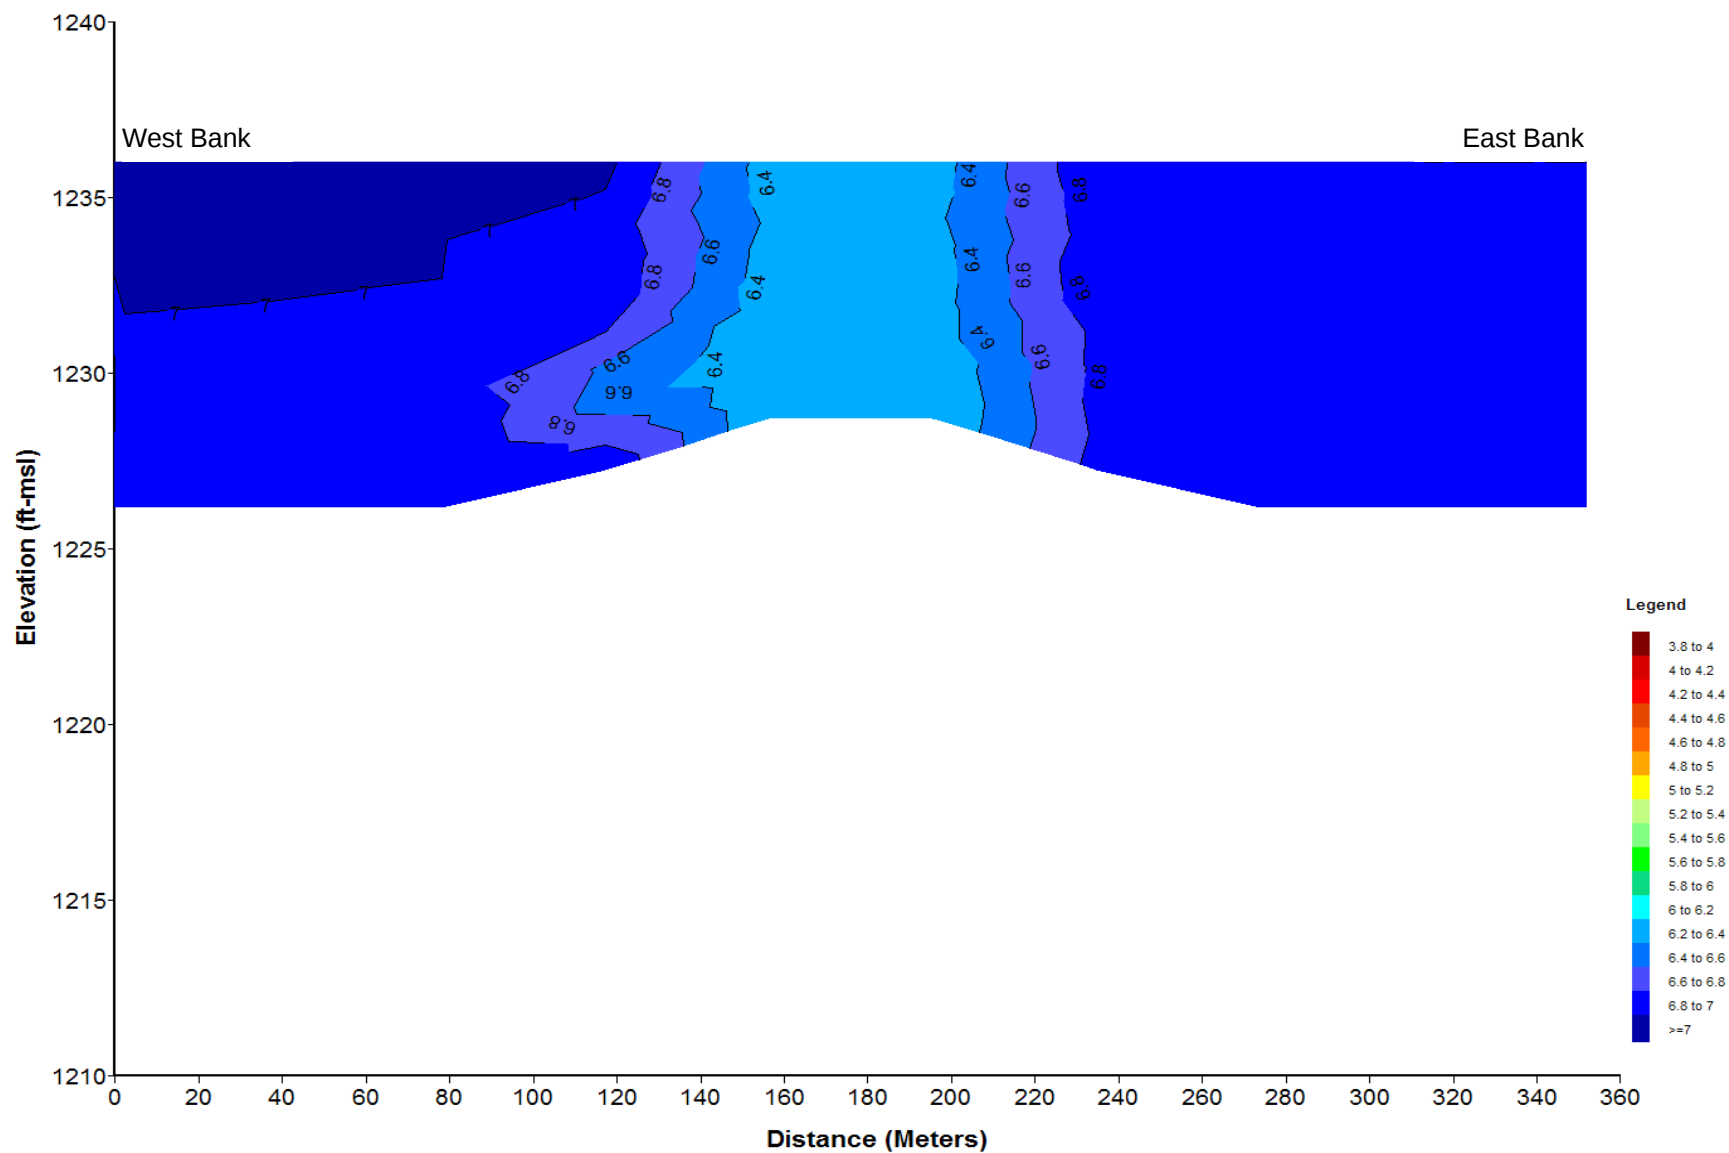
**Figure 53.** Contour plot depicting dissolved oxygen concentrations measured across the downstream transect (FTRTW1) on August 26, 2010.
